Proposed New Roof Over Car Stands 193 Whale Beach Road, Whale Beach NSW

Geotechnical Investigation

Our ref: 7799- R1
13 May 2025

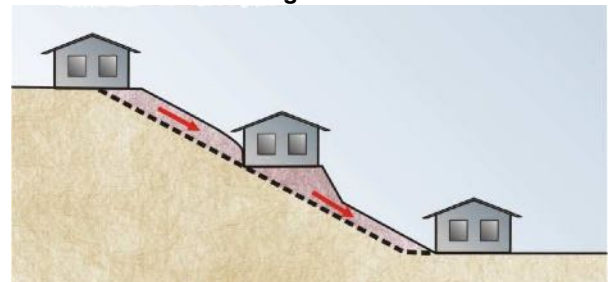
Figure 2

Translational slip failures (Figure 2) - tend to occur on moderate to very steep slopes (Table 1) where soil, or weak rock, overlies stronger strata. The sliding mass is often relatively shallow. It can move, or deform slowly (creep) over long periods of time. Extensive linear cracks and hummocks sometimes form along the contours. The sliding mass may accelerate after heavy rain.

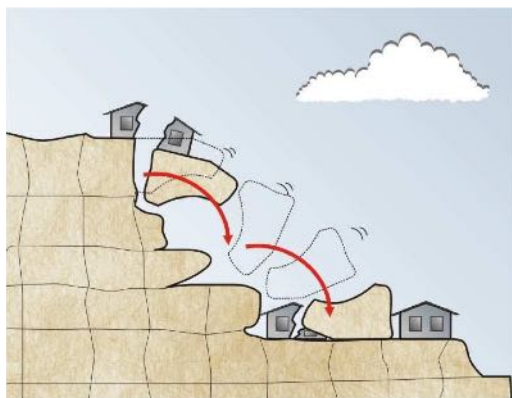
Figure 1 - Failure of an undercut block

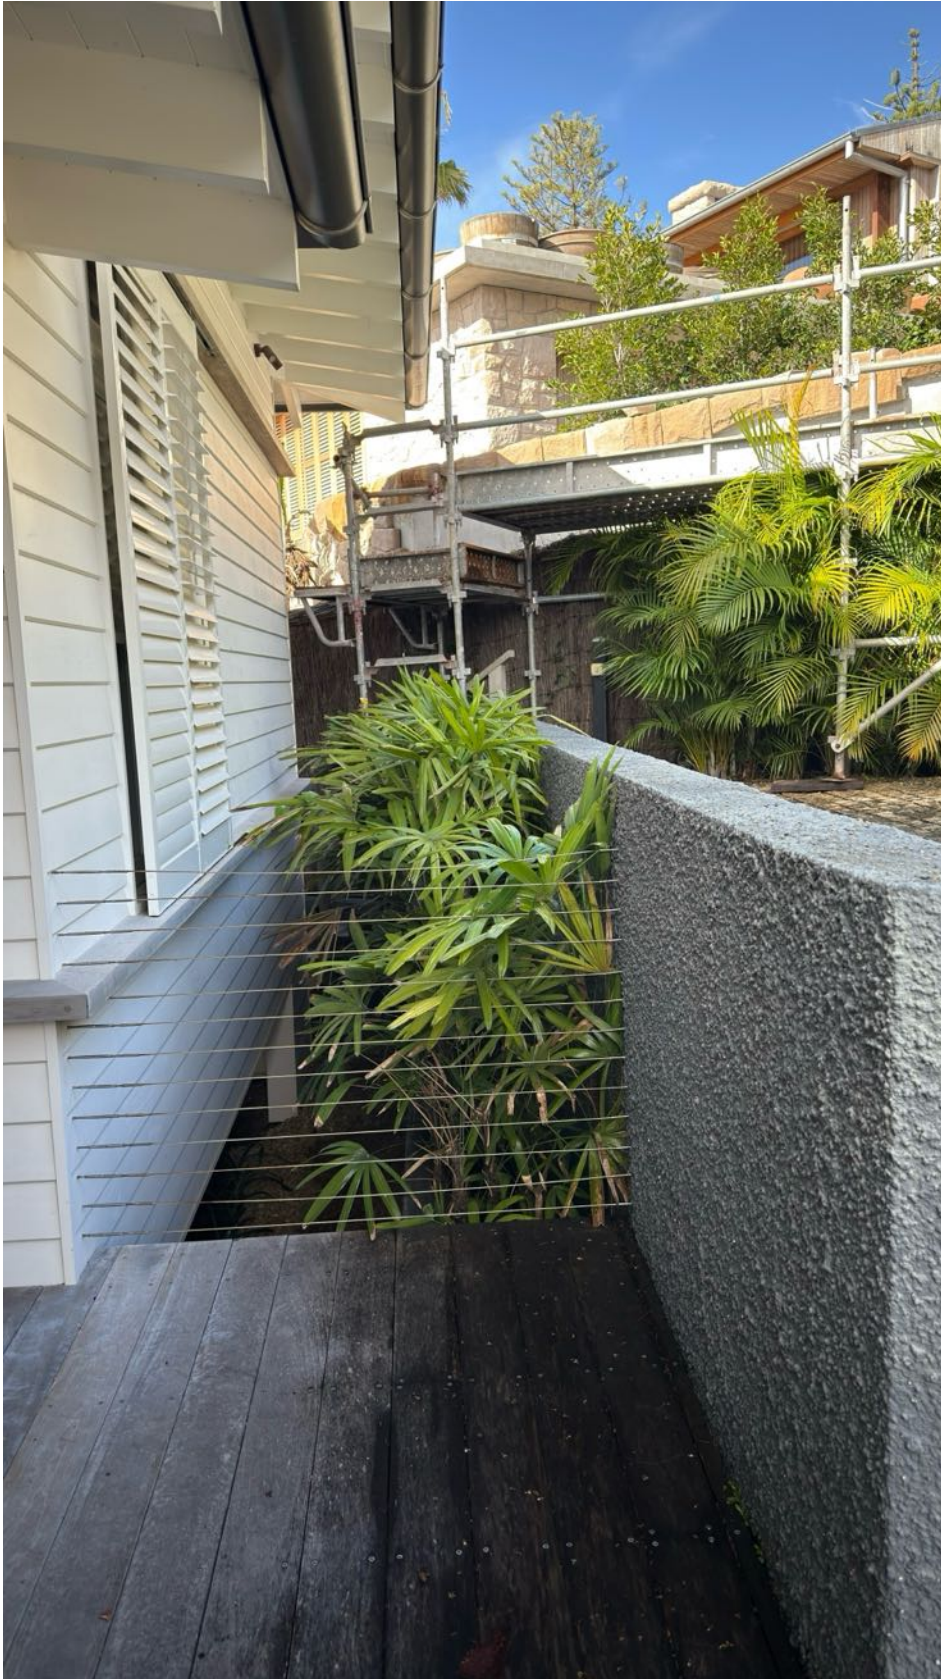
Photo 2 – View of rendered concrete block retaining wall at front.

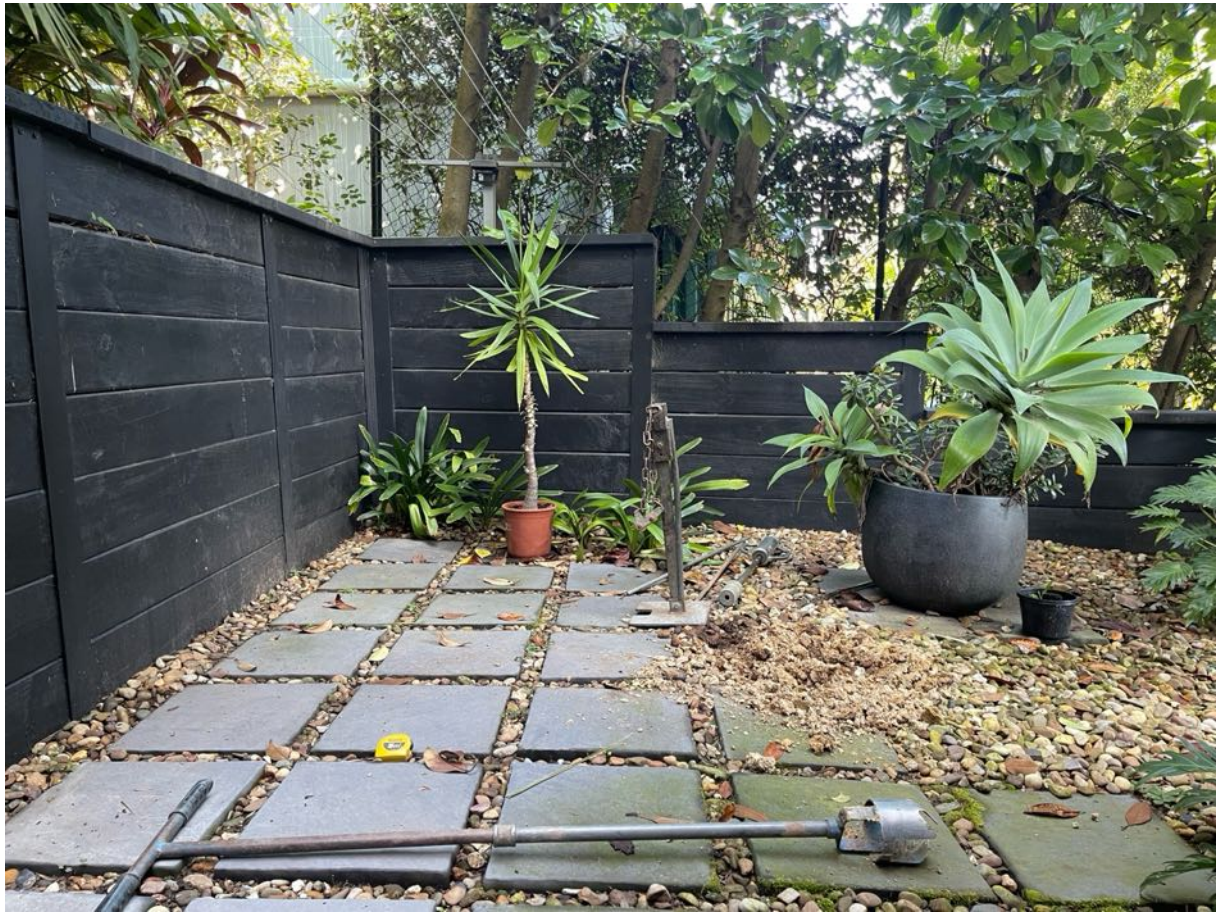
Photo 3 – BH01 Location, note timber sleeper cantilever wall with steel post

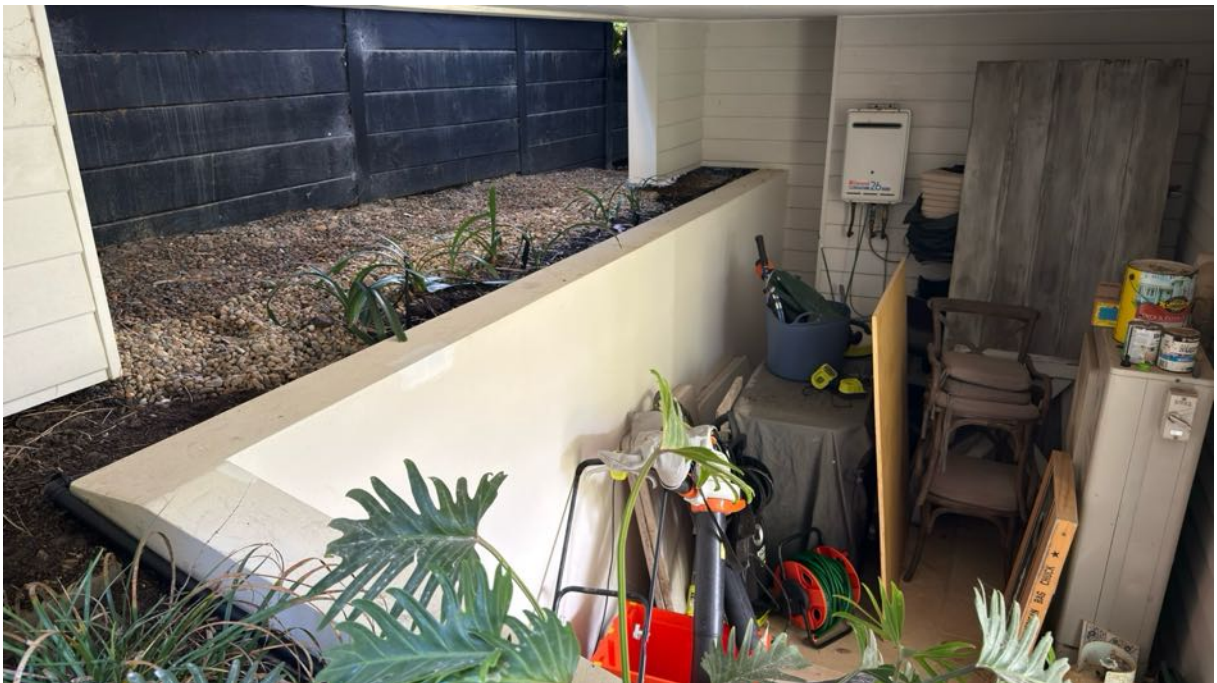
Photo 5 – Rendered concrete wall at lower level of house.

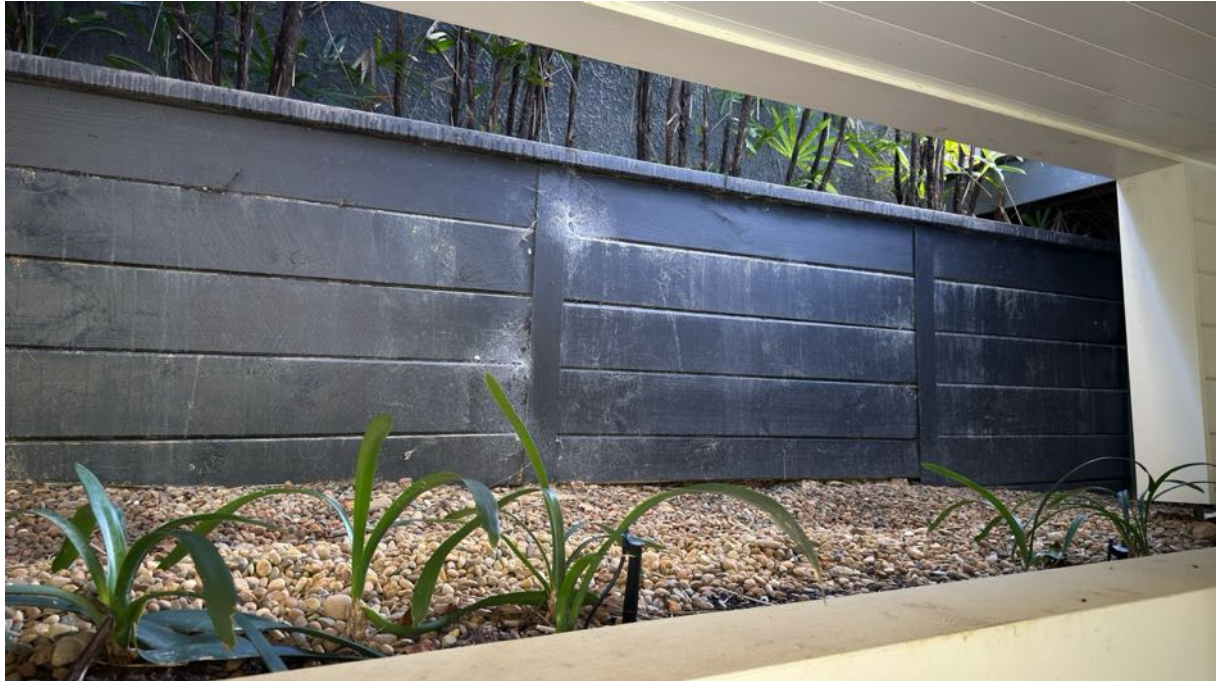
Photo 6 – Closeup view of timber sleeper cantilever wall with steel posts.

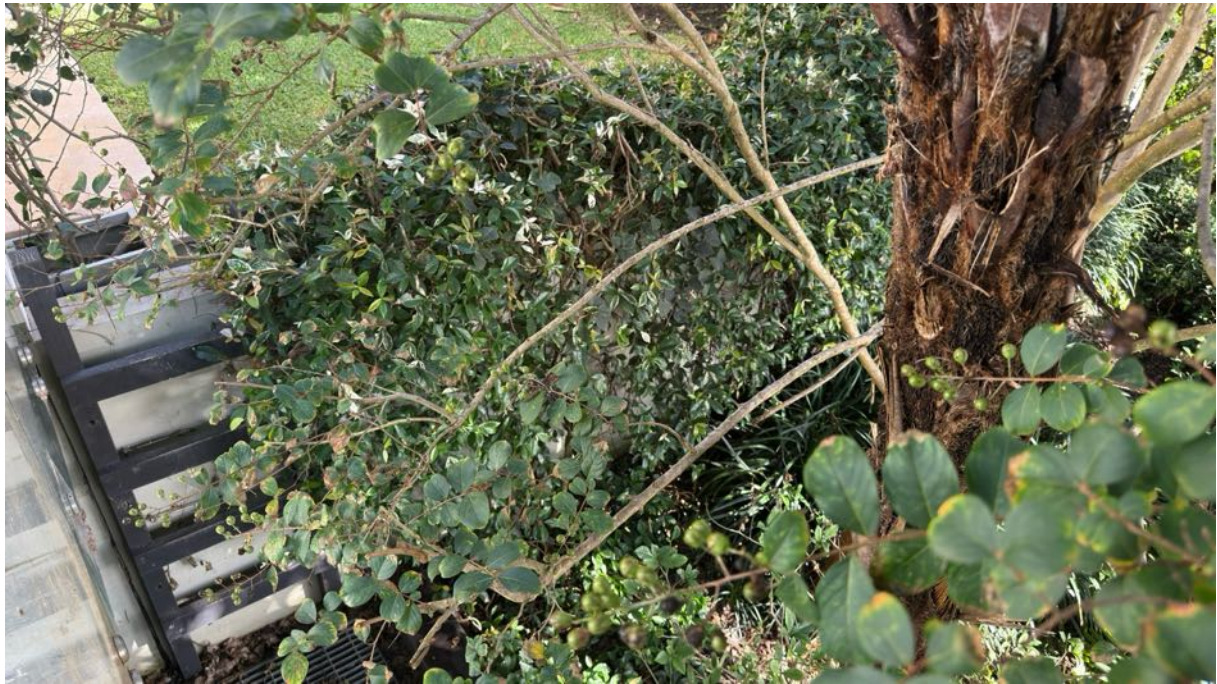
Photo 7 – View of concrete wall at lower part of site adjacent to pool.
