Geotechnical Assessment

For Building Information Certificate Application

Related to As-Built Studio at

4 Kemble Place, Bilgola Plateau NSW

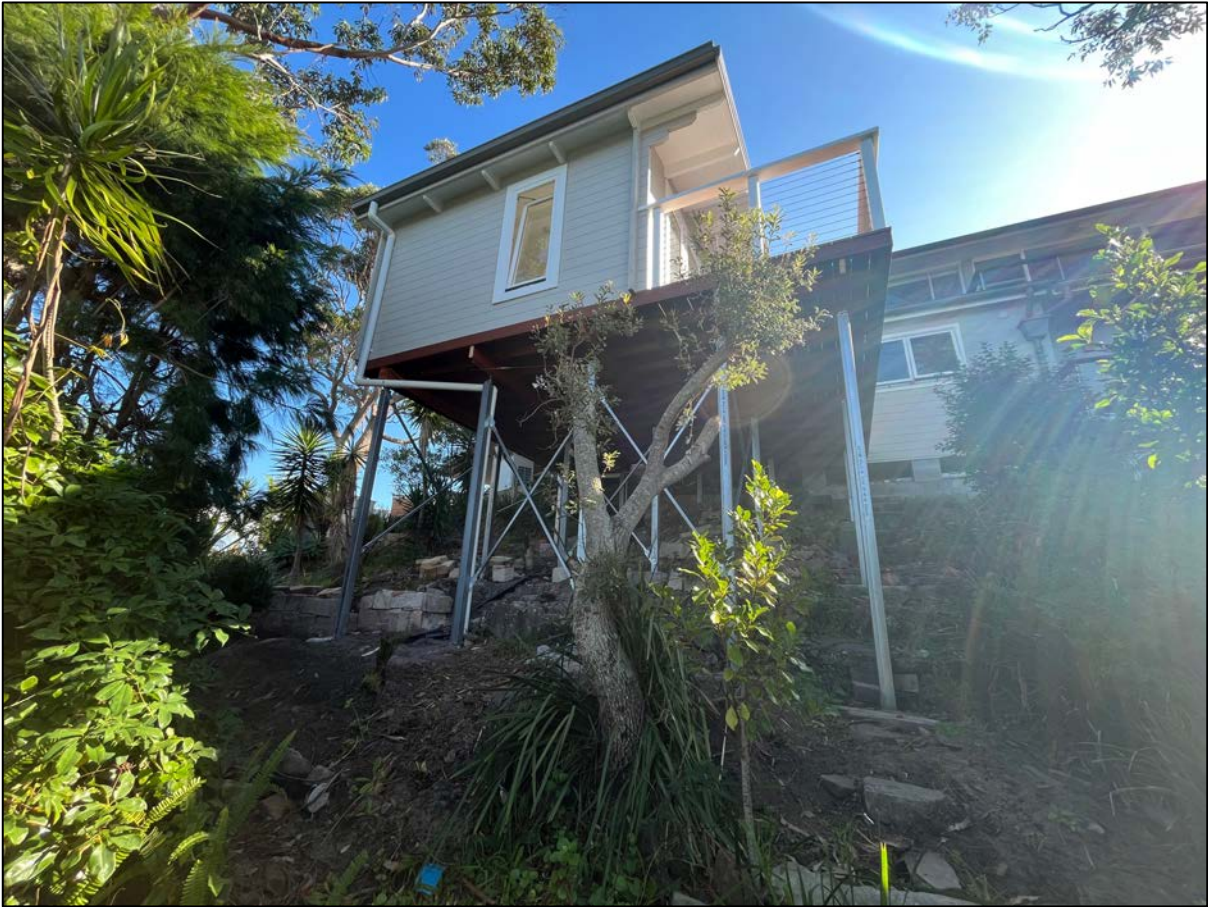
This assessment relates to the unauthorised construction of a studio on the south-eastern rear of the existing dwelling (Photo 1). The structure is a single storey timber clad studio supported on steel posts, founded on concrete pier footings bearing on sandstone bedrock, as confirmed in statutory declaration (attached at the end of this report) by the builder Shayne Price, builders licence # 280310C.

The as-built studio is considered to be well constructed and has been founded directly upon foundation material with an allowable end bearing pressure appropriate for the structural requirement for the safe construction of structures of this type.

The as-built existing studio is considered suitable for the site. Its construction does not constitute a significant geotechnical hazard, nor does it compromise the stability of any existing landforms or structures on or adjacent to the site.

Photo 1. As-built studio

We recommend that sandstone landscaping boulders leaning against some of the steel post footings be removed, to eliminate point loads from landscaping materials impacting on the posts.
