# **HERITAGE IMPACT STATEMENT**

For the change of use to a gymnasium with  
associated fit-out and signage

**at Office No. 4, 4-10 Inman Road, Cromer**

Issue A – July 2023

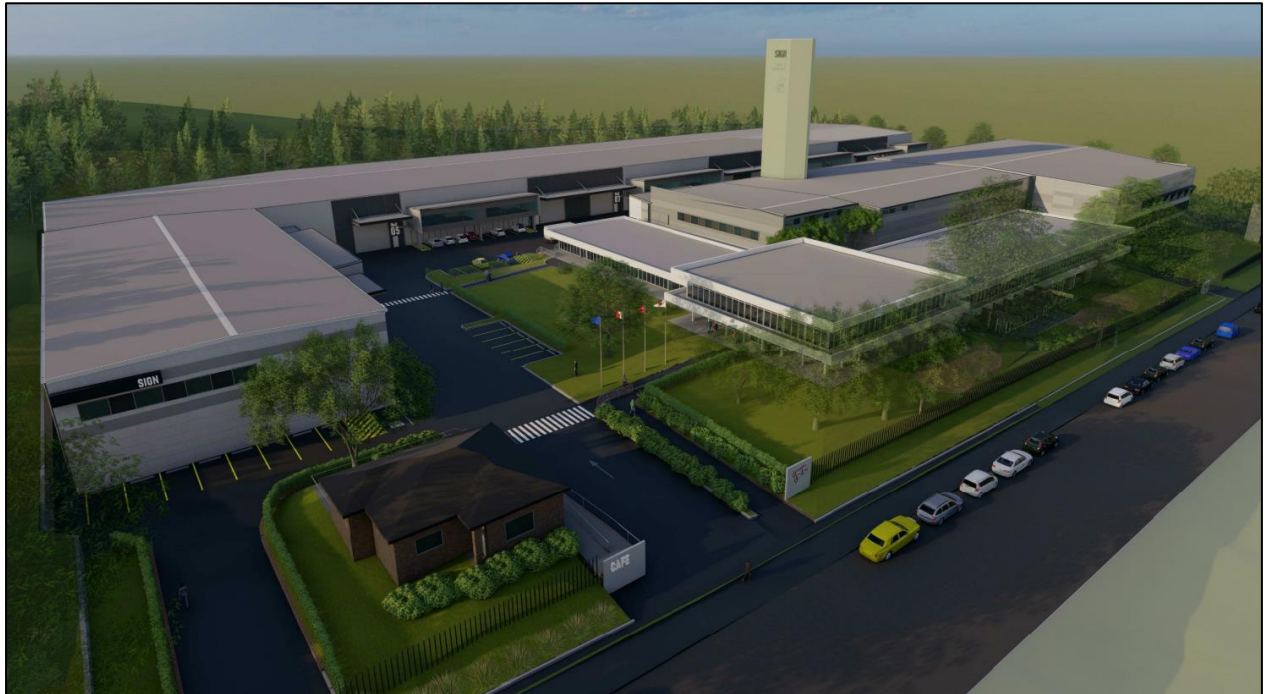
**Figure 04:** Approved development at No. 4-10 Inman Road, Cromer

The subject site was approved for demolition works and alterations and additions to an existing industrial facility, including new warehouse, self-storage, office premises and ancillary café on 17th August 2020 under DA2019/1346. Office 4 is currently vacant.
