SERVICE PROTECTION REPORT

57 CUTLER ROAD CLONTARF.

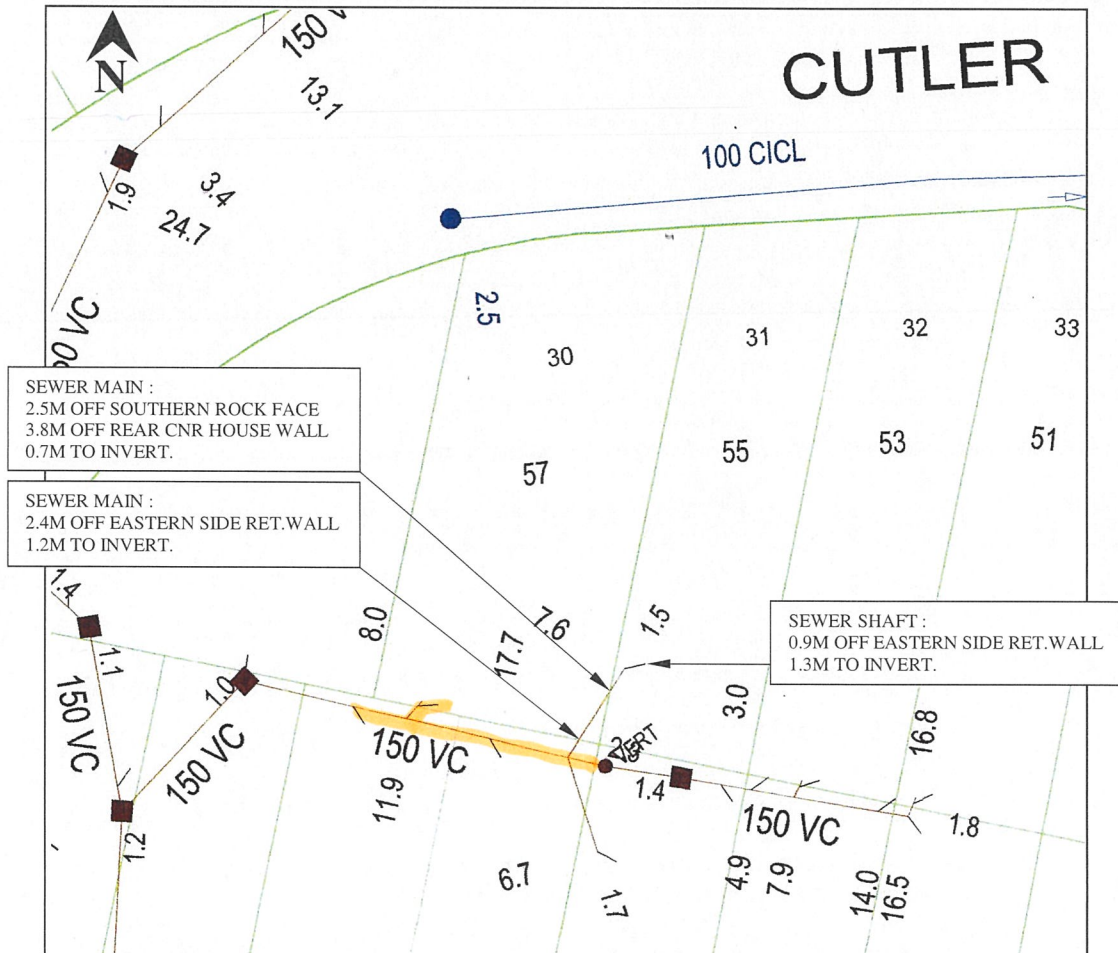
Asset Location Method: Electronic Equipment / Accessing Structures.

Pipe Size: 150mm / 150mm **Pipe Type:** VC / PVC.

Strata: Soil / Rock **Asset Indicators:** Paint marks.

NB : ALL MEASUREMENTS TAKEN OFF RET. WALL / HOUSE / ROCK FACE ONLY.

DIMENSIONS REFLECTED IN THIS REPORT MAY NEED TO BE CONFIRMED BY EXCAVATION EXPOSING THE SYDNEY WATER ASSETS PRIOR TO DESIGN / PIERING / CONSTRUCTION WORK COMMENCING ON SITE IF WITHIN THE ZOI.
