AG-1566_1

13th August 2024

RE: Site Classification at 75 Cheryl Cr, NEWPORT, NSW

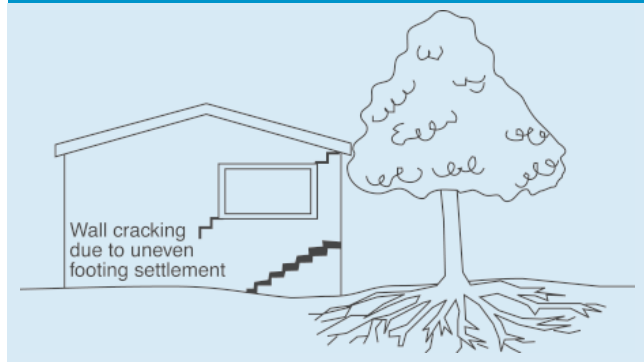
Trees can cause shrinkage and damage

Trees and shrubs that are allowed to grow in the vicinity of footings can cause foundation soil movement in two ways:

- Roots that grow under footings may increase in cross-sectional size, exerting upward pressure on footings.
- Roots in the vicinity of footings will absorb much of the moisture in the foundation soil, causing shrinkage or subsidence.

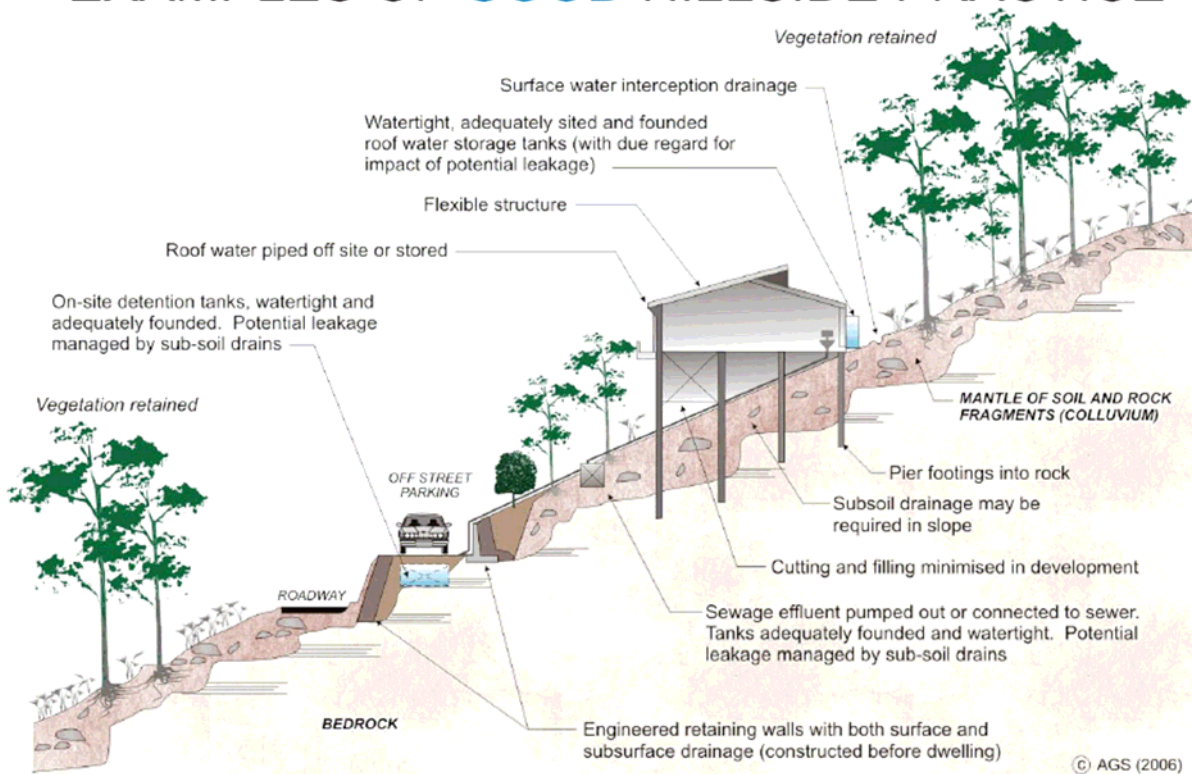
EXAMPLES OF **GOOD** HILLSIDE PRACTICE

FILLS	Minimise height. Strip vegetation and topsoil and key into natural slopes prior to filling. Use clean fill materials and compact to engineering standards. Batter to appropriate slope or support with engineered retaining wall. Provide surface drainage and appropriate subsurface drainage.	Loose or poorly compacted fill, which if it fails, may flow a considerable distance including onto property below. Block natural drainage lines. Fill over existing vegetation and topsoil. Include stumps, trees, vegetation, topsoil, boulders, building rubble etc in fill.
ROCK OUTCROPS & BOULDERS	Remove or stabilise boulders which may have unacceptable risk. Support rock faces where necessary.	Disturb or undercut detached blocks or boulders.
RETAINING WALLS	Engineer design to resist applied soil and water forces. Found on rock where practicable. Provide subsurface drainage within wall backfill and surface drainage on slope above. Construct wall as soon as possible after cut/fill operation.	Construct a structurally inadequate wall such as sandstone flagging, brick or unreinforced blockwork. Lack of subsurface drains and weepholes.

FOOTINGS	Found within rock where practicable. Use rows of piers or strip footings oriented up and down slope. Design for lateral creep pressures if necessary. Backfill footing excavations to exclude ingress of surface water.	Found on topsoil, loose fill, detached boulders or undercut cliffs.
SWIMMING POOLS	Engineer designed. Support on piers to rock where practicable. Provide with under-drainage and gravity drain outlet where practicable. Design for high soil pressures which may develop on uphill side whilst there may be little or no lateral support on downhill side.	
DRAINAGE		
SURFACE	Provide at tops of cut and fill slopes. Discharge to street drainage or natural water courses. Provide general falls to prevent blockage by siltation and incorporate silt traps. Line to minimise infiltration and make flexible where possible. Special structures to dissipate energy at changes of slope and/or direction.	Discharge at top of fills and cuts. Allow water to pond on bench areas.
