**Proposed Mixed-Use Development  
351-353 Barrenjoey Road, Newport NSW**

Preliminary Geotechnical Assessment

Our ref: 5622-G1 Rev 2  
22 September 2021

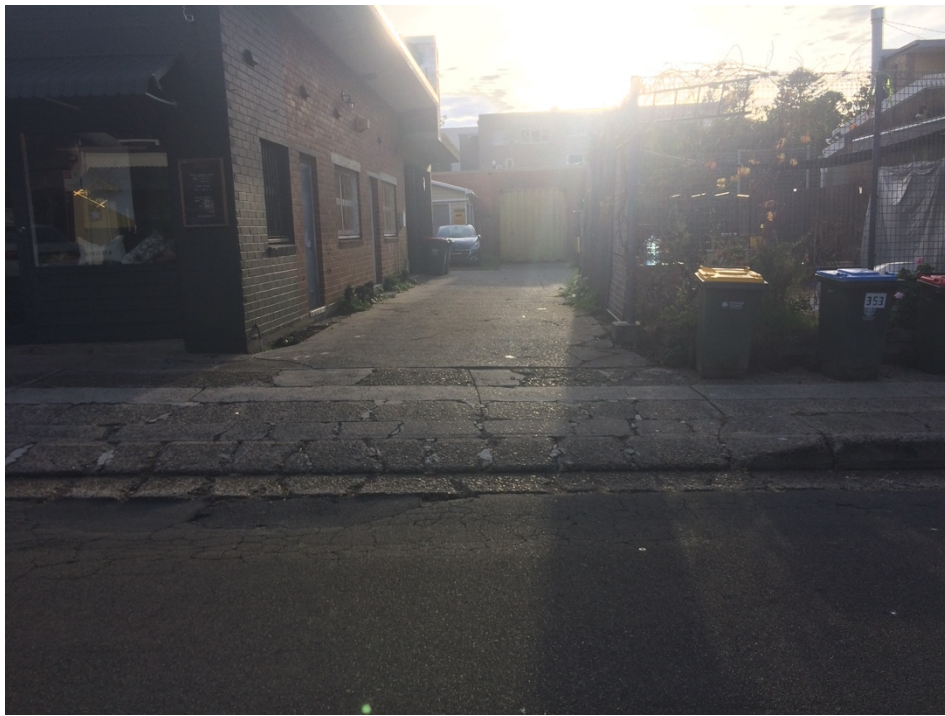
**Photo 1**  
Driveway via Robertson  
Road, cracks on  
concrete pavement
