Site Classification as per AS2870-2011

Lot 6, No. 29-31 Lorikeet Grove, Warriewood

Site Classification	CLASS P
Site Features	Vacant site with grasses and street trees
Ground Slope	Gentle
Proposed Earthworks	Unknown (refer "about your report")
Ys Range (normal)	41-60 mm (Hs = 1800 mm)
Ips Value	TS1 (500-800 mm) = 2.8%
Water Table	Not present

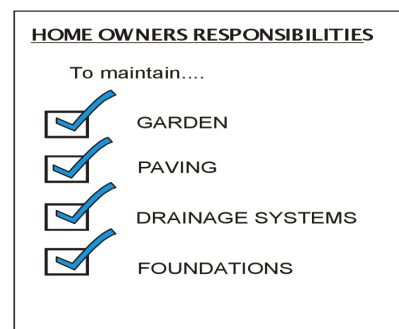
Fig.7

The home owner should read and become familiar with the Site Classification report provided prior to construction and the type of footing system used in the building. To comply with Australian Standard 2870 – "Residential slabs and footings", and achieve acceptable performance and safety during the design life of the house, the owners shall maintain the garden and foundation soil moistures, paving and drainage systems. (Fig. 7)
