Geotechnical Investigation Report 5 Mulawa Place, Frenchs Forest NSW

Stephan & Dearne Cameron
 5 Mulawa Place, Frenchs Forest NSW
 Geotechnical Investigation
 Borehole Location Plan

Project No: P1355
 Client: Stephan & Dearne Cameron
 Project: Residential Development
 5 Mulawa Place
 Frenchs Forest NSW

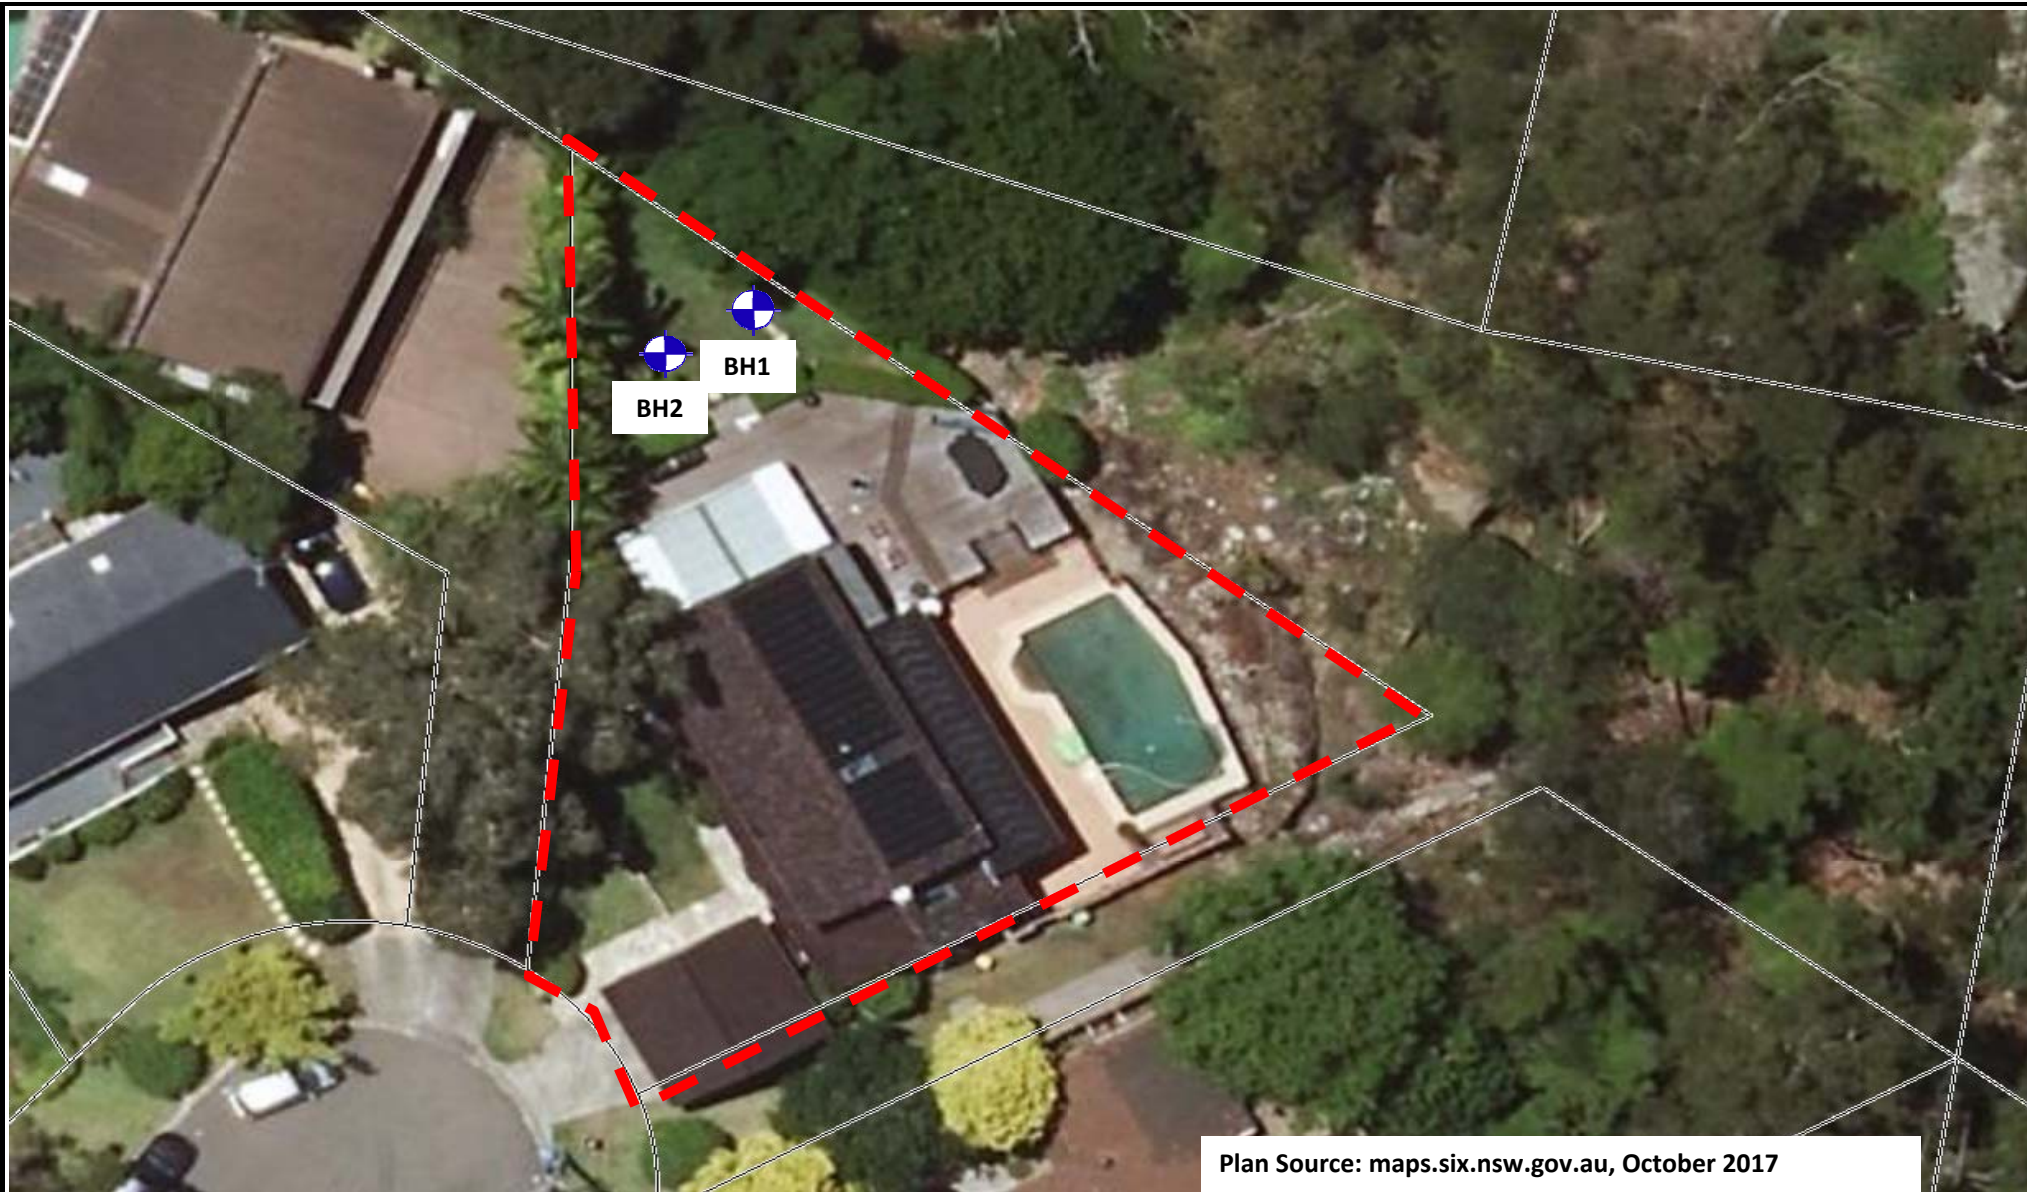
Figure:

A senior engineering geologist inspected the site on 24 October 2017. Two hand auger boreholes were drilled during the investigation. Dynamic Cone Penetrometer (DCP) tests were carried out adjacent to borehole locations to assess soil consistency and density. The approximate borehole locations are shown on the attached plan.
