martens consulting engineers

Onsite Wastewater Assessment: 17 Thompson Street, Scotland Island, NSW.

P2108321JR02V02 May 2022

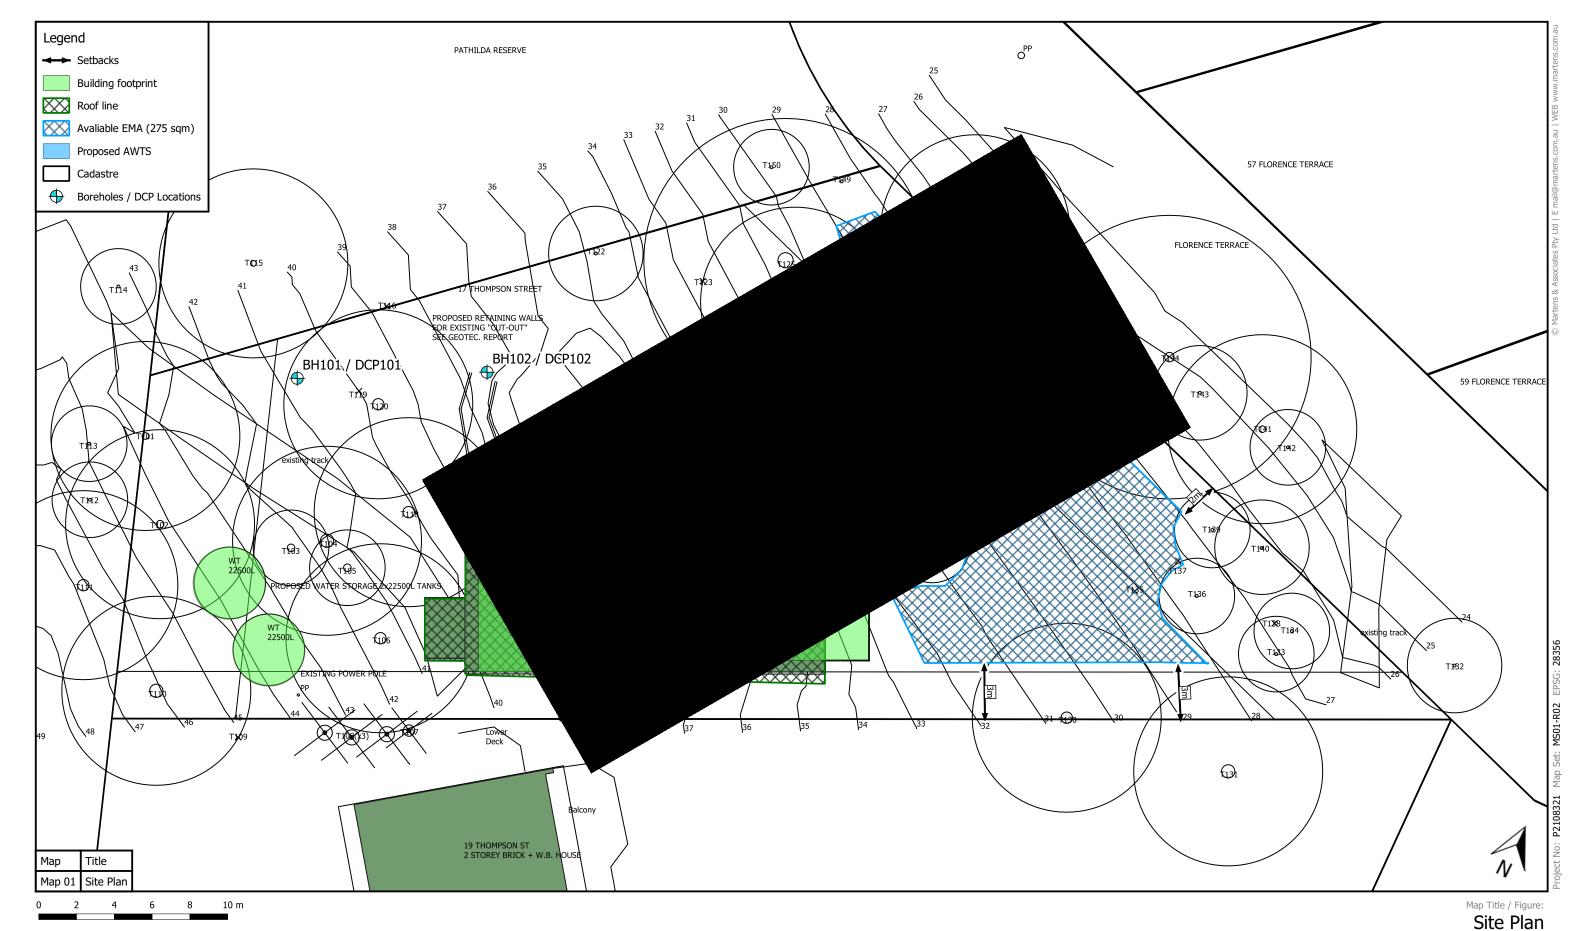
6 Attachment B – Site Wastewater Plan

A suitable available EMA of 275 m<sup>2</sup> is shown in Attachment B.

Source: Design Waves (2022) Site Plan, Drawing No 02, Revision DA.1, dated 03 May 2022.

Refer to the site plan in Attachment A for the proposed EMA, borehole locations, setback distances and location of the proposed building footprint (Attachment B).

EMA to be constructed as a subsurface irrigation system as shown on attached plan. Irrigation laterals are to be laid at 1 m centres parallel to site contours. Laterals are to be fixed in place. Laterals are to be laid directly into site topsoil at a depth of 150 mm.
