## **Proposed Alterations and Additions 828 Barrenjoey Road, Palm Beach, NSW**

Report on  
Geotechnical Investigation

3487-R1-Rev1  
3 March 2016

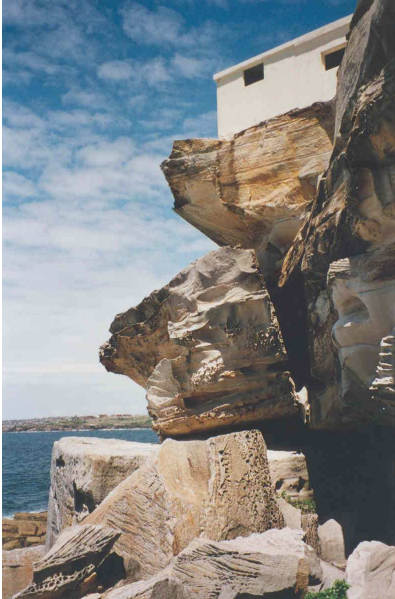
Photo courtesy Greg Kotze

Waves, wind and salt spray play a significant part, causing dunes to move and cliff-faces to erode well above sea level. Our response is often to try to neutralise these effects by doing such things as dumping rock in the sea, building groynes, dredging, or carrying out dune stabilisation. Such works can be very effective, but ongoing maintenance is usually needed and total reconstruction may be necessary after a relatively short working life.

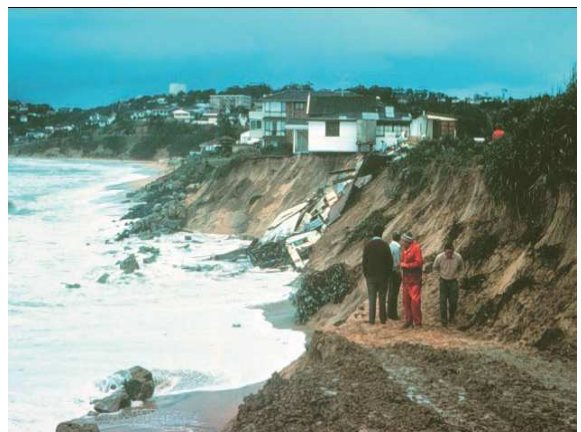
An understanding of coastal processes is essential when determining beach erosion potential. Waves produced by large oceanic storms can erode beaches and cut escarpments into dunes. These may be of relatively short duration, when beach rebuilding happens after the storm, but can be a permanent feature where long term beach recession is taking place. In many locations, houses and infrastructure are sited on or immediately behind coastal dunes. After an escarpment has eroded, those assets may be lost or damaged by subsequent slumping of the dune. It is important that, on erodible coastal soils, the potential for landward incursion of an erosion escarpment is determined. Having done this, the likelihood of slope instability can be established as part of the landslide risk management process. Injury, death and structural damage have occurred around the Australian coast from collapsing sand escarpments.

Photo courtesy DNR NSW
