## **Geotechnical Assessment**

**Project:** Alterations and Additions  
2 Alma Street, Clontarf NSW.

**REF: AG 20237**  
29 September, 2020

## Preliminary Geotechnical Assessment

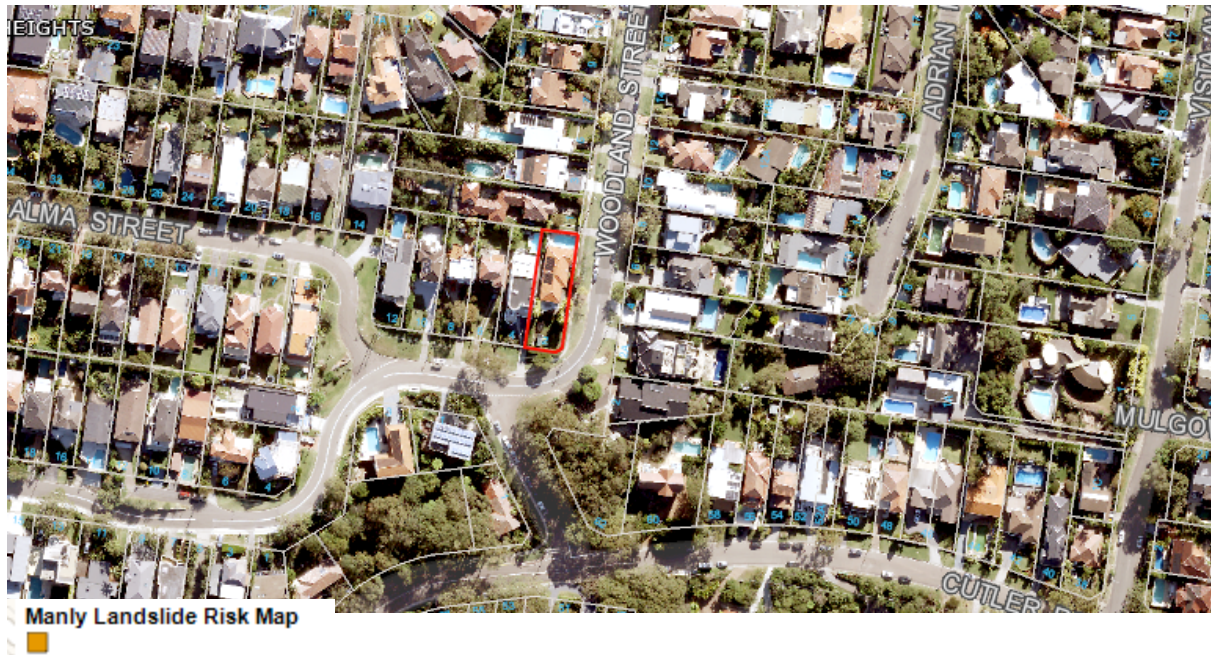
The site is not subject to specific landslip risk/geotechnical hazard mapping with reference to the Manly Landslip Risk Map (**Image 1**).

**Image 1.** 2 Alma Street, Clontarf. Manly Landslip Risk Map (© NBC)
