Our Ref: A16087B3: JT  
Council REF: DA2017/0206  
RFS REF: DA2014/1062

**Re: Review of bushfire issues outlined in the Planning Report  
The Falls Estate, Barnes Road, Frenchs Forest (Lot 1113 DP 752038)**

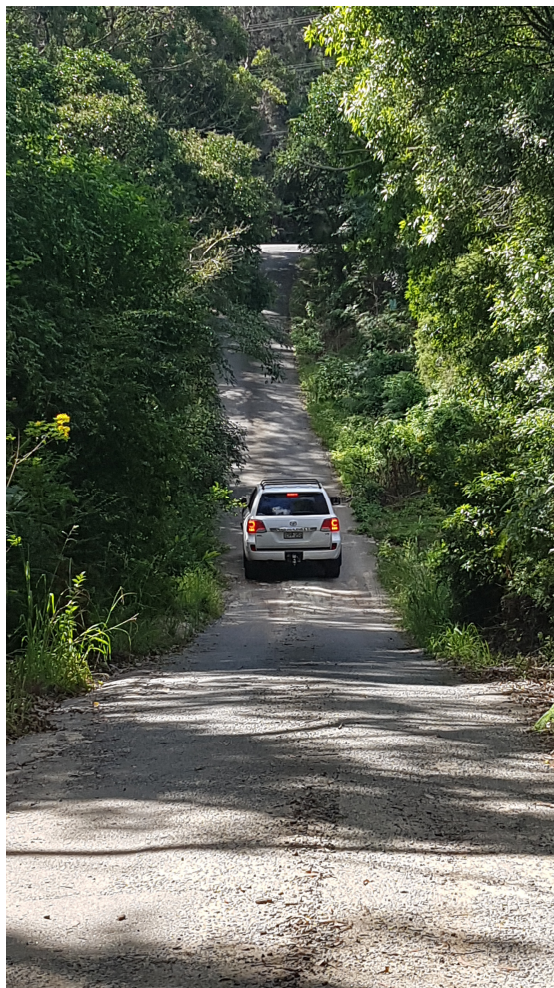
**Photo 1** – Barnes Road looking north

- Paved seal of 3 metres width.
- An obvious zone of mowing or slashing on its edge, albeit, not managed often but certainly not allowing weed impingement upon the road and or growth of trees.
- Gas mains (50mm) - see attached Jemena plan.
- Water mains 150mm DICL - see attached Sydney Water plan. I note the 150mm DICL main also contains several hydrants and stop valves, presumably for fire fighting purposes which implies it is already an important part of fire fighting infrastructure for this area and thus accessible by apparatus (and suitable for evacuation).
- I believe the aerial cable from the poles some 10m west and parallel of the road is a Telstra comm's line that goes over head rather than under the creek. Checking with Ausgrid reveals that they have no assets on the road corridor or nearby so the aerial cable must be communications and thus a Telstra asset.

| <b>The unformed road does not comply in terms of height clearances</b> | Incorrect | The road is already free of over-hanging branches such that the required 4.0m is available. See Photo 1 below. |

| <b>Need for vegetation removal</b> | Incorrect | Vegetation is already managed by mowing and slashing and that activity should continue given the past access use by the community and the extent of infrastructure within and over the land. This is explained below. |
