Our Ref: A16087B3: JT  
Council REF: DA2017/0206  
RFS REF: DA2014/1062

**Re: Review of bushfire issues outlined in the Planning Report  
The Falls Estate, Barnes Road, Frenchs Forest (Lot 1113 DP 752038)**

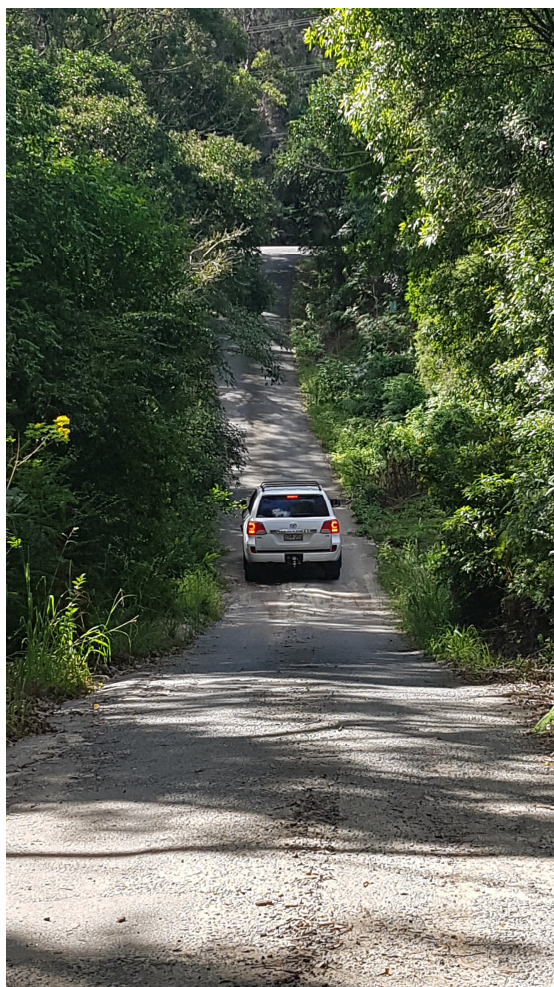
**Photo 1** – Barnes Road looking north

| <b>The unformed road does not comply in terms of height clearances</b> | Incorrect | The road is already free of over-hanging branches such that the required 4.0m is available. See Photo 1 below. |

| <b>Need for vegetation removal</b> | Incorrect | Vegetation is already managed by mowing and slashing and that activity should continue given the past access use by the community and the extent of infrastructure within and over the land. This is explained below. |
