1 December 2021 Ref: E34266PDlet

PRELIMINARY (DESKTOP) ACID SULFATE SOIL ASSESSMENT AND CONCEPTUAL MANAGEMENT PLAN PROPOSED BOAT SHED DEVELOPMENT 3 PANIMA PLACE, NEWPORT, NSW

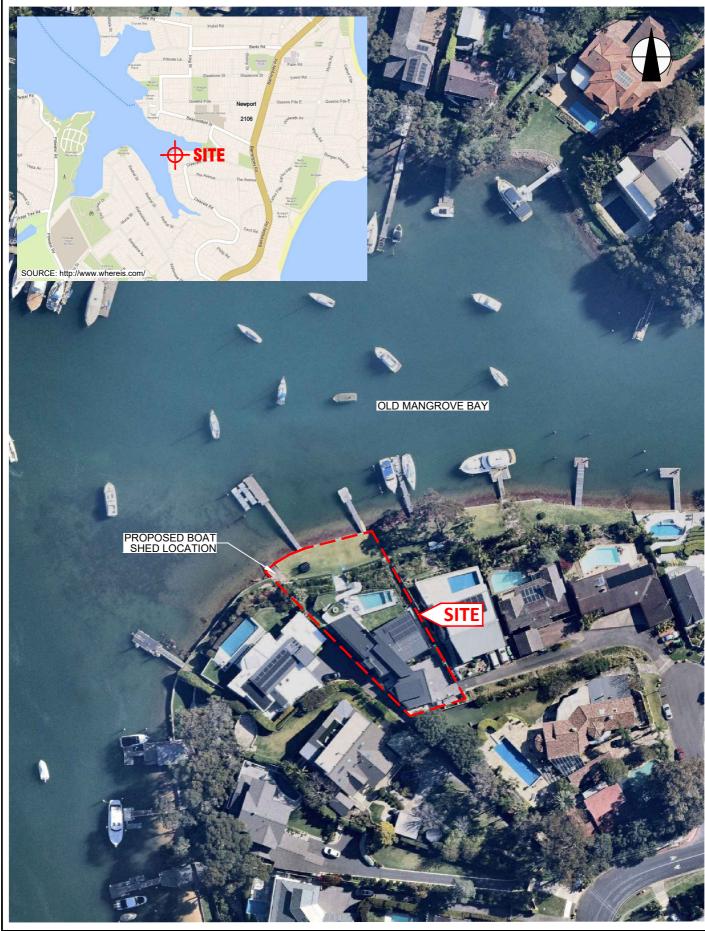
Appendix A: Report Figure

AERIAL IMAGE SOURCE: MAPS.AU.NEARMAP.COM - 4/10/21

Toby Browne ('the client') commissioned JK Environments (JKE) to undertake a preliminary (desktop) acid sulfate soil (ASS) assessment and prepare a conceptual acid sulfate soil management plan (ASSMP) for the proposed boatshed at 3 Panima Place, Newport, NSW. The site location is shown on Figure 1.

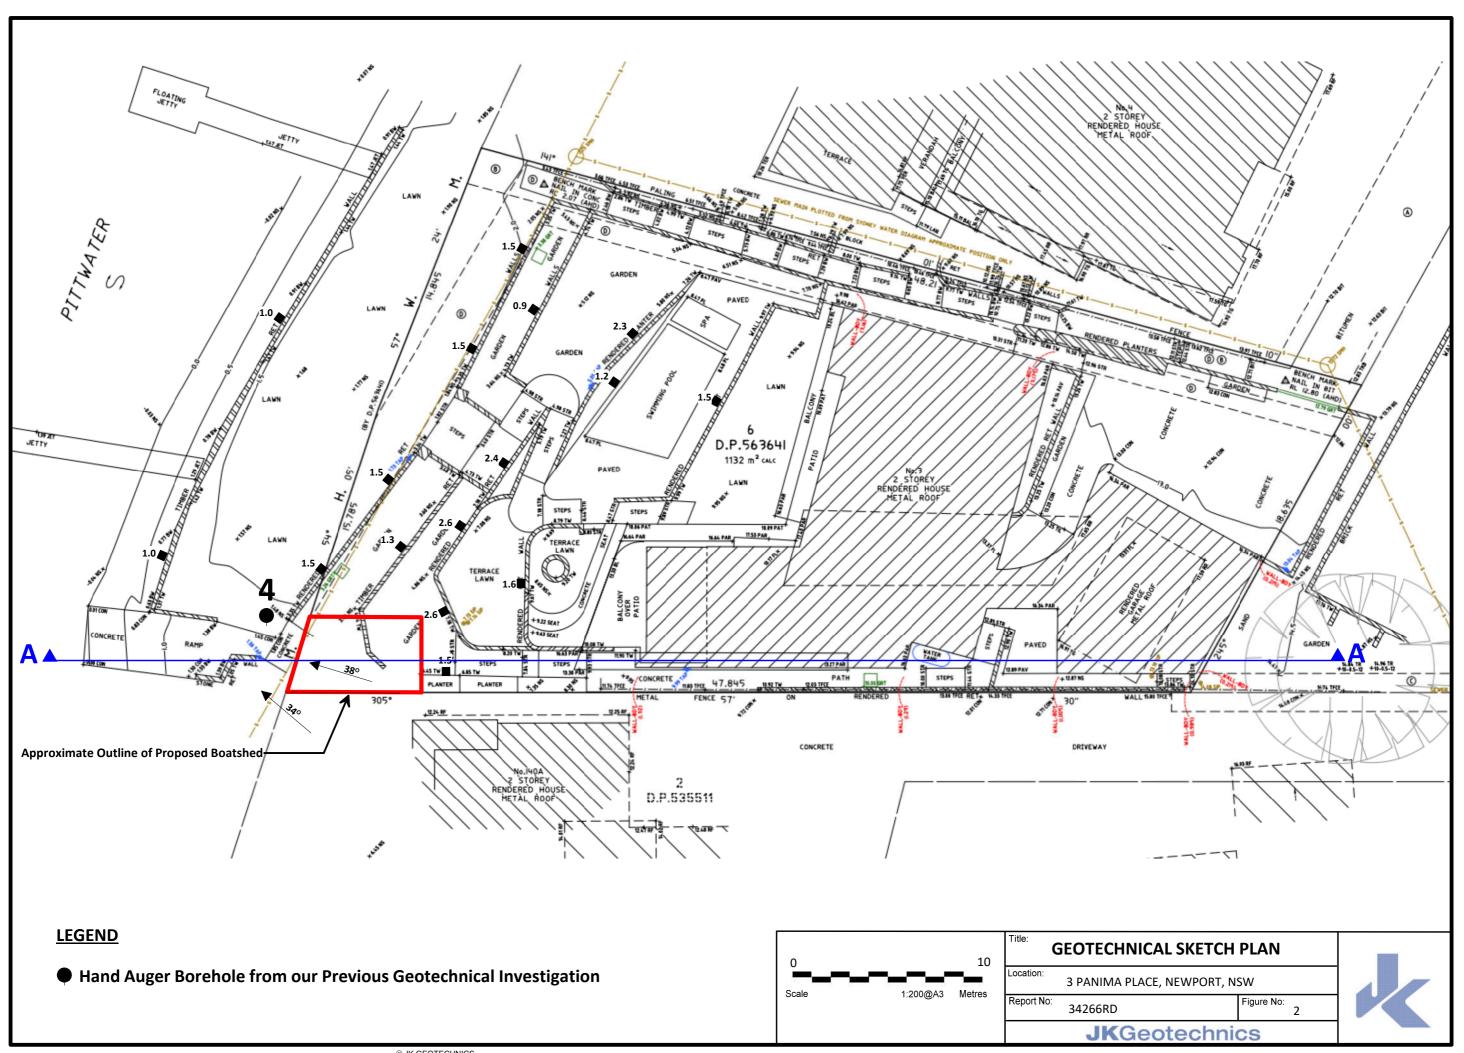
Appendix B: JK Geotechnics Report Information

The JKG 2021 report indicated that JKG had previously drilled one borehole (BH4) with a hand auger adjacent and to the north-east of the proposed boat shed and behind a retaining wall. Subsurface conditions encountered silty sand and silty clay fill material with traces of building rubble to approximately 1mBGL, where refusal was encountered on inferred shale bedrock. Groundwater seepage was encountered at a depth of 0.7mBGL during drilling BH4. A standing groundwater level was measured at 1.0m upon completion of drilling BH4. JKG anticipated that water encountered within the borehole is most likely influenced by tidal variations. JKGs sampling location plan and BH4 borehole log are attached in the appendices.
