February 11, 2019  
Project No. 22381/1565D-G  
Report No. 19/0299  
MG/ms

## **SITE ADDRESS: 73 UNDERCLIFF ROAD, FRESHWATER**

**PROJECT: 73 UNDERCLIFF ROAD, FRESHWATER**  
**PROJECT No:22381/1565D-G**  
**REPORT No:19/0299**  
**TITLE: SITE PHOTOS**

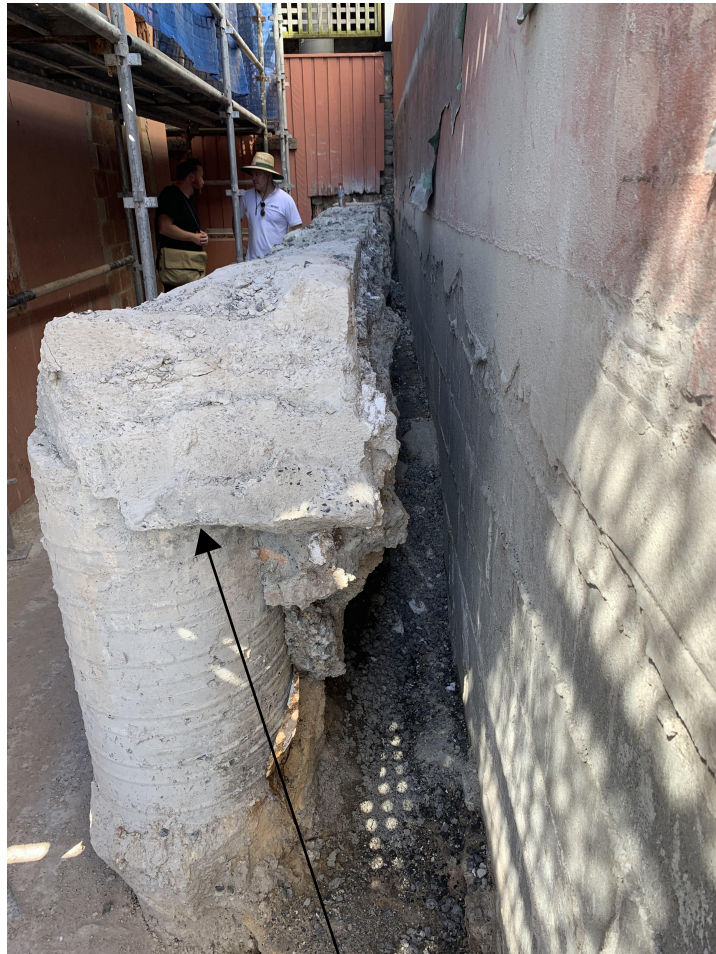
A cross section of the site and photographs are attached. The shoring piles that are to be trimmed have been installed along the north western site boundary and were likely installed some time ago, and well before the current works occurring on the site. The piles are 450mm in diameter, have been constructed of reinforced concrete and are contiguous, i.e. there is no gap between the piles. The piles are embedded below the basement garage level of No.73 and protrude approximately 1.4 metres above the ground floor slab of No.73.

**Piles to be trimmed**

We understand that it is proposed to trim the piles from the ground floor slab up. I.e. the section of pile below the ground floor slab would remain and the remaining piles would be propped at the top by the ground floor slab.

In our opinion, the piles are redundant, and trimming the piles above the ground floor slab is not expected to negatively impact on the adjoining buildings foundations, the stability of the piles, or the stability of the rock column.

Due to the proximity of the piles to the adjoining dwelling we would recommend that the piles be cut with a saw, rather than demolished using hydraulic rock hammers.

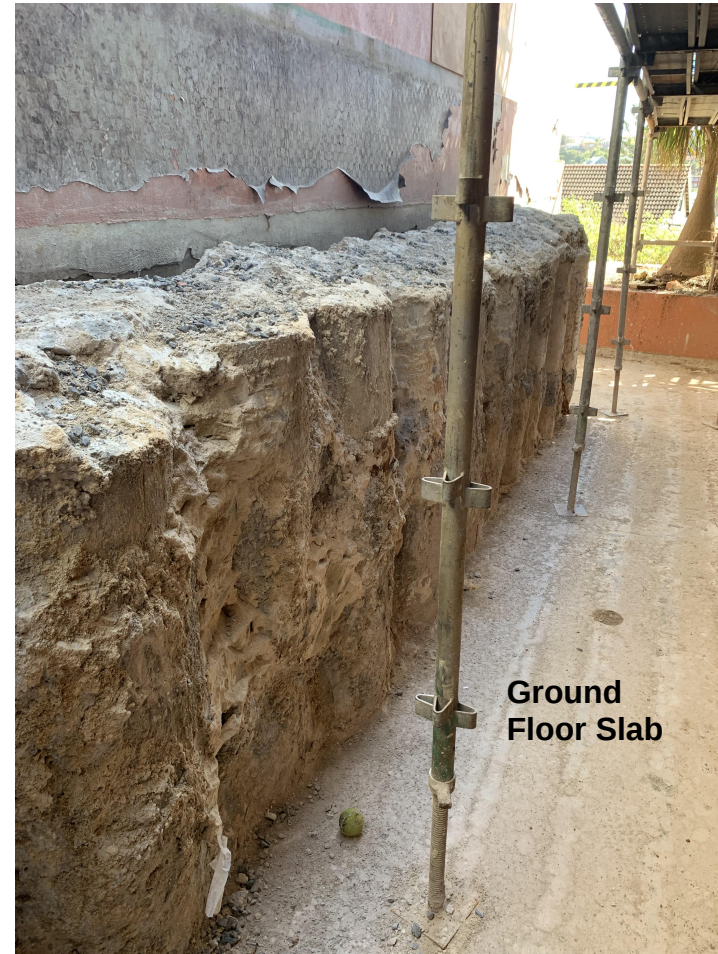
**Ground  
Floor Slab**

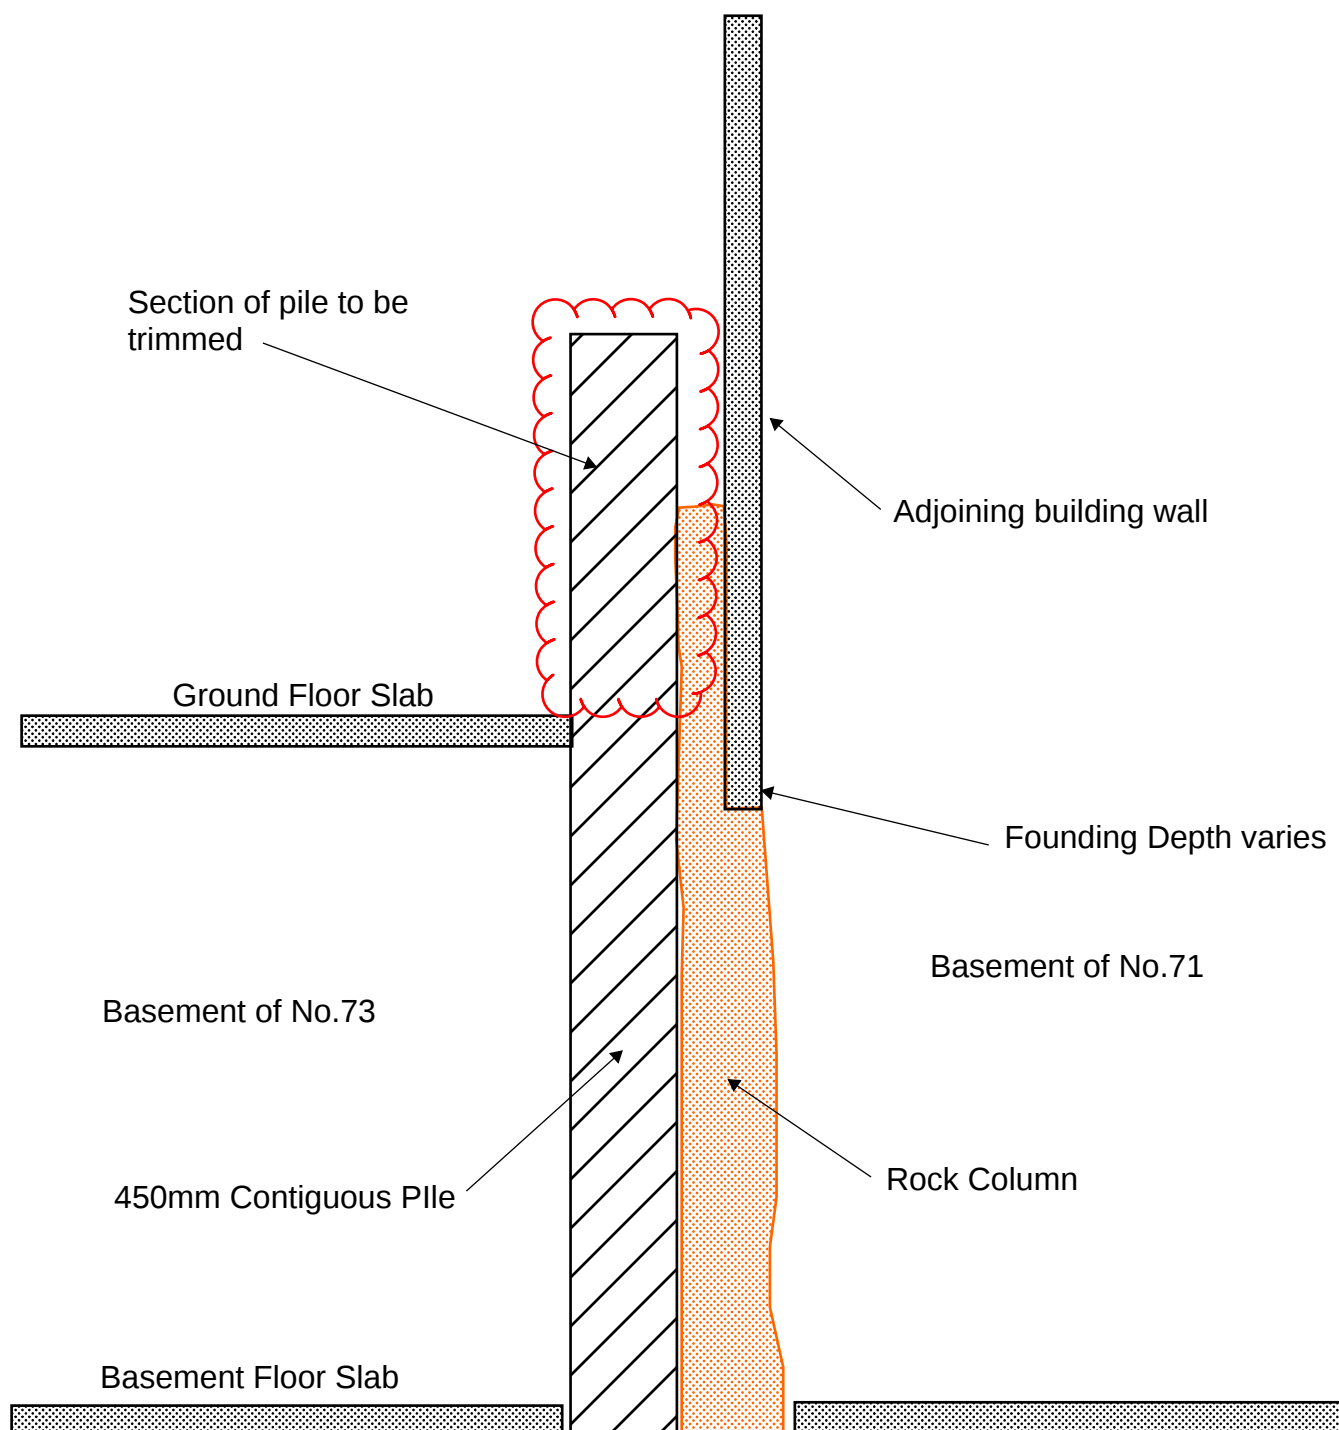
**PROJECT: 73 UNDERCLIFF ROAD, FRESHWATER**  
**PROJECT No:22381/1565D-G**  
**REPORT No:19/0299**  
**TITLE: CROSS SECTION SKETCH**

The piles were more than likely installed to retain the site at No.71 during the bulk excavation of the basement garage on No.73. The site at No.71 has subsequently been re-developed and now includes a basement that is at the same level, or lower than the basement on No.73.

The excavation of the basement at No.71 has resulted in the creation of a rock column between the two basement garages. The column is estimated to be 300mm in with, and the contiguous piles are present on the south eastern side of the rock column.

Further, the rock column is providing foundation support to the adjoining dwelling at No.71. Therefore, any trimming of the rock column on the subject site should be minimised and should be carried out using saws and not rock hammers. The foundations of the dwelling on No.73 should not be undermined.
