DILAPIDATION REPORT

Bubalo Street, Warriewood

Prepared by: Rezoning Pty Ltd t/as Effective Building & Consultancy

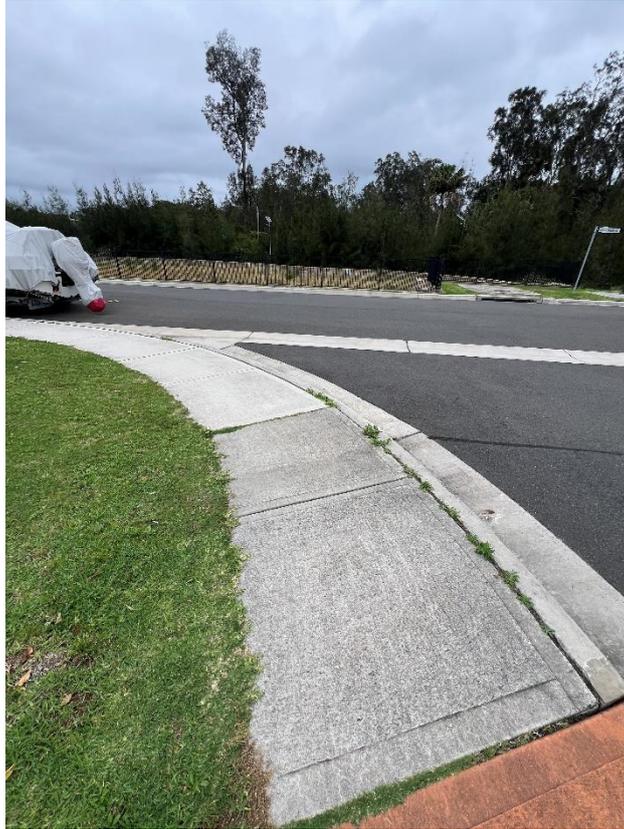
Figure 1 – General condition of the footpath.

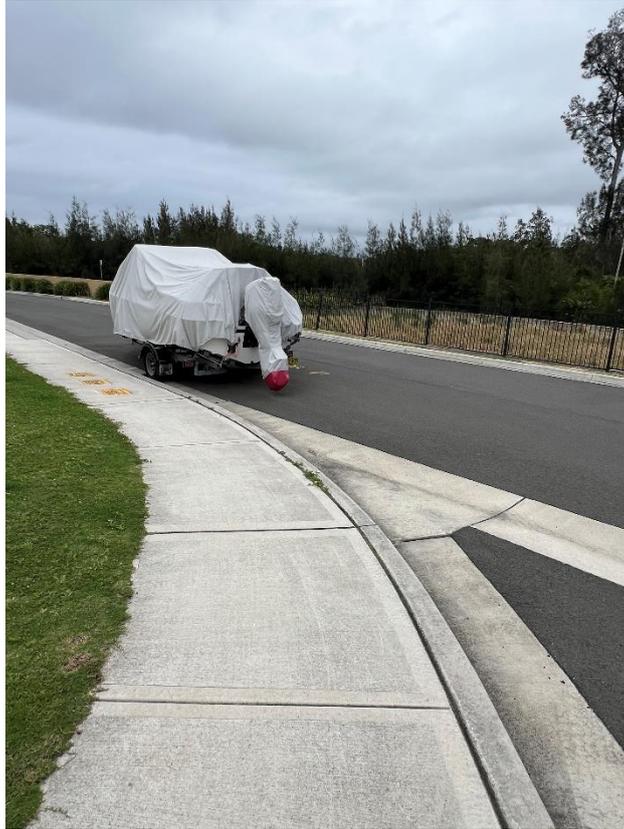
Figure 3 – General condition of the footpath.

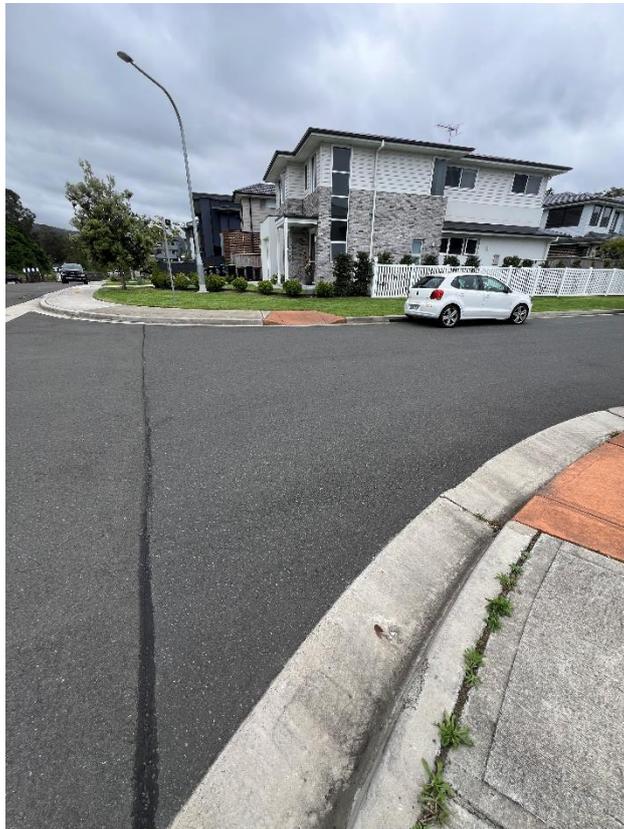
Figure 4 – General condition of the road.

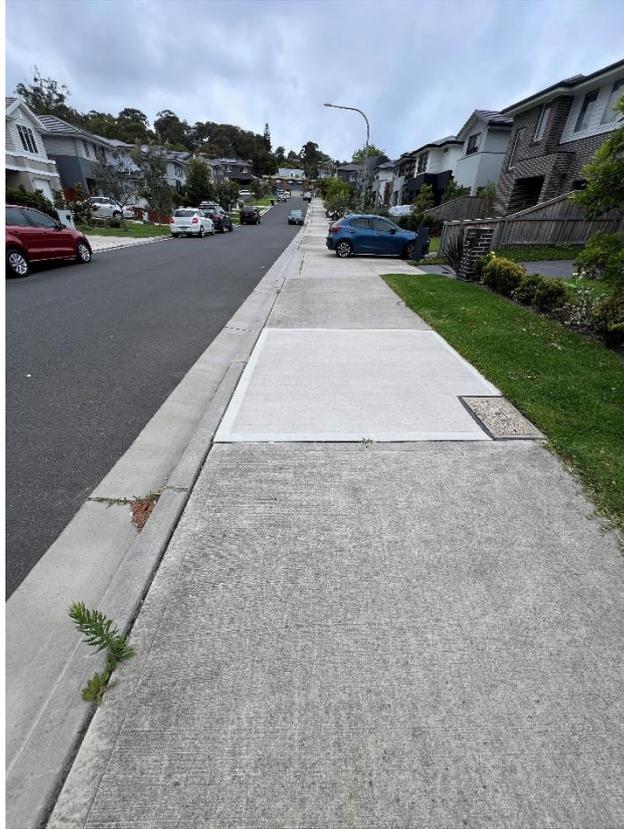
Figure 11 – General condition of the footpath.

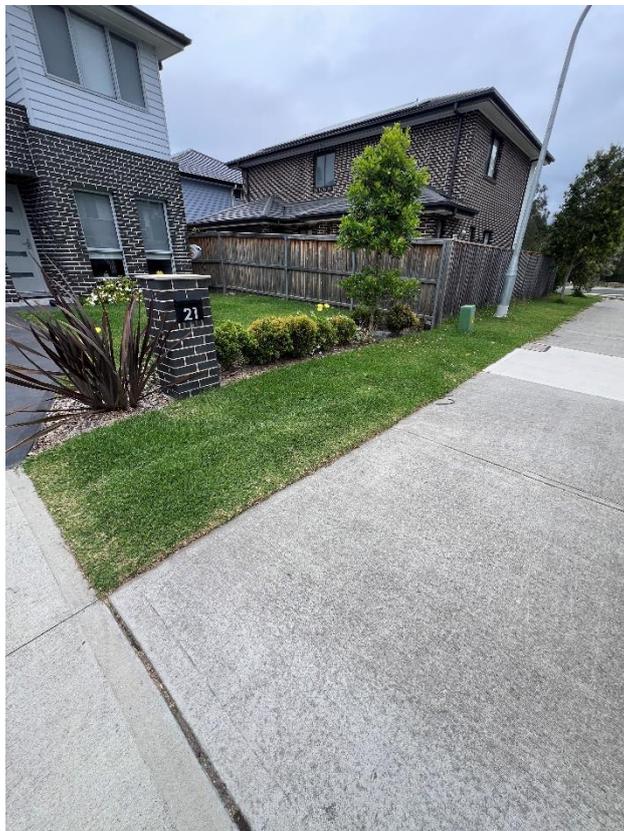
Figure 14 – General condition of the footpath/nature strip.

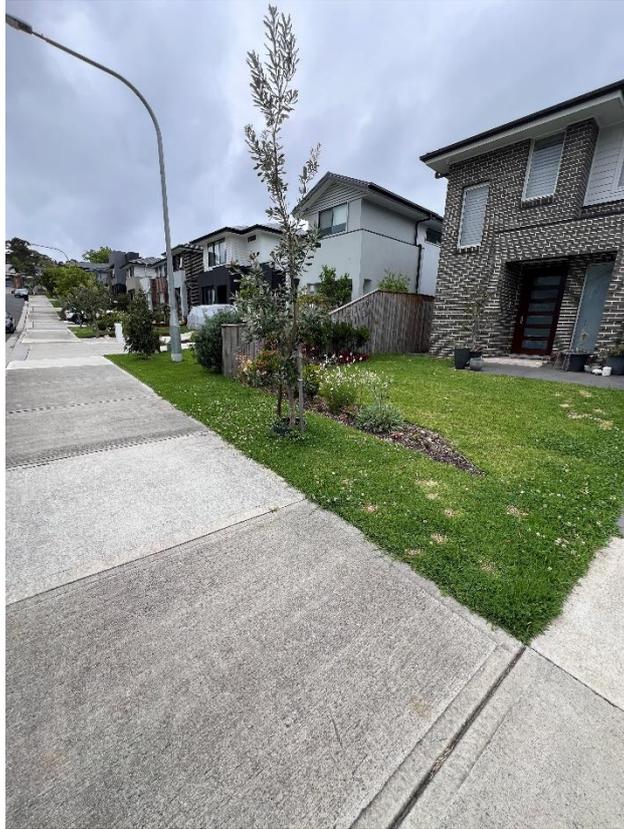
Figure 15 – General condition of the footpath/tree.

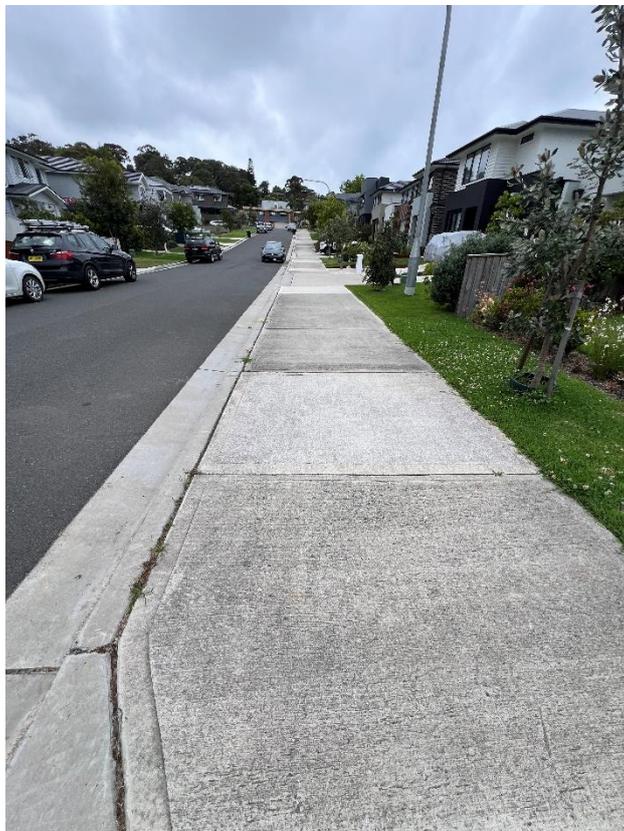
Figure 16 – General condition of the footpath.

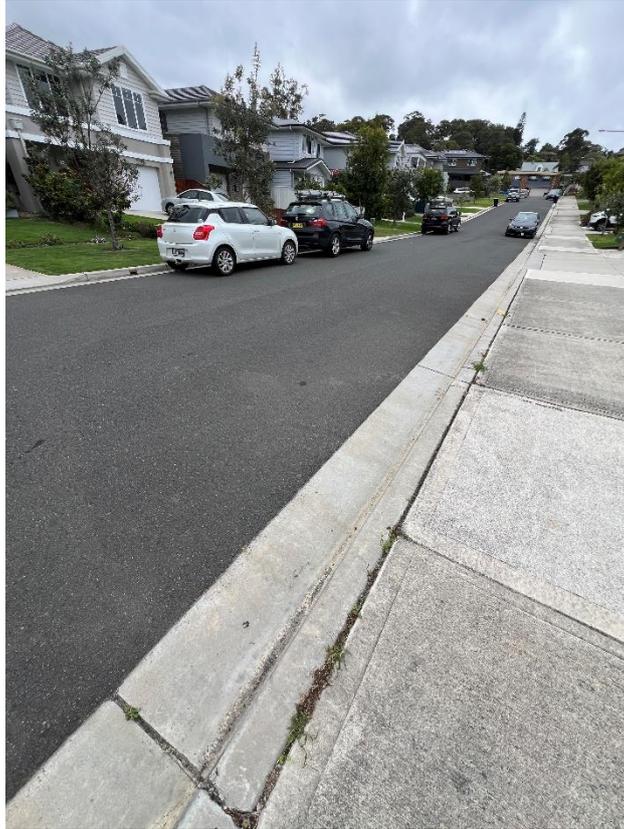
Figure 17 – General condition of the road/kerb.

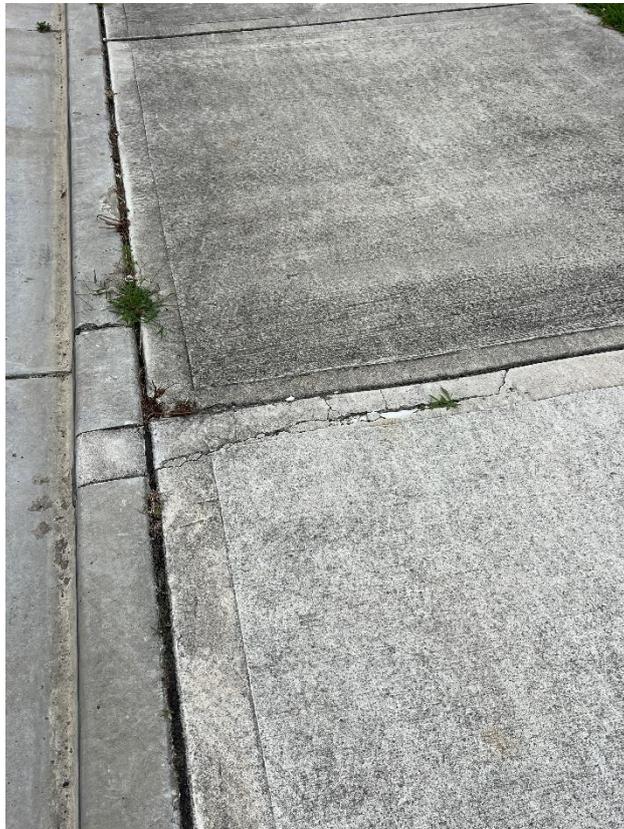
Figure 18 – Crack is evident to the footpath.

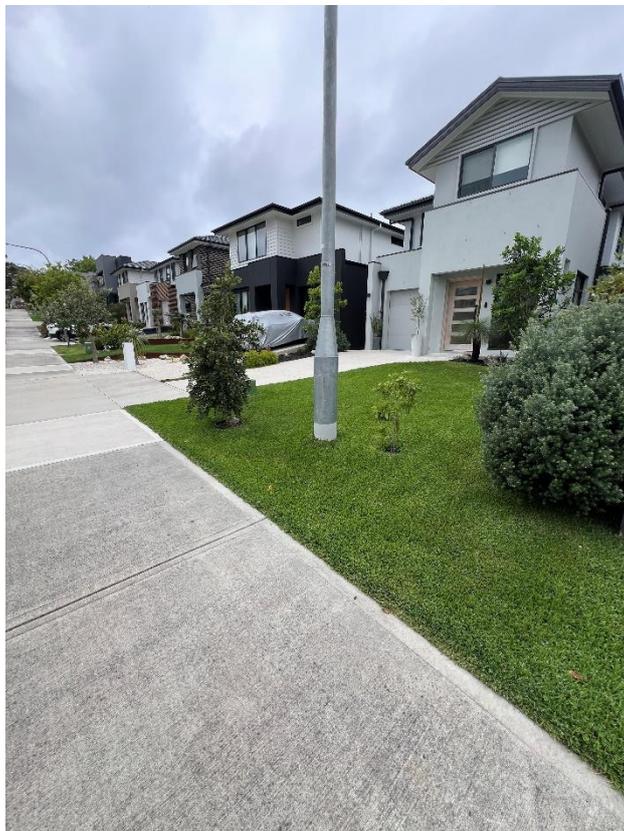
Figure 20 – General condition of the landscaping.

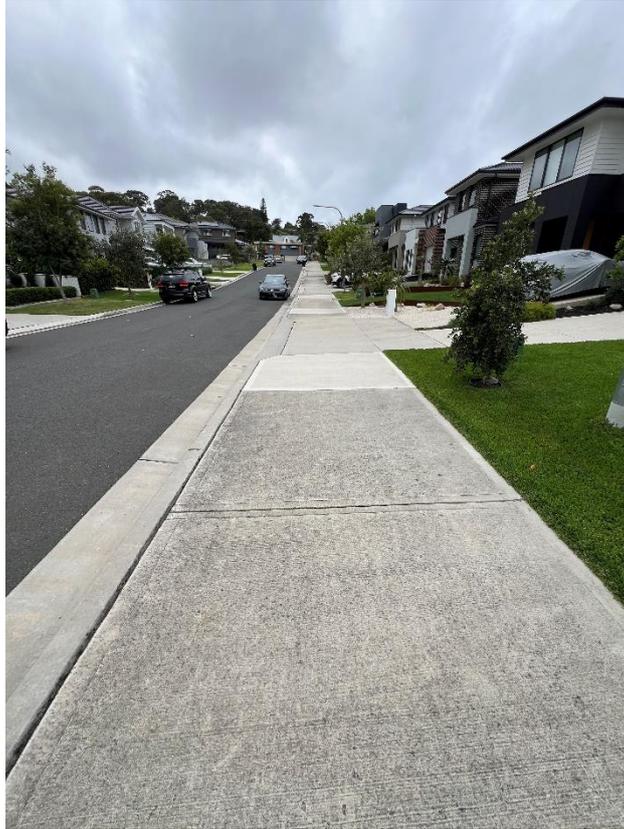
Figure 21 – General condition of the footpath.

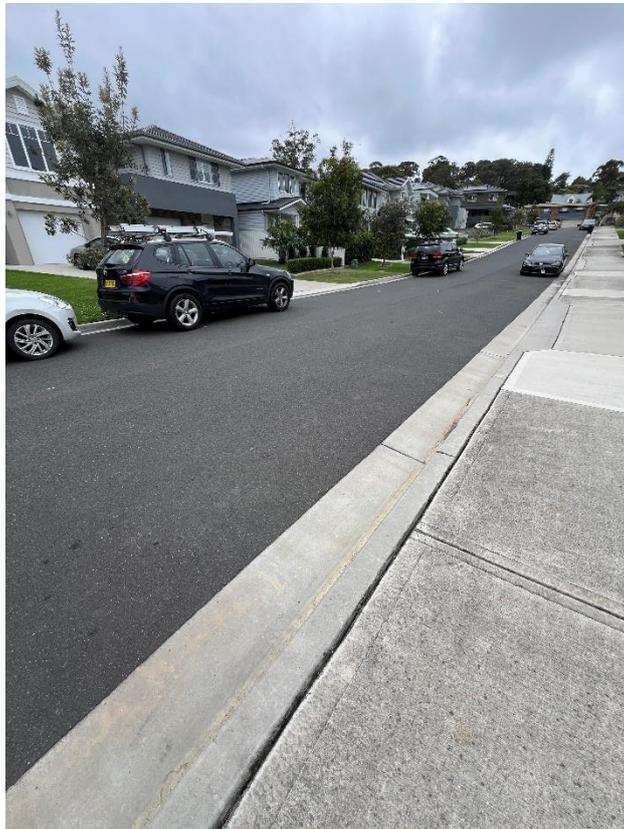
Figure 22 – General condition of the road/road.

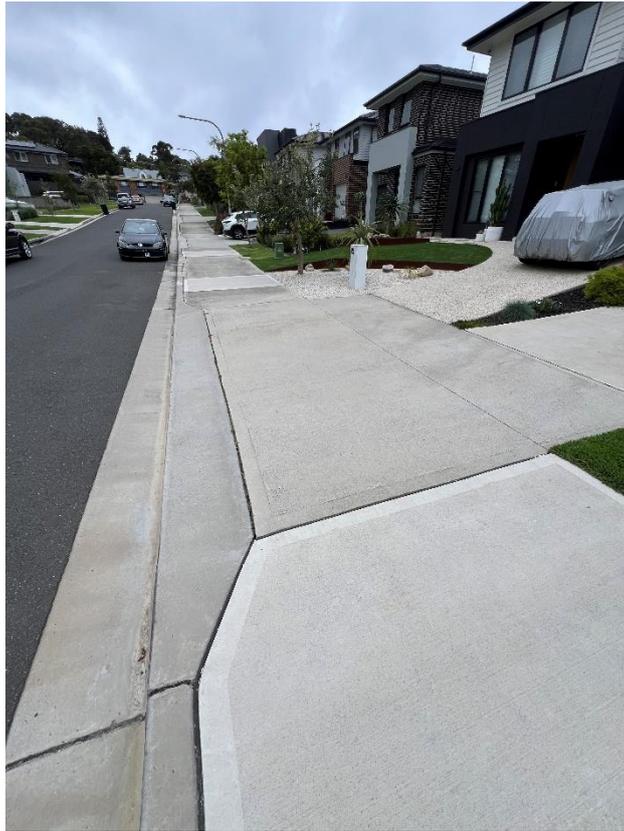
Figure 23 – General condition of the driveway.

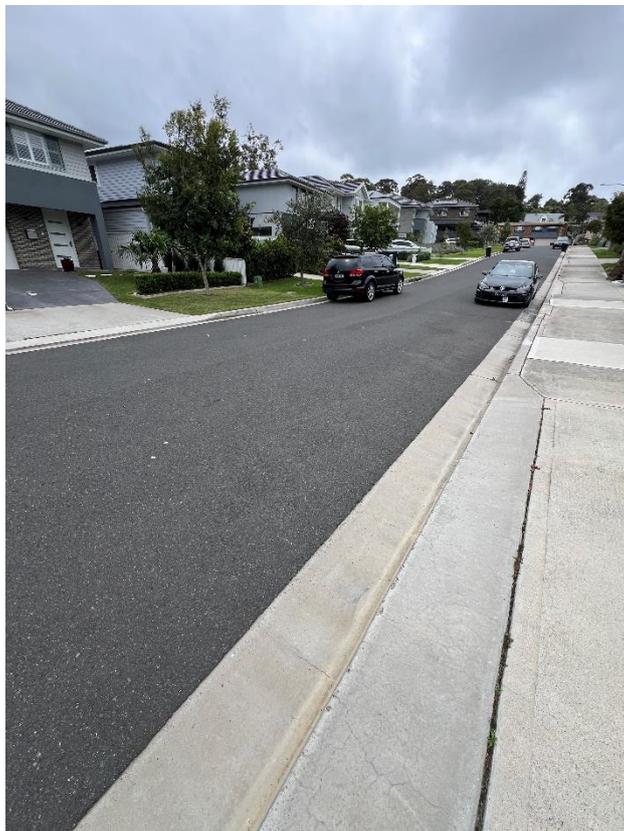
Figure 24 – General condition of the road.

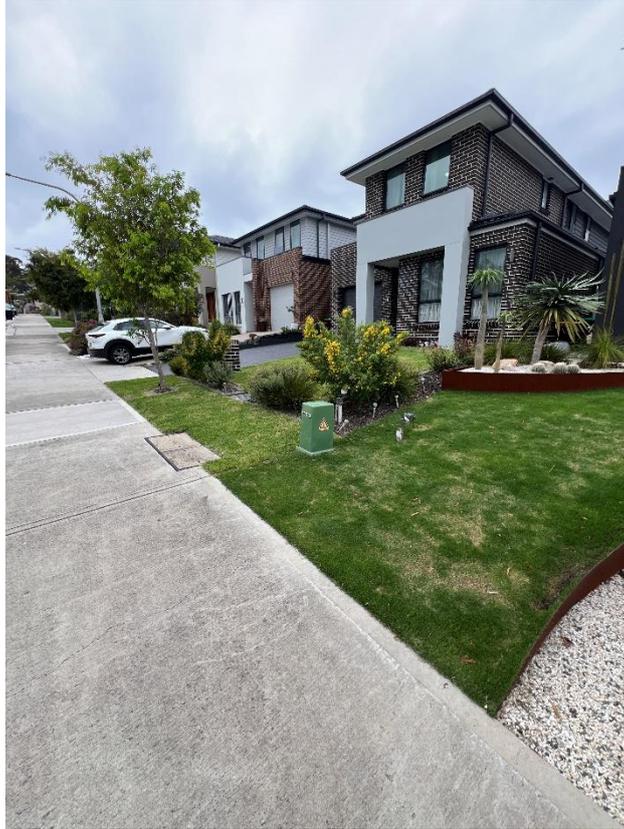
Figure 27 – General condition of the transformer box.

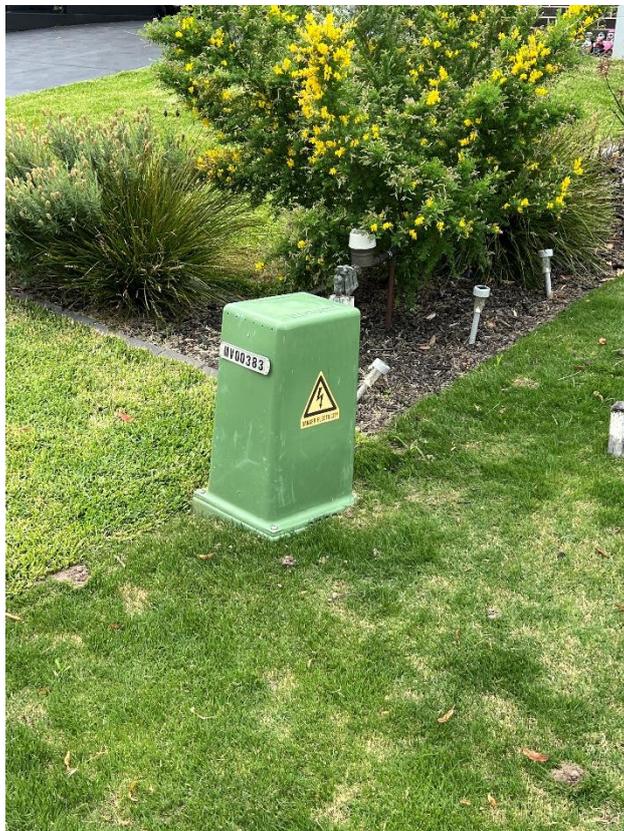
Figure 28 – General condition of the transformer box.

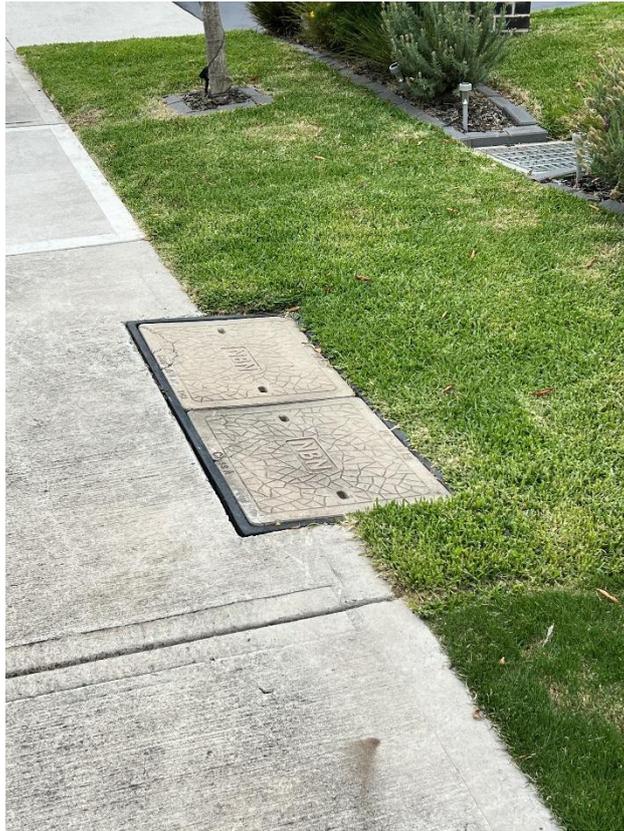
Figure 29 – General condition of the pit.

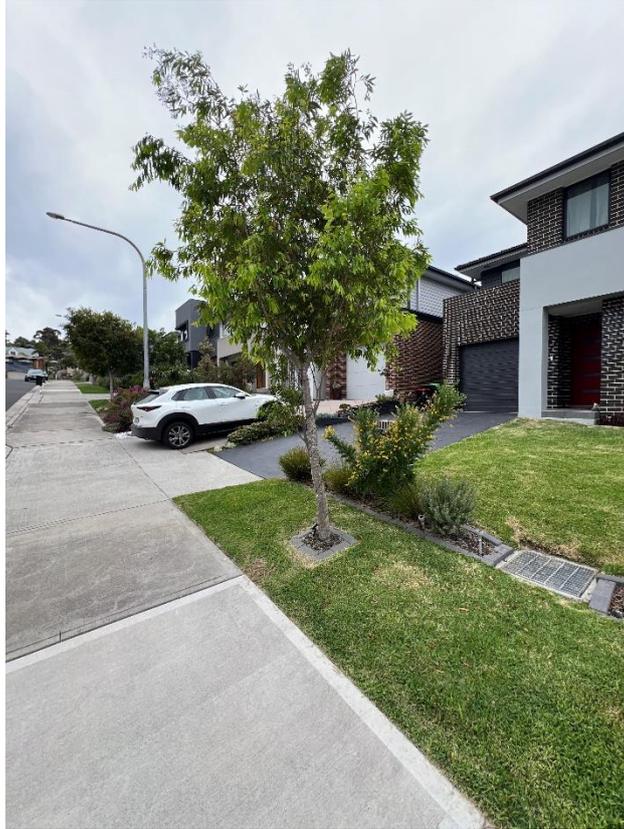
Figure 33 – General condition of the tree.

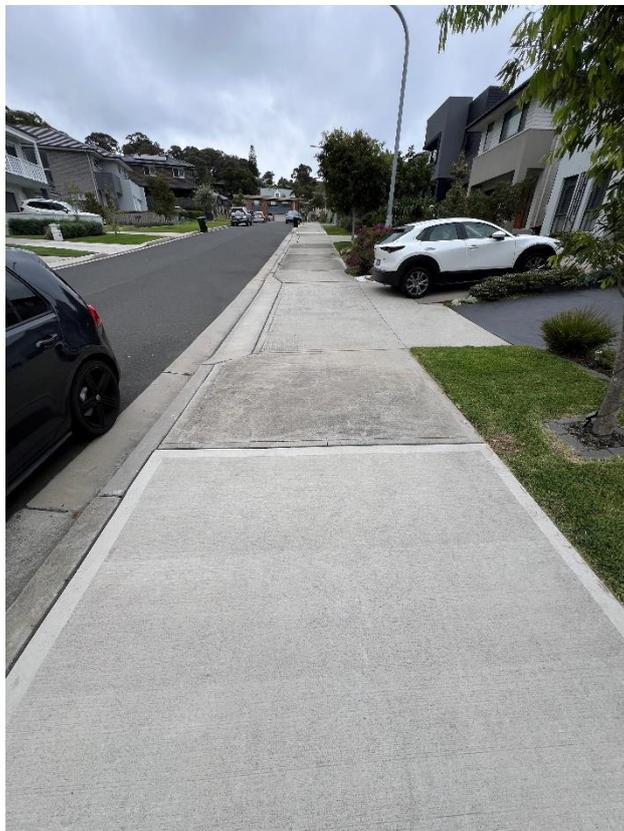
Figure 34 – General condition of the footpath.

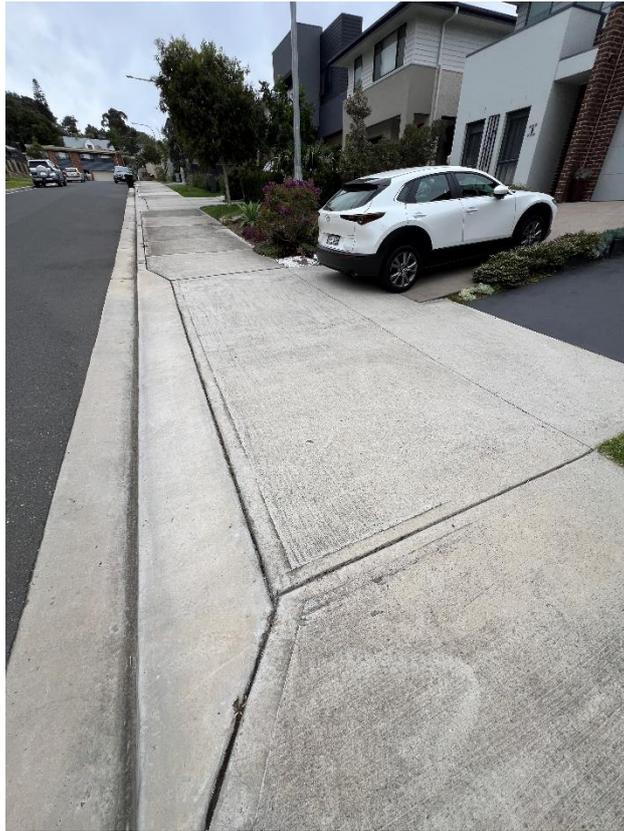
Figure 35 – General condition of the driveway.

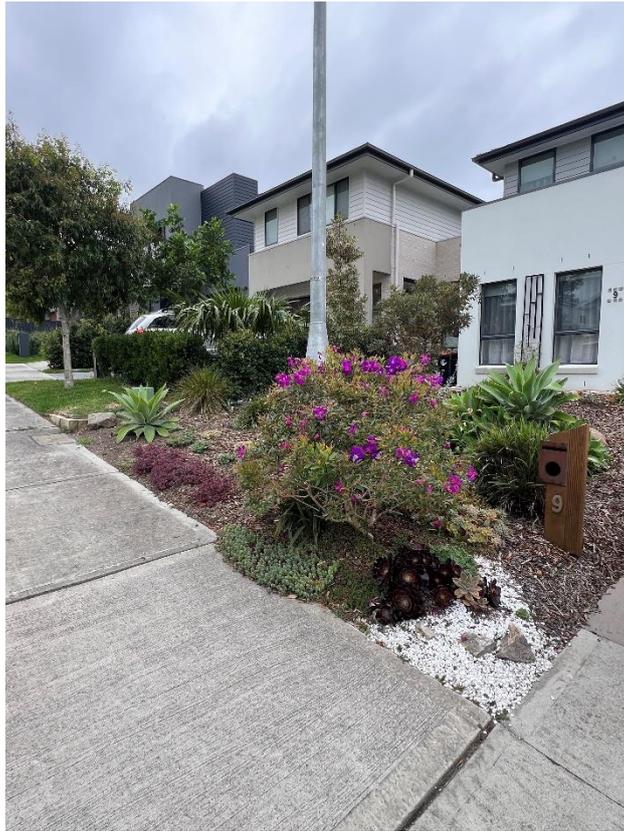
Figure 37 – General condition of the landscaping.

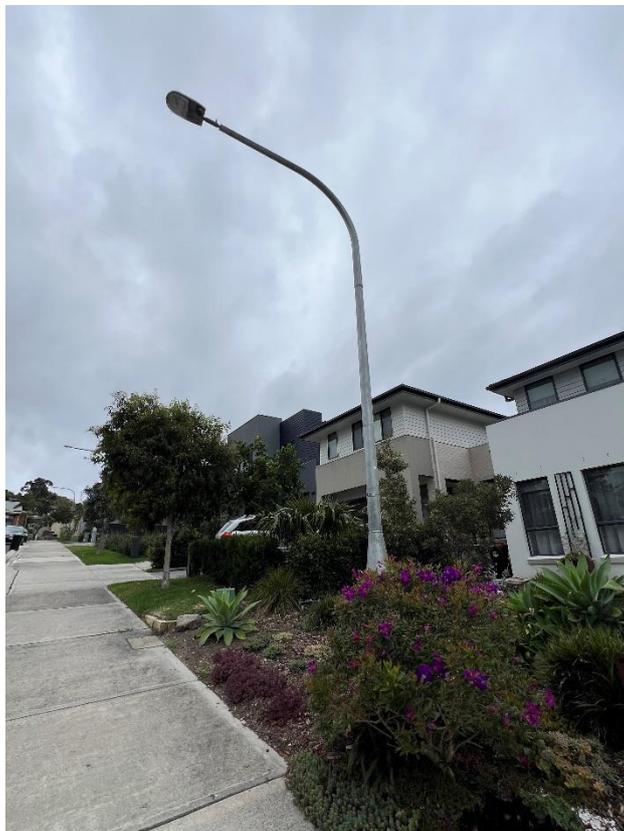
Figure 38 – General condition of the street light.

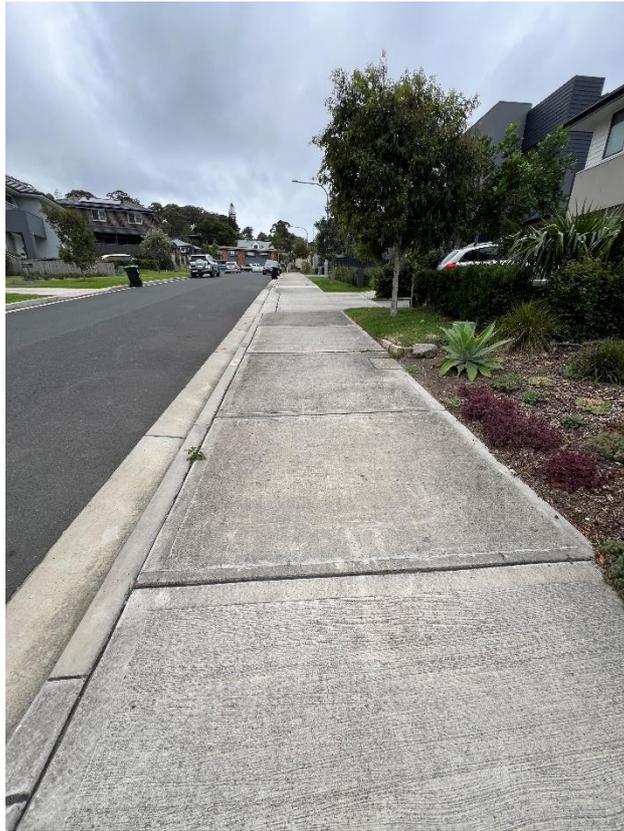
Figure 39 – General condition of the footpath.

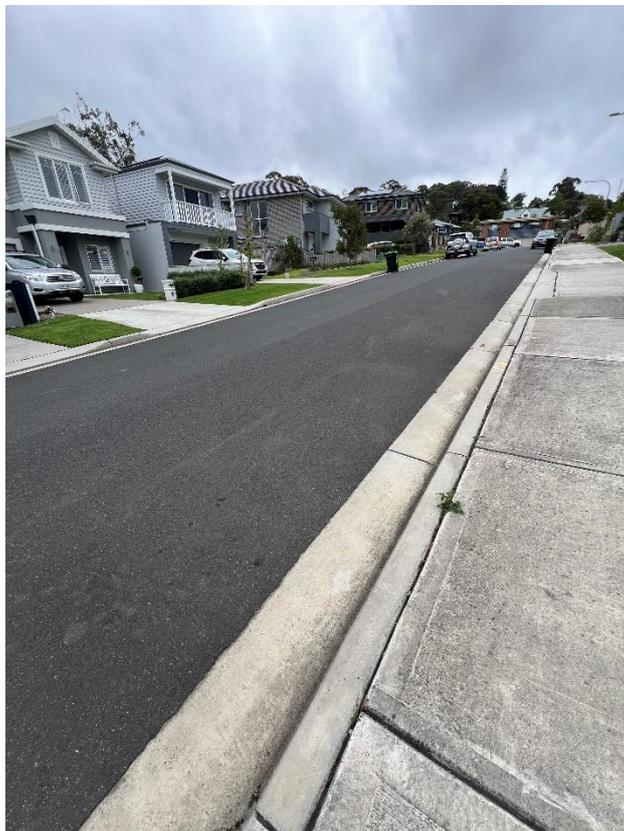
Figure 40 – General condition of the road/kerb.

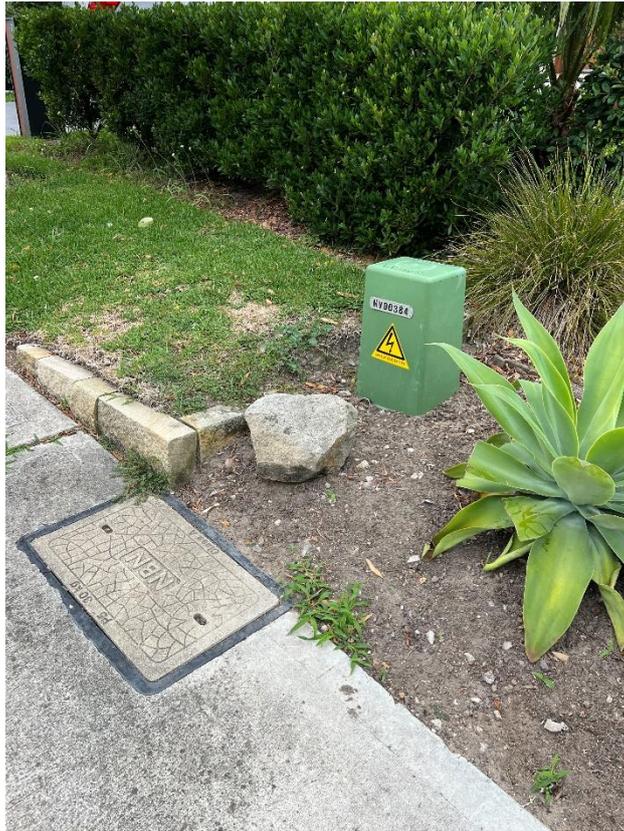
Figure 41 – General condition of the pit/transformer box.

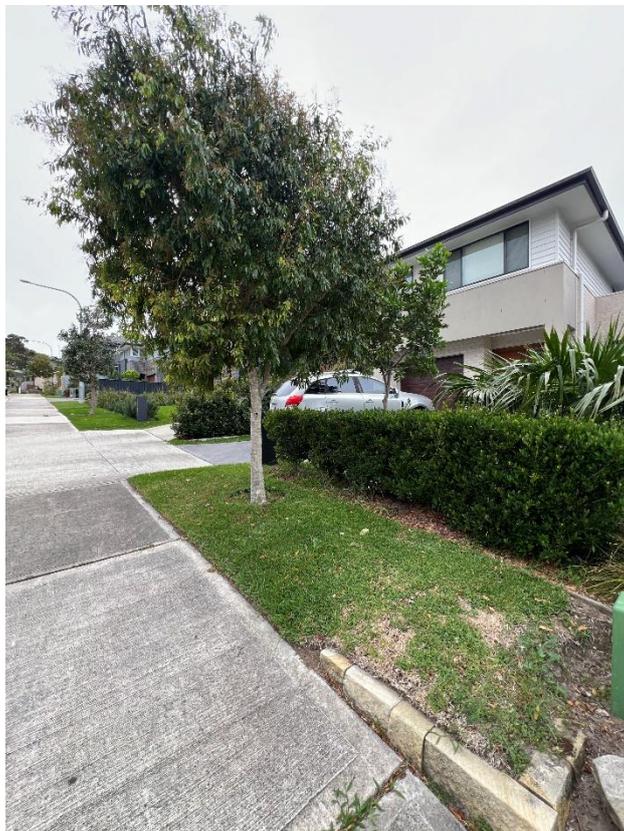
Figure 42 – General condition of the tree.

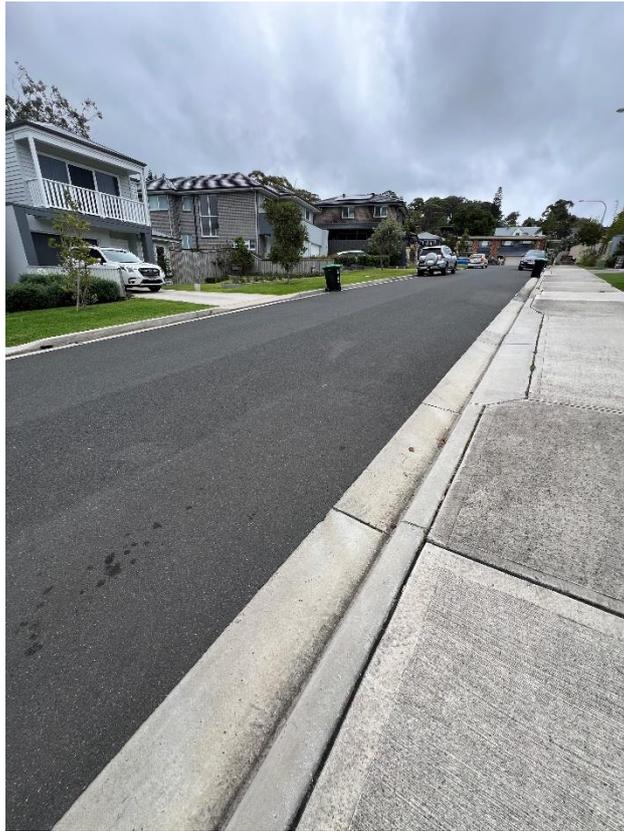
Figure 43 – General condition of the road/kerb.

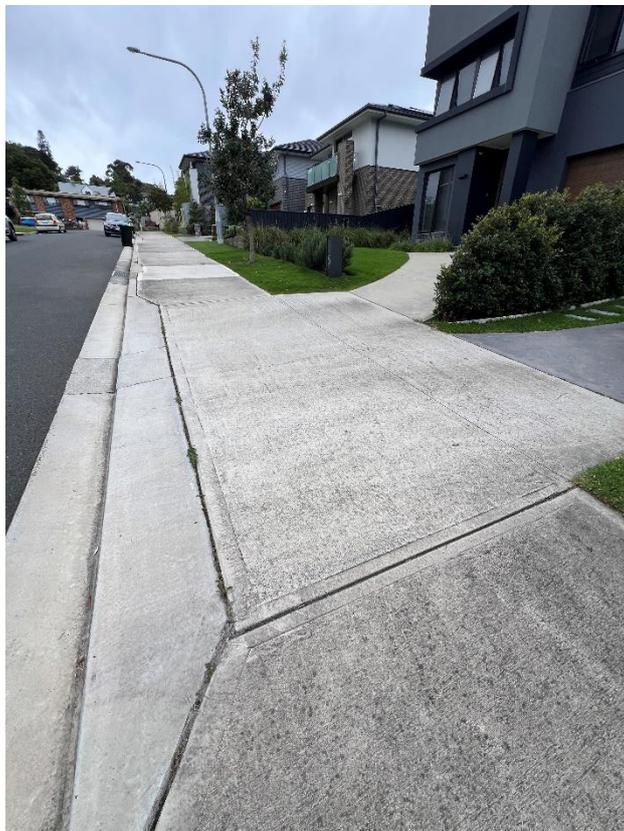
Figure 44 – General condition of the driveway.

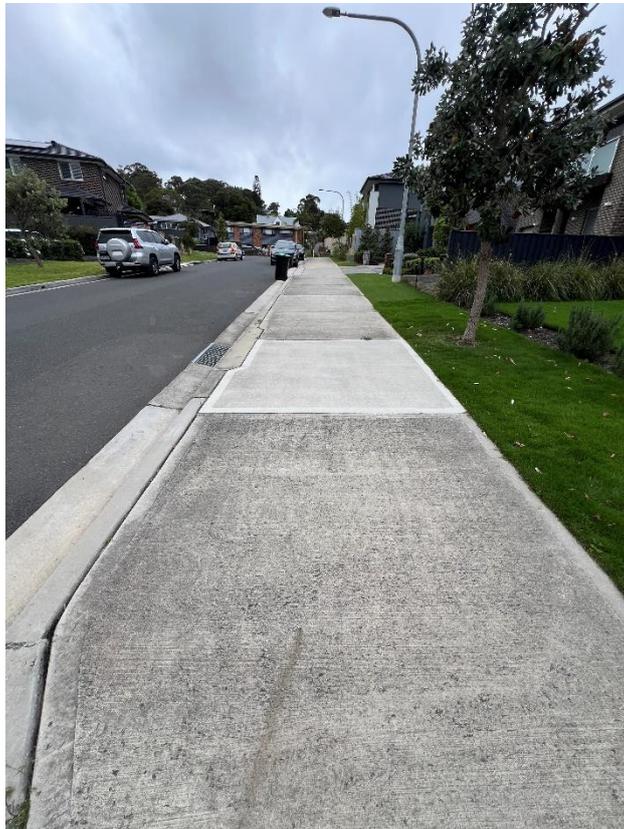
Figure 46 – General condition of the footpath.

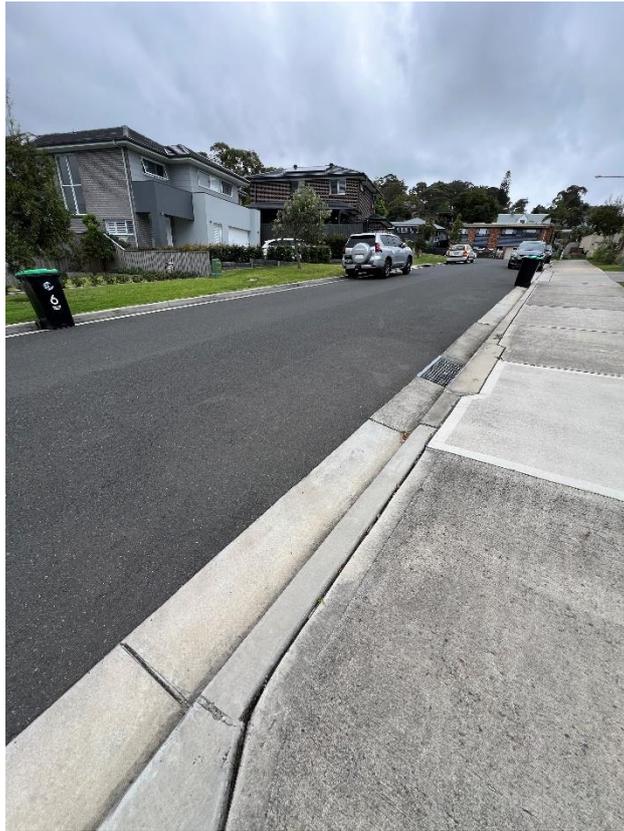
Figure 47 – General condition of the road/kerb.

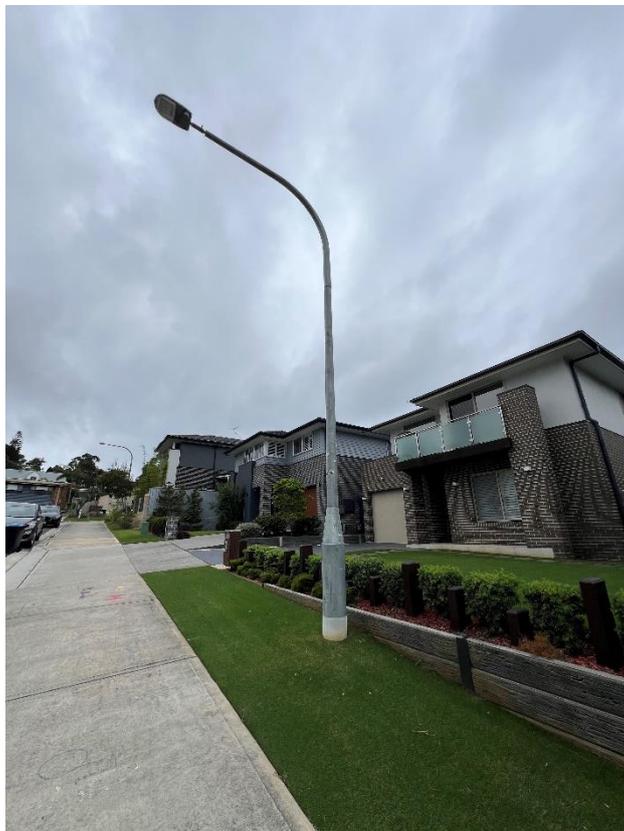
Figure 48 – General condition of the street light.

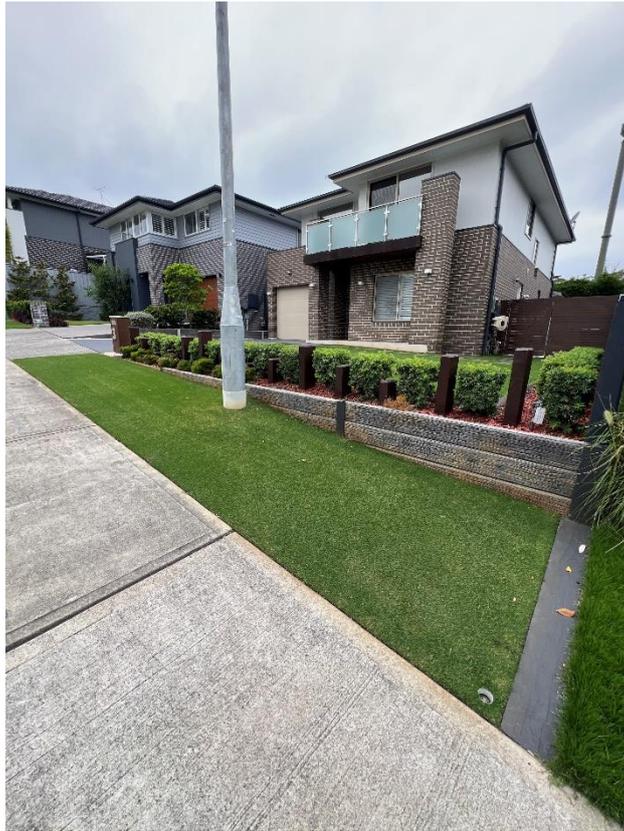
Figure 49 – General condition of the nature strip.

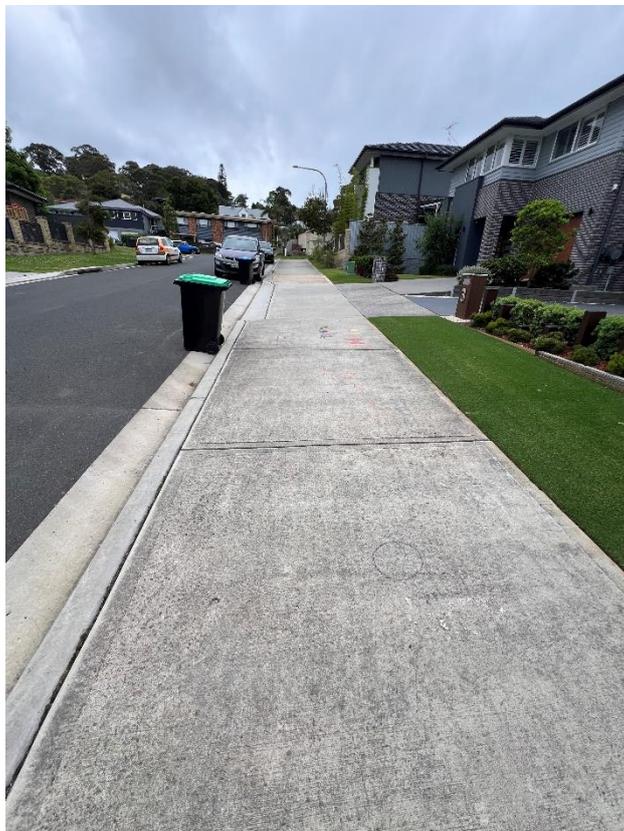
Figure 50 – General condition of the footpath.

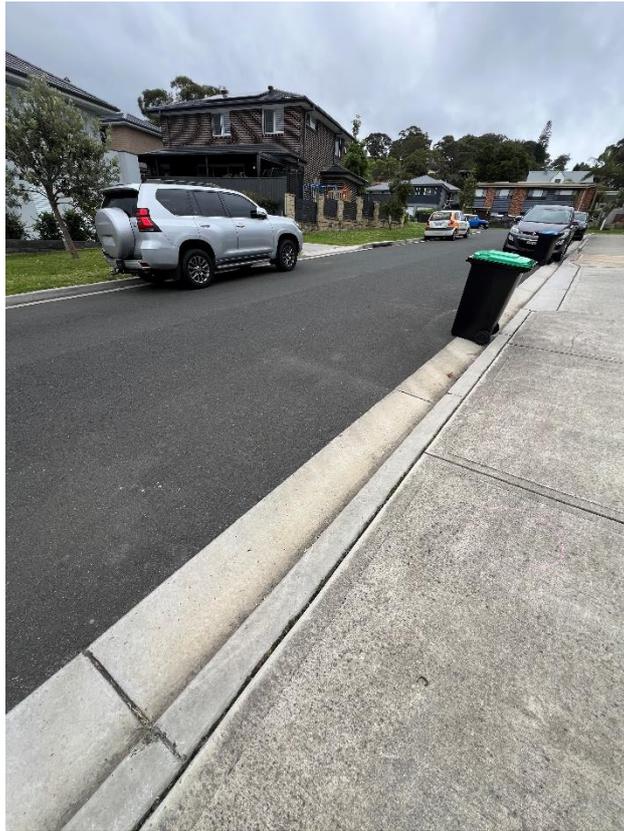
Figure 51 – General condition of the road/kerb.

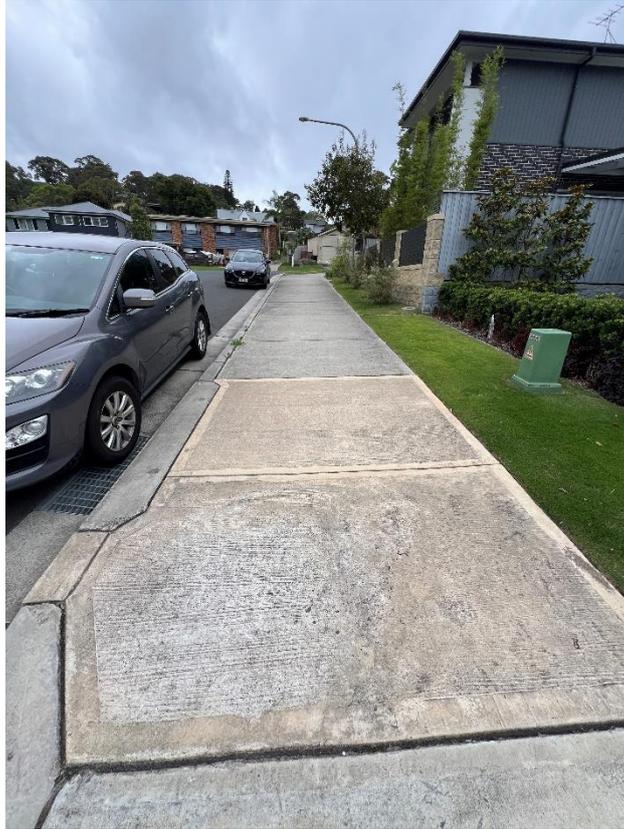
Figure 55 – General condition of the footpath.

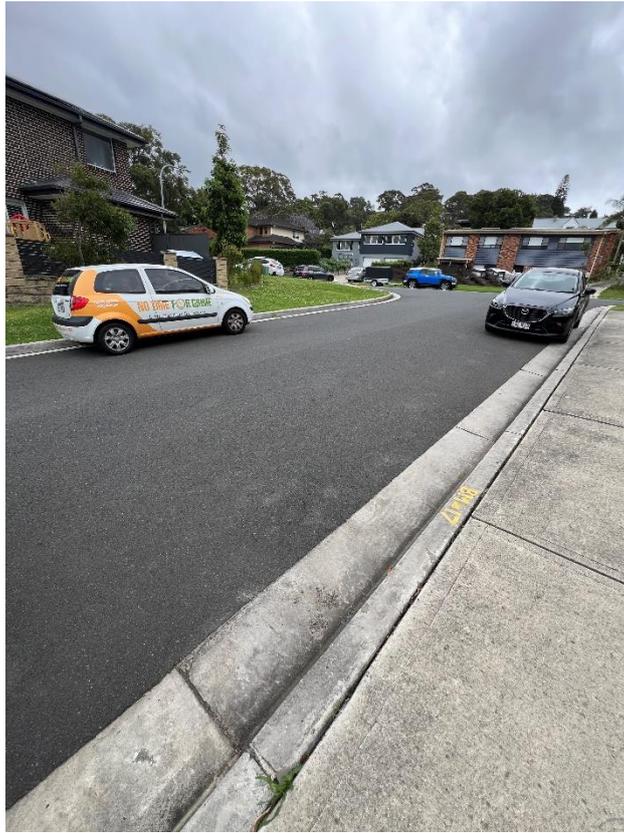
Figure 56 – General condition of the road/kerb.

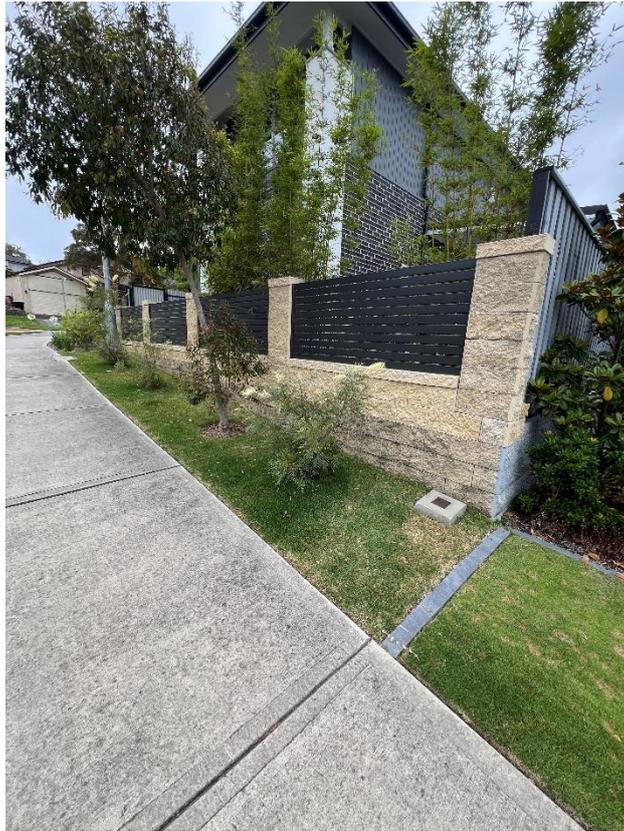
Figure 57 – General condition of the tree.

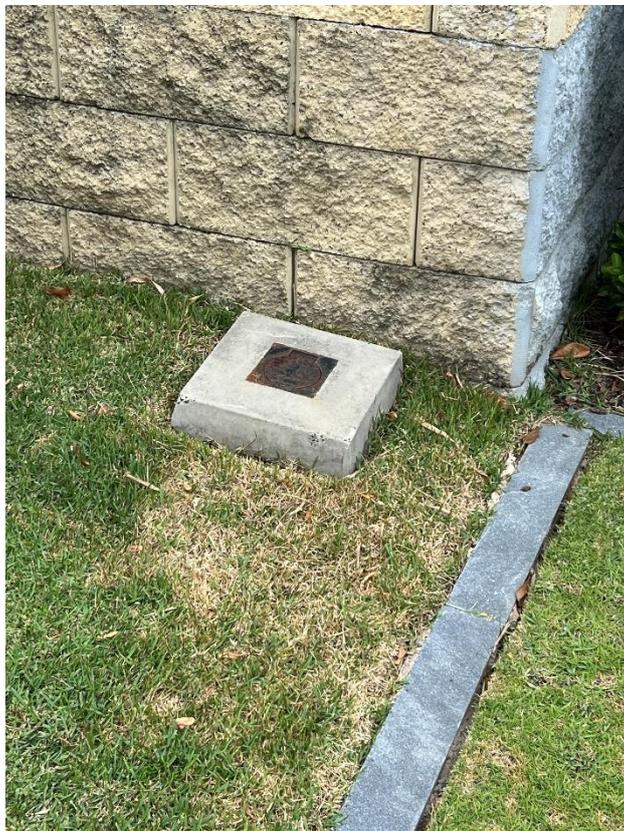
Figure 58 – General condition of the utility lid.

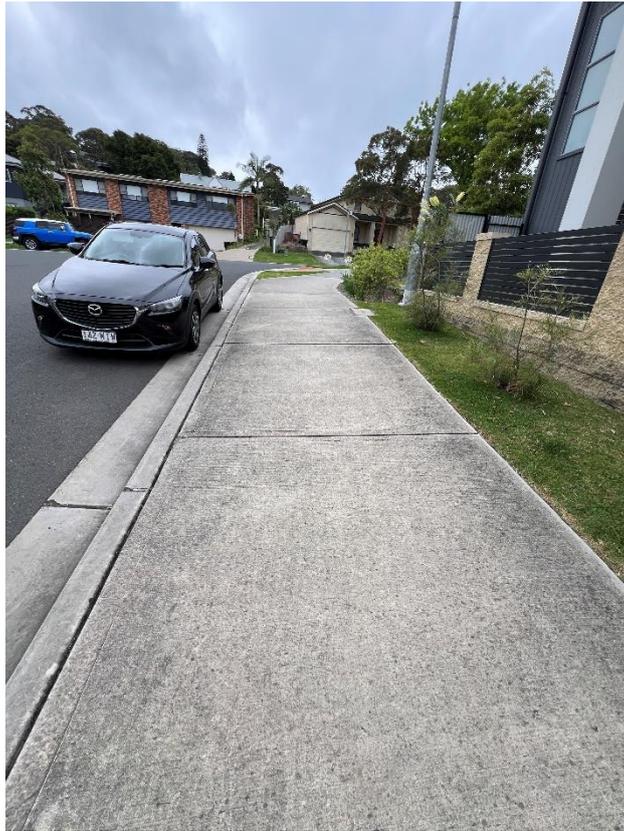
Figure 59 – General condition of the footpath.

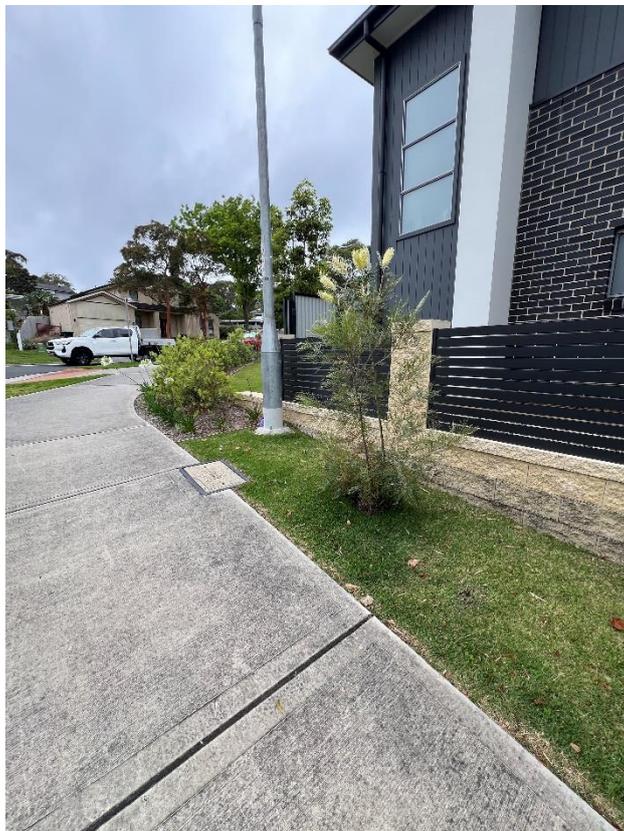
Figure 60 – General condition of the nature strip.

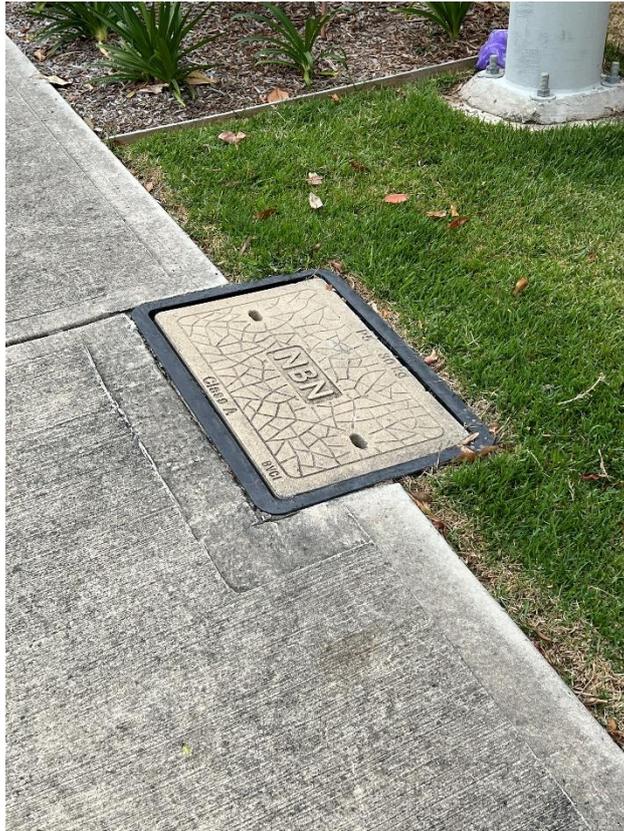
Figure 61 – General condition of the pit.

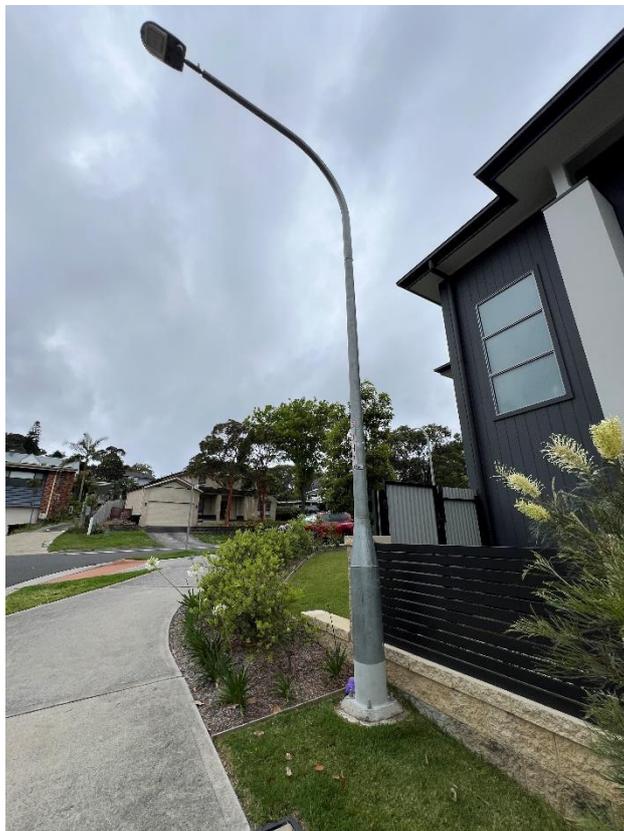
Figure 62 – General condition of the street light.

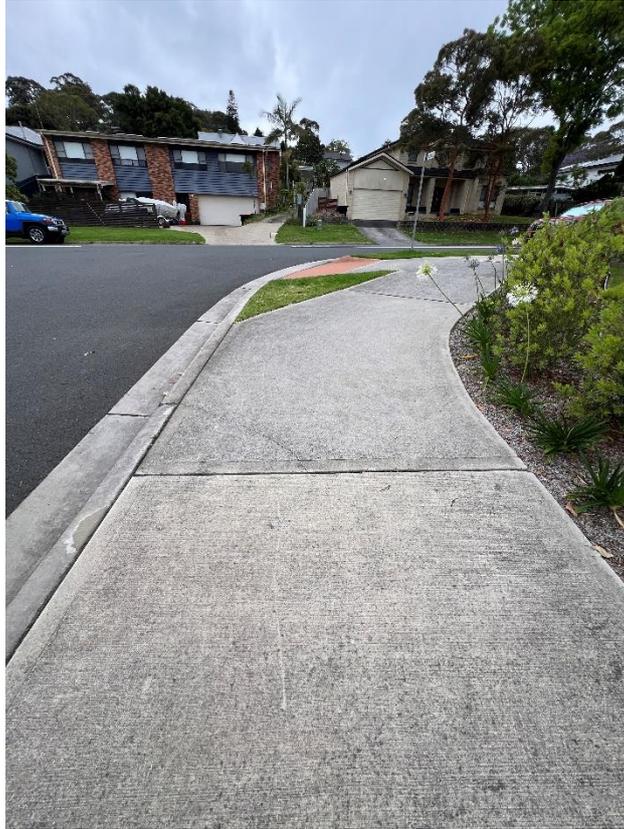
Figure 63 – General condition of the footpath.

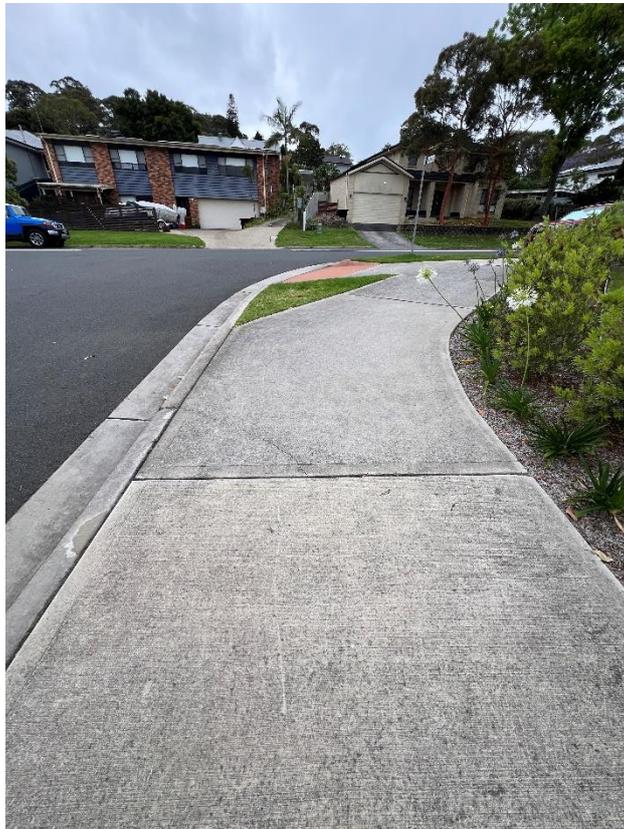
Figure 64 – General condition of the footpath.
