DILAPIDATION REPORT

Bubalo Street, Warriewood

Prepared by: Rezoning Pty Ltd t/as Effective Building & Consultancy

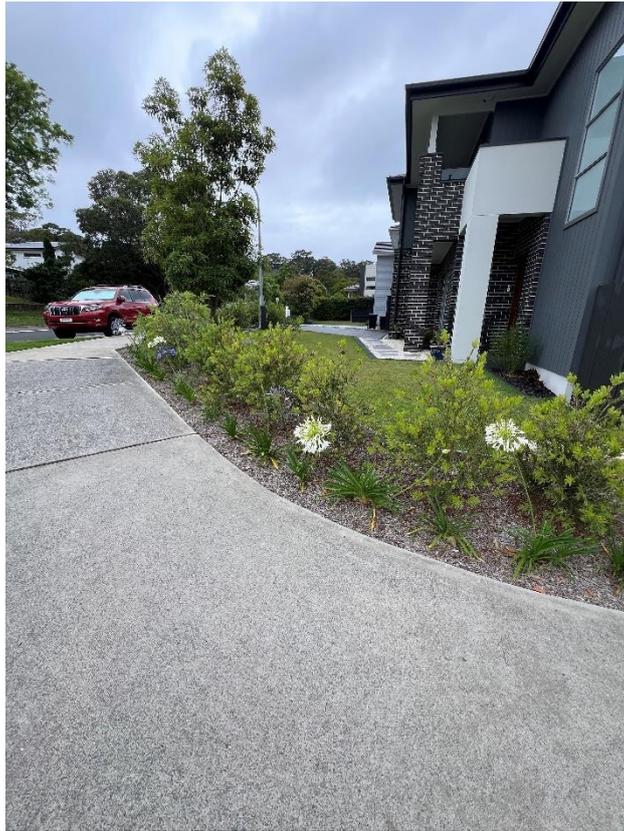
Figure 67 – General condition of the landscaping.

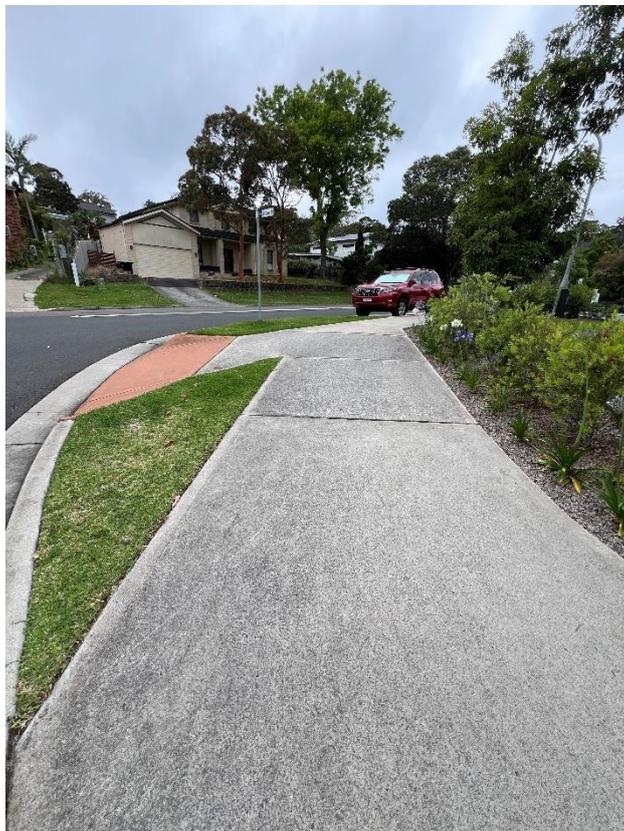
Figure 68 – General condition of the footpath.

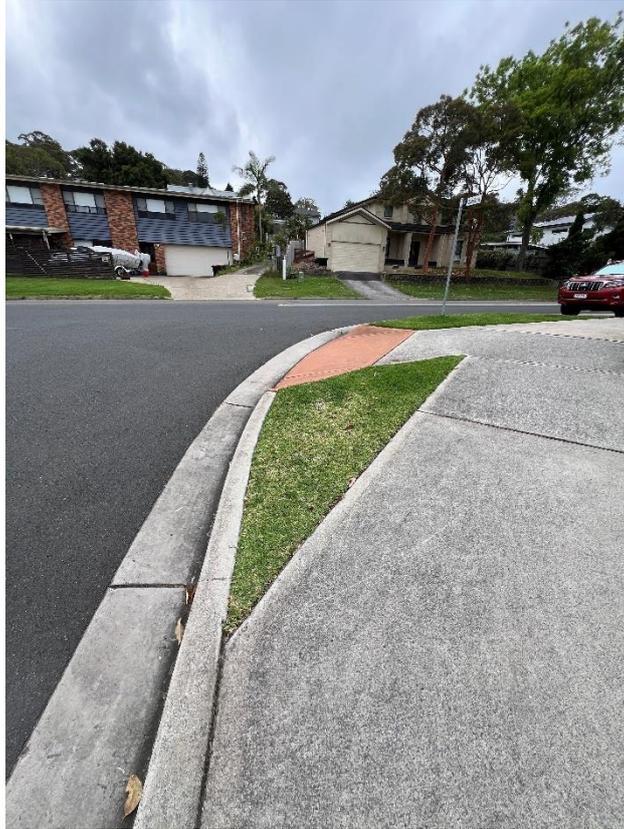
Figure 69 – General condition of the nature strip/kerb.

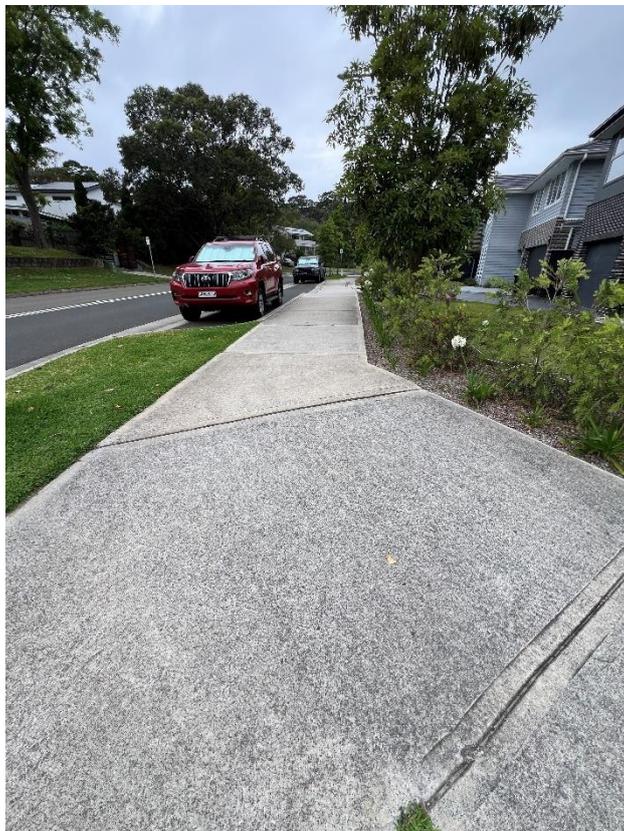
Figure 70 – General condition of the footpath.

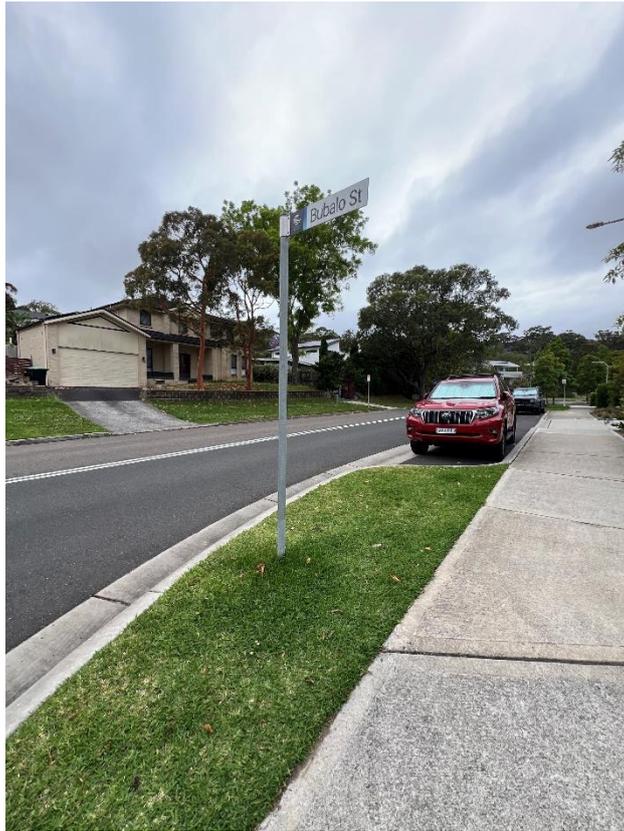
Figure 71 – General condition of the street signpost.

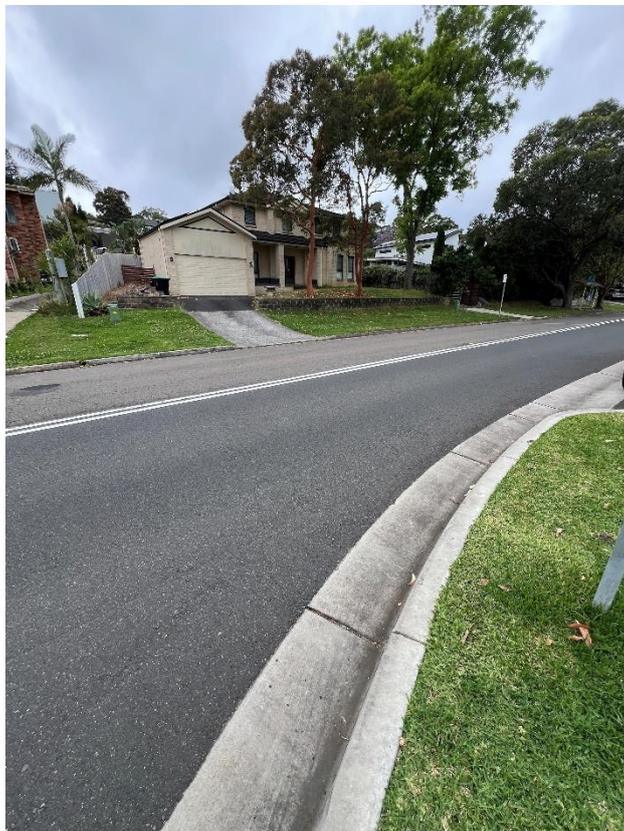
Figure 72 – General condition of the road/kerb.

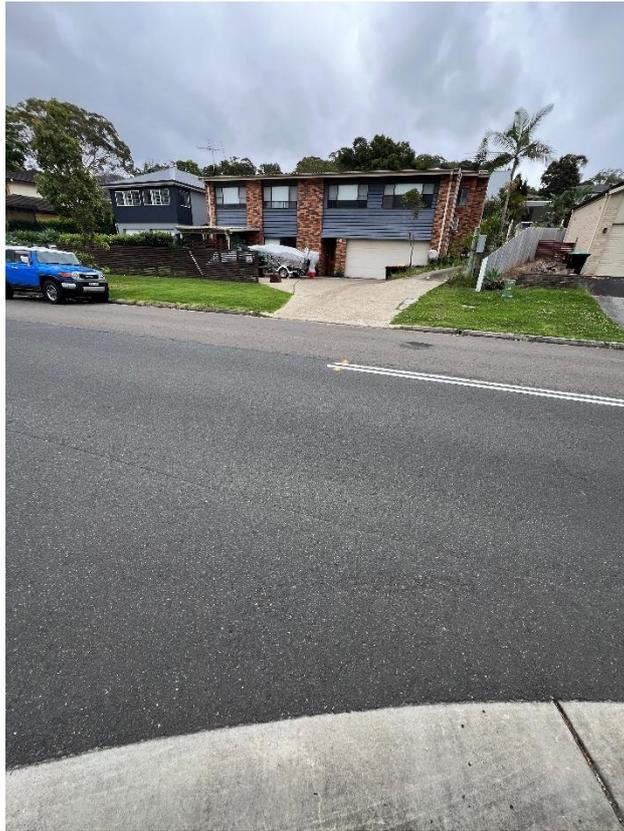
Figure 73 – General condition of the road.

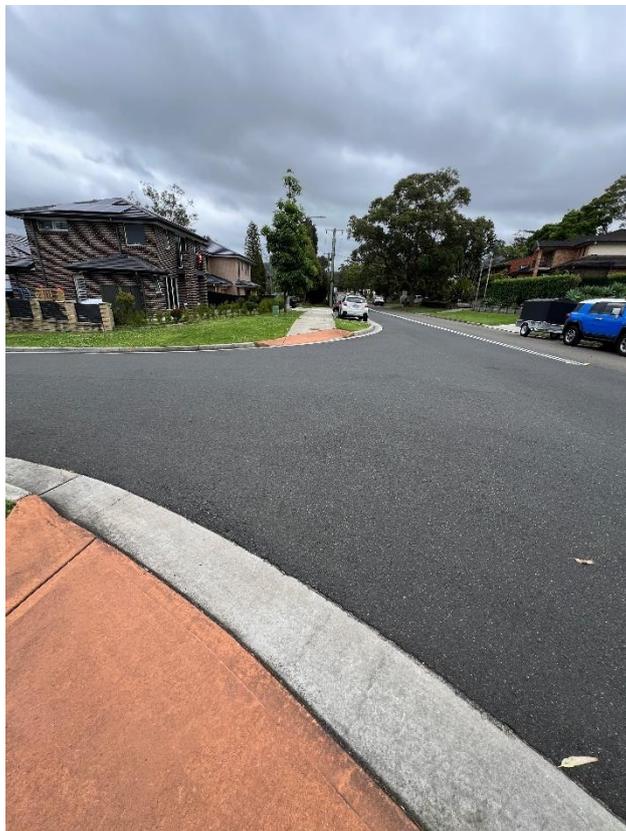
Figure 76 – General condition of the road.

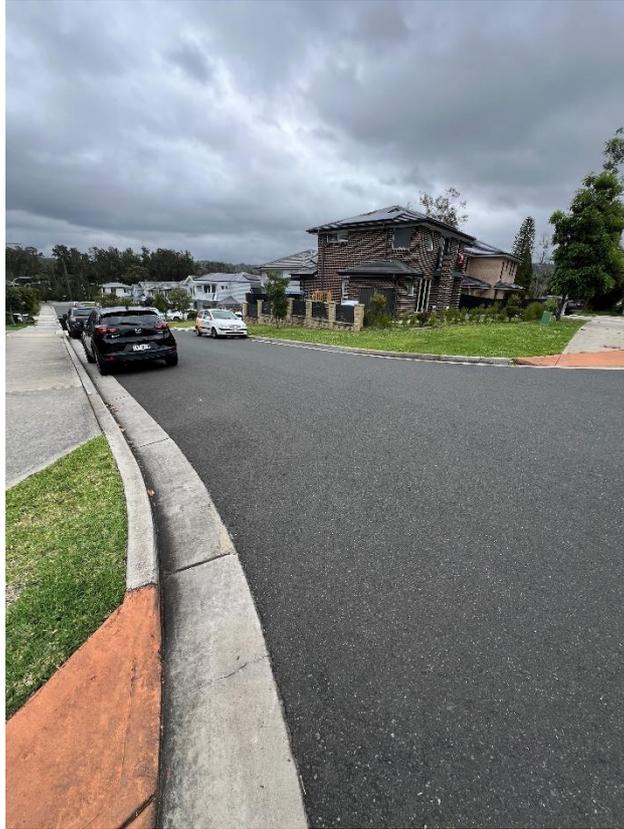
Figure 77 – General condition of the road/kerb.

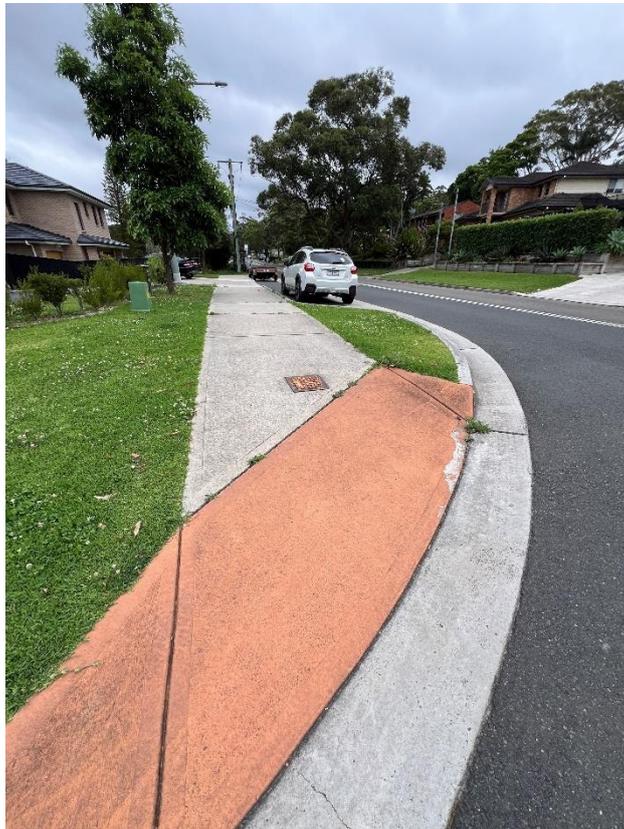
Figure 78 – General condition of the footpath/layback.

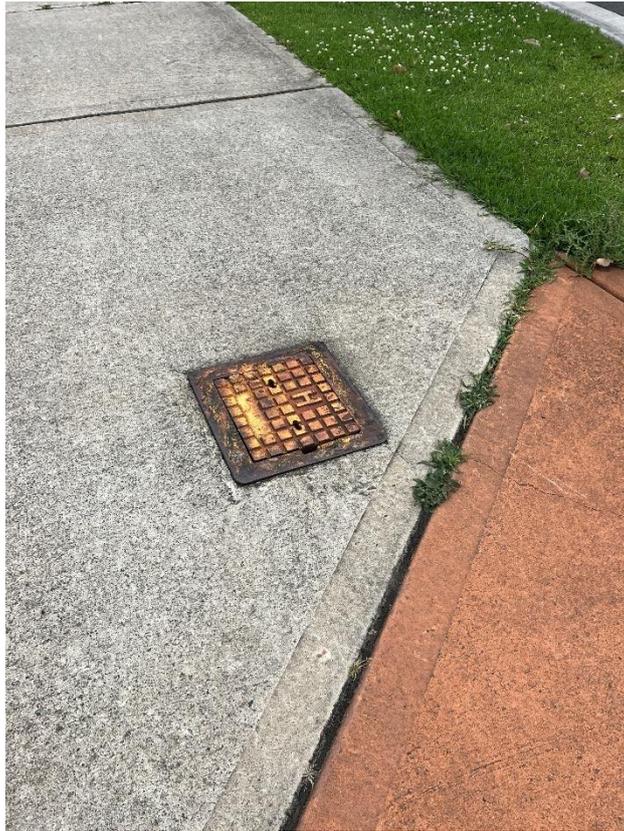
Figure 79 – General condition of the utility lid.

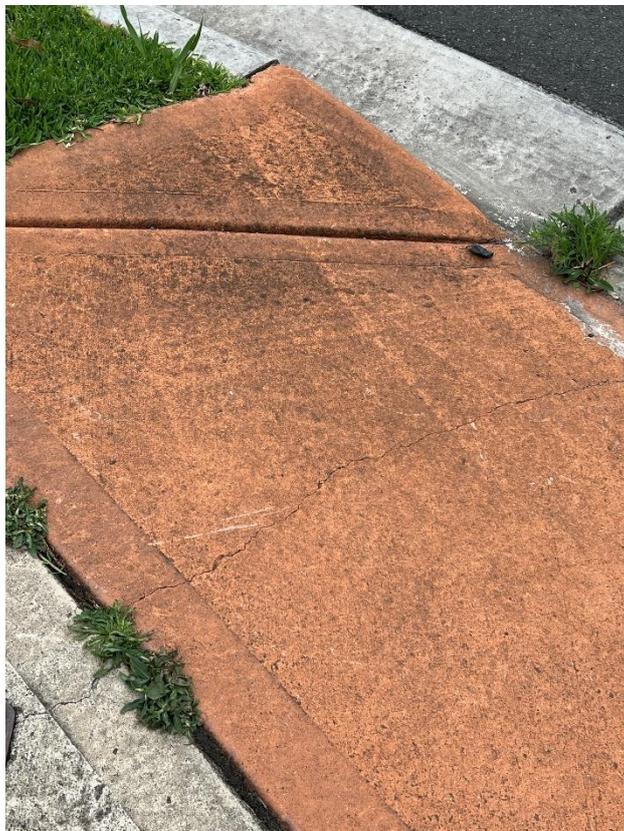
Figure 80 – Crack is evident to the layback.

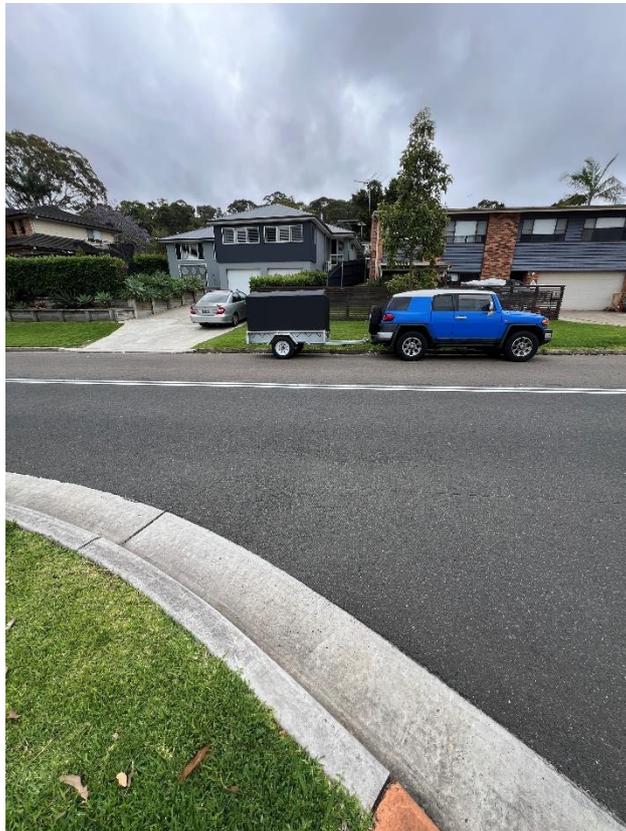
Figure 82 – General condition of the road/kerb.

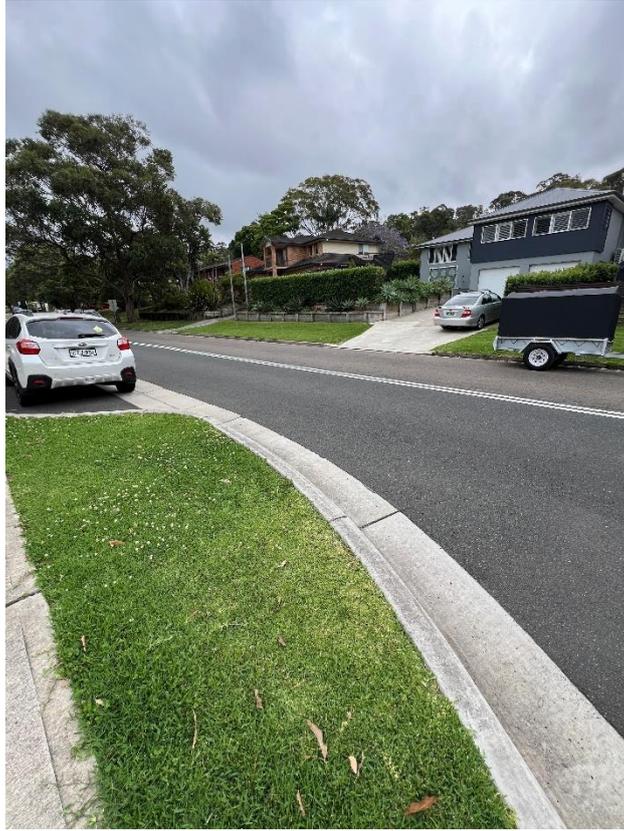
Figure 83 – General condition of the nature strip/kerb.

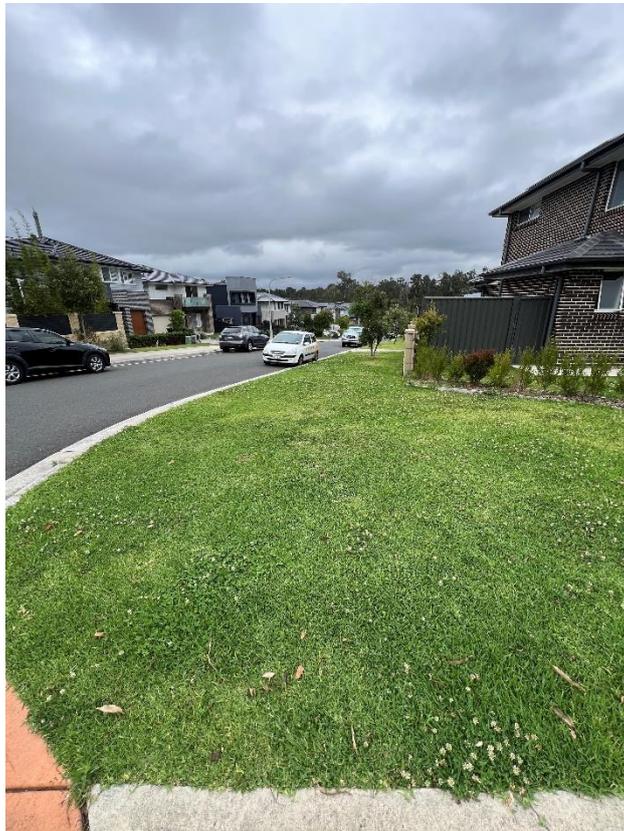
Figure 84 – General condition of the nature strip.

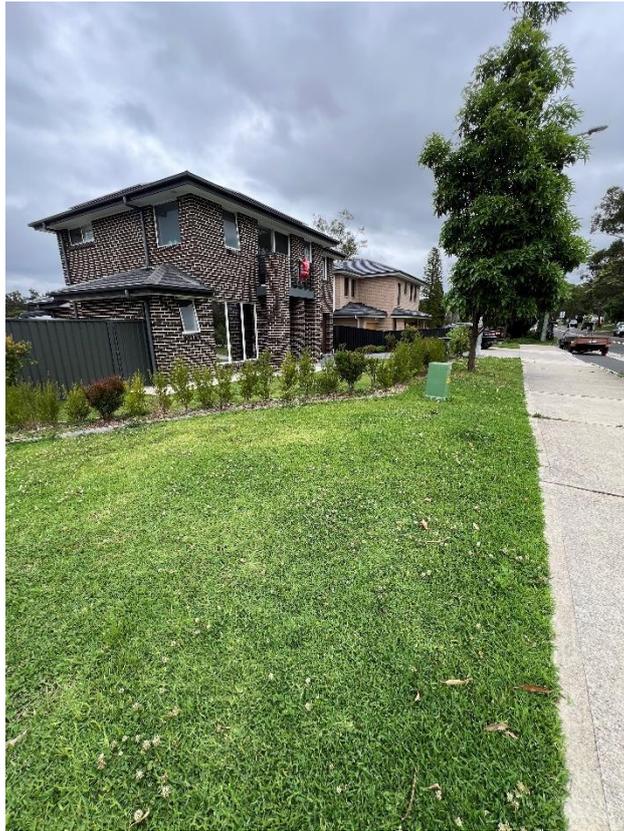
Figure 85 – General condition of the nature strip.

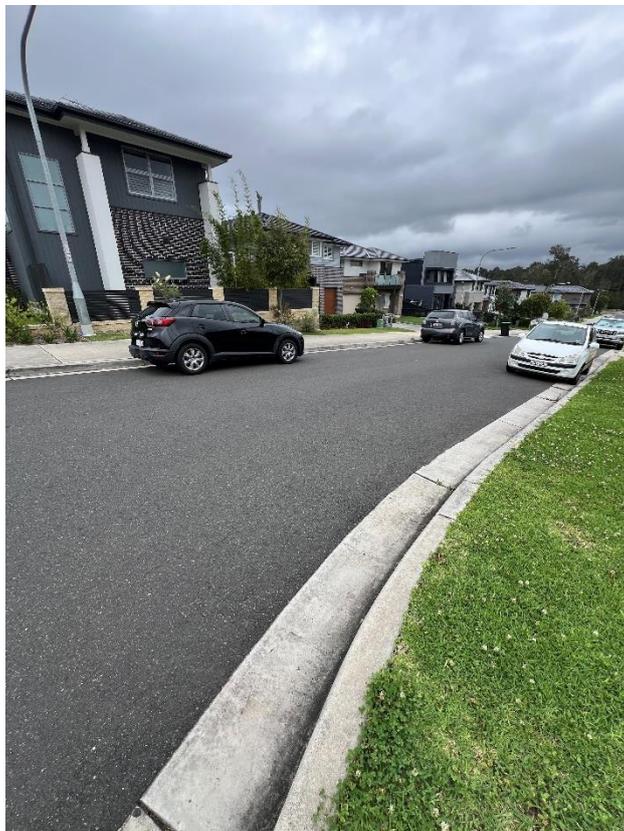
Figure 86 – General condition of the road/kerb.

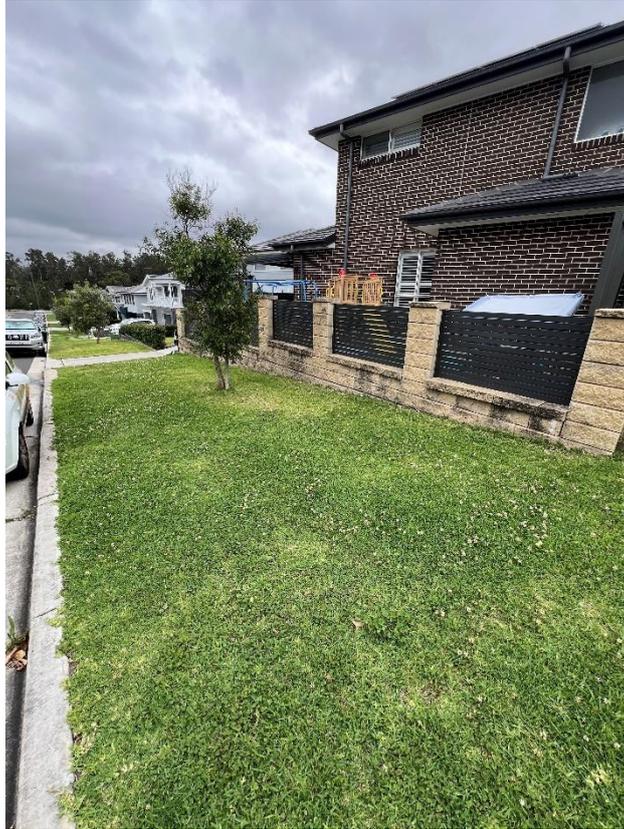
Figure 87 – General condition of the nature strip.

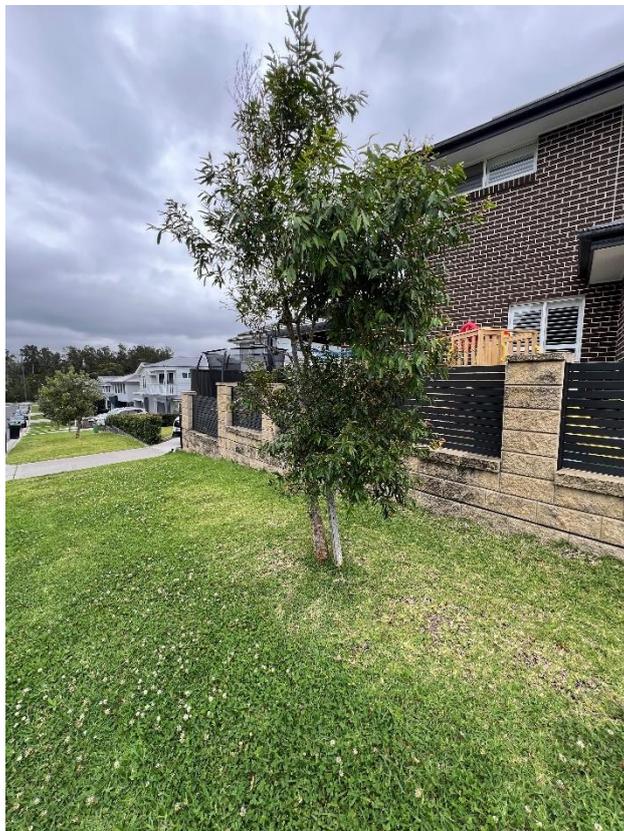
Figure 88 – General condition of the tree.

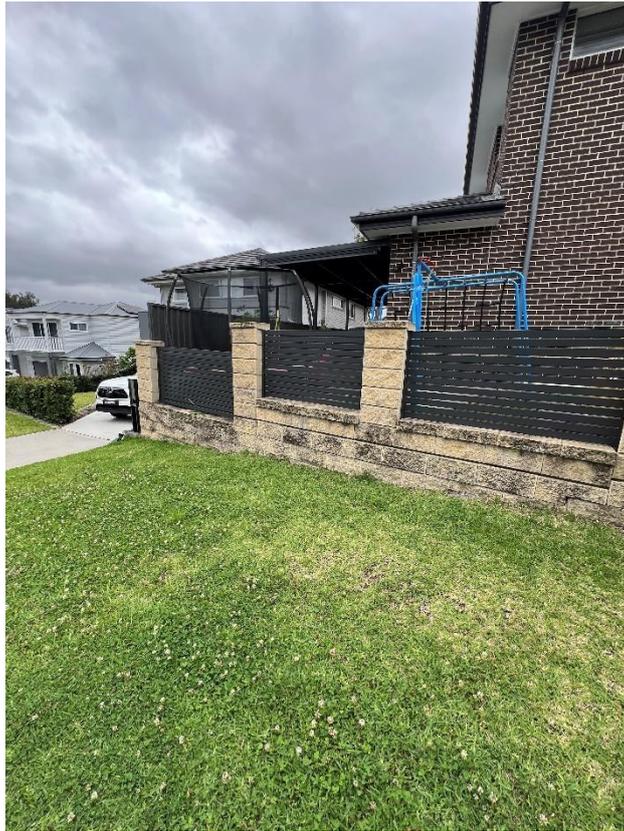
Figure 89 – General condition of the nature strip/retaining wall.

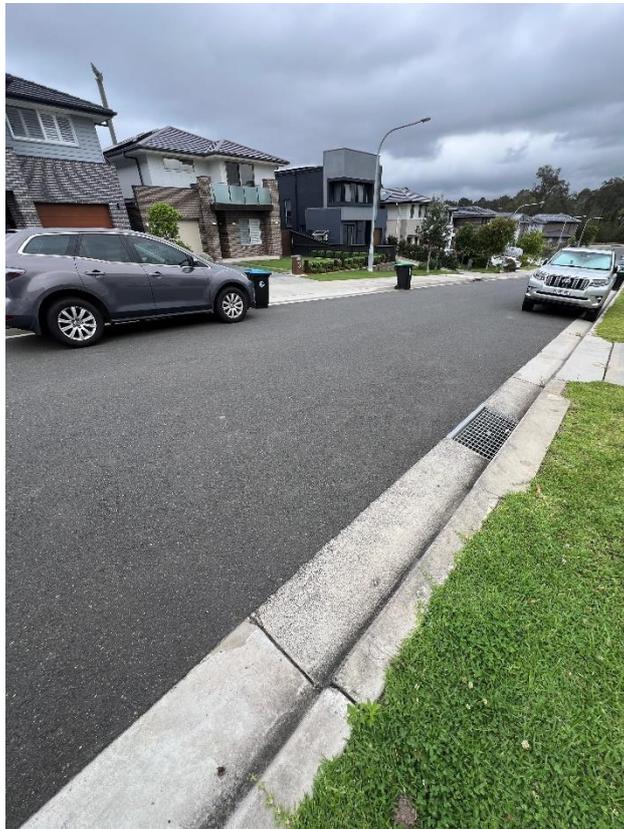
Figure 90 – General condition of the road/kerb.

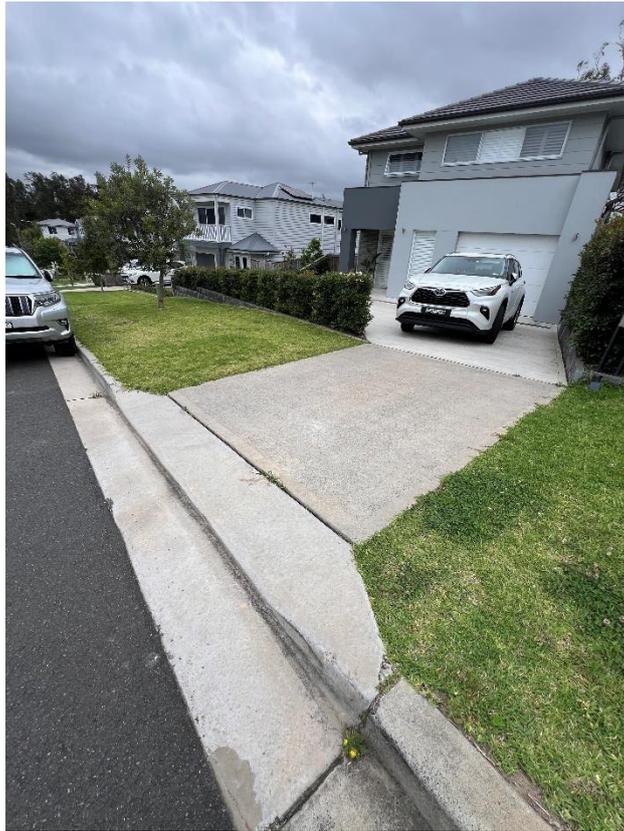
Figure 91 – General condition of the driveway.

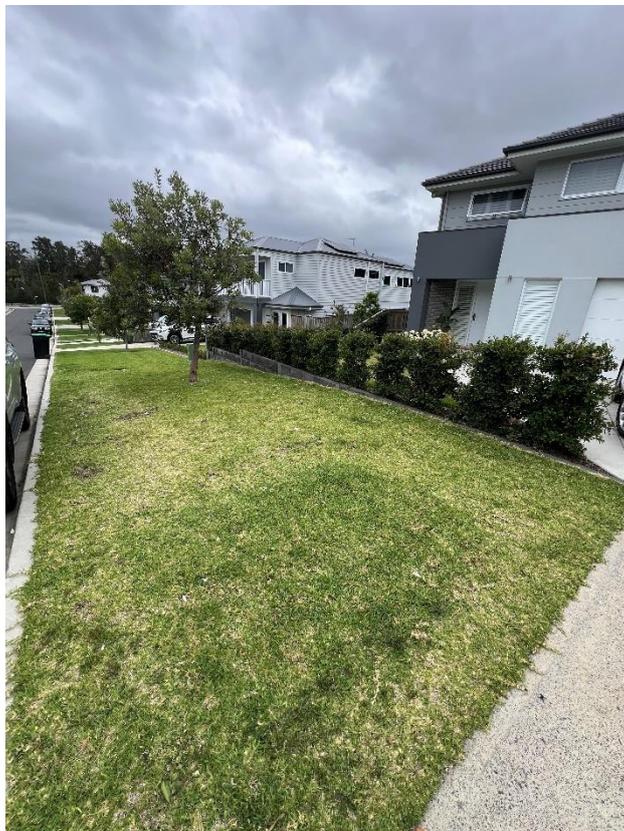
Figure 92 – General condition of the nature strip.

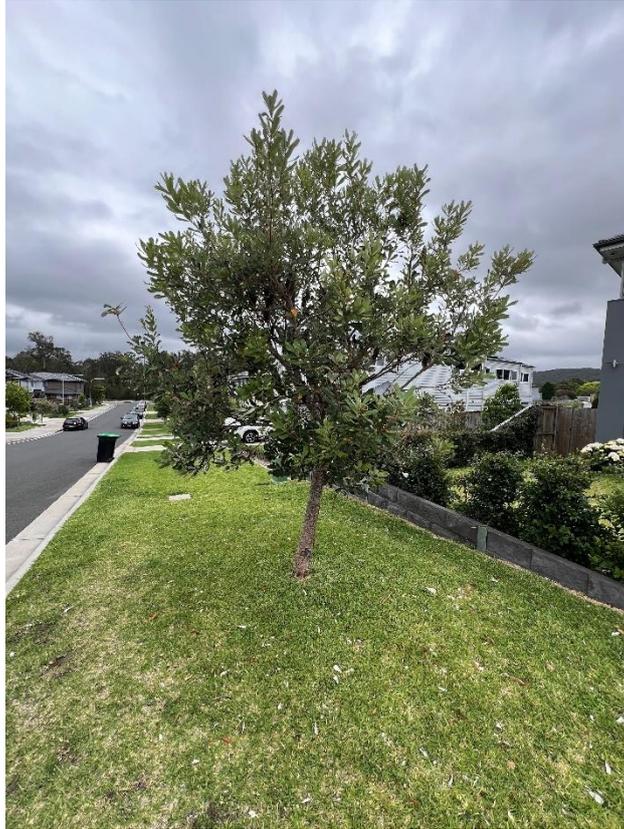
Figure 93 – General condition of the tree.

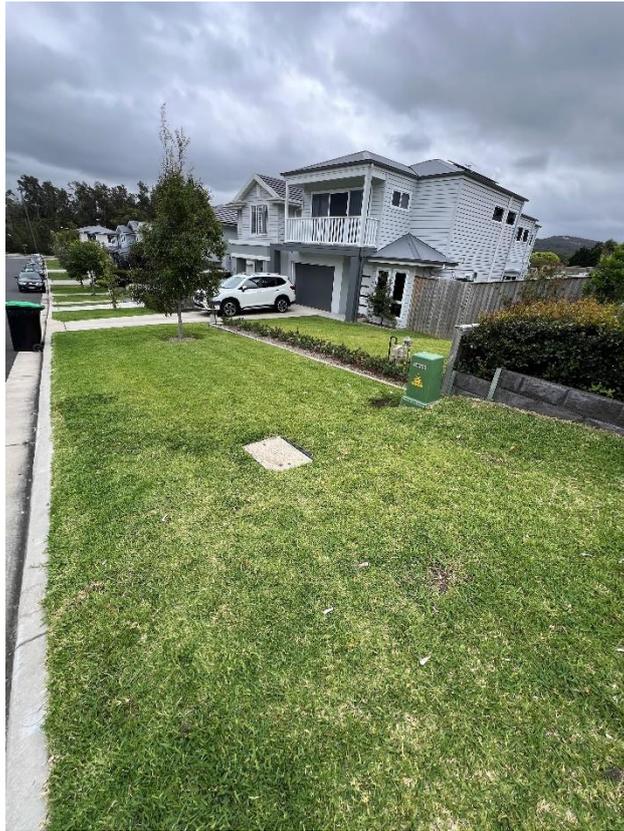
Figure 95 – General condition of the nature strip.

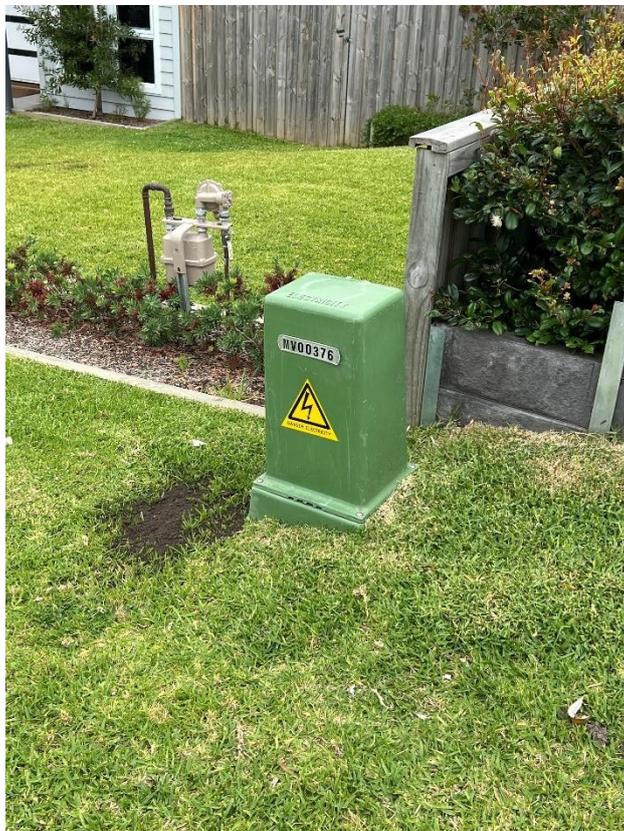
Figure 96 – General condition of the transformer box.

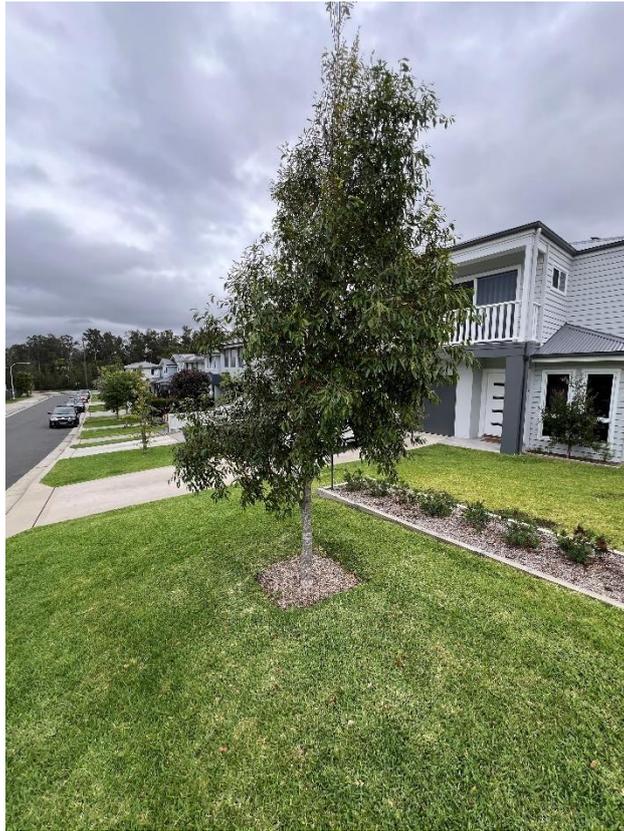
Figure 99 – General condition of the tree.

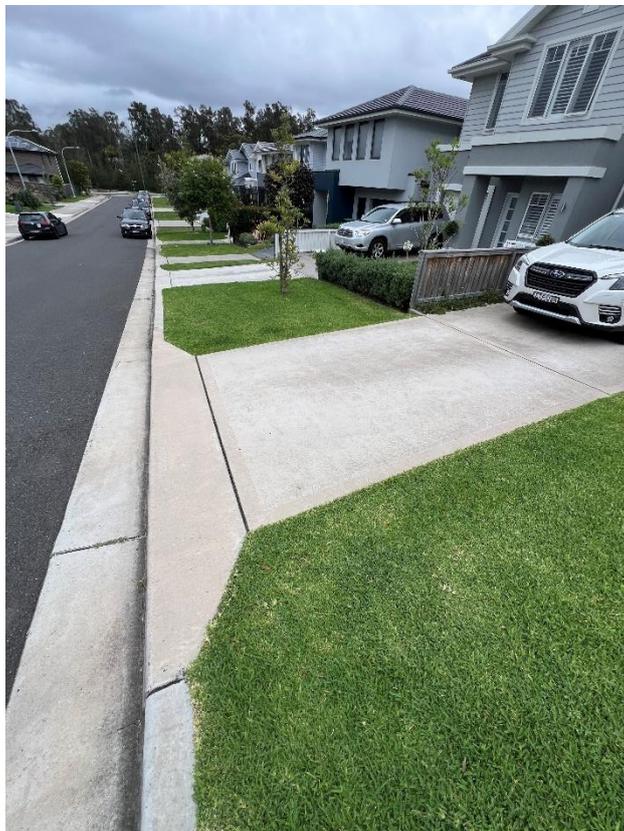
Figure 100 – General condition of the driveway.

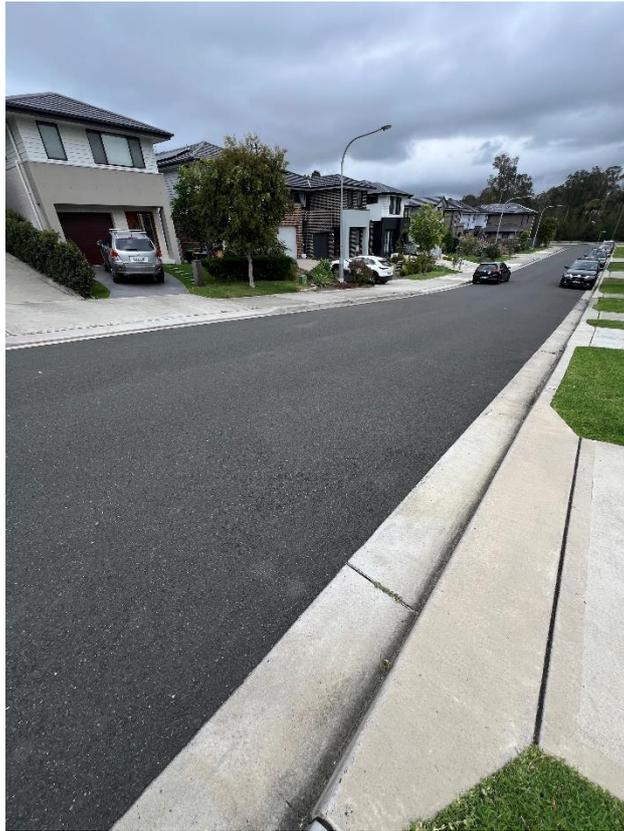
Figure 101 – General condition of the road.

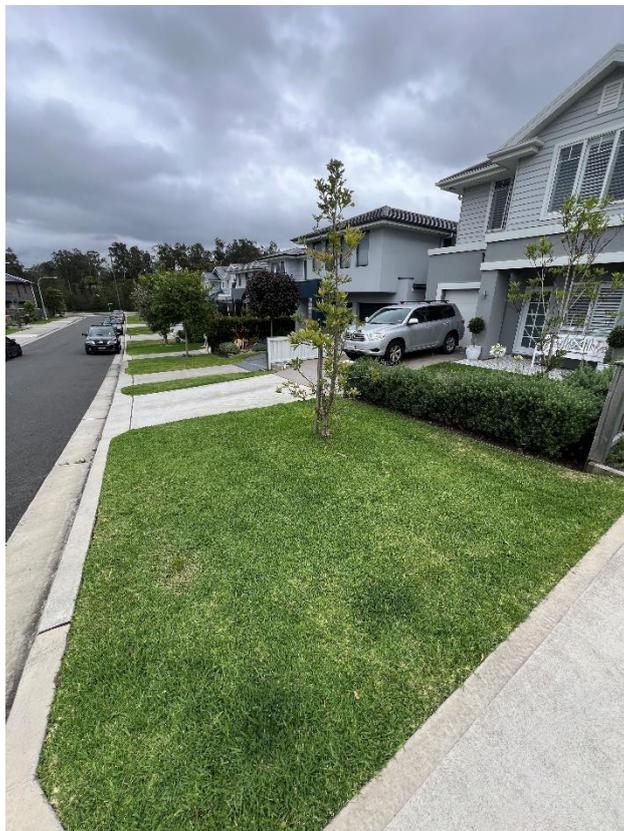
Figure 102 – General condition of the nature strip/tree.

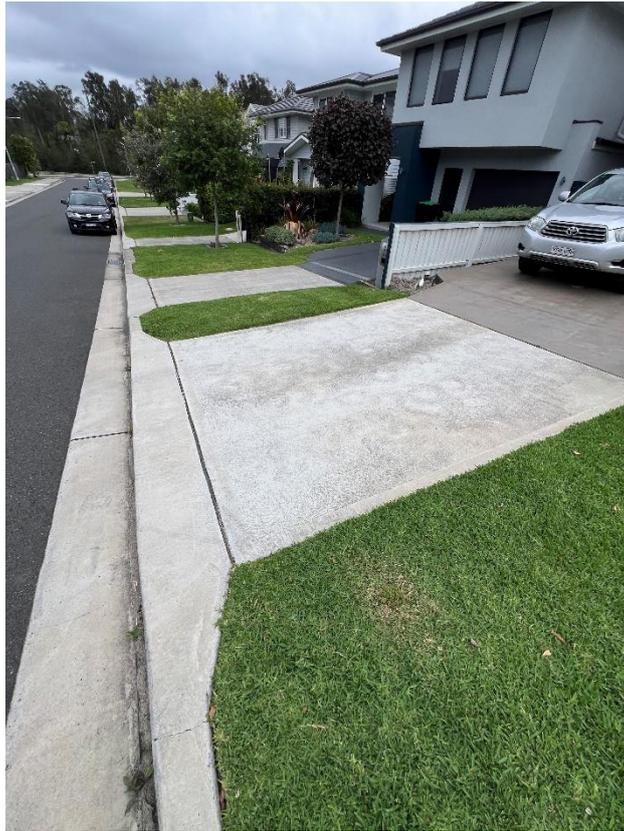
Figure 103 – General condition of the driveway.

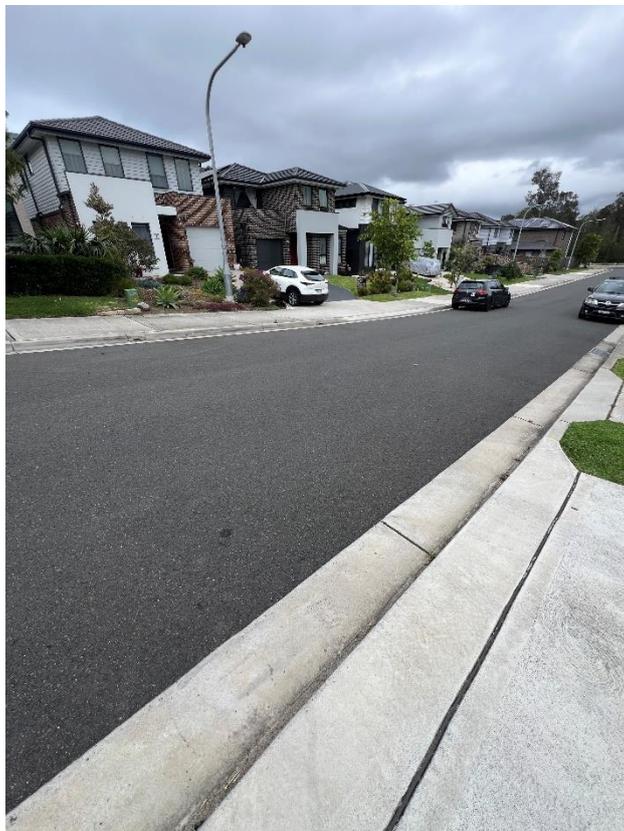
Figure 104 – General condition of the road/layback.

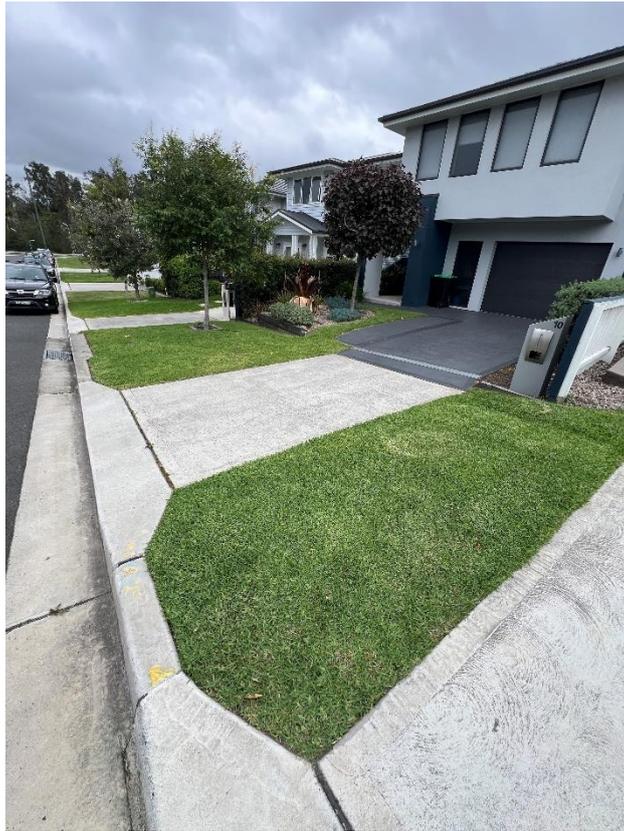
Figure 105 – General condition of the nature strip.

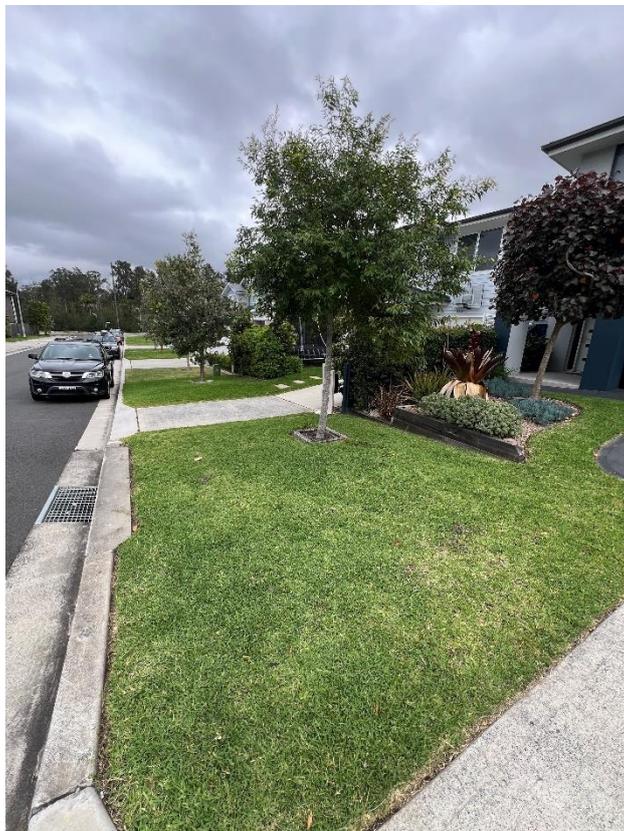
Figure 106 – General condition of the nature strip.

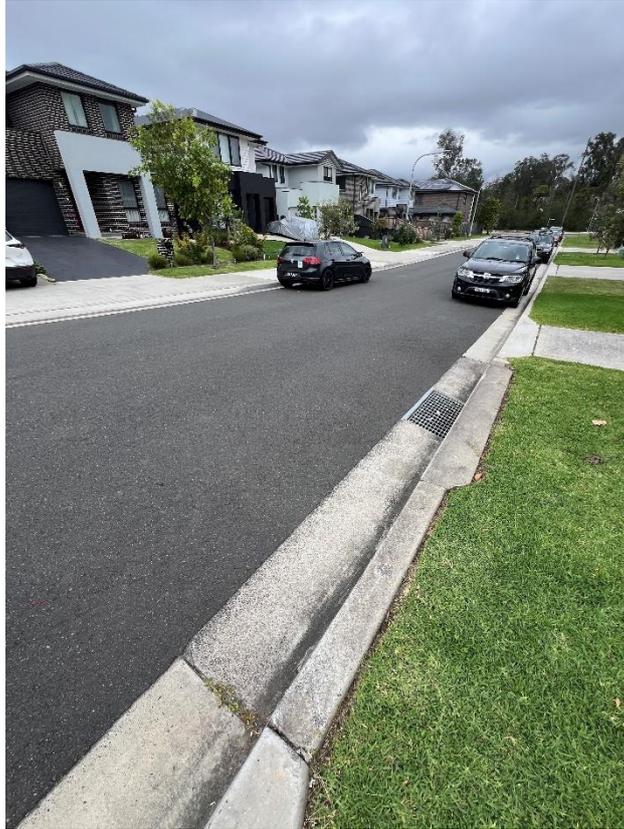
Figure 107 – General condition of the road/kerb.

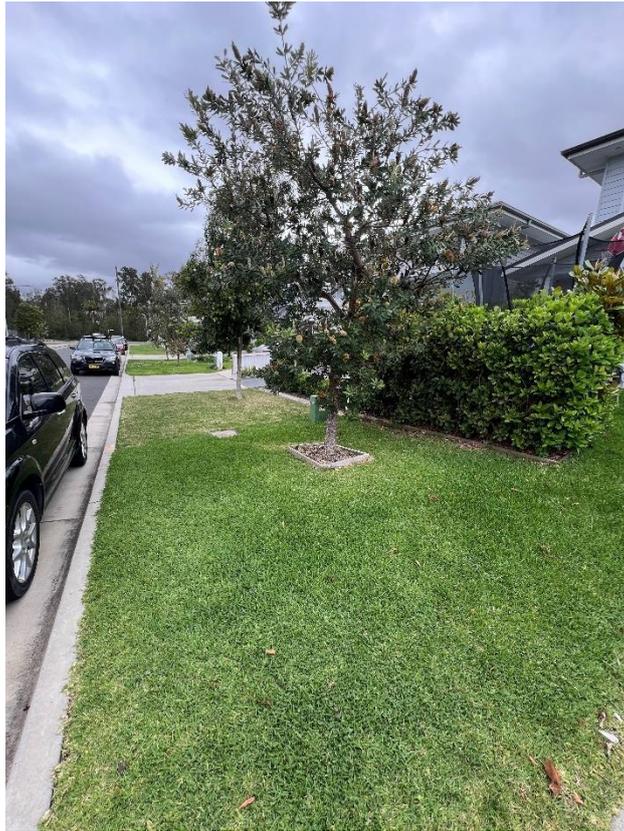
Figure 109 – General condition of the tree.

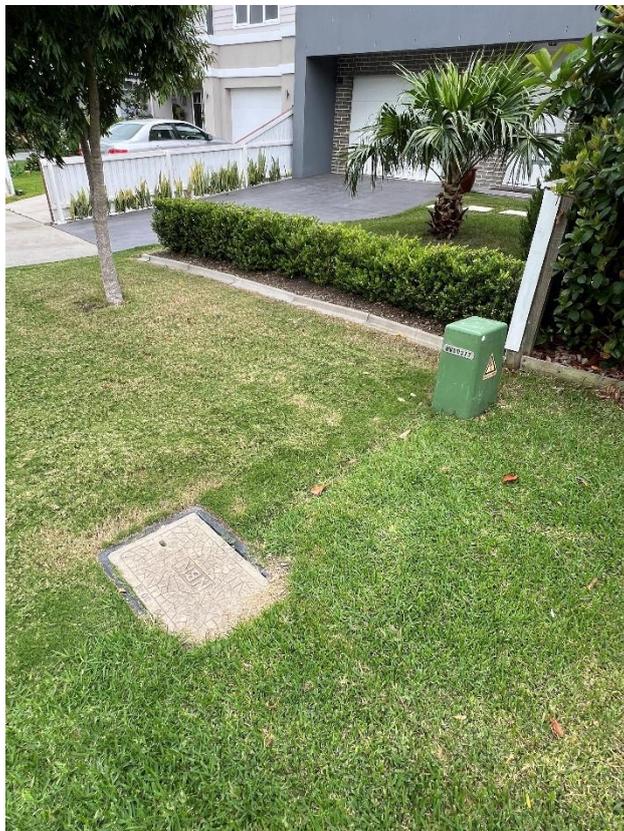
Figure 110 – General condition of the pit/transformer box.

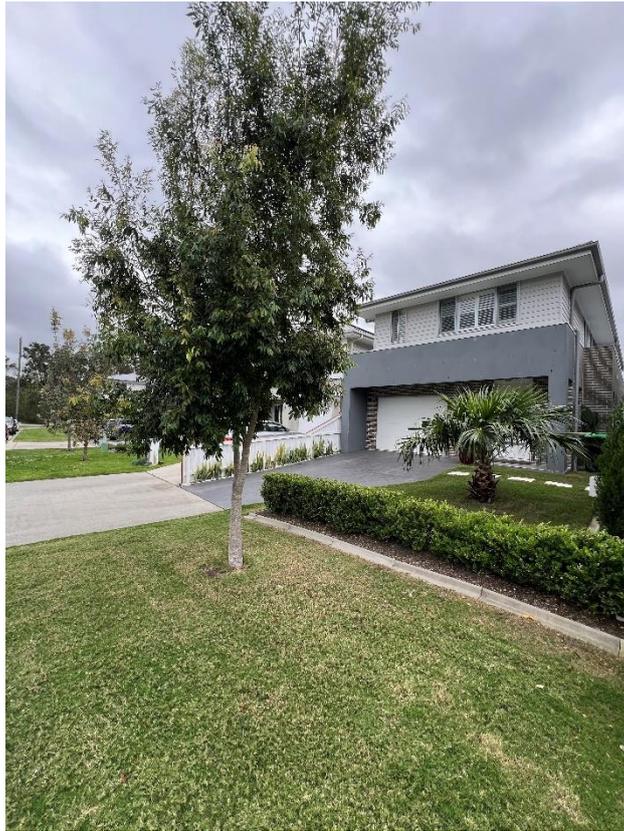
Figure 111 – General condition of the tree.

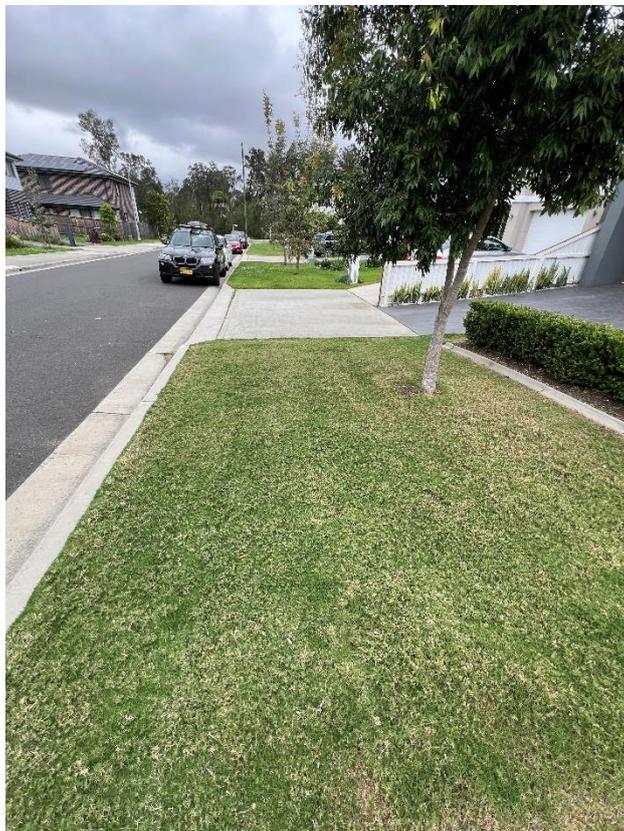
Figure 112 – General condition of the nature strip.

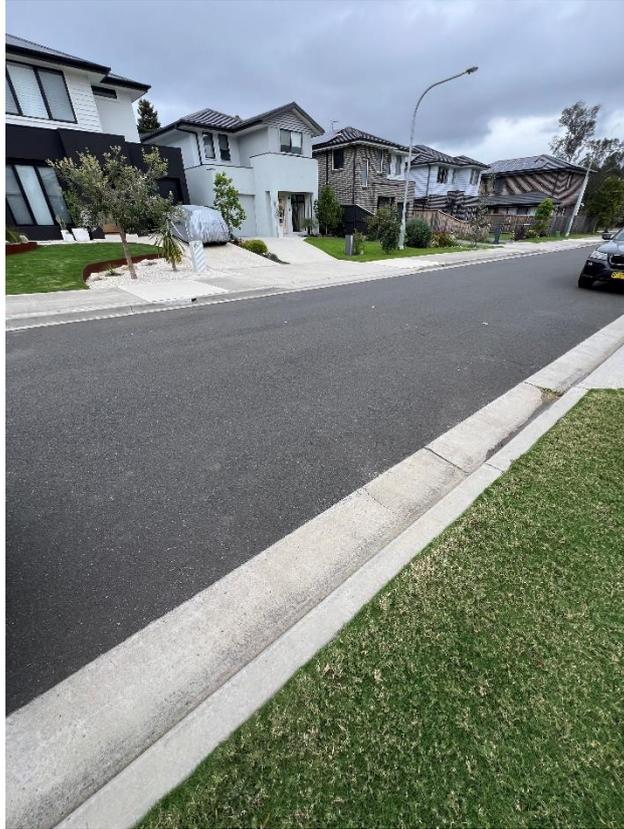
Figure 113 – General condition of the road/kerb.

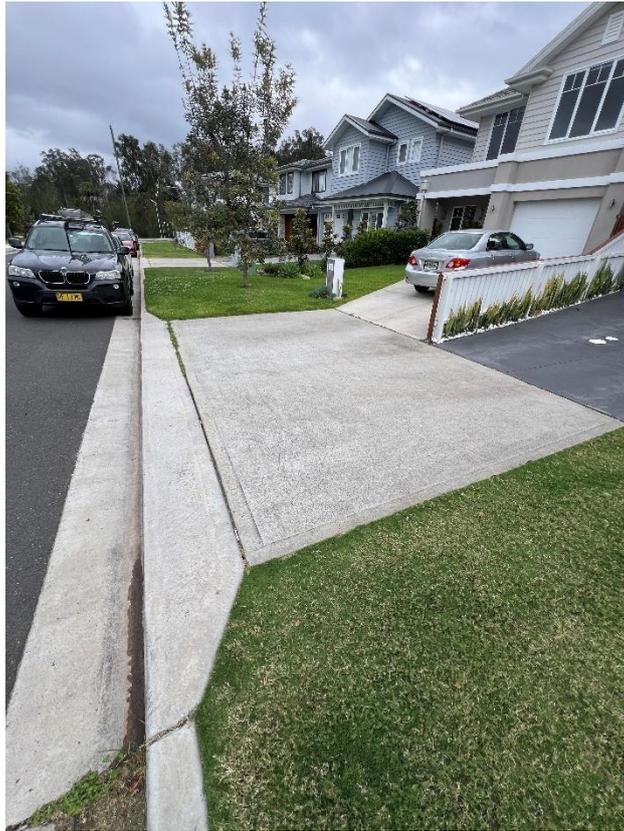
Figure 115 – General condition of the driveway.

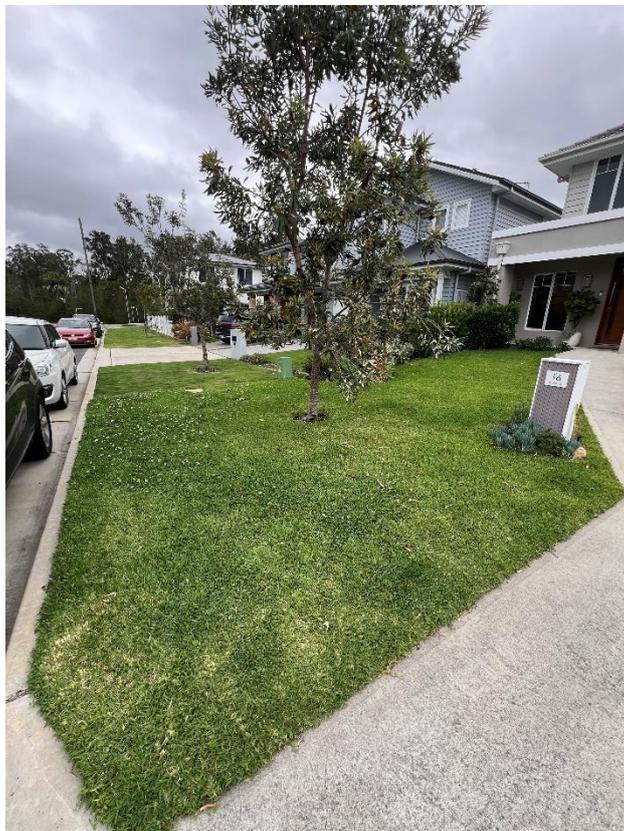
Figure 116 – General condition of the nature strip/tree.

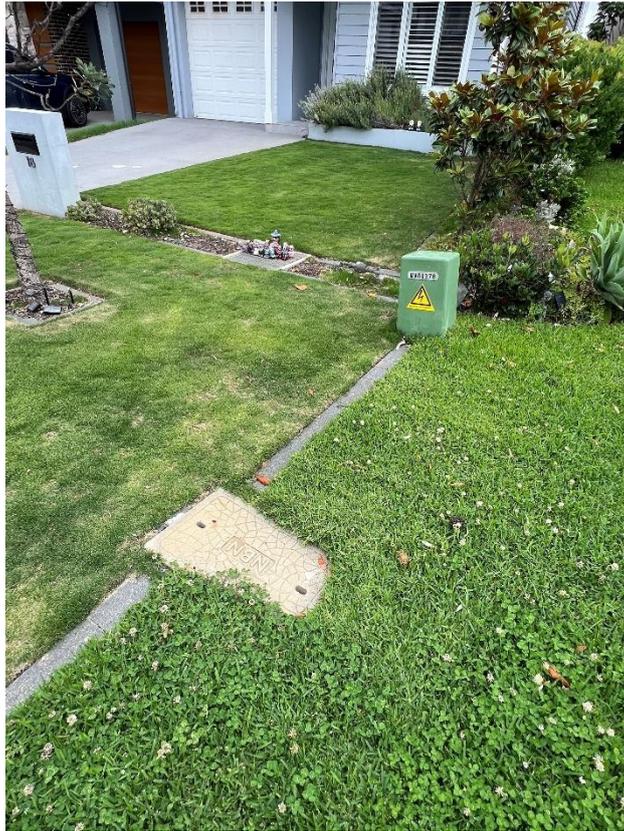
Figure 117 – General condition of the pit/transformer box.
