DILAPIDATION REPORT

Bubalo Street, Warriewood

Prepared by: Rezoning Pty Ltd t/as Effective Building & Consultancy

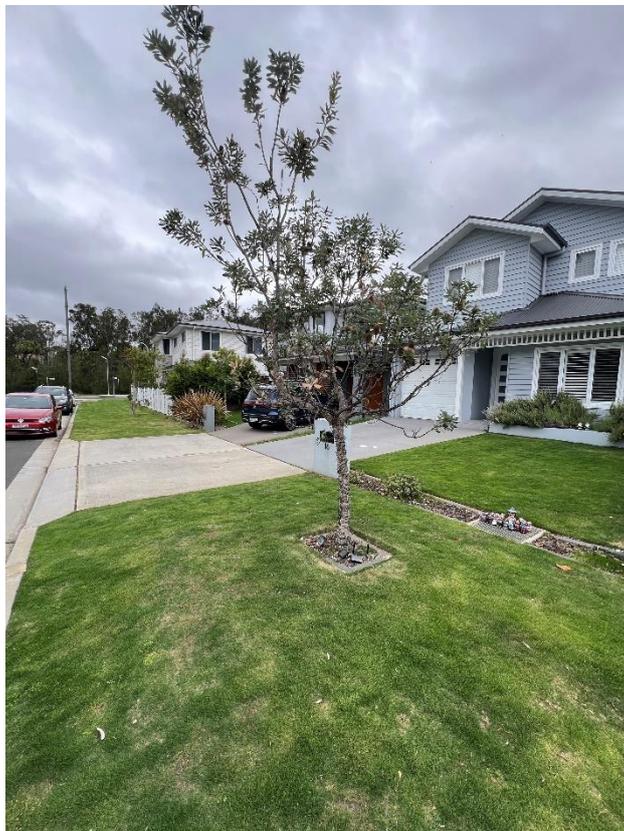
Figure 118 – General condition of the tree.

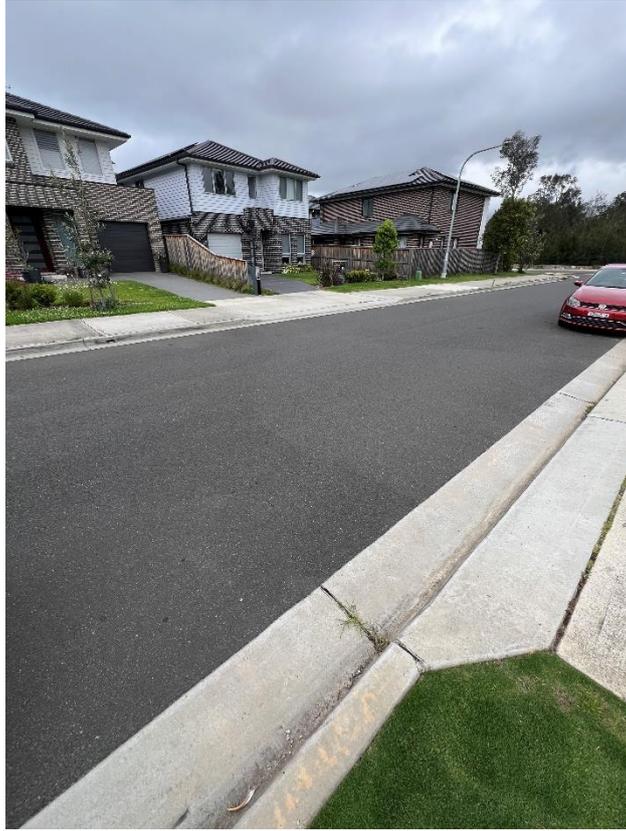
Figure 119 – General condition of the road.

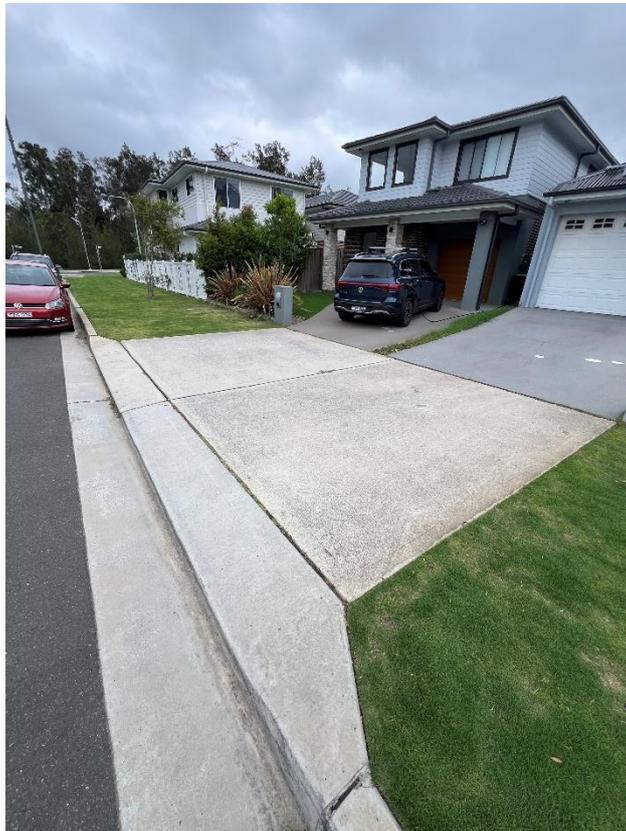
Figure 120 – General condition of the driveway.

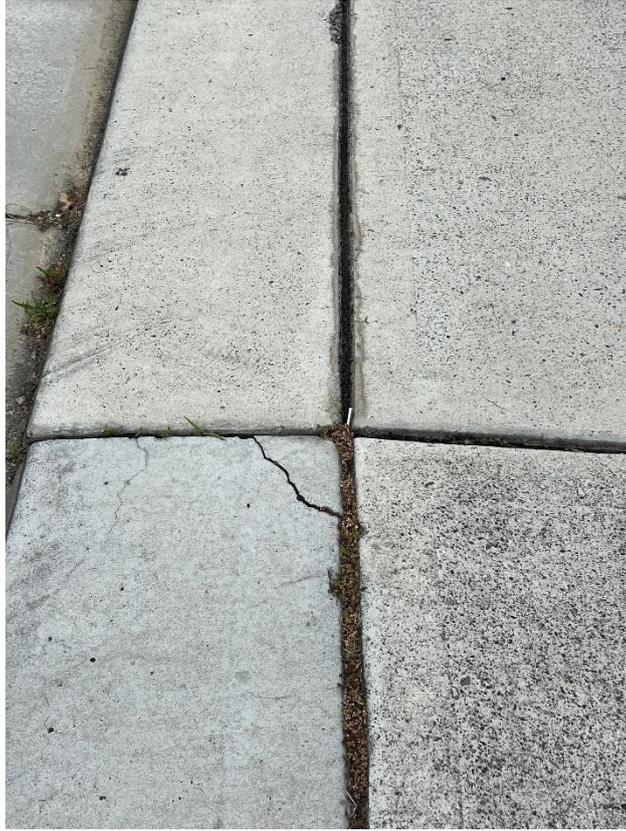
Figure 121 – Crack is evident to the layback.

The council assets were found to be in a fair condition with evidence of crack to the footpath, pit, kerb, and layback.

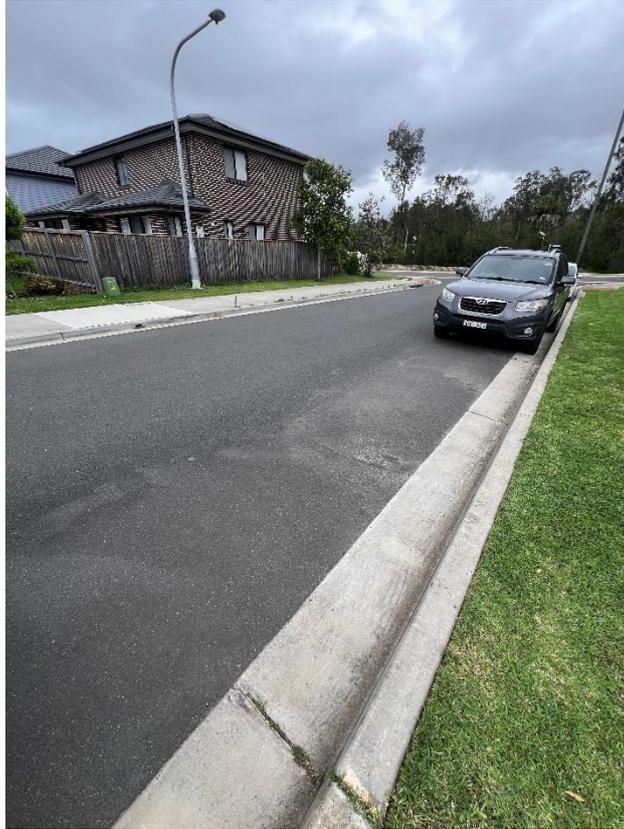
Figure 123 – General condition of the road/kerb.

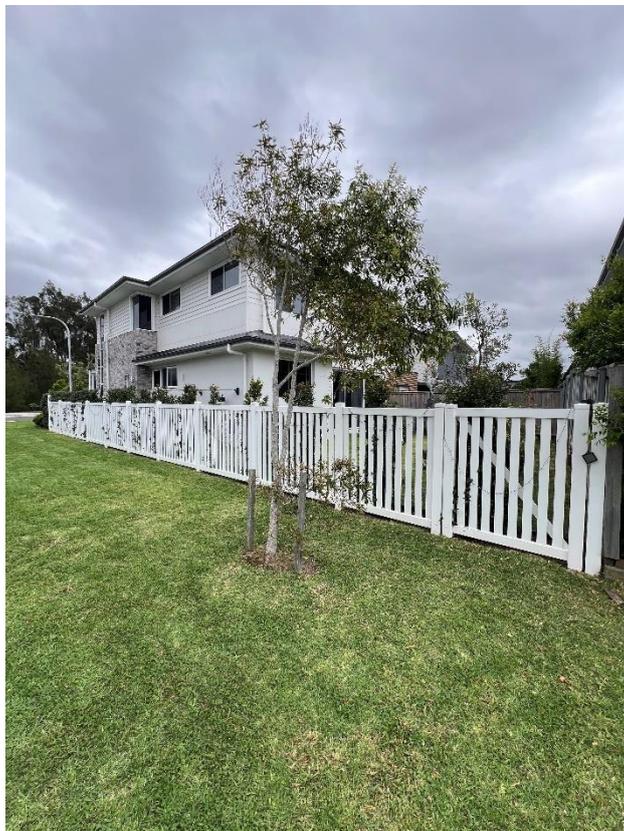
Figure 124 – General condition of the tree.

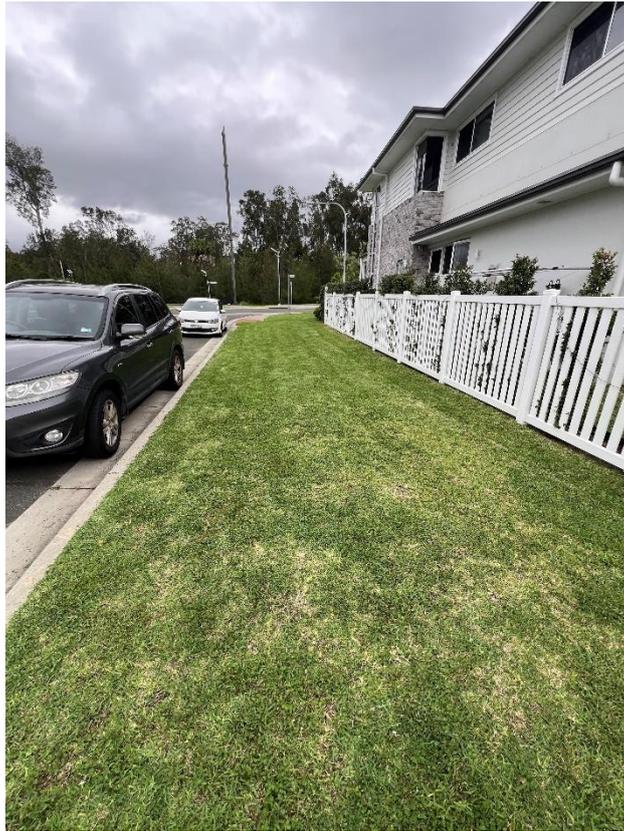
Figure 125 – General condition of the nature strip.

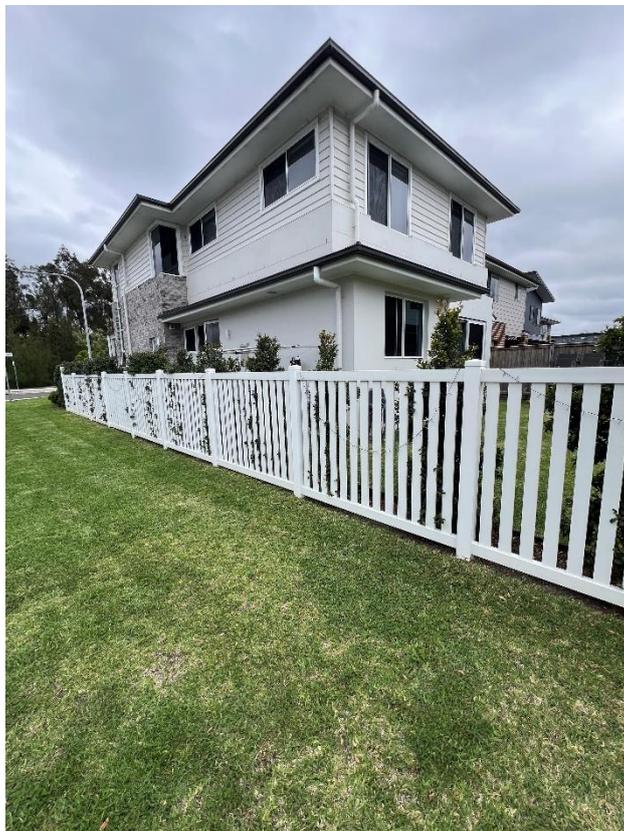
Figure 126 – General condition of the fence.

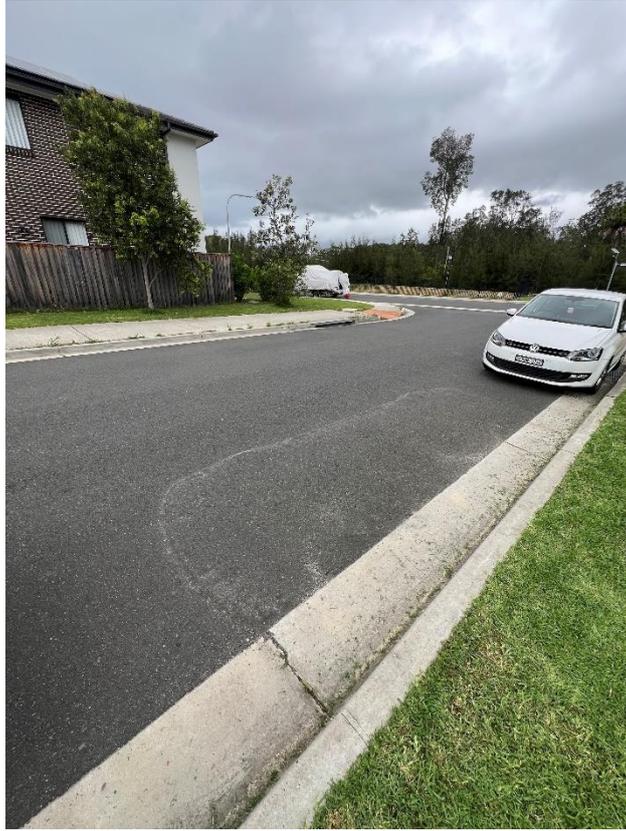
Figure 127 – General condition of the road/kerb.

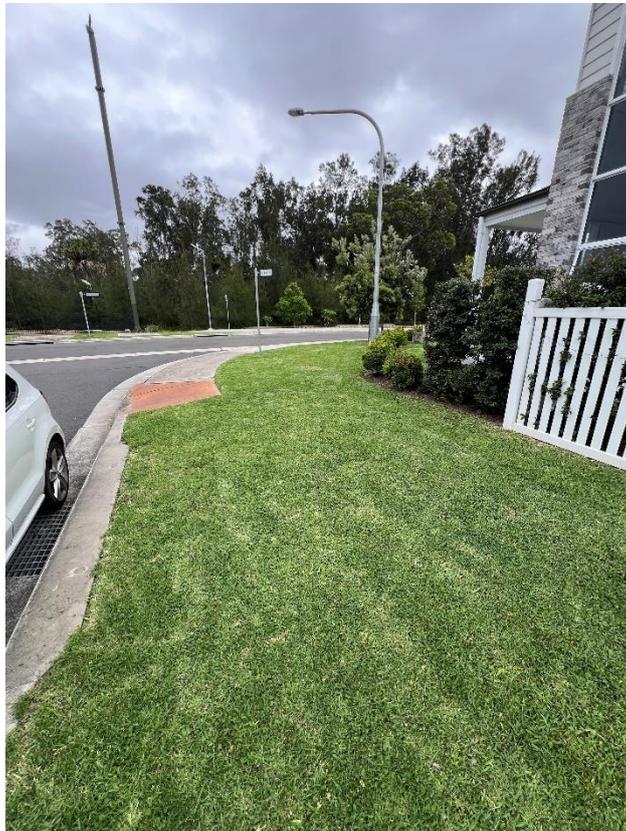
Figure 128 – General condition of the nature strip.

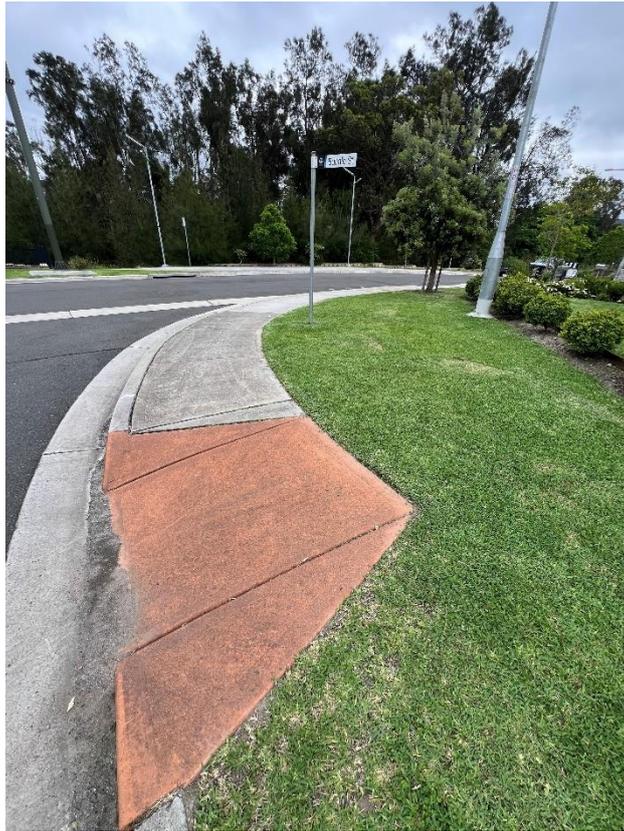
Figure 129 – General condition of the footpath.

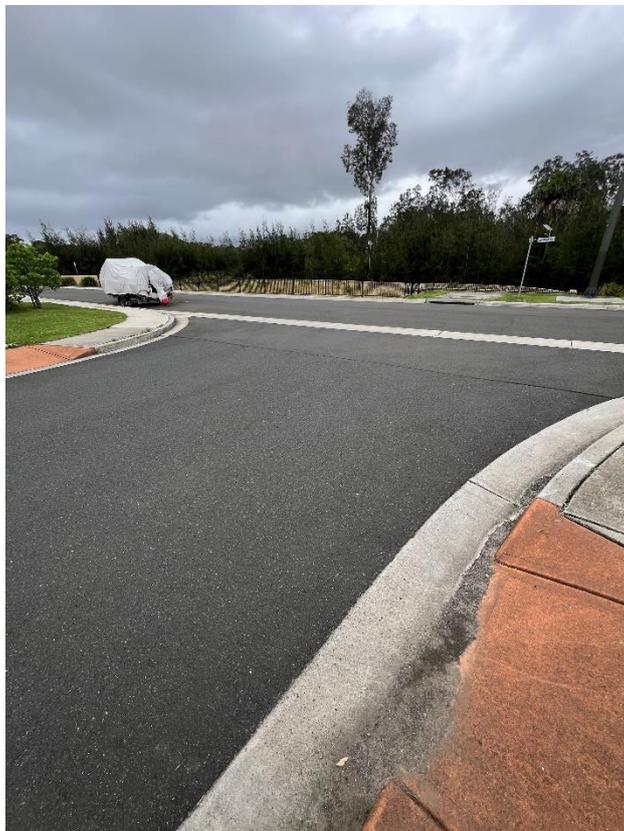
Figure 130 – General condition of the road/layback.
