Hazardous Building Materials (HBM) Assessment

Narrabeen Sports High School (8512)

Project 86973.02  
March 2020

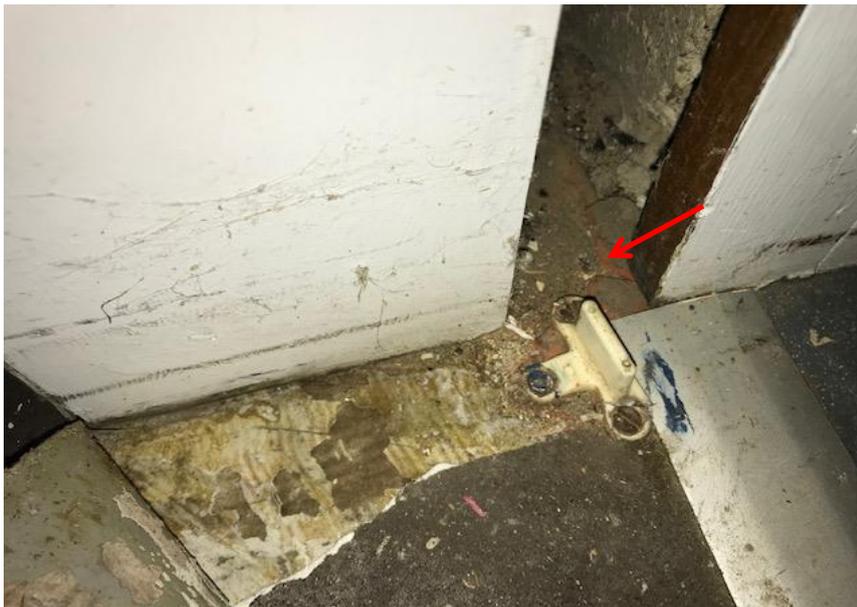
Photograph 2: B00A, R0010 - Design Room , floor (below newer floor covering/s), residual vinyl tile and/or associated debris, asbestos detected by analysis

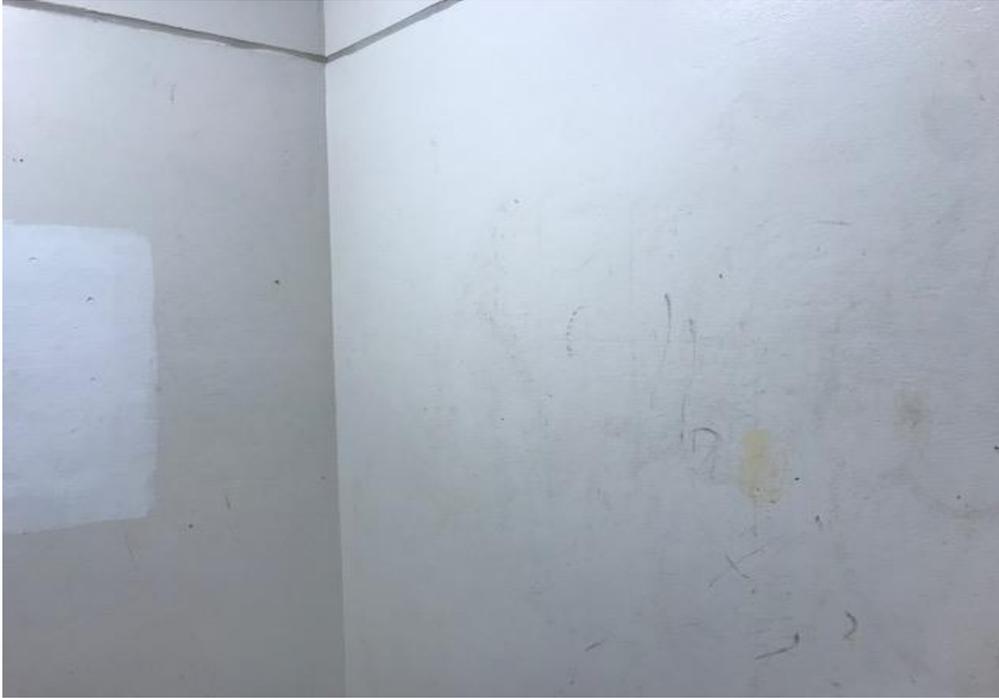
Photograph 7: B00A, R0052 - Shower and Toilets, walls, typical grey paint, negative for lead.

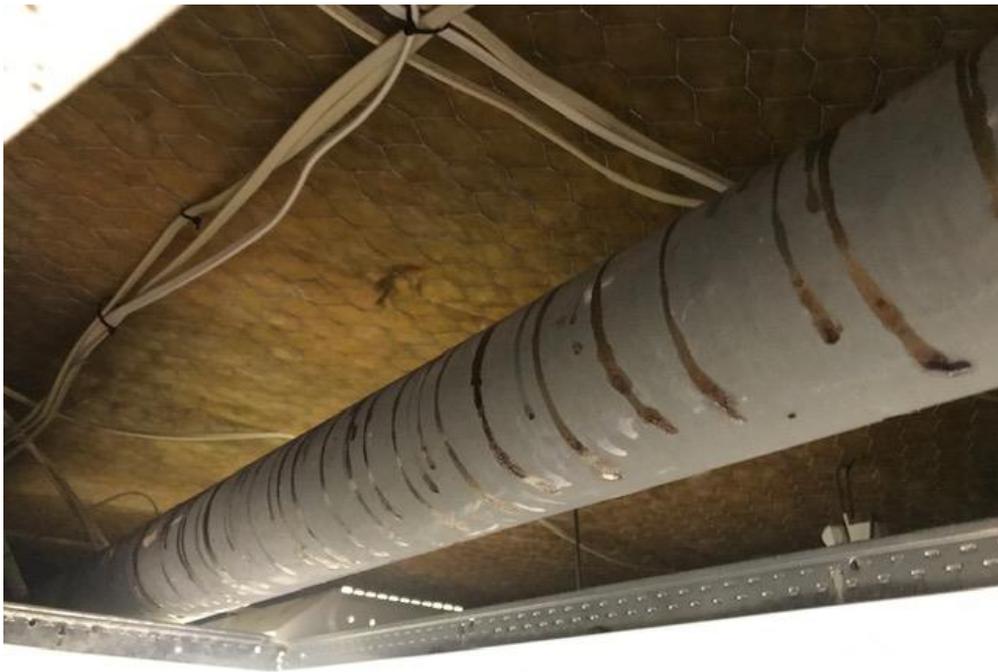
Photograph 10: B00A, Level 1, internal, ceiling void, steel beams , typical grey paint, negative for lead.

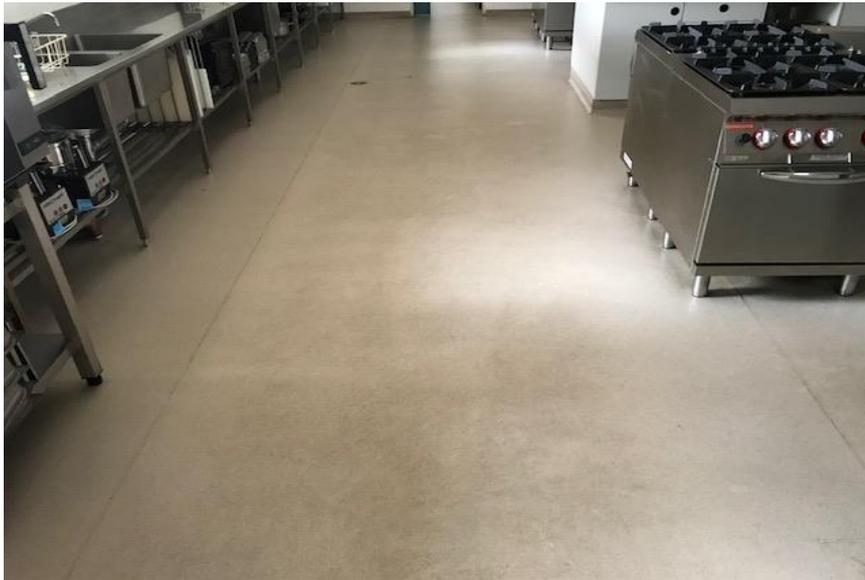
Photograph 16: B00A, R1001 - Food Technology, floor, vinyl tiles, asbestos detected by analysis

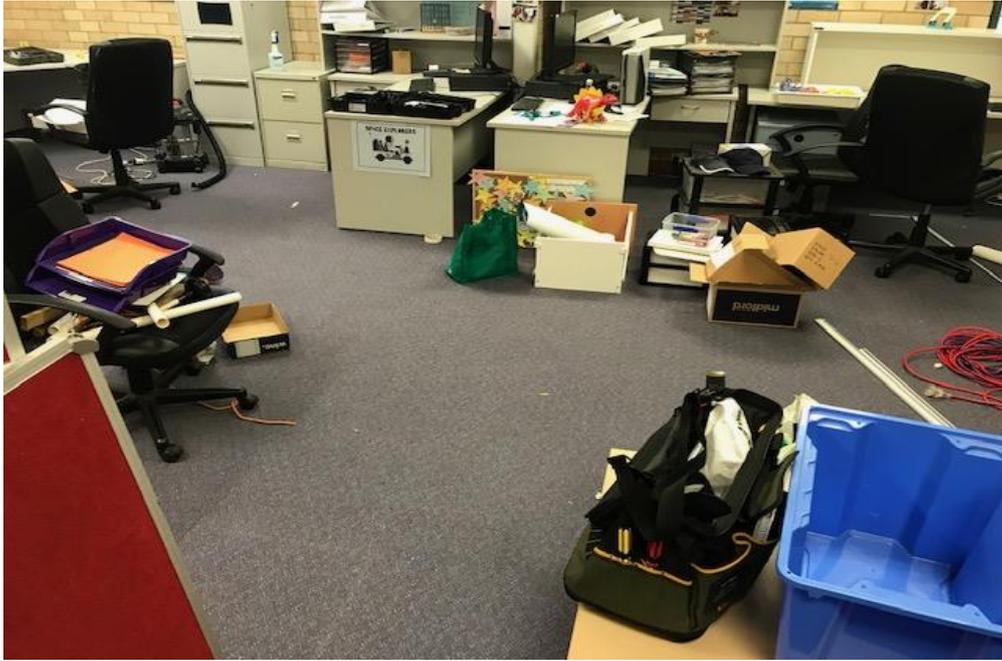
Photograph 3: B00B, R0004 - Staff Study , floor, vinyl tiles, material removed.

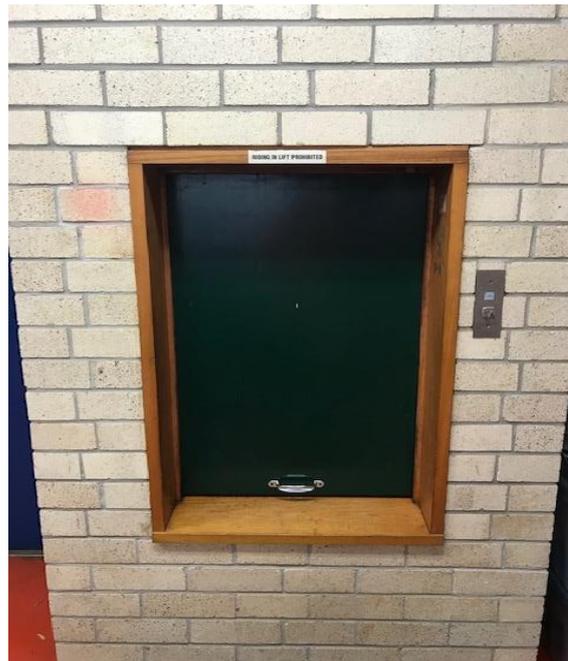
Photograph 6: B00B, R0013 - Lift, lift plant and lift shaft, internal components, asbestos (assumed).

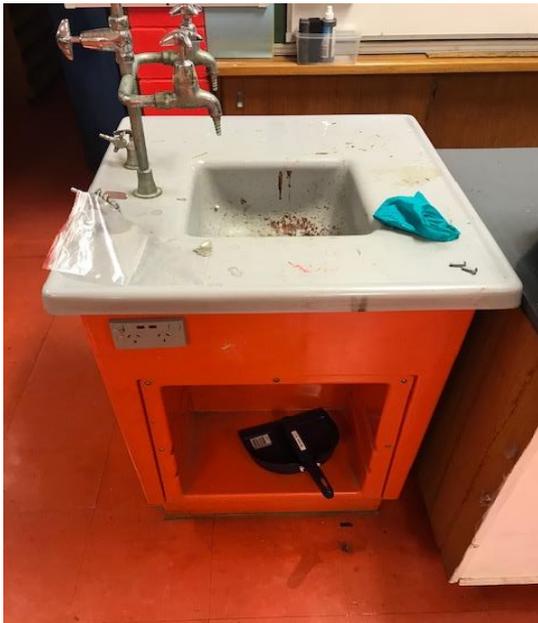
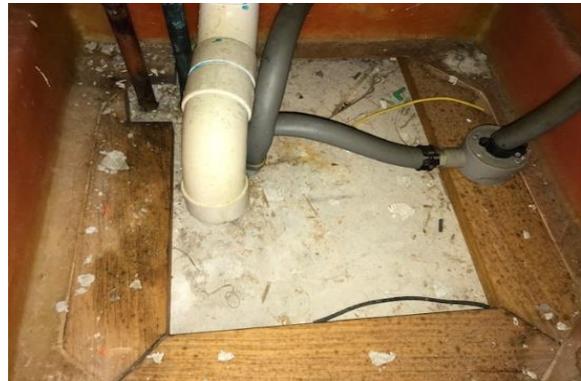
Photograph 8: B00B, R0014 - Laboratory , void under teacher's sink, fibrous debris , asbestos detected by analysis.

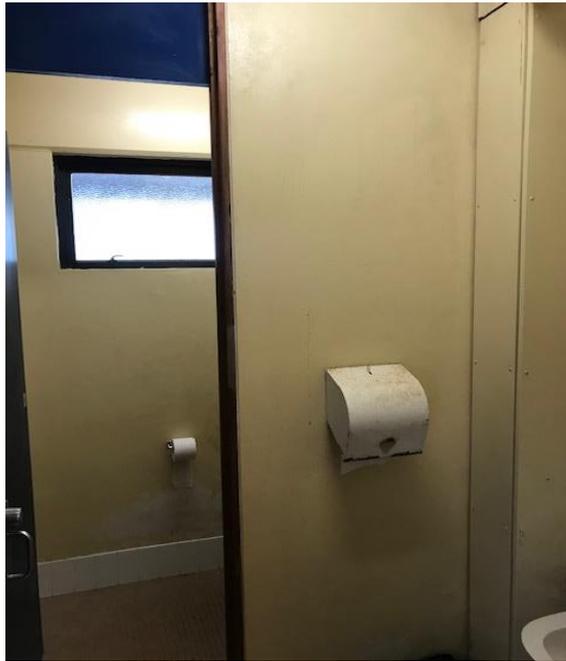
Photograph 2: B00C, R0014 - Staff Toilet, wall, cream paint, negative for lead.

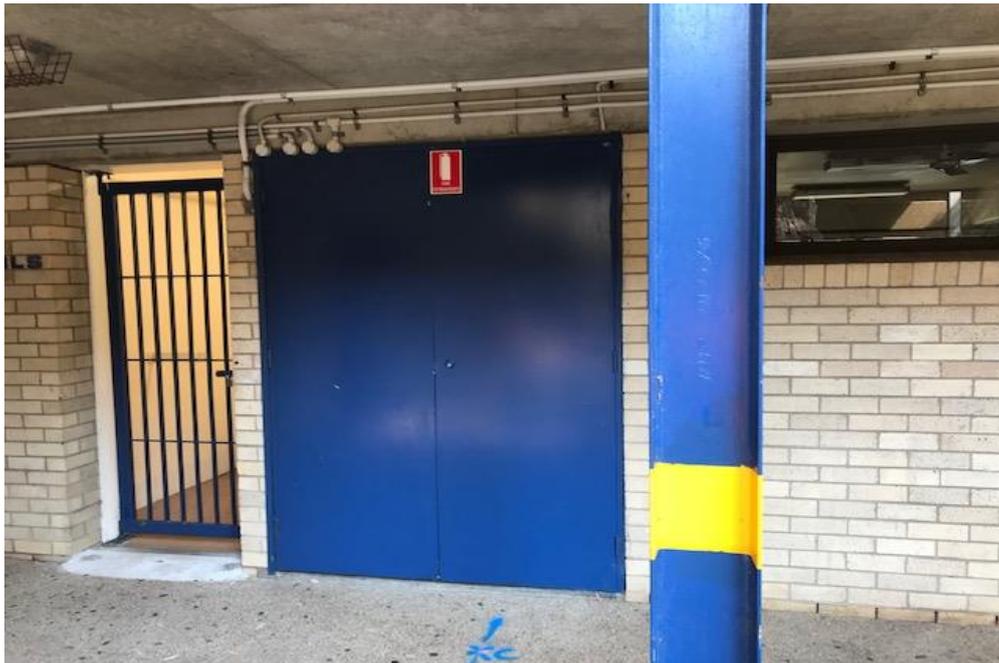
Photograph 6: B00C, exterior, throughout, typical blue paint, negative for lead.

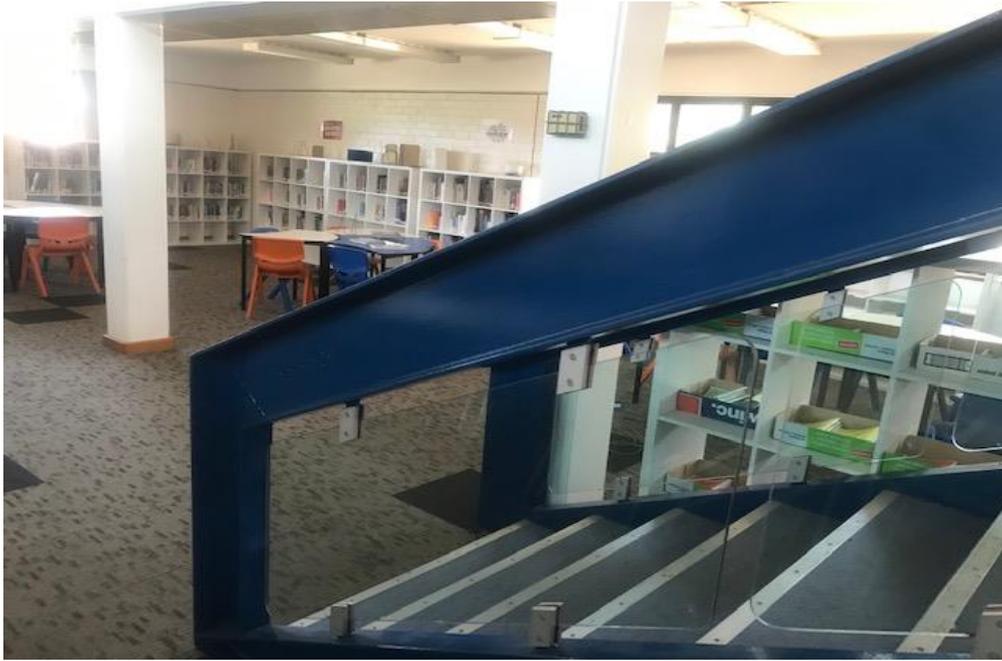
Photograph 3: B00D, R0011 - Main area, handrails , typical blue paint , negative for lead.

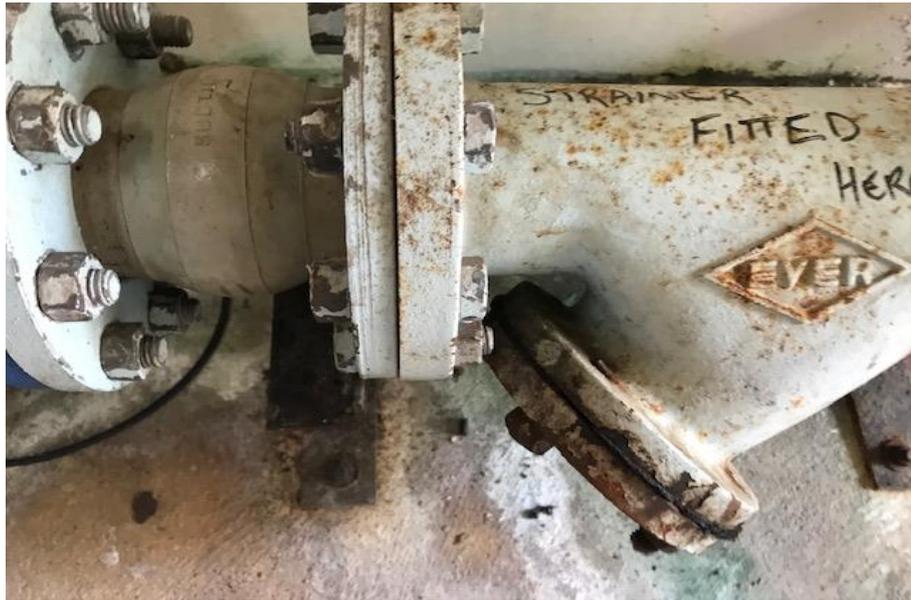
Photograph 7: B00D, R0002 - Plant, pipework, gasket, no asbestos detected by analysis.

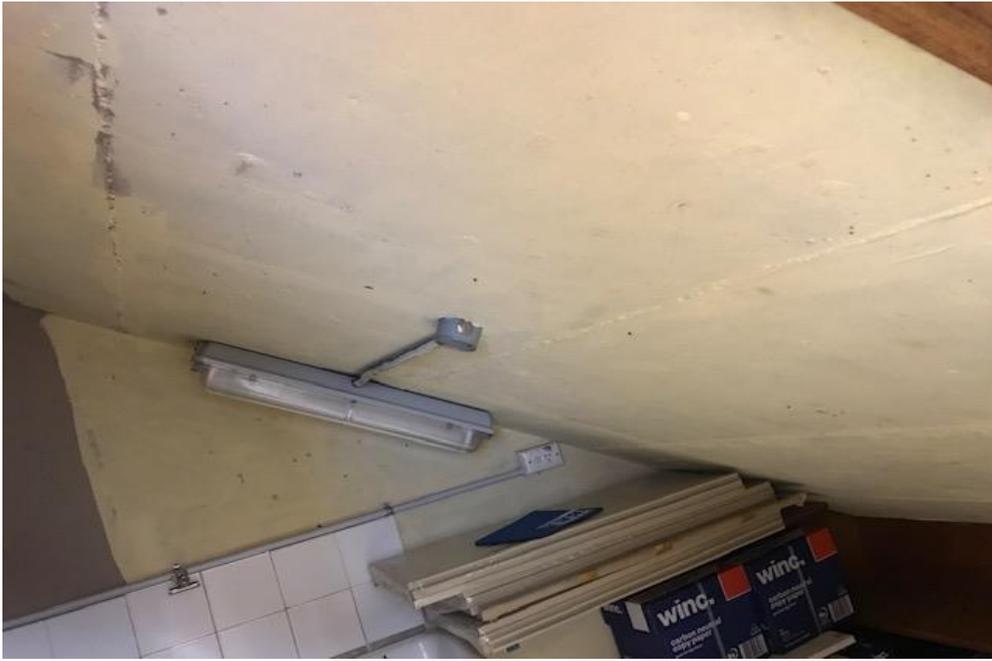
Photograph 1: B00E, R0014 - Storeroom, ceiling , vermiculite, appears removed.

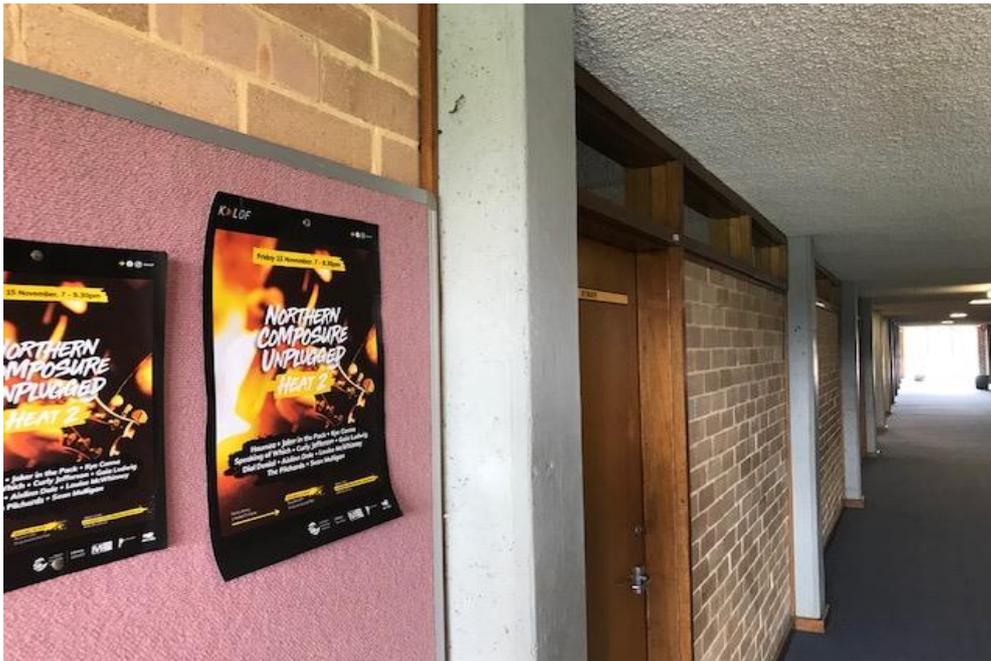
Photograph 6: B00E, internal, throughout, concrete walls, typical grey paint, negative for lead.

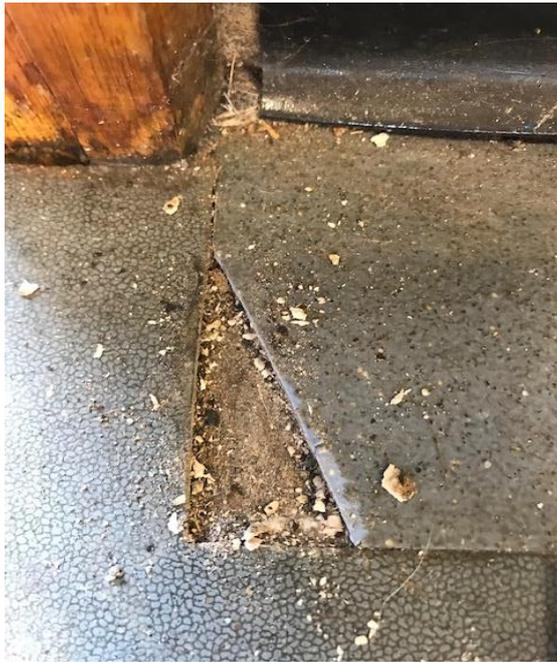
Photograph 1: B00F, R0003 - Art Learning Space, flooring, vinyl and underlay , no asbestos detected by analysis.

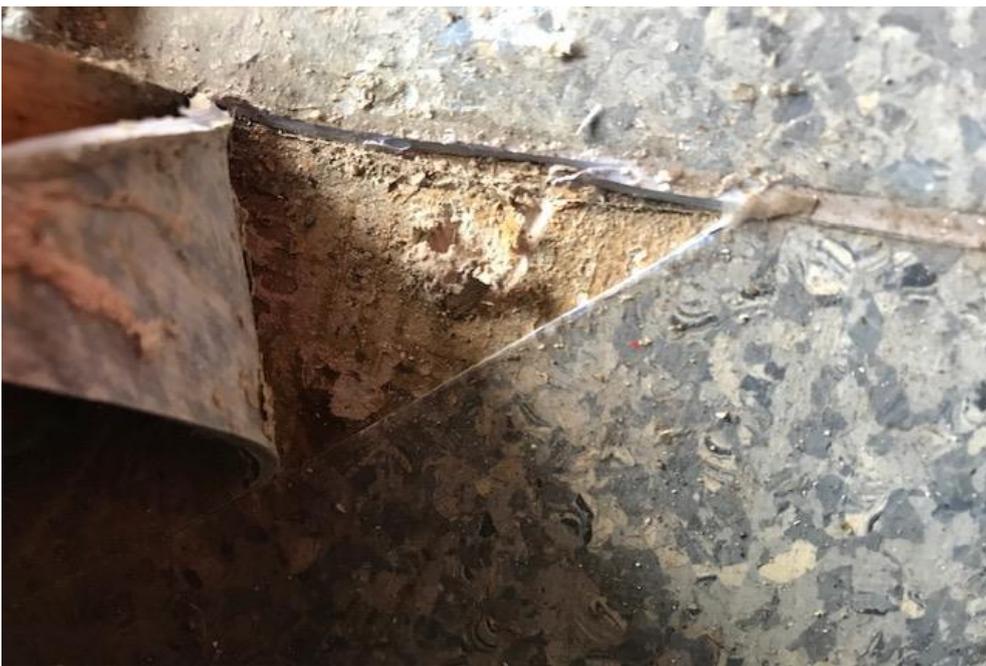
Photograph 2: B00F, R0010 - Art Learning Space , flooring, vinyl and underlay , non asbestos (assumed).

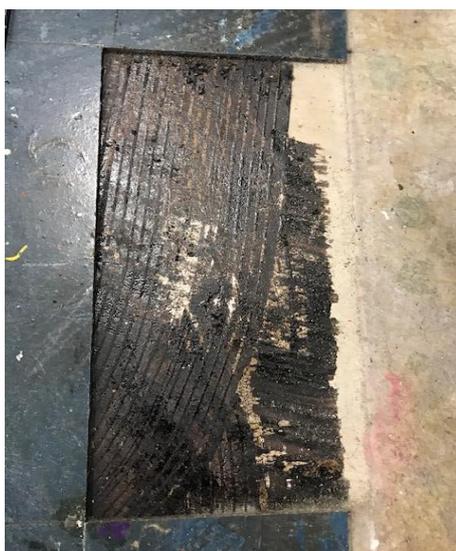
Photograph 5: B00F, R1001 - Art Learning Space , flooring, glue under vinyl tiles, non-asbestos (assumed).

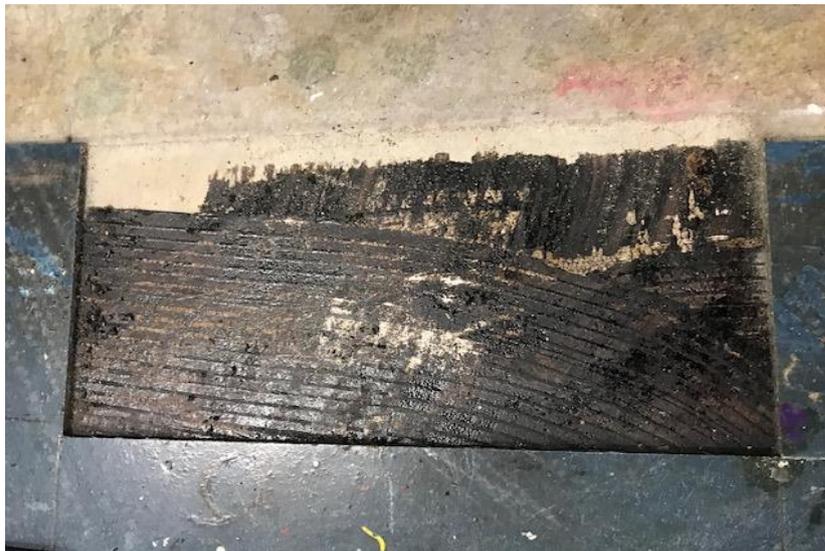
Photograph 8: B00F, R1005 - Art Learning Space , flooring, glue under vinyl tiles, no asbestos detected by analysis.

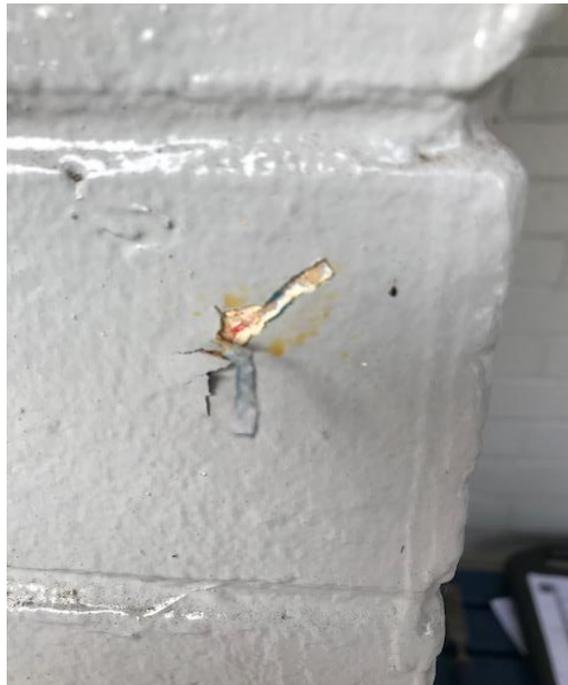
Photograph 12: B00F, exterior, brickwork, throughout, undercoat to grey paint, positive for lead.

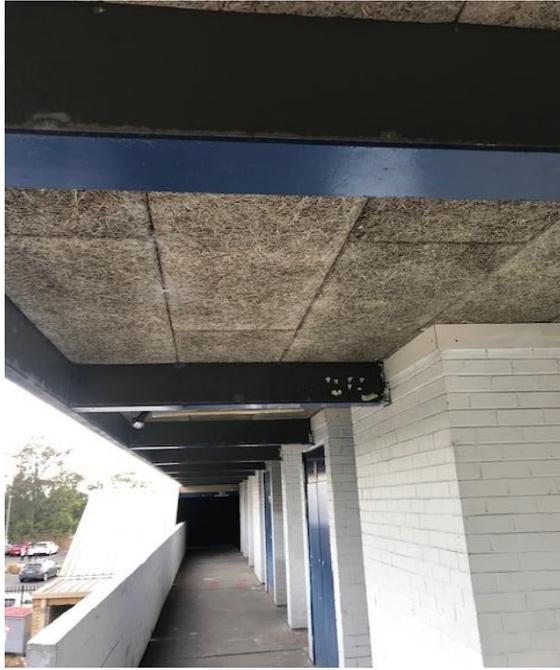
Photograph 13: B00F, exterior, throughout, blue paint, negative for lead.

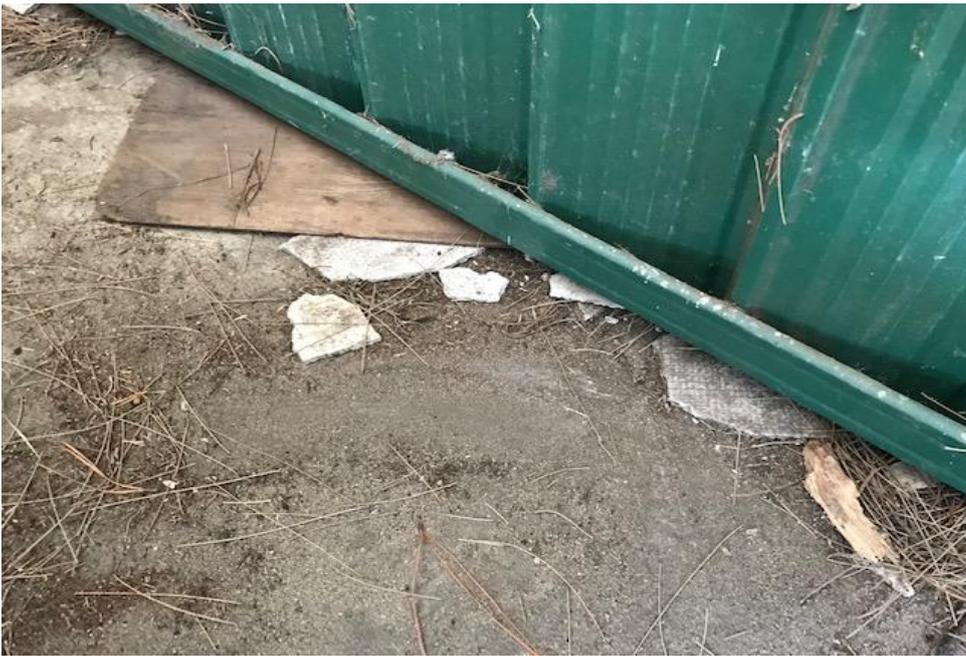
Photograph 2: B00G, exterior, south eastern corner of building, on floor, fibre cement debris, no asbestos detected by analysis
