DILAPIDATION REPORT

Bubalo Street, Warriewood

Prepared by: Rezoning Pty Ltd t/as Effective Building & Consultancy

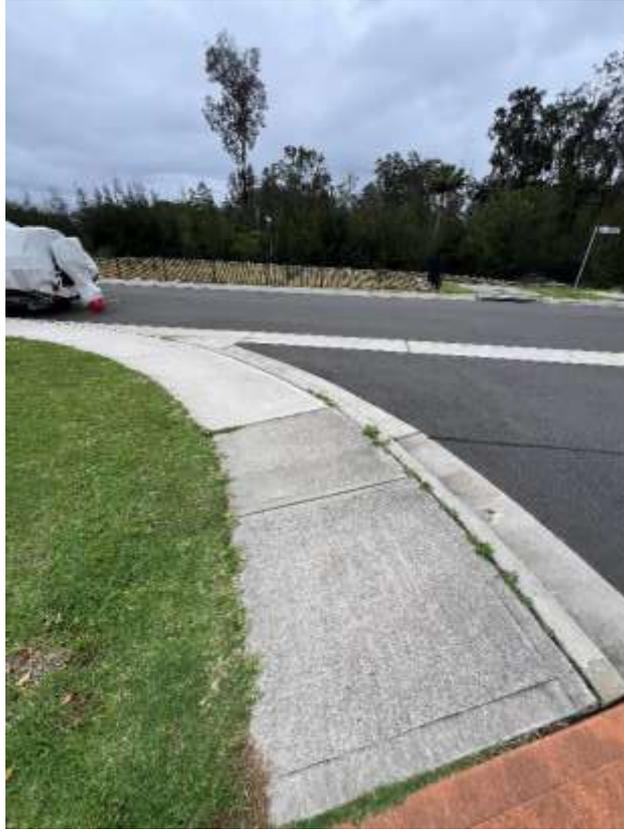
Figure 1 – General condition of the footpath.

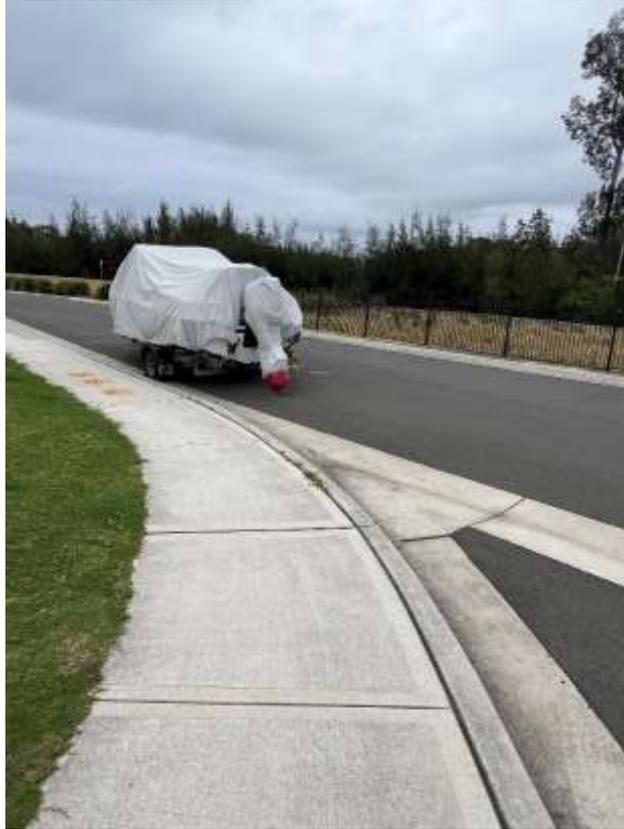
Figure 3 – General condition of the footpath.

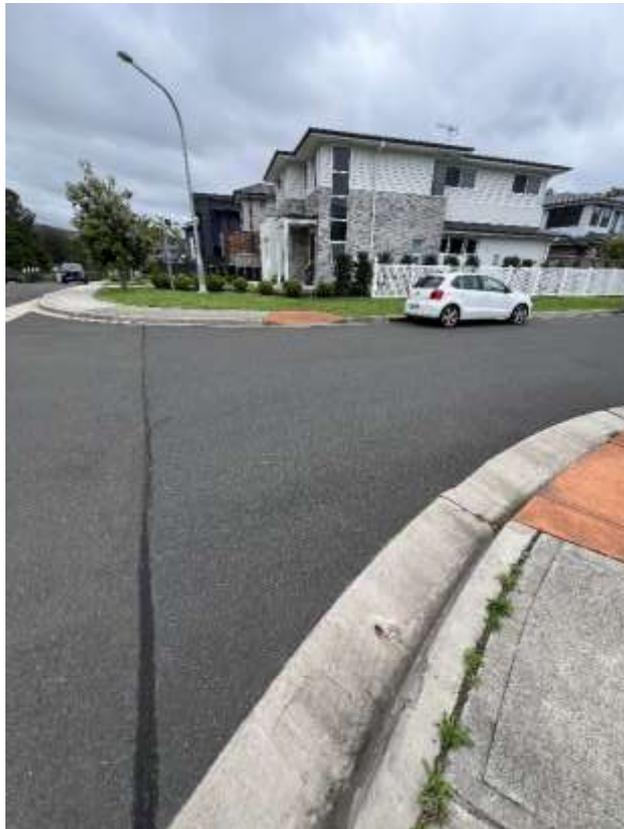
Figure 4 – General condition of the road.

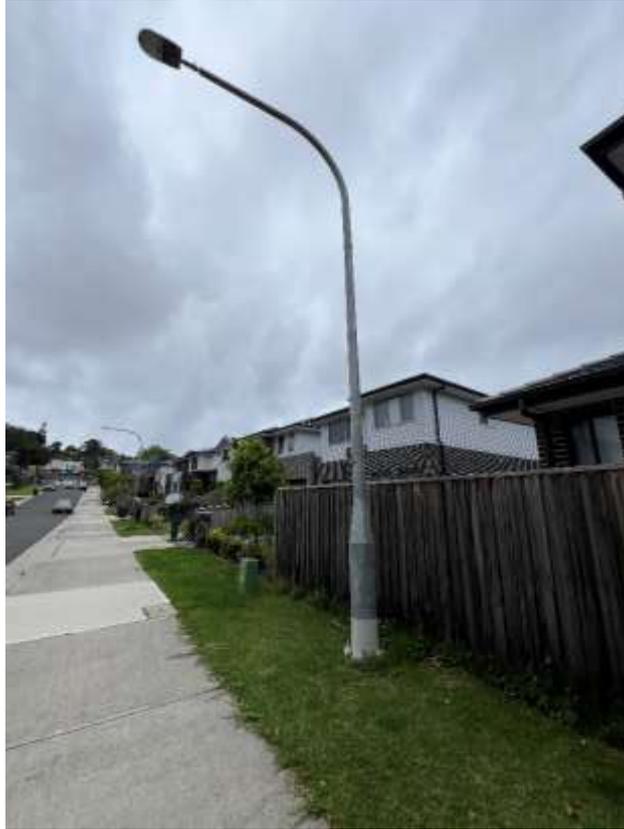
Figure 7 – General condition of the street light.

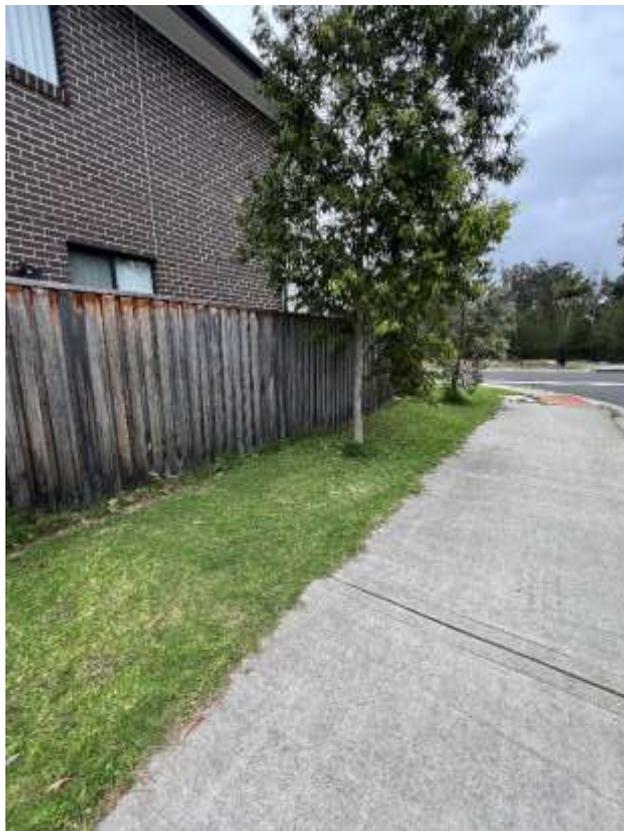
Figure 8 – General condition of the nature strip/tree.

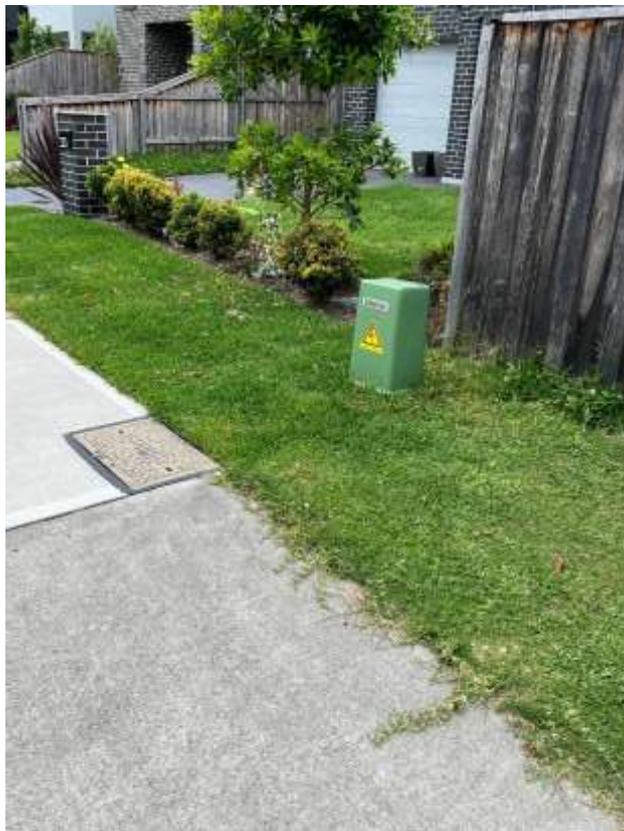
Figure 10 – General condition of the nature strip/transformer box.

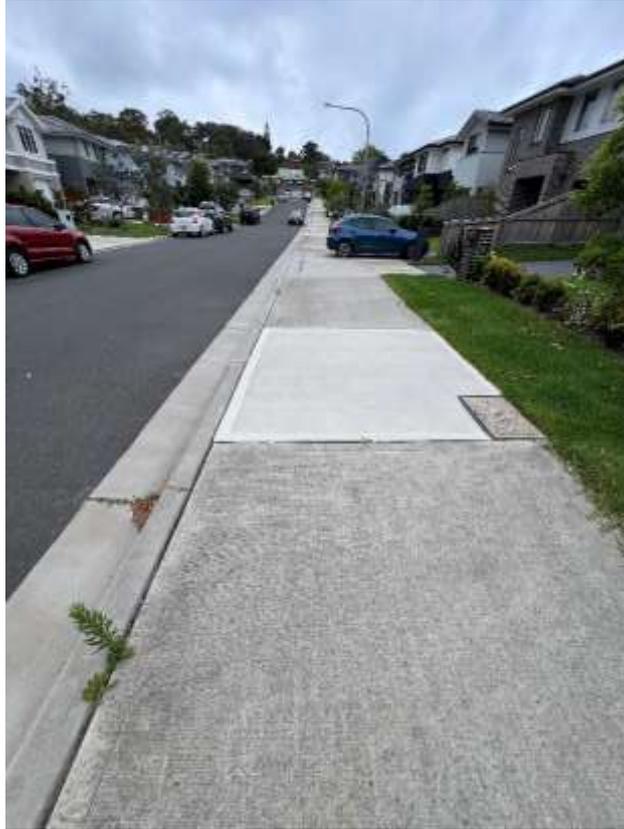
Figure 11 – General condition of the footpath.

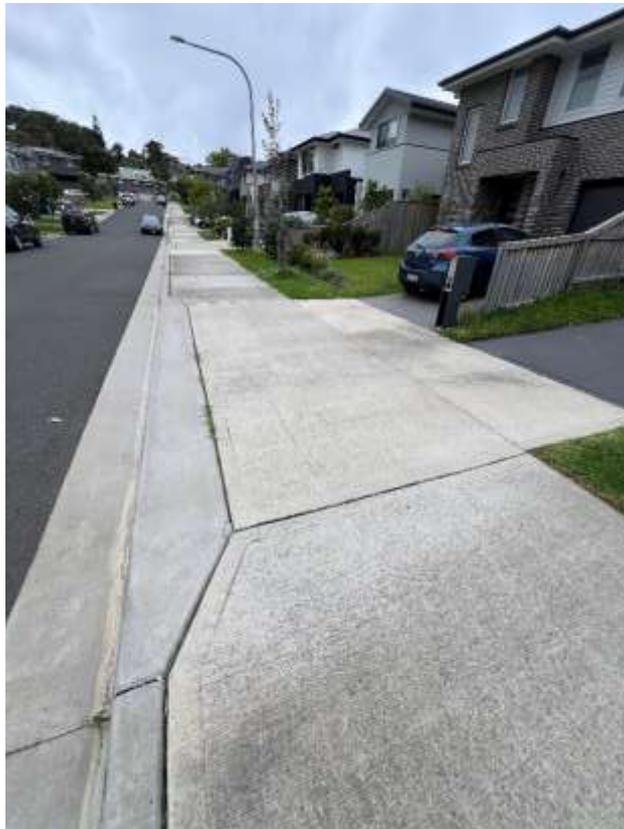
Figure 12 – General condition of the driveway.

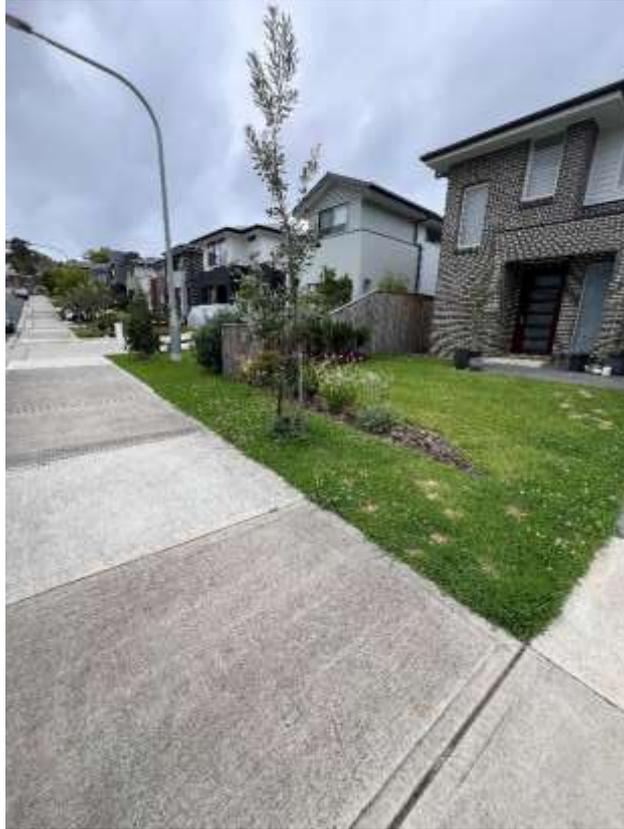
Figure 15 – General condition of the footpath/tree.

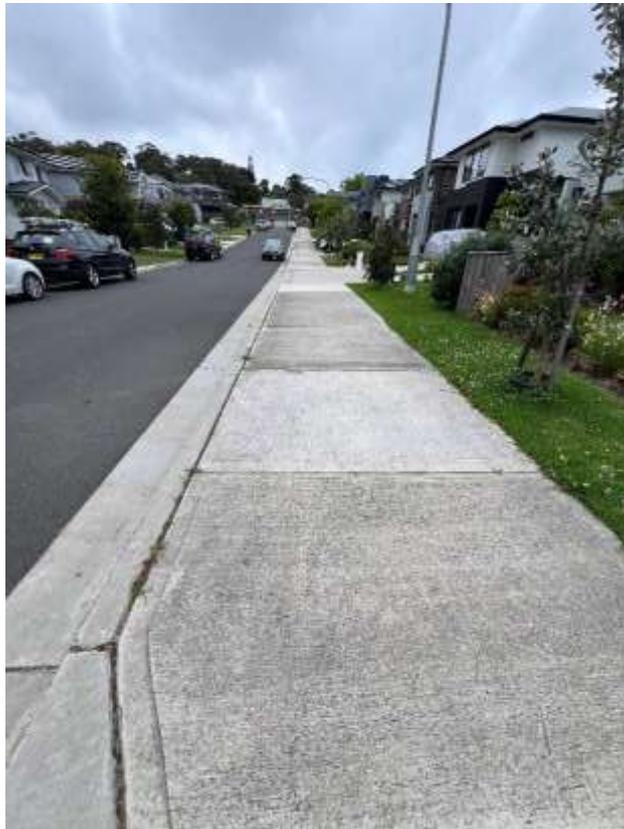
Figure 16 – General condition of the footpath.

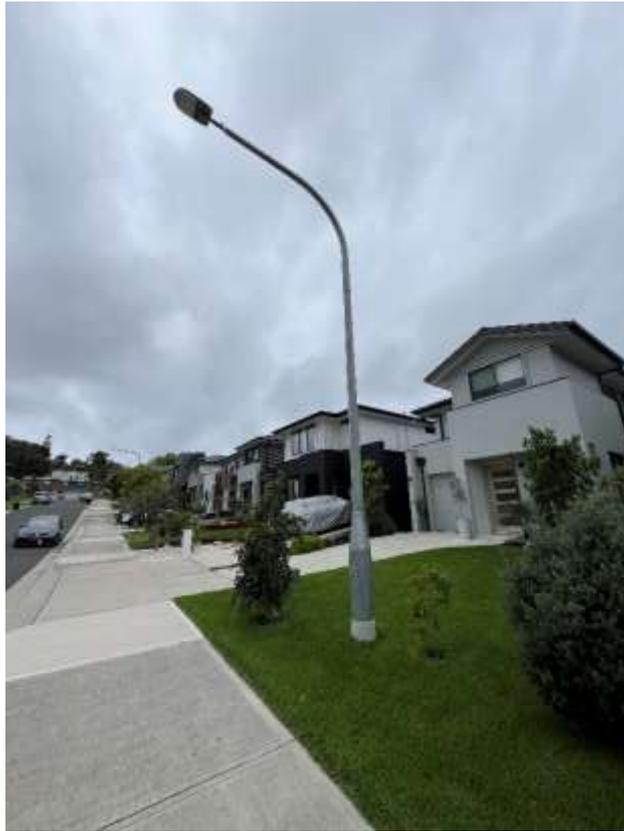
Figure 19 – General condition of the street light.

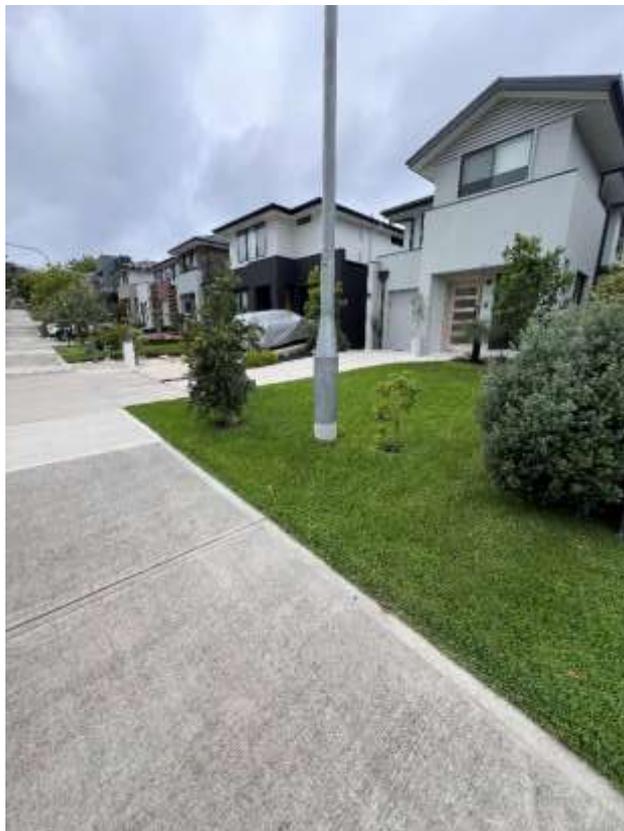
Figure 20 – General condition of the landscaping.

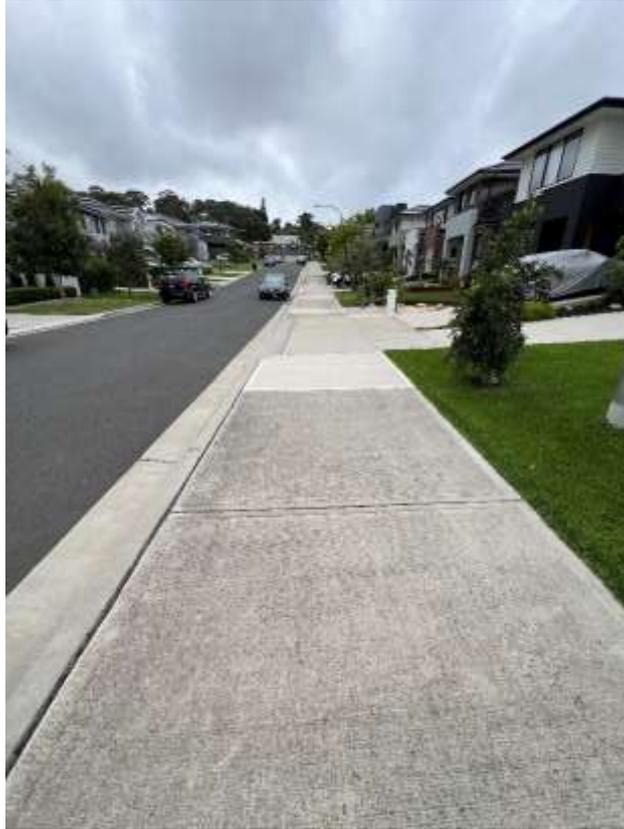
Figure 21 – General condition of the footpath.

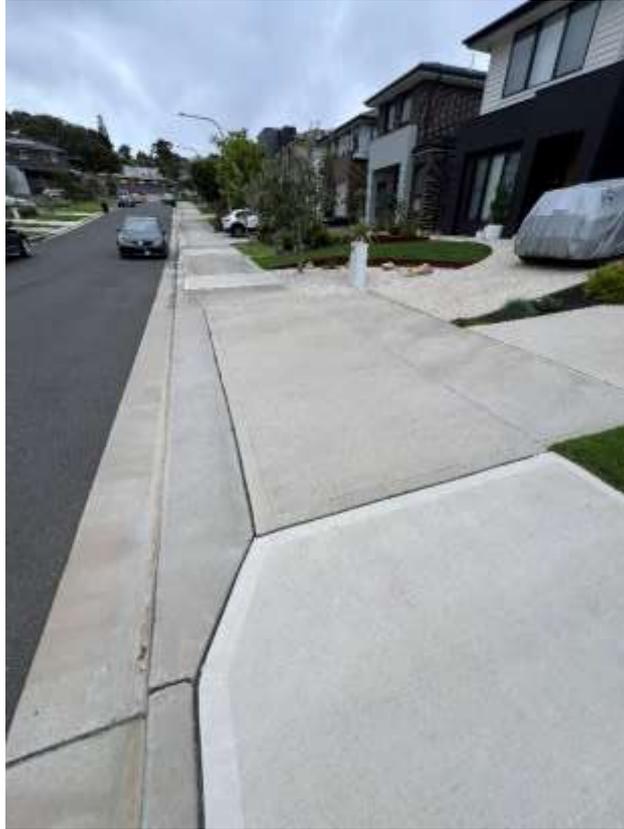
Figure 23 – General condition of the driveway.

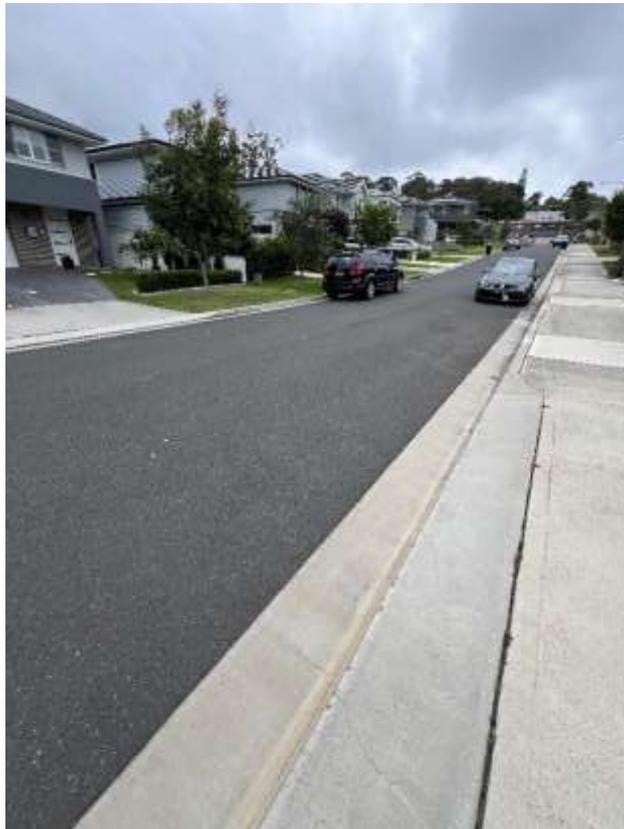
Figure 24 – General condition of the road.

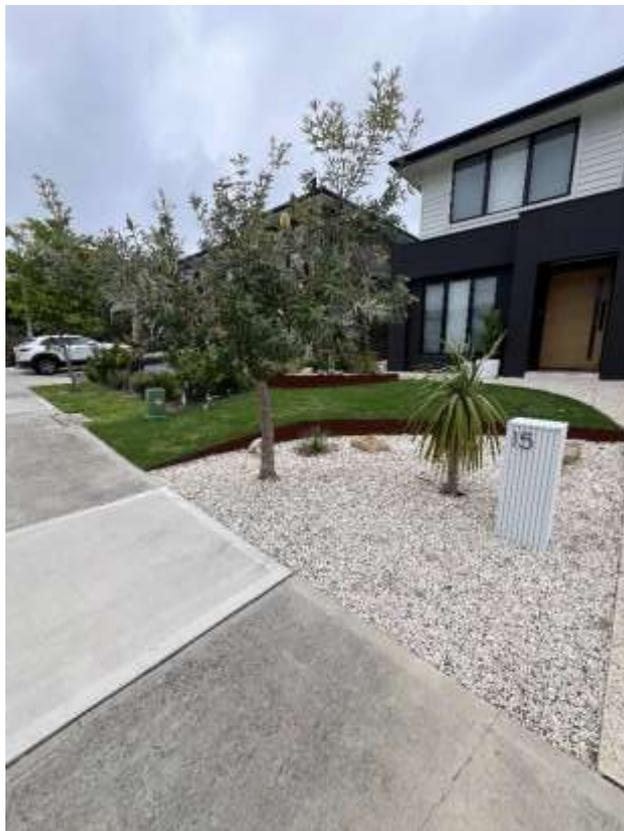
Figure 26 – General condition of the landscaping.

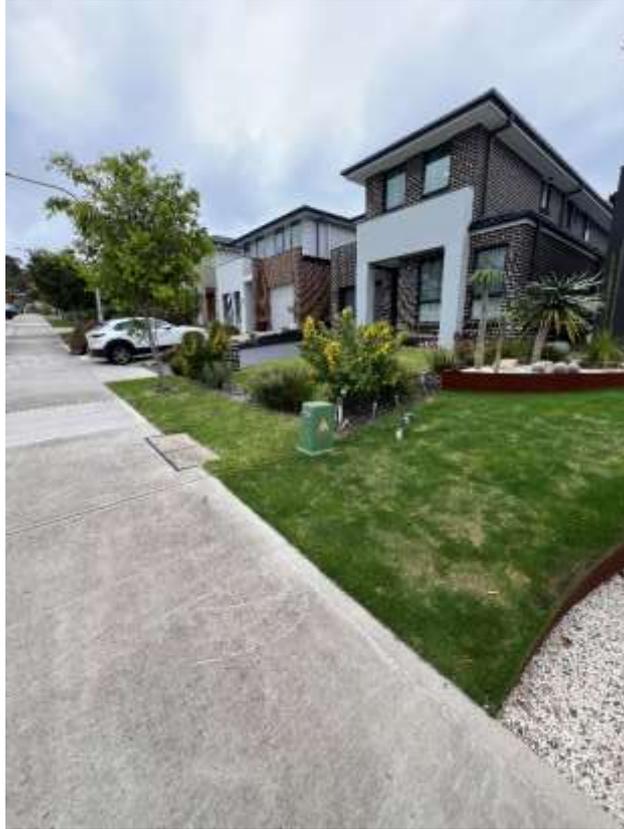
Figure 27 – General condition of the transformer box.

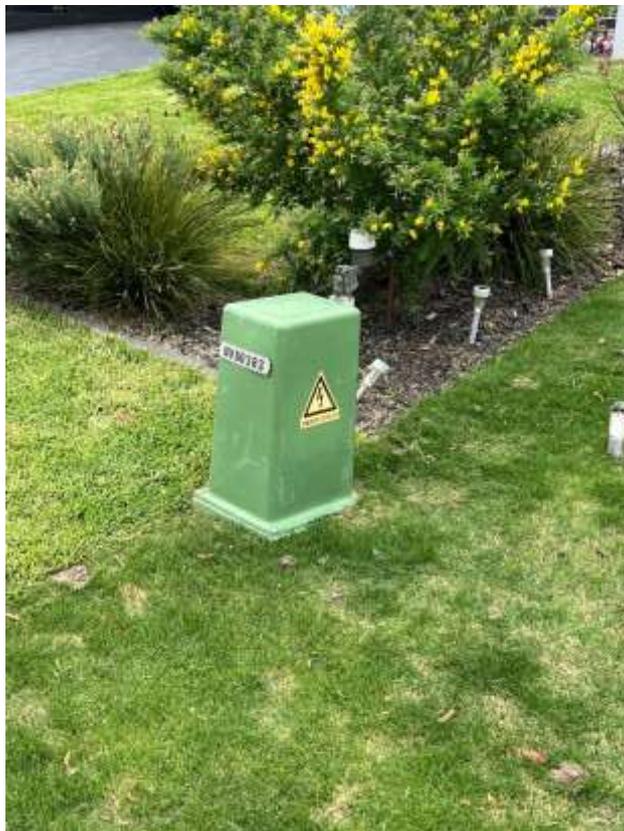
Figure 28 – General condition of the transformer box.

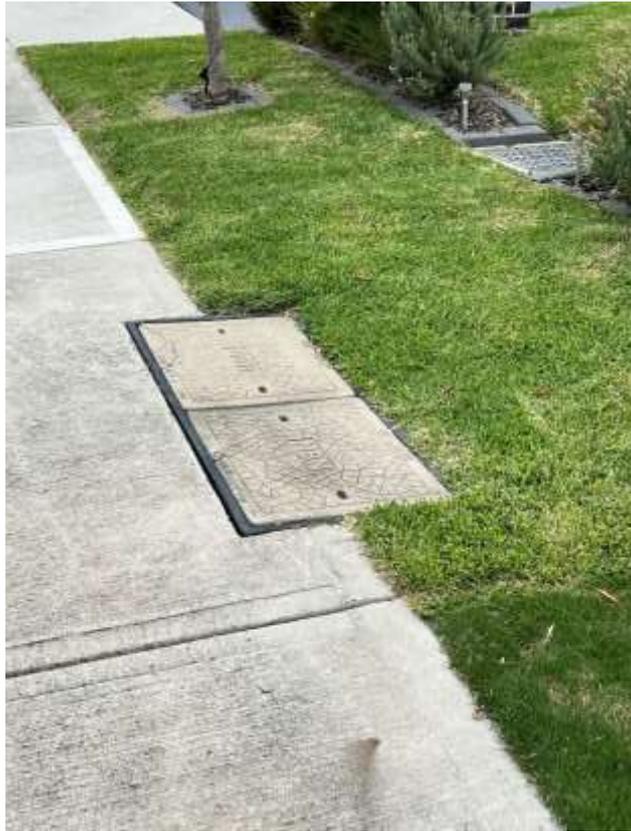
Figure 29 – General condition of the pit.

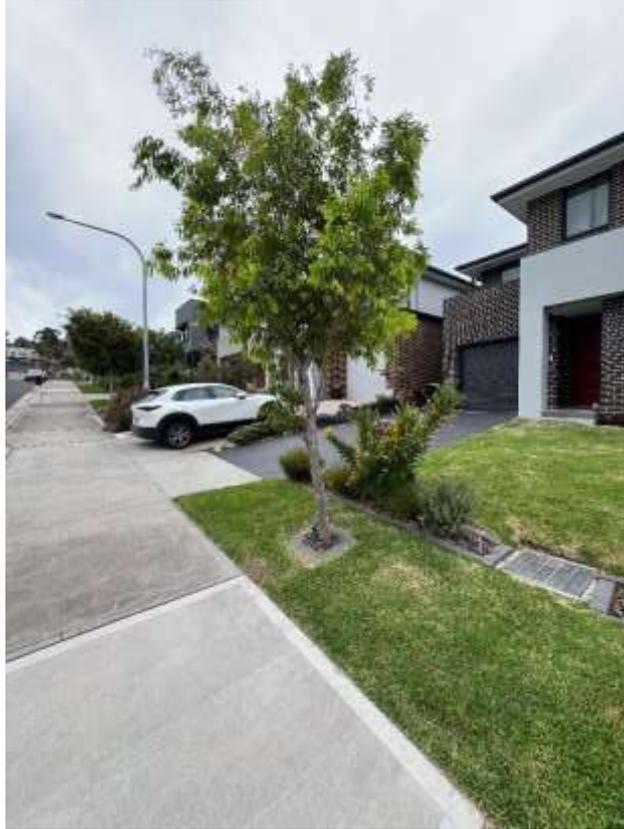
Figure 33 – General condition of the tree.

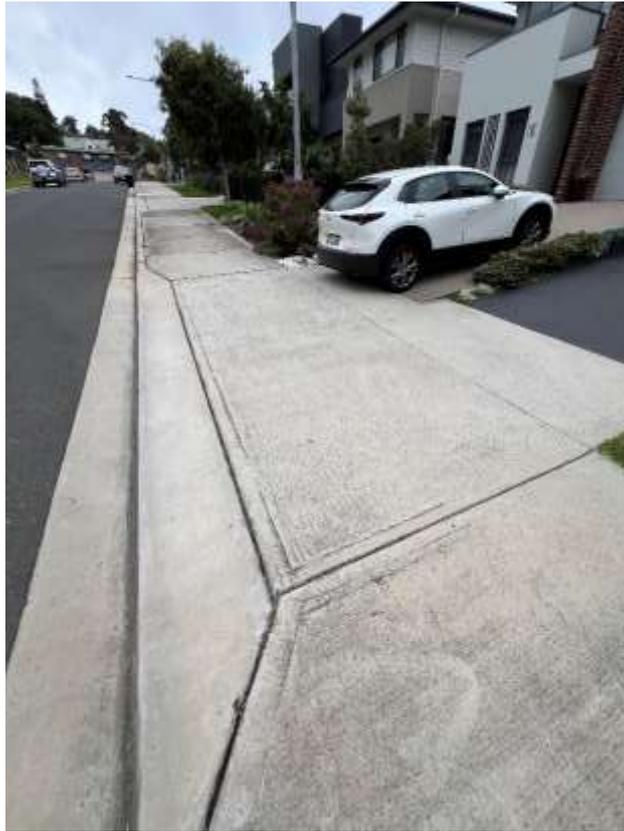
Figure 35 – General condition of the driveway.

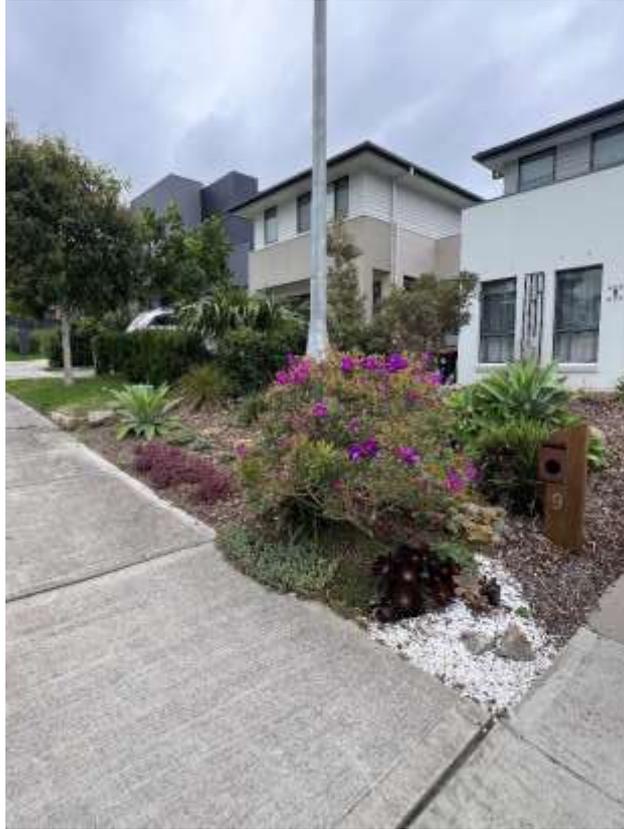
Figure 37 – General condition of the landscaping.

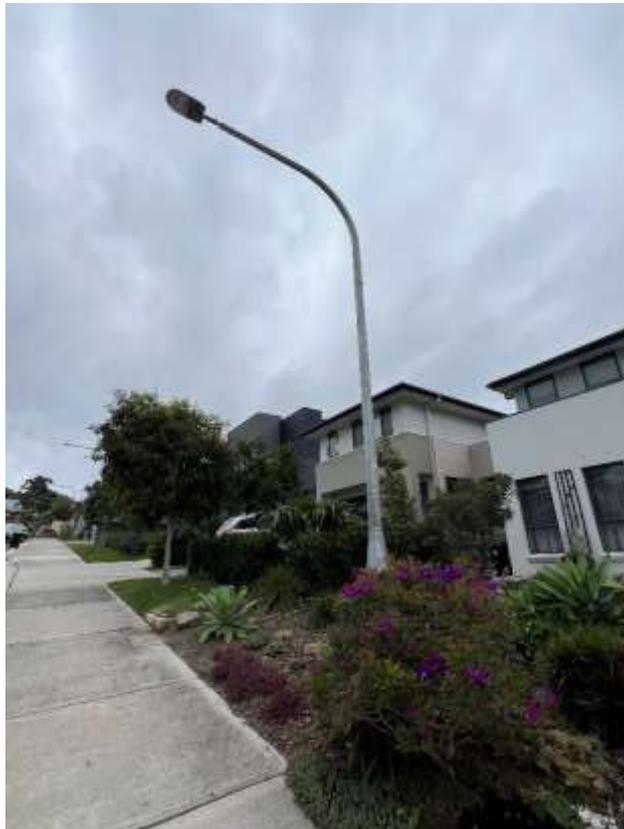
Figure 38 – General condition of the street light.

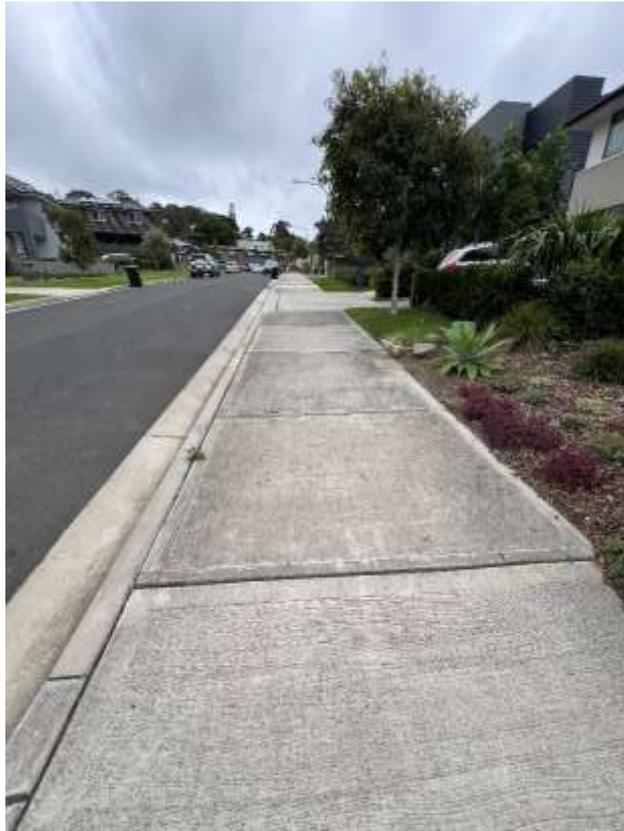
Figure 39 – General condition of the footpath.

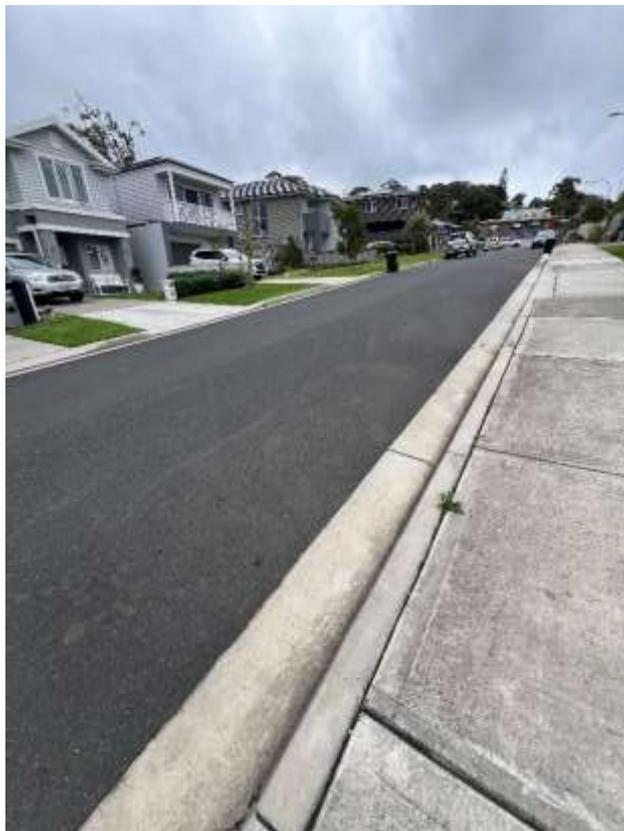
Figure 40 – General condition of the road/kerb.

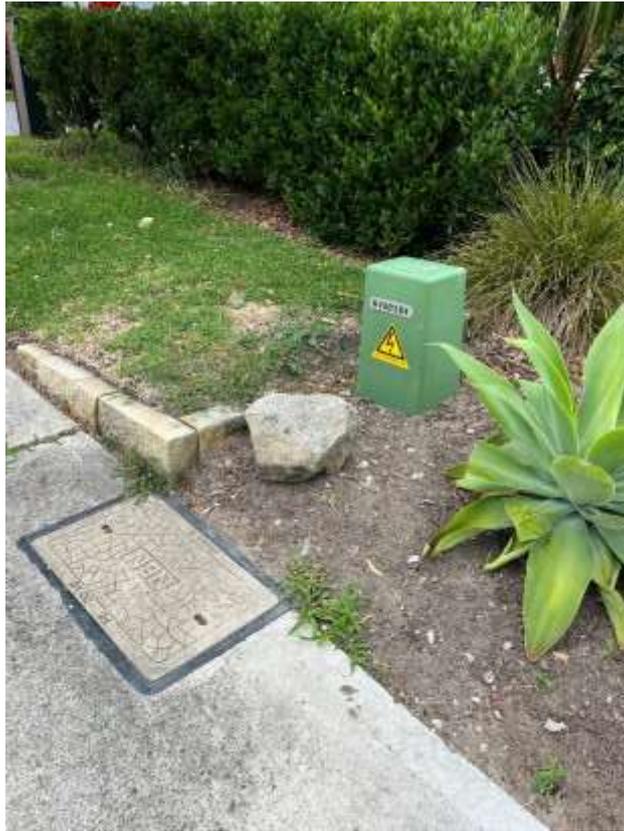
Figure 41 – General condition of the pit/transformer box.

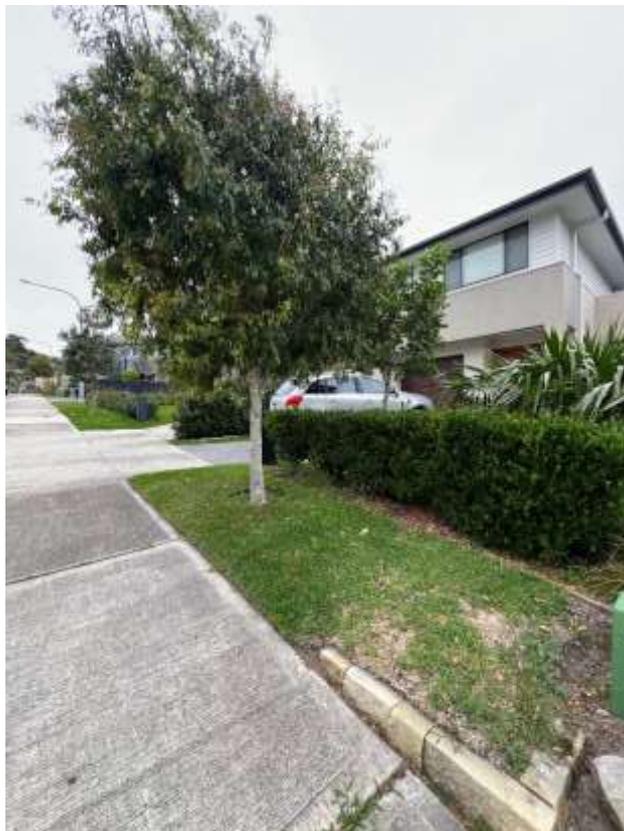
Figure 42 – General condition of the tree.

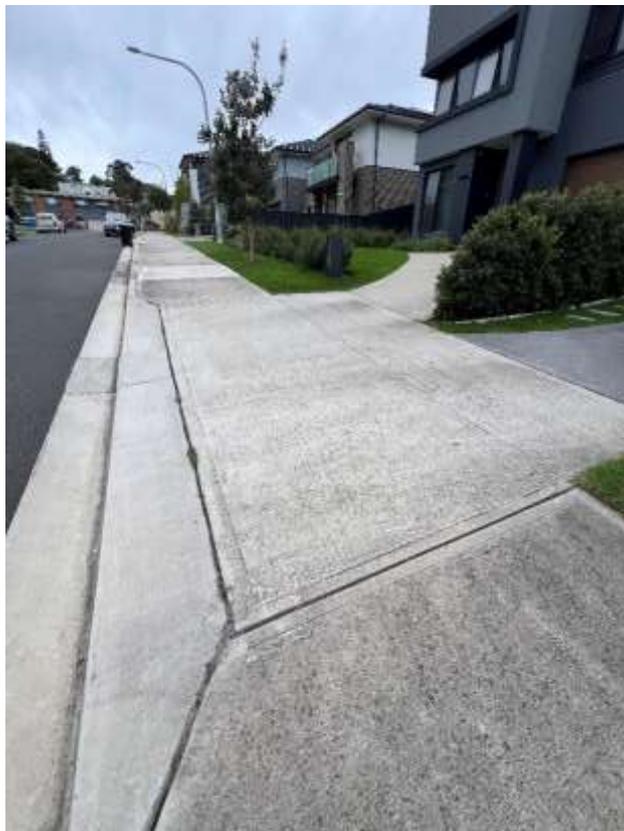
Figure 44 – General condition of the driveway.

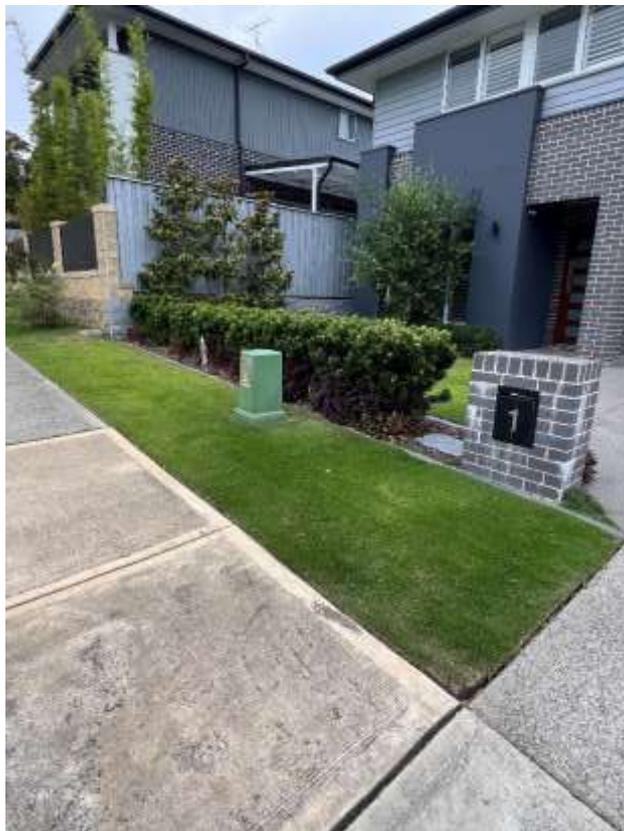
Figure 54 – General condition of the nature strip/transformer box.

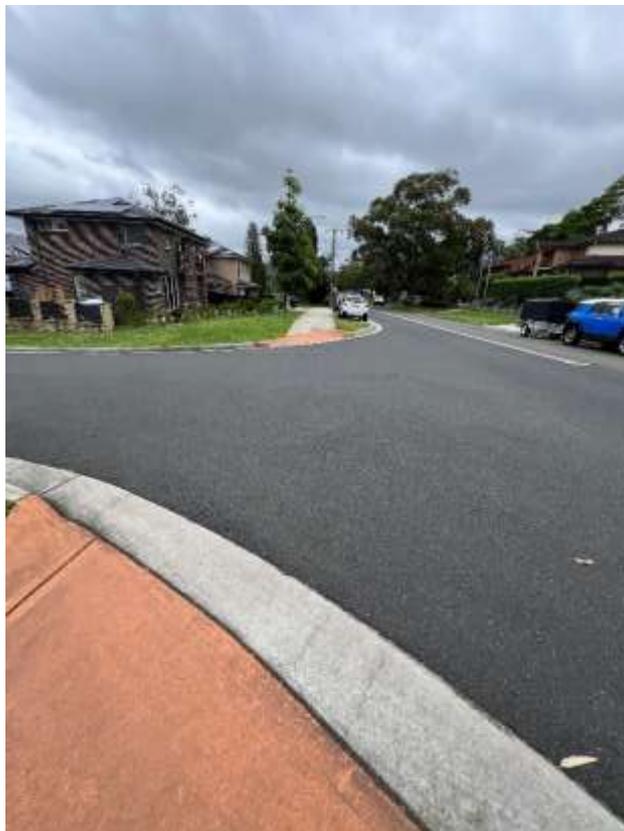
Figure 75 – Crack is evident to the layback outside 61 Warriewood Road Warriewood.

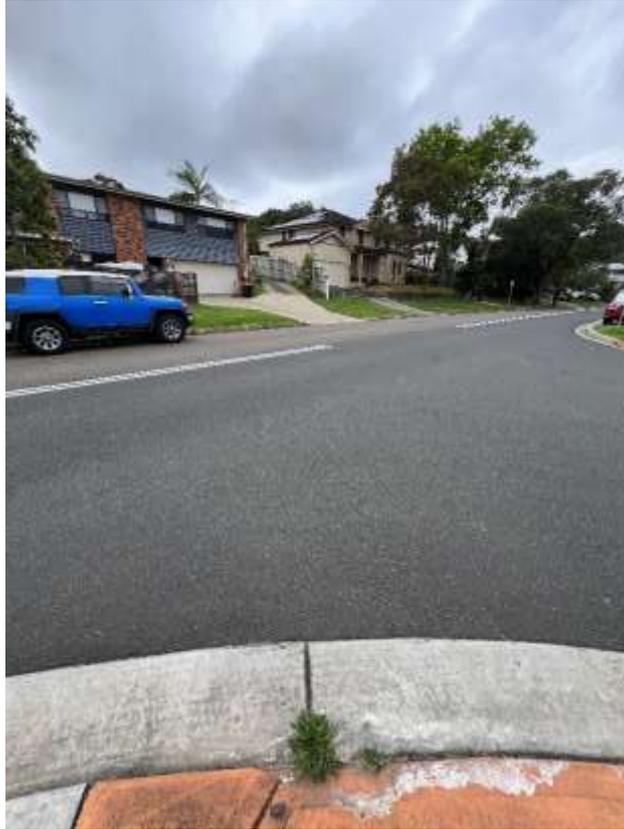
Figure 80 – Crack is evident to the layback outside 63 Warriewood Road Warriewood.

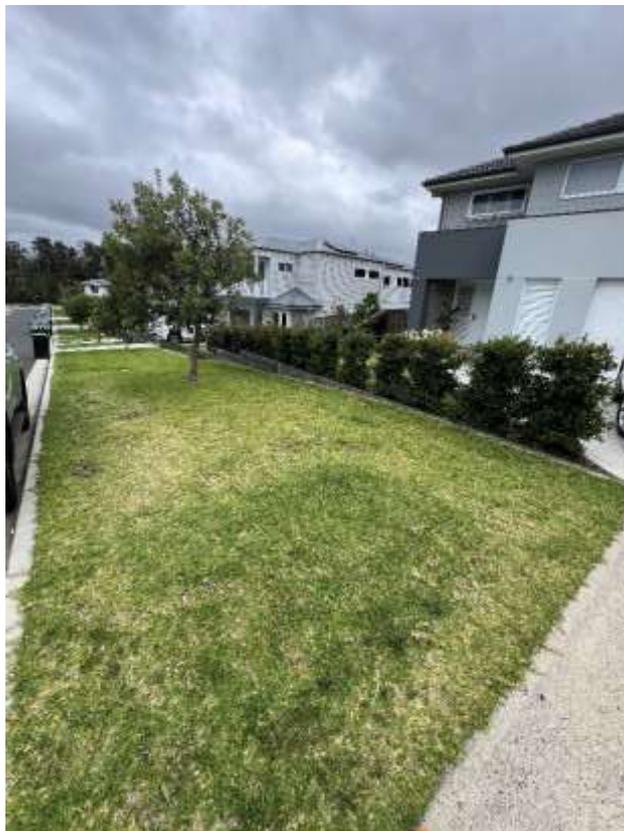
Figure 92 – General condition of the nature strip.

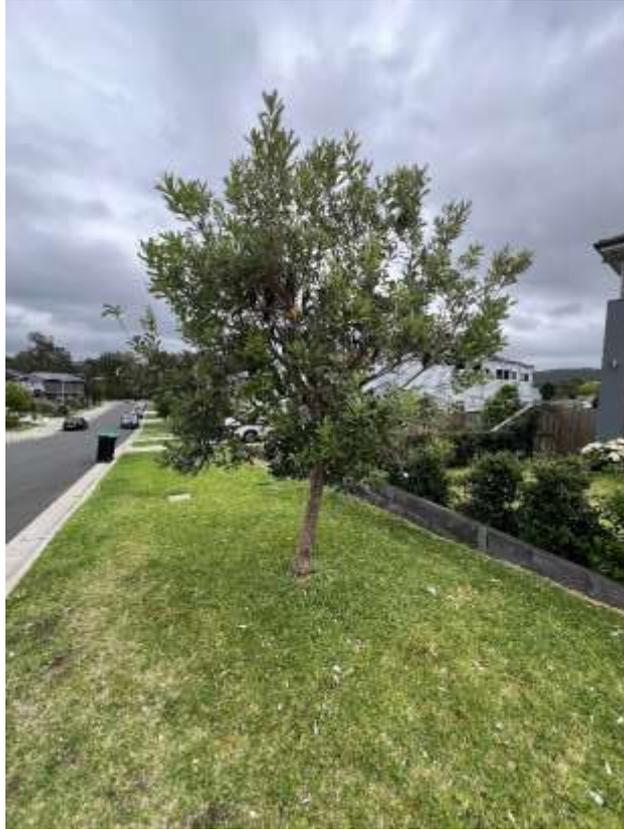
Figure 93 – General condition of the tree.

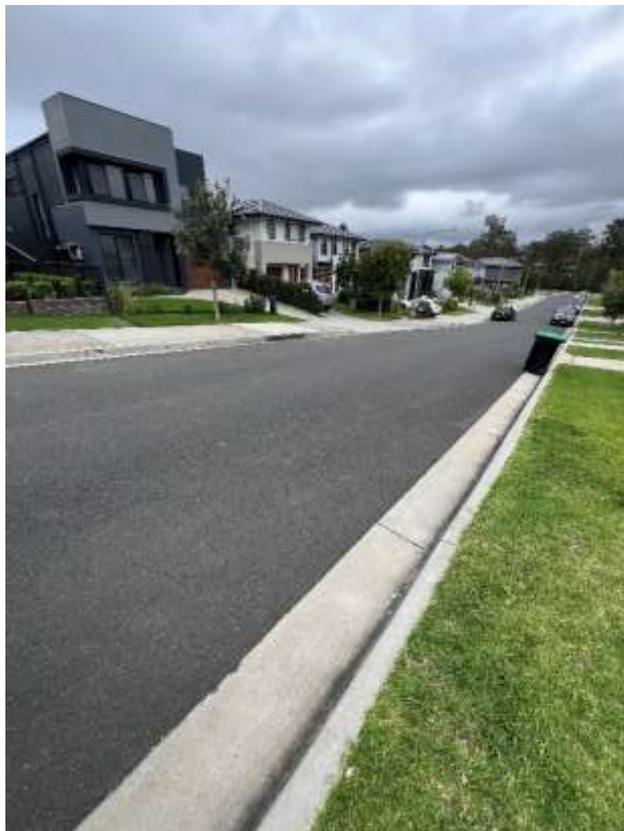
Figure 94 – General condition of the road/kerb.

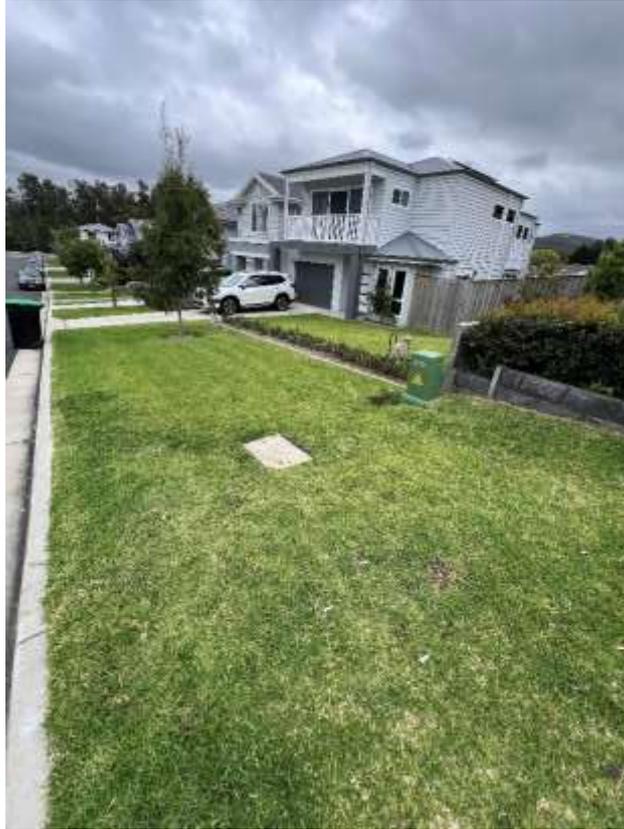
Figure 95 – General condition of the nature strip.

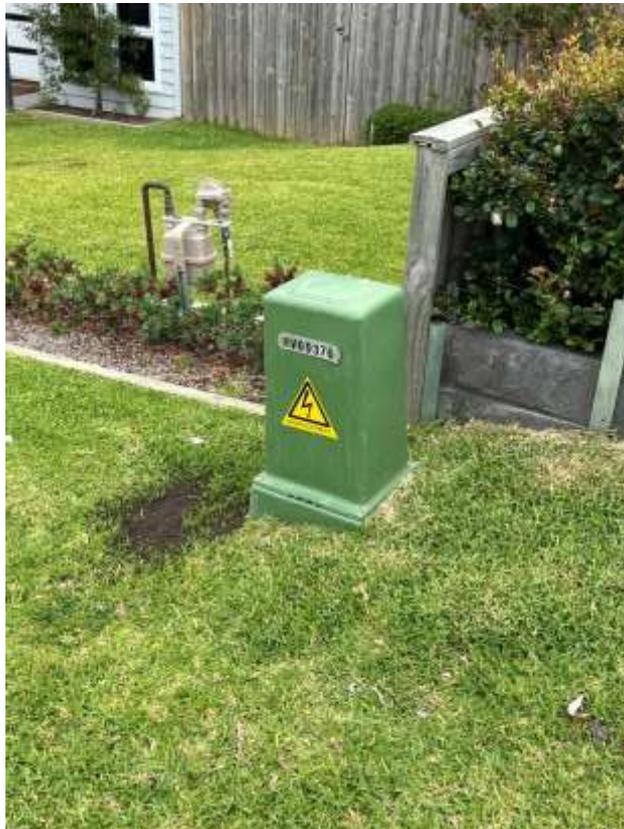
Figure 96 – General condition of the transformer box.

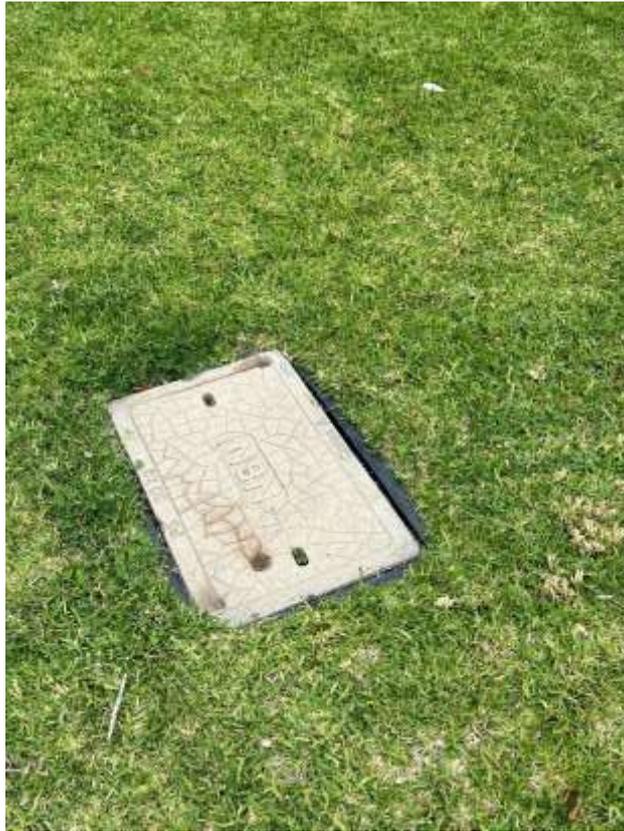
Figure 97 – General condition of the pit.

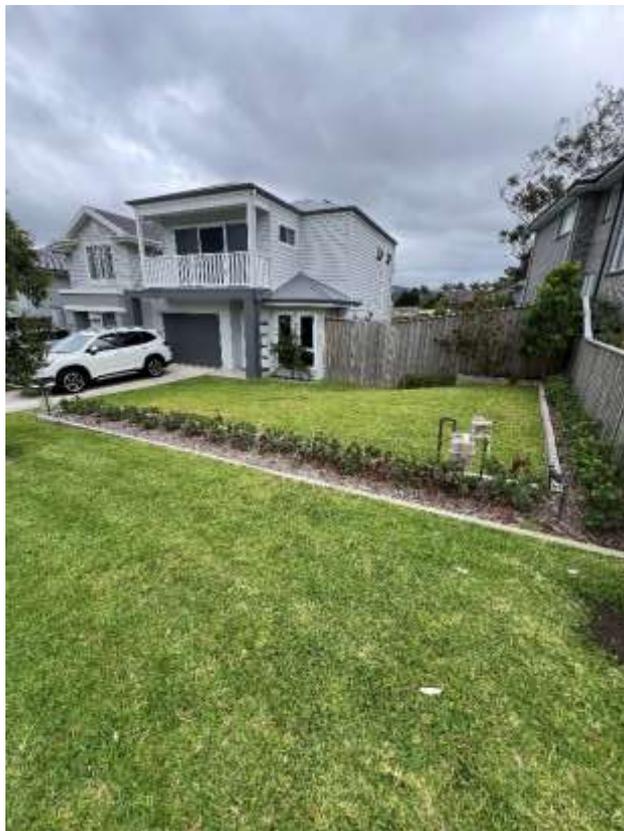
Figure 98 – General condition of the landscaping.

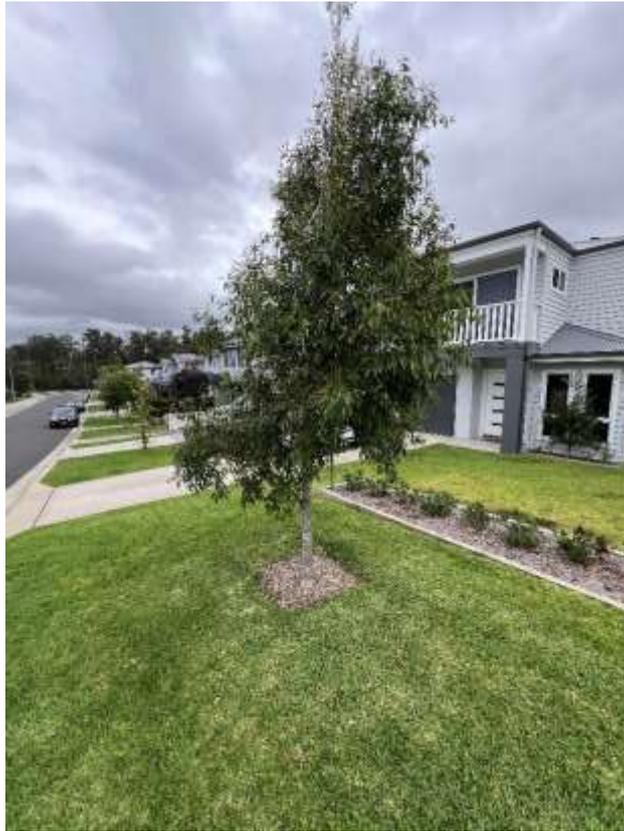
Figure 99 – General condition of the tree.

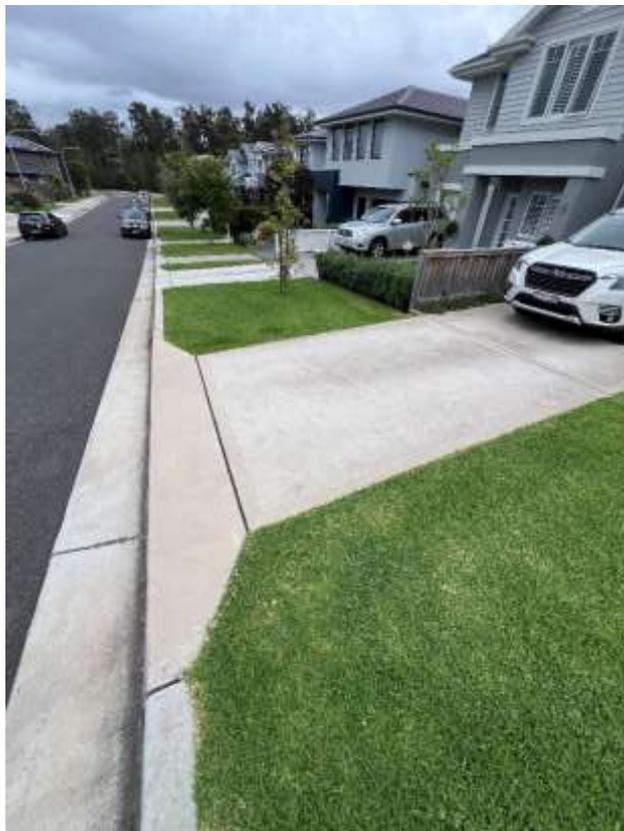
Figure 100 – General condition of the driveway.

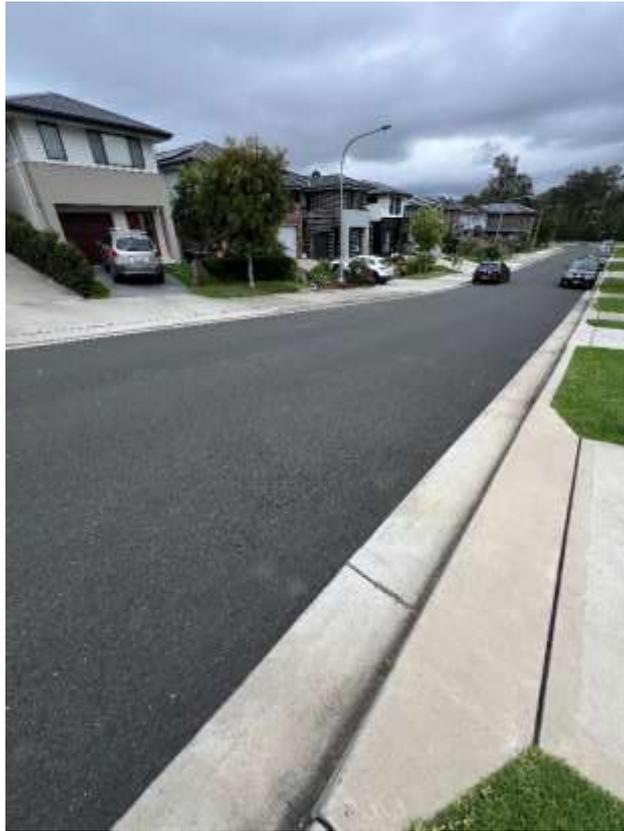
Figure 101 – General condition of the road.

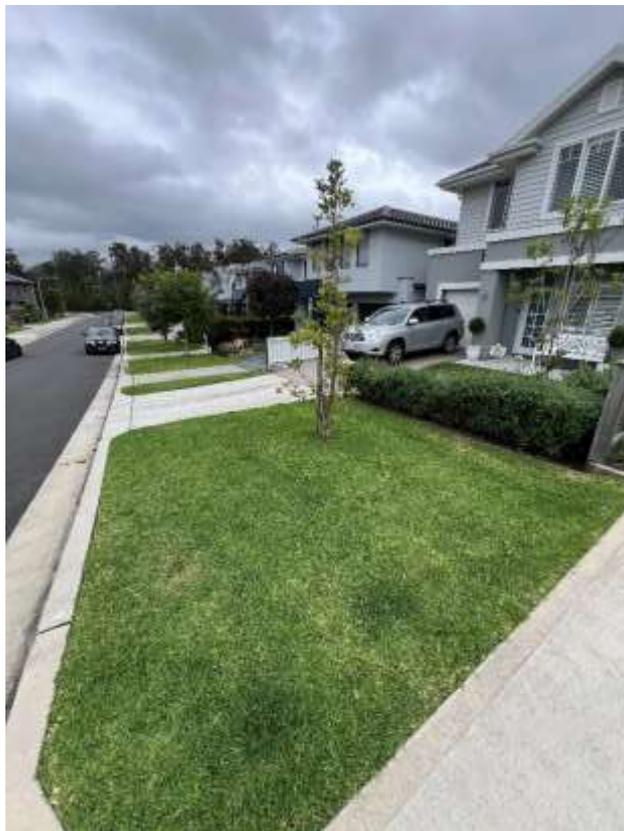
Figure 102 – General condition of the nature strip/tree.

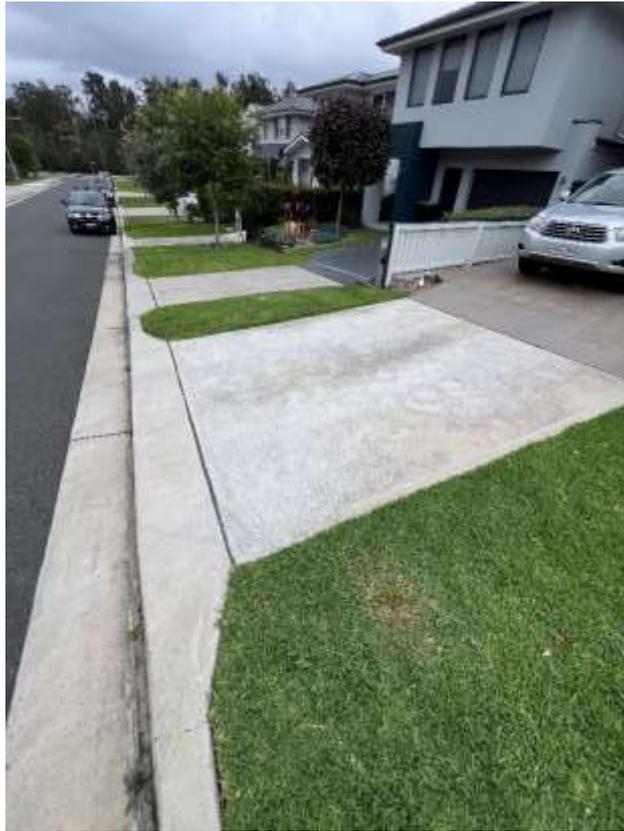
Figure 103 – General condition of the driveway.
