DILAPIDATION REPORT

Bubalo Street, Warriewood

Prepared by: Rezoning Pty Ltd t/as Effective Building & Consultancy

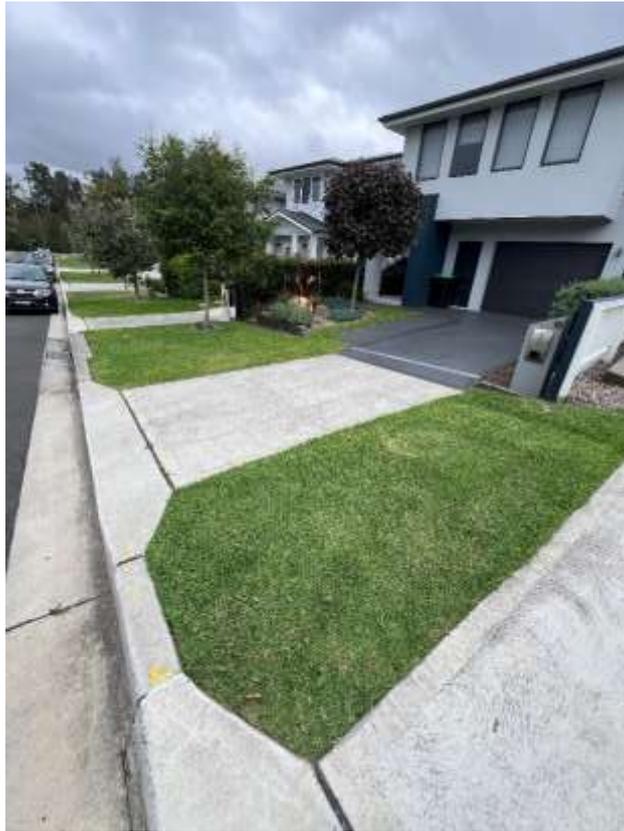
Figure 105 – General condition of the nature strip.

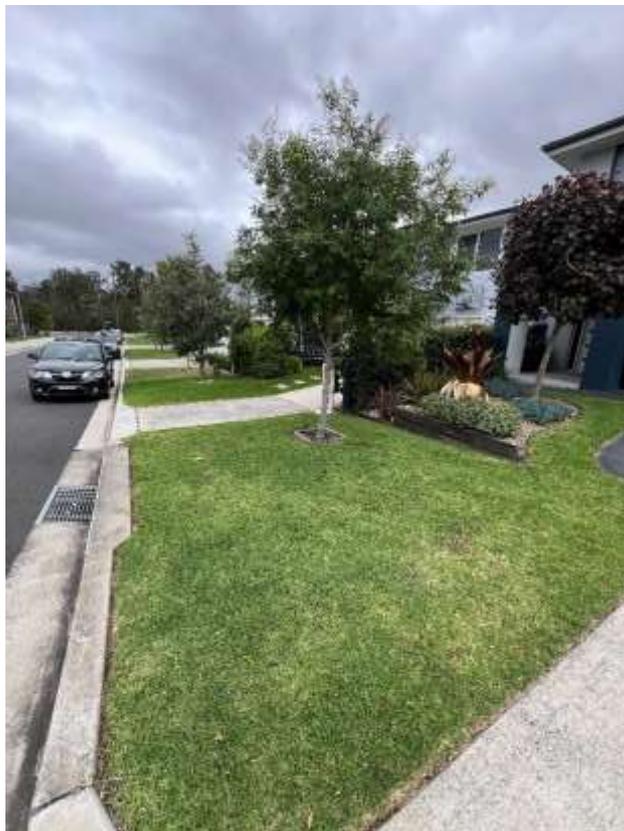
Figure 106 – General condition of the nature strip.

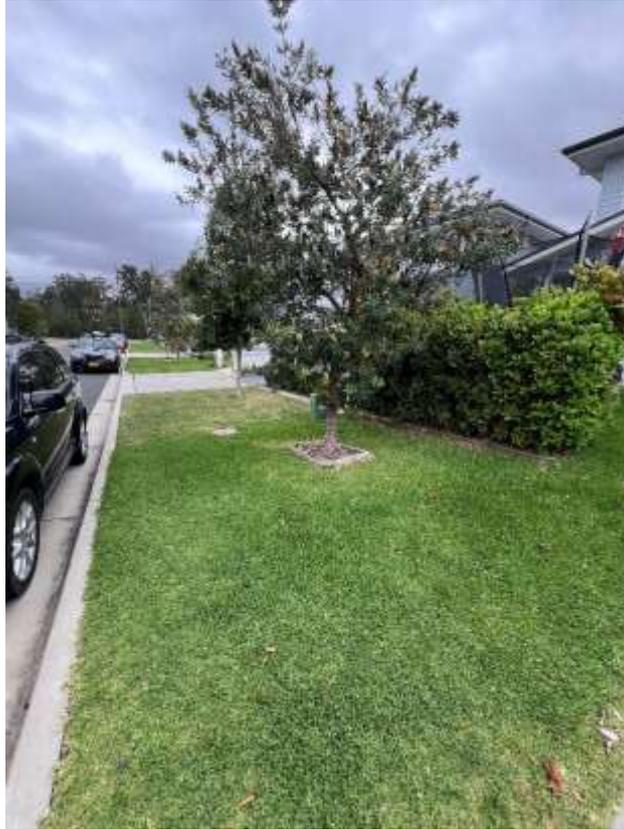
Figure 109 – General condition of the tree.

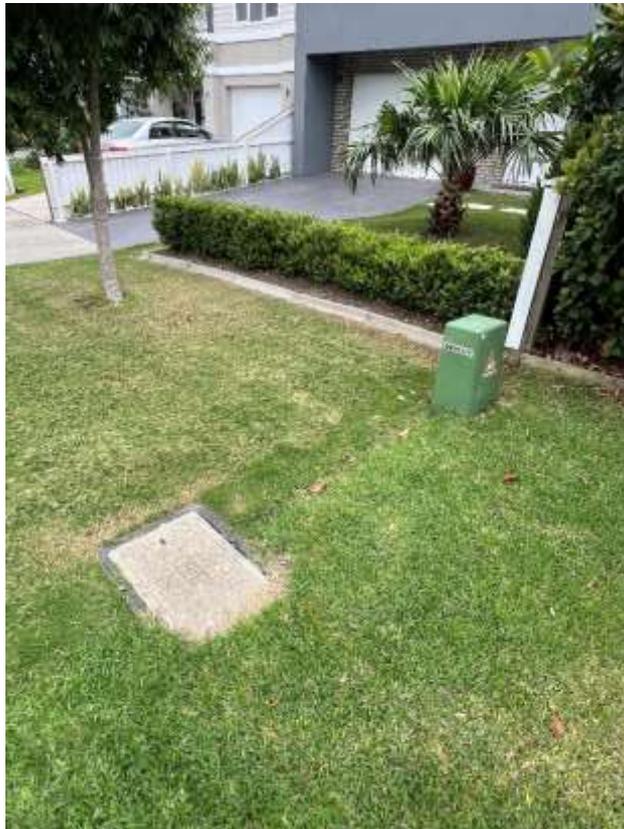
Figure 110 – General condition of the pit/transformer box.

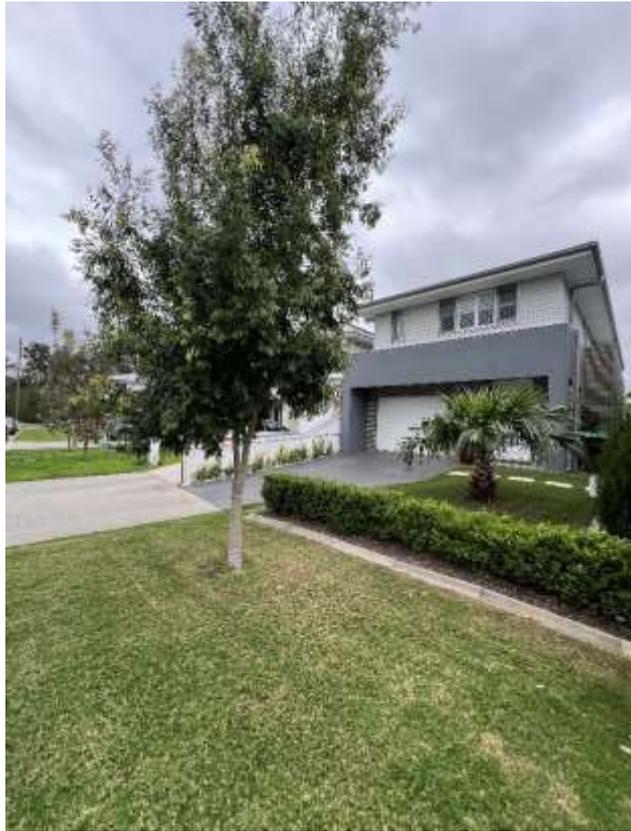
Figure 111 – General condition of the tree.

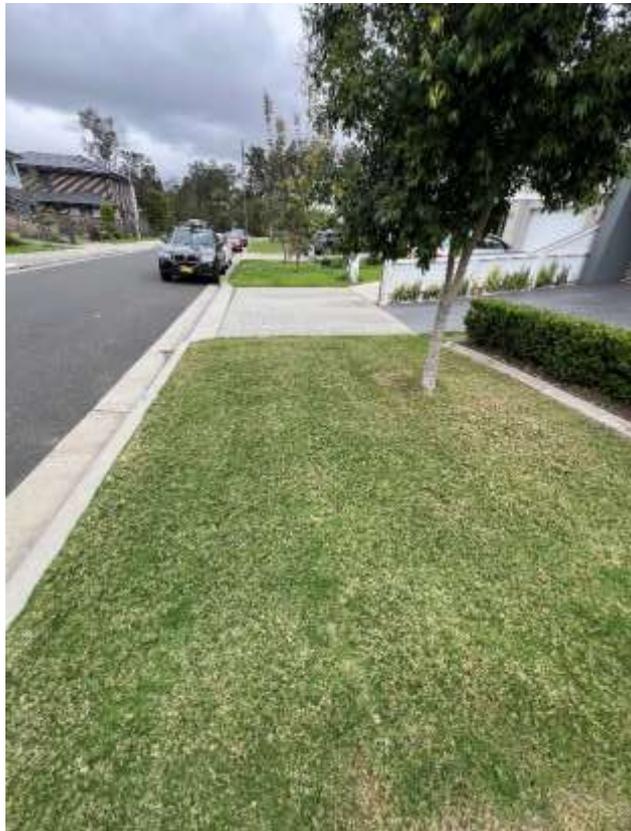
Figure 112 – General condition of the nature strip.

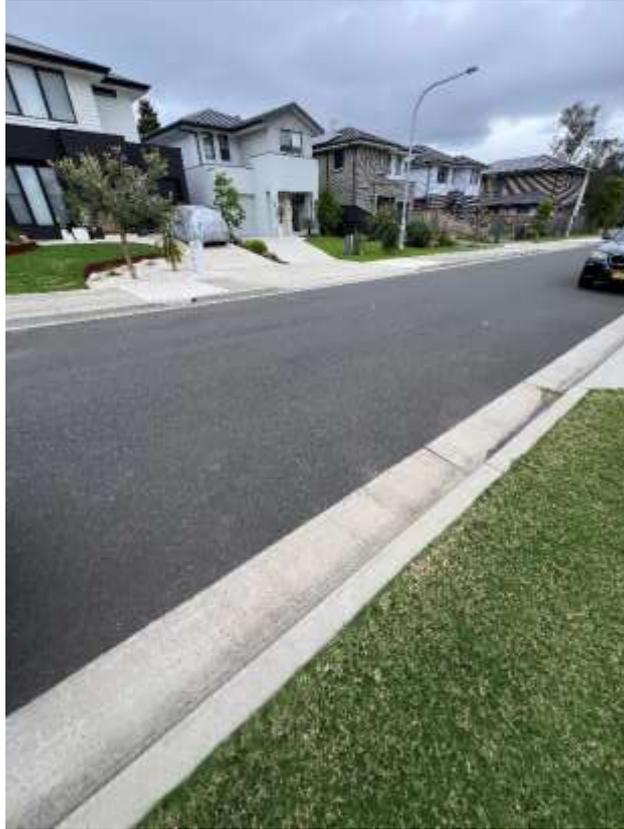
Figure 113 – General condition of the road/kerb.

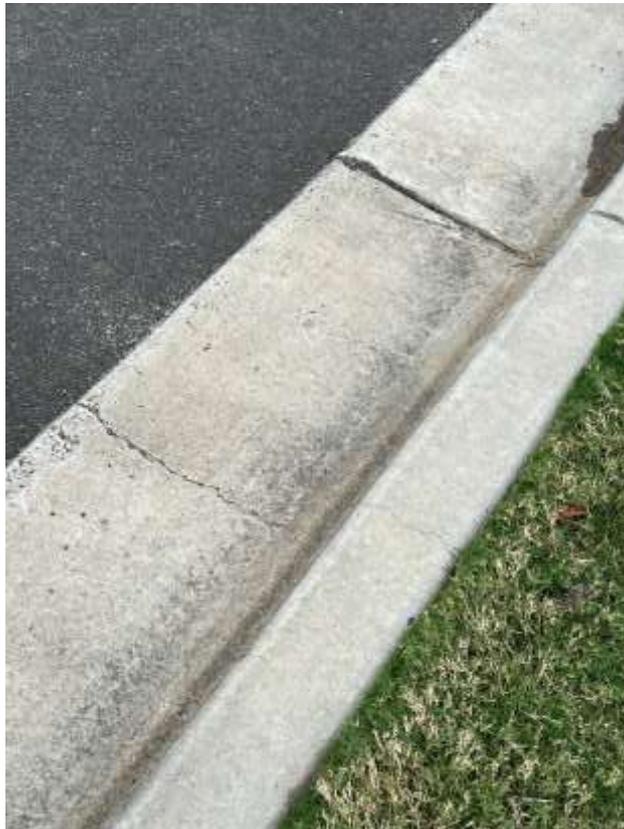
Figure 114 – Crack is evident to the kerb outside 16 Bubalo Street Warriewood.

The council assets were found to be in a fair condition with evidence of crack to the footpath, pit, kerb, and layback.

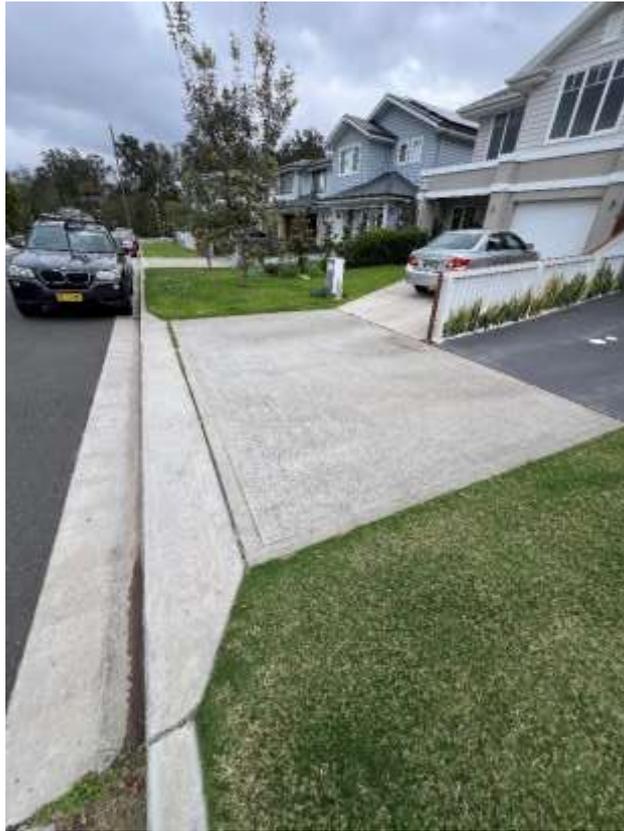
Figure 115 – General condition of the driveway.

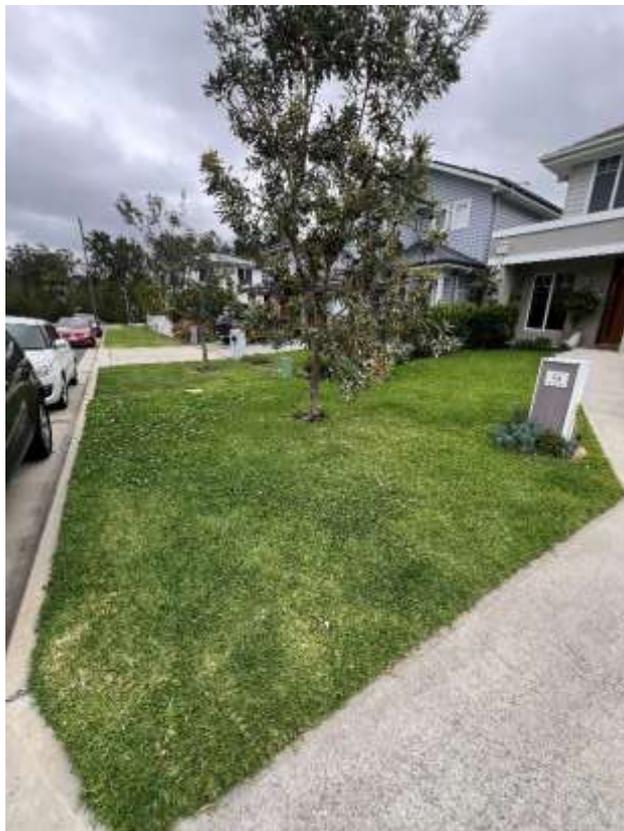
Figure 116 – General condition of the nature strip/tree.

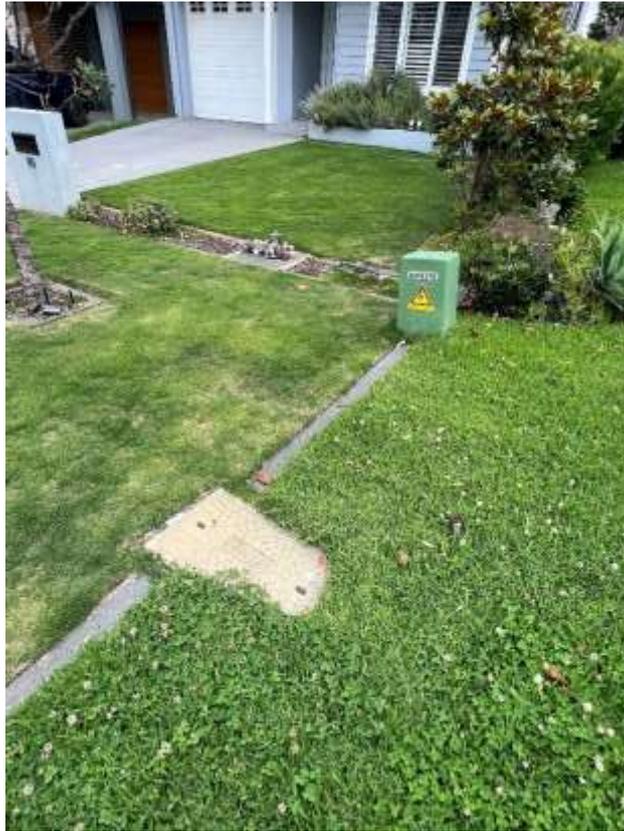
Figure 117 – General condition of the pit/transformer box.

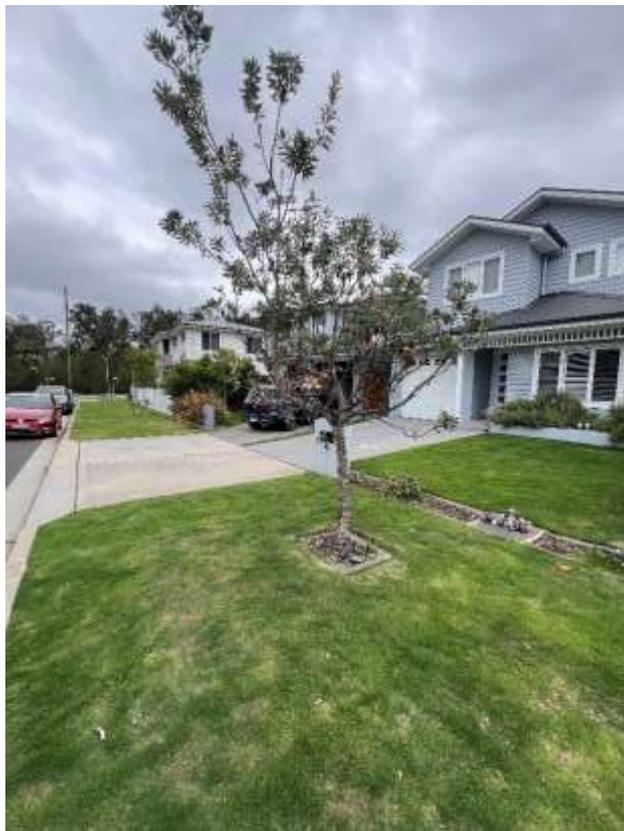
Figure 118 – General condition of the tree.

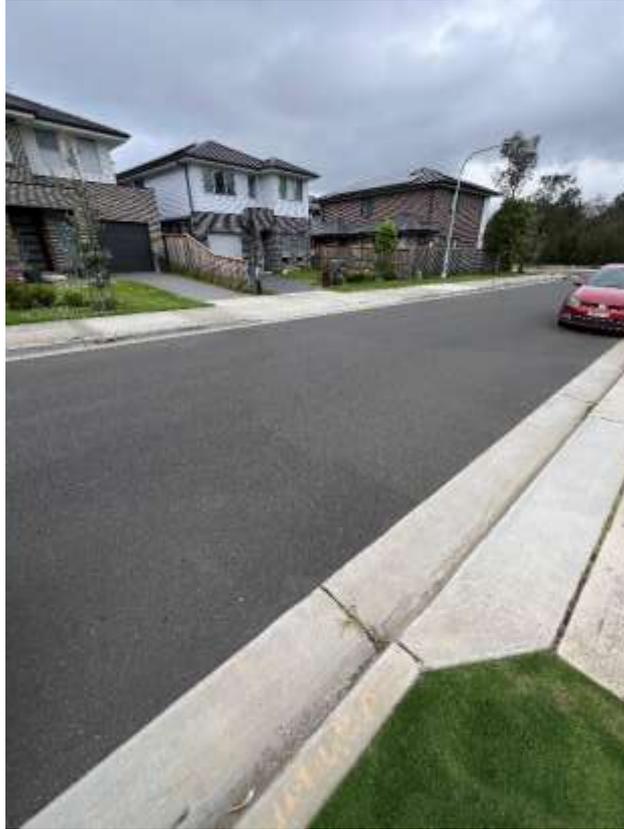
Figure 119 – General condition of the road.

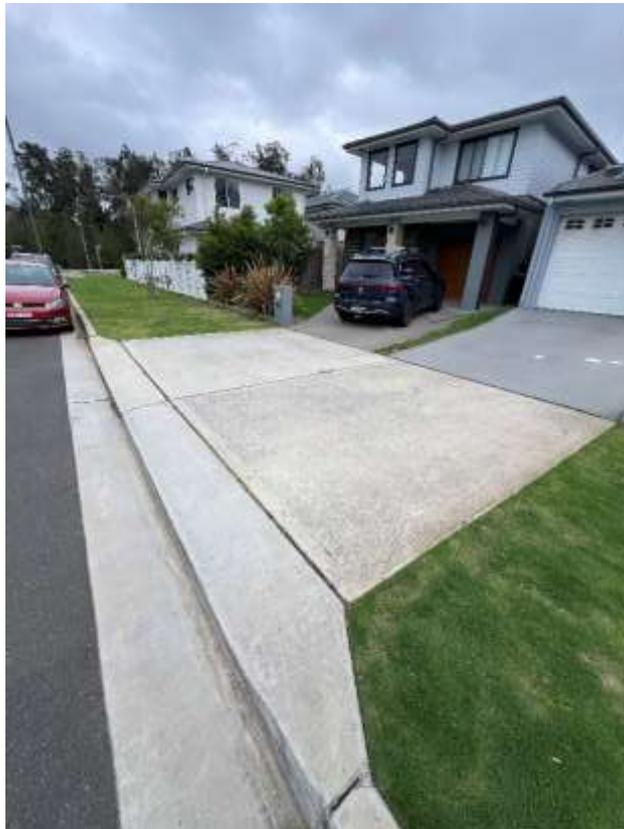
Figure 120 – General condition of the driveway.

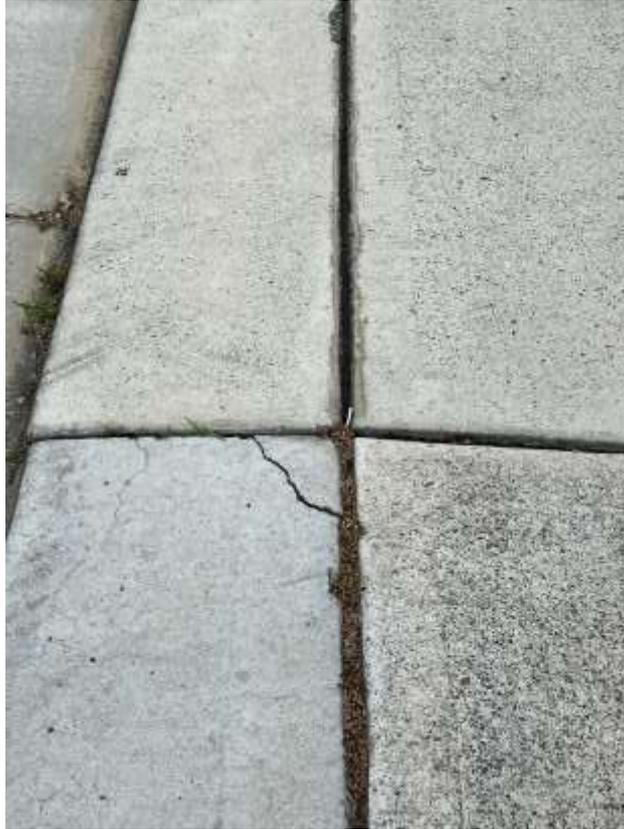
Figure 121 – Crack is evident to the layback outside 18 Bubalo Street Warriewood.

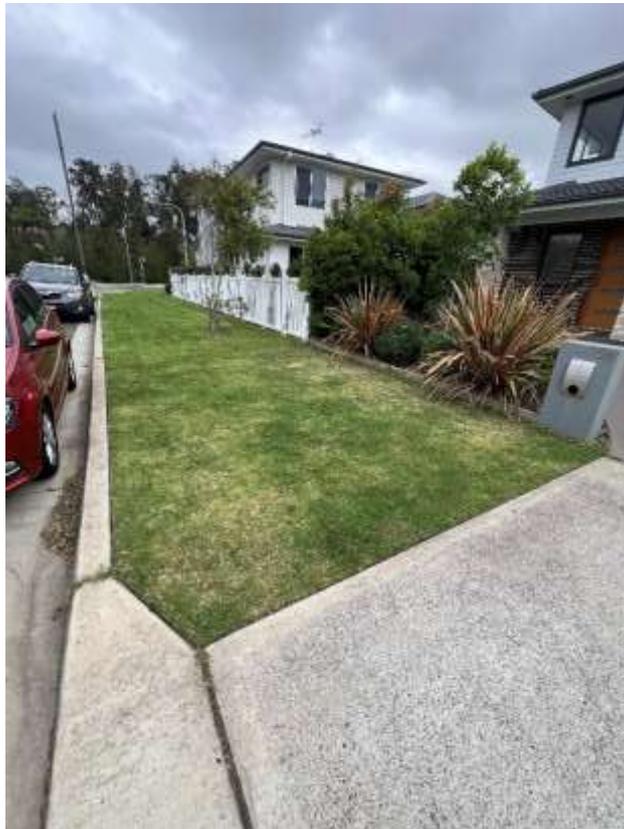
Figure 122 – General condition of the nature strip.

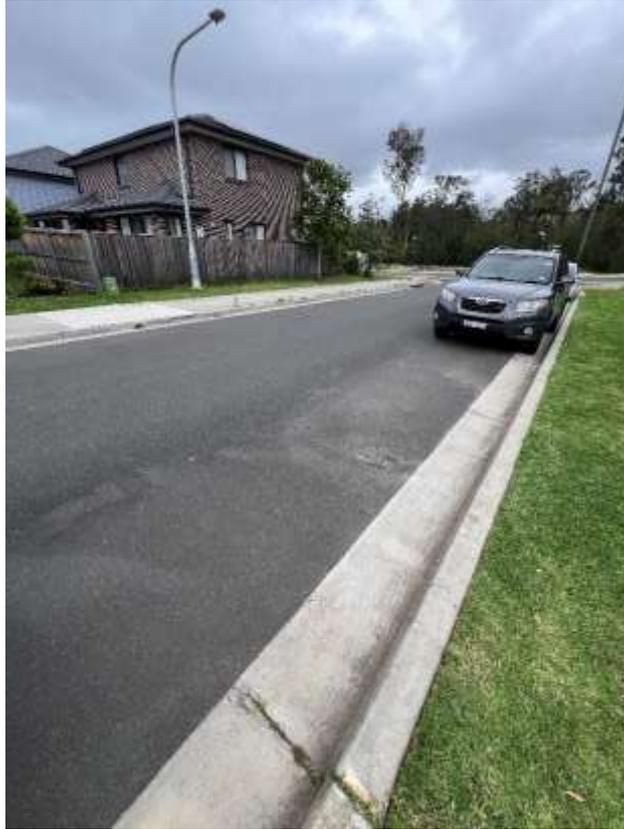
Figure 123 – General condition of the road/kerb.

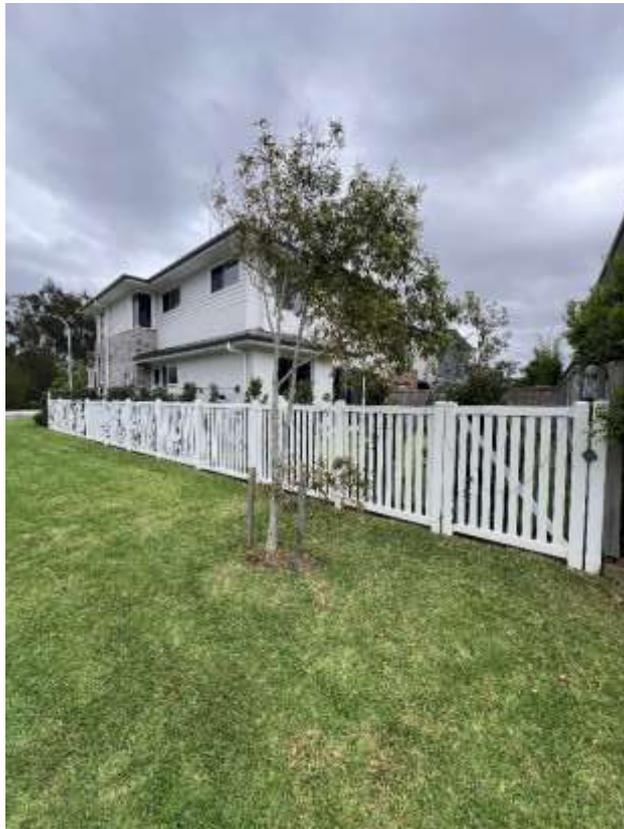
Figure 124 – General condition of the tree.

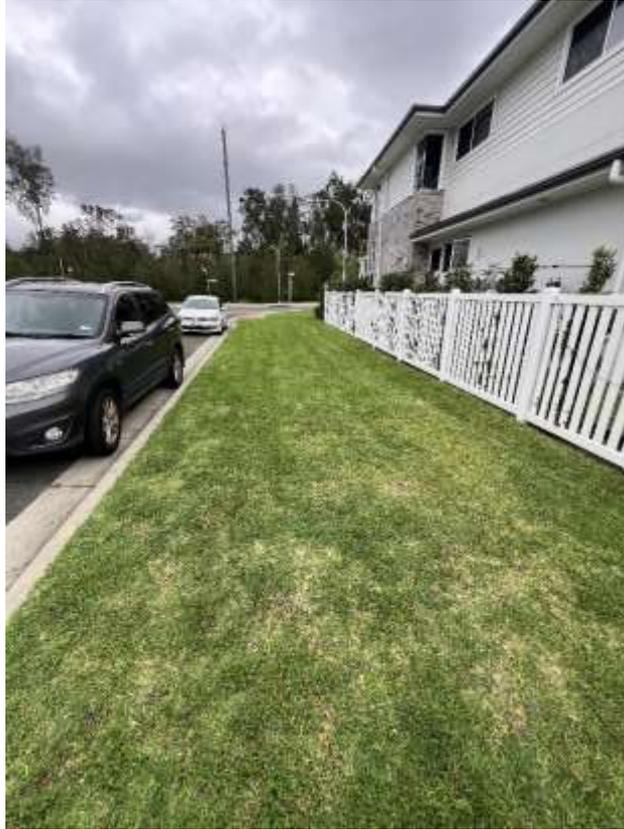
Figure 125 – General condition of the nature strip.

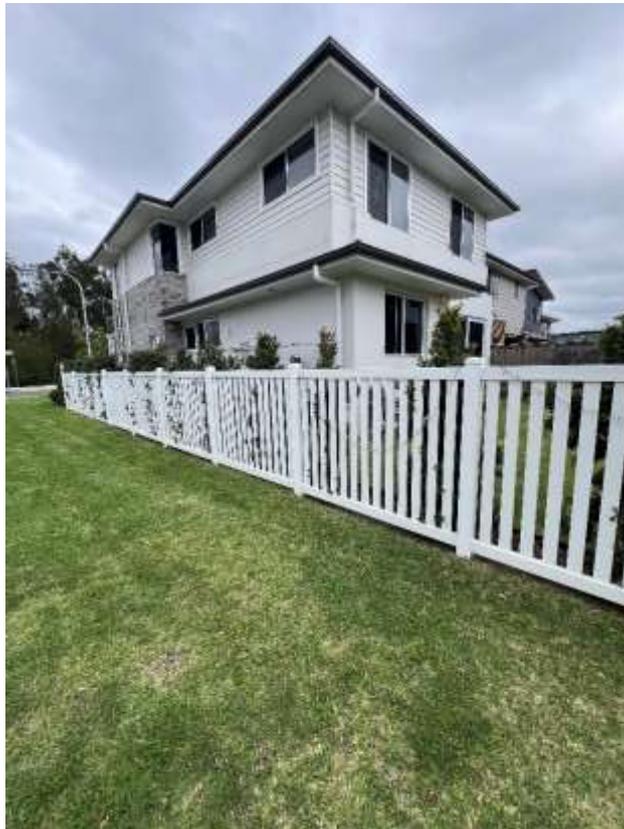
Figure 126 – General condition of the fence.

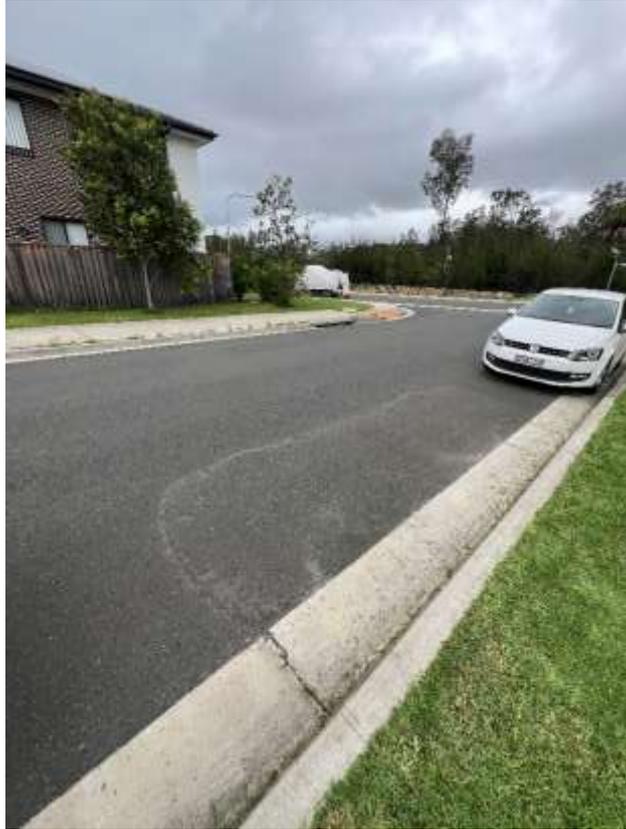
Figure 127 – General condition of the road/kerb.

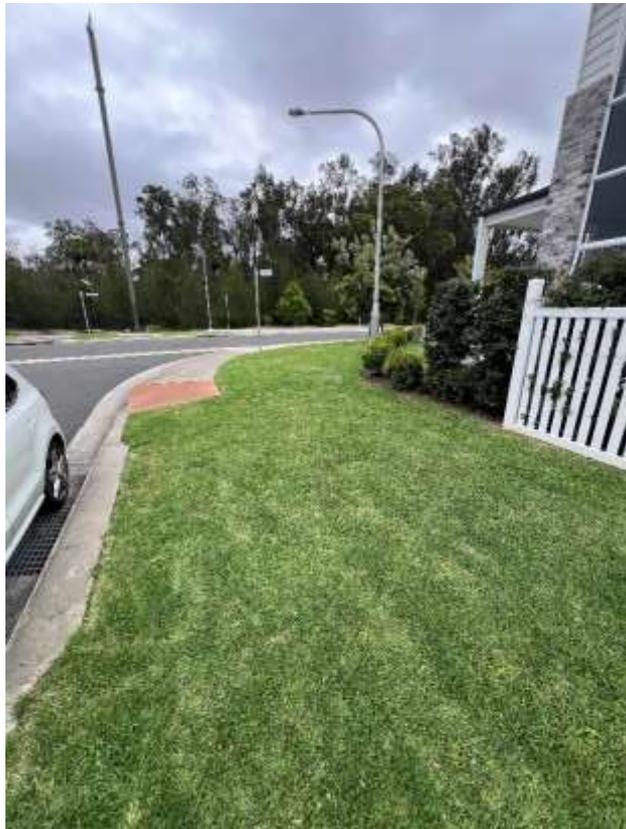
Figure 128 – General condition of the nature strip.

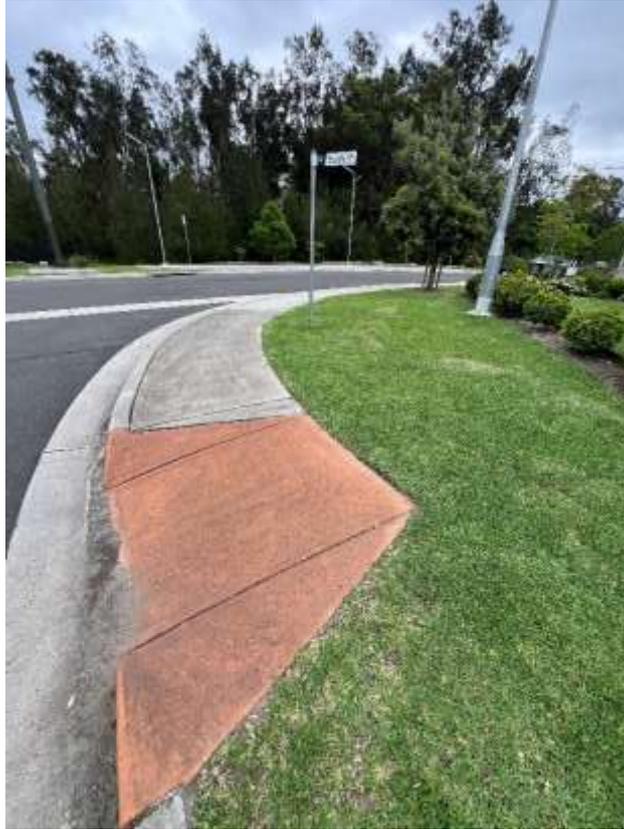
Figure 129 – General condition of the footpath.

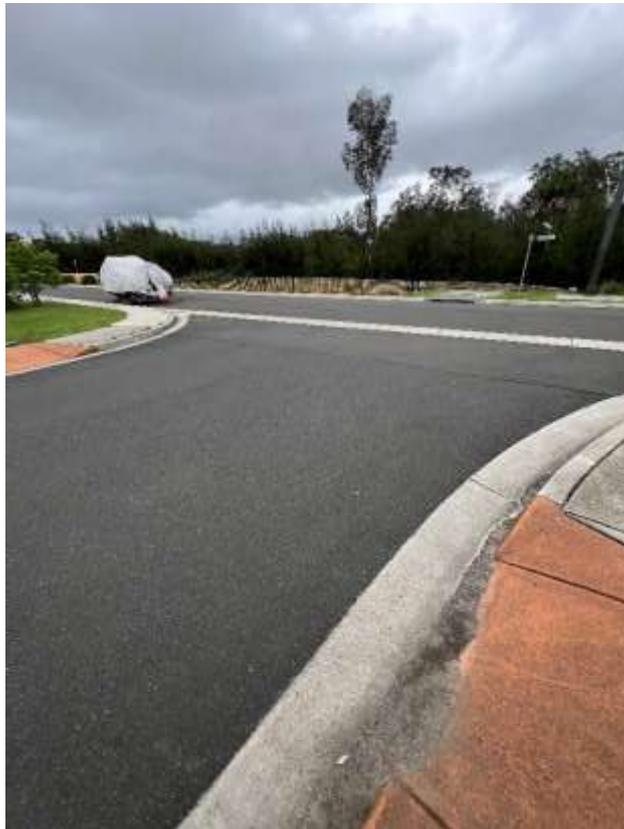
Figure 130 – General condition of the road/layback.
