Geotechnical Investigation Report for Reggie's Residential Design & Drafting At 71 Alexandra Crescent, Bayview, NSW 2104

Job No: G-00182

Date: 23rd March 2021

Revision B, 7th June 2021

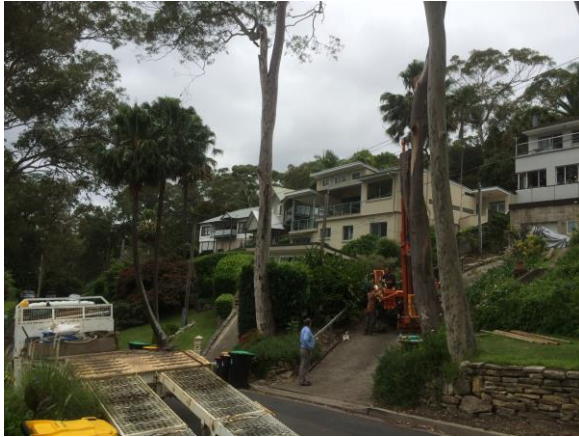
Property at No. 69

Series-1: A view of Entrance and Adjacent Properties to the Property at No. 71 Alexandra Crescent

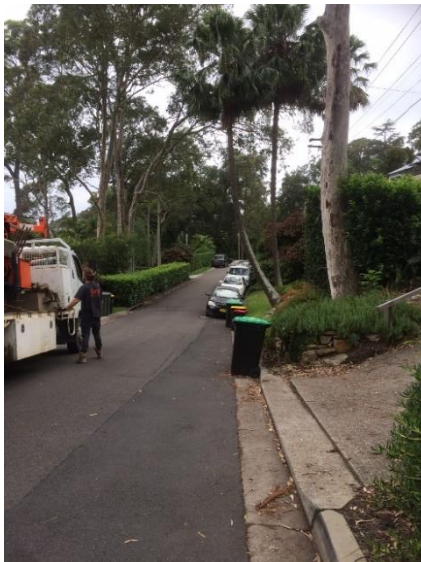
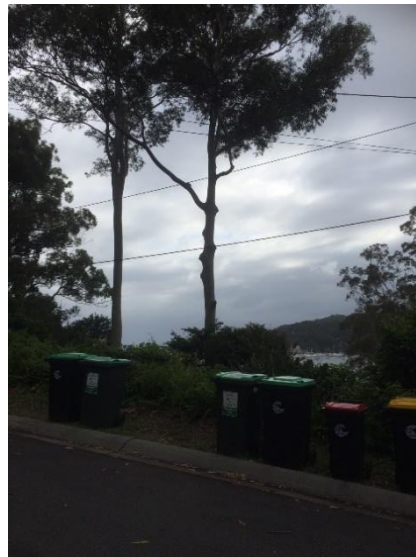
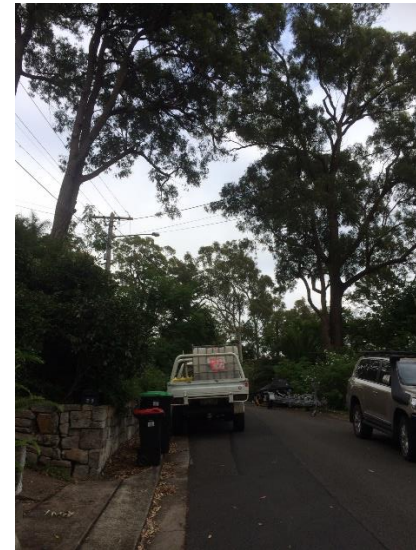
Series-2: View of the Access at the front of the Property

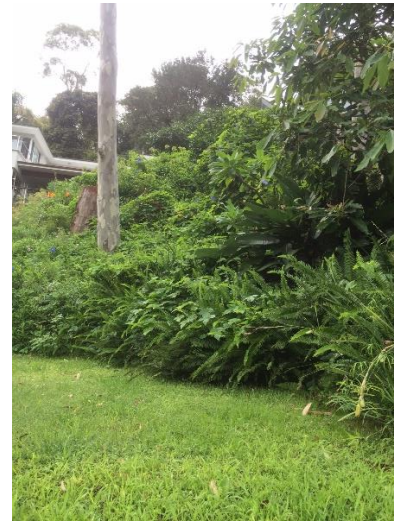
Series-3: A view of the Sloped Profile of the Property

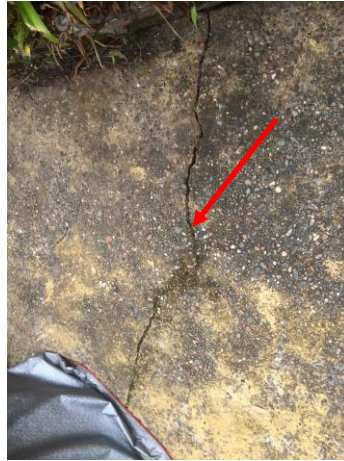
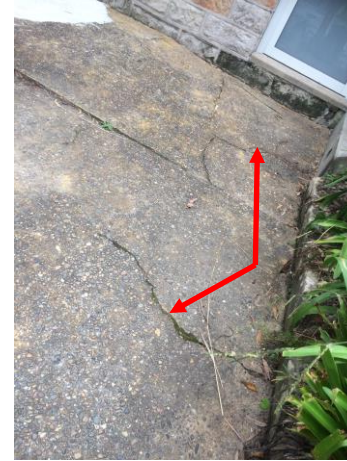
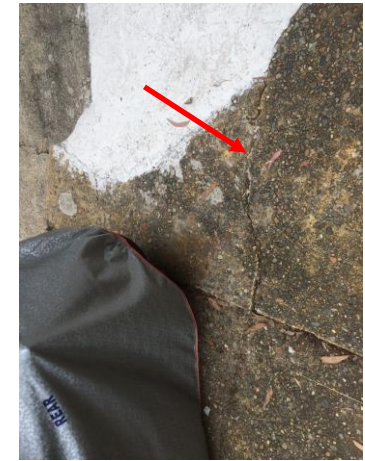
Series-5: Signs of movement in and around the Property (Contd...)

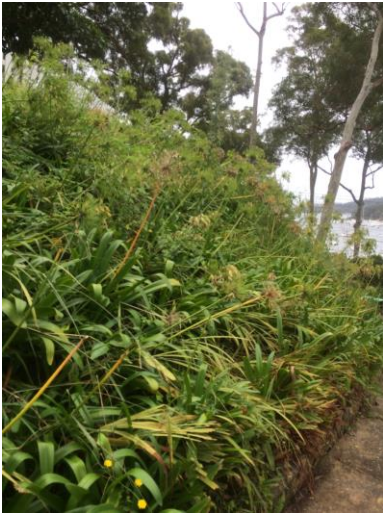
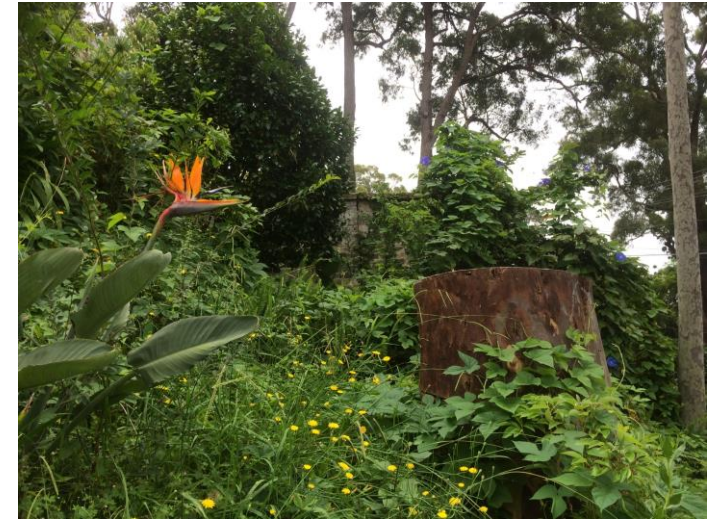
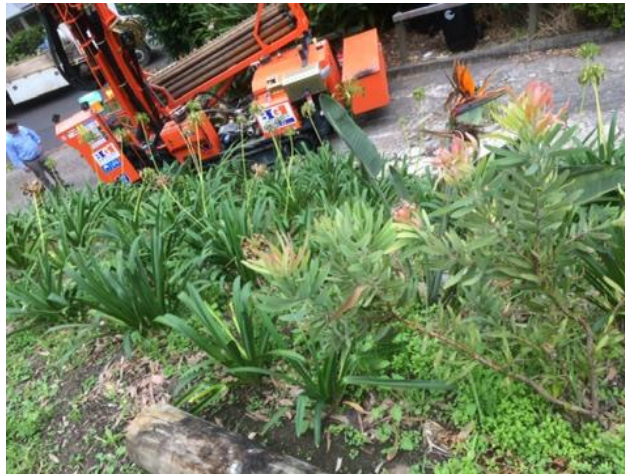
Series-6: Ground Features of the Property
