# DILAPIDATION REPORT

**Warriewood Road, Warriewood**

**Prepared by: Rezoning Pty Ltd t/as Effective Building & Consultancy**

The inspection was carried out on 11 November 2024.

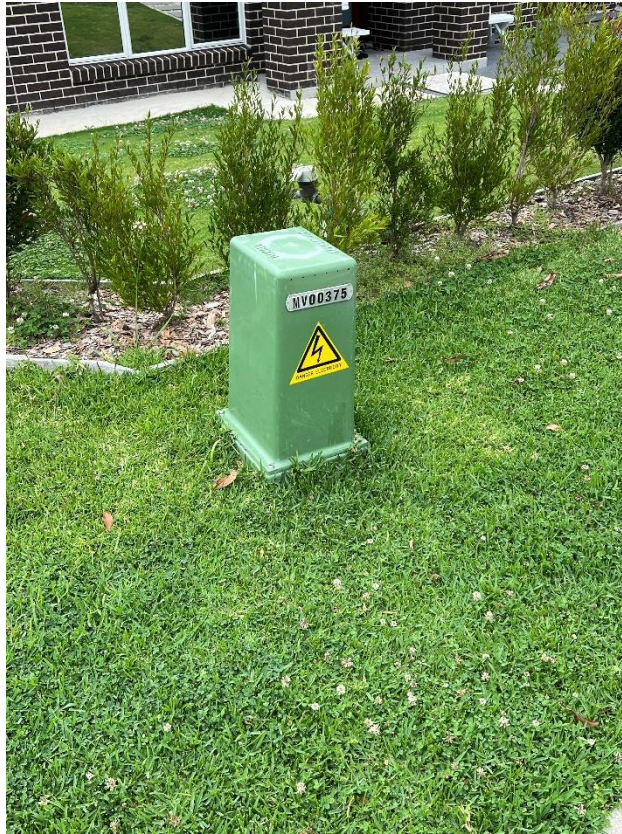
*Figure 3 – General condition of the transformer box.*

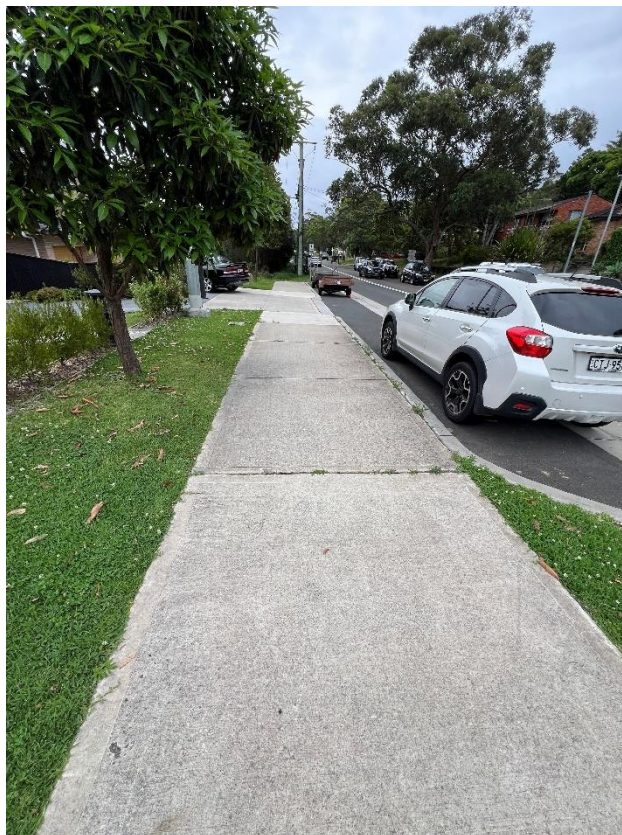
*Figure 4 – General condition of the footpath.*

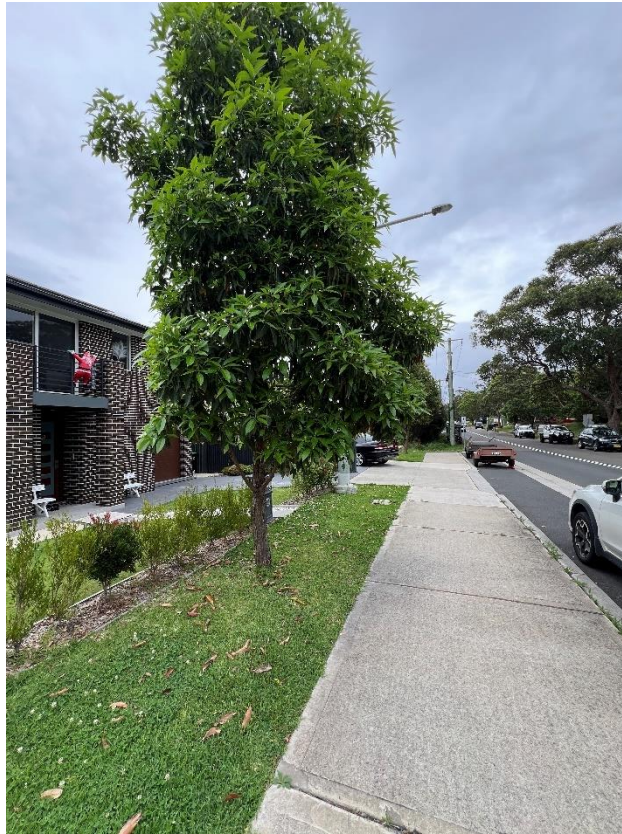
*Figure 5 – General condition of the tree.*

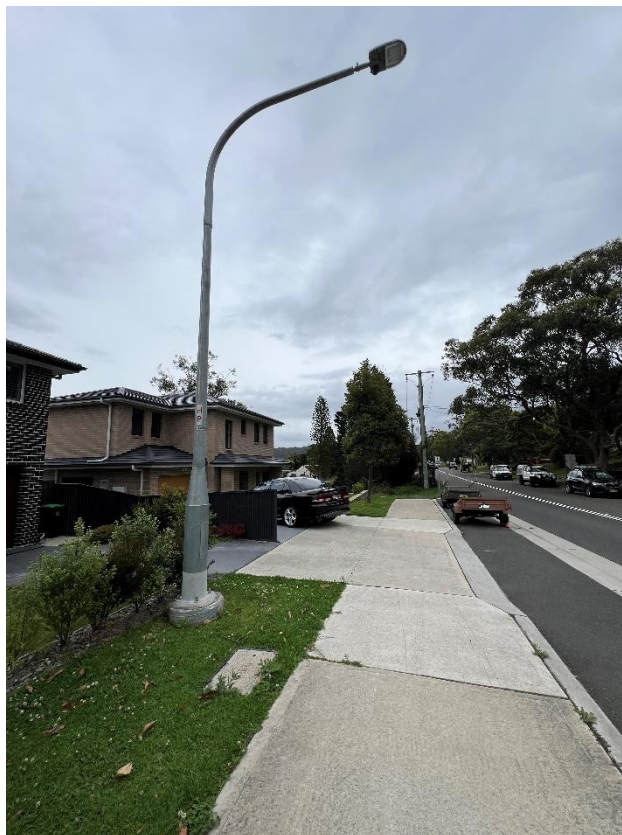
*Figure 6 – General condition of the nature street light.*

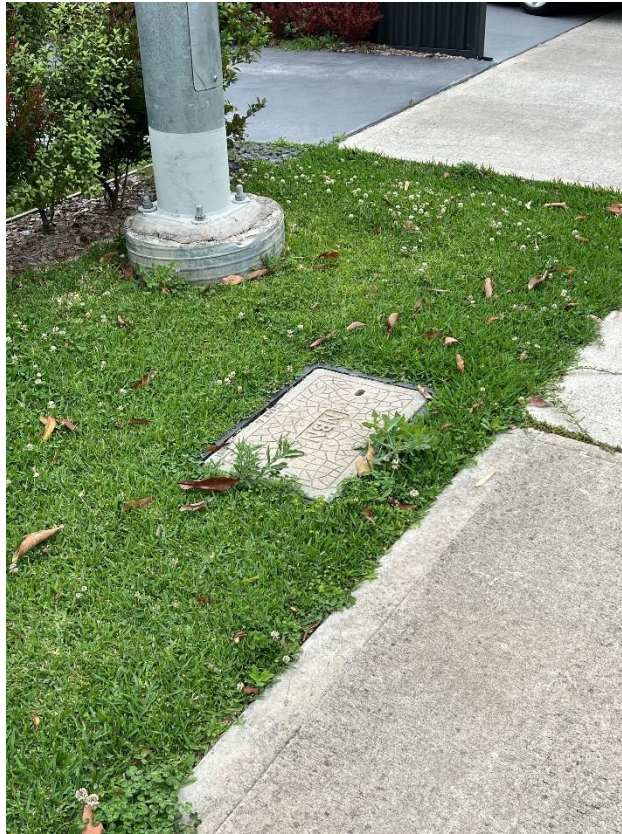
*Figure 7 – General condition of the pit.*

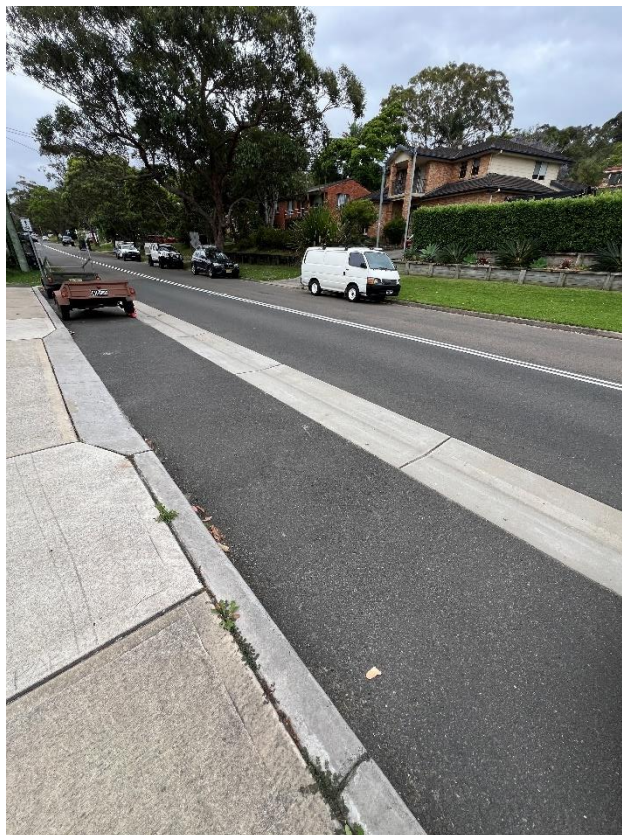
*Figure 8 – General condition of the kerb/road.*

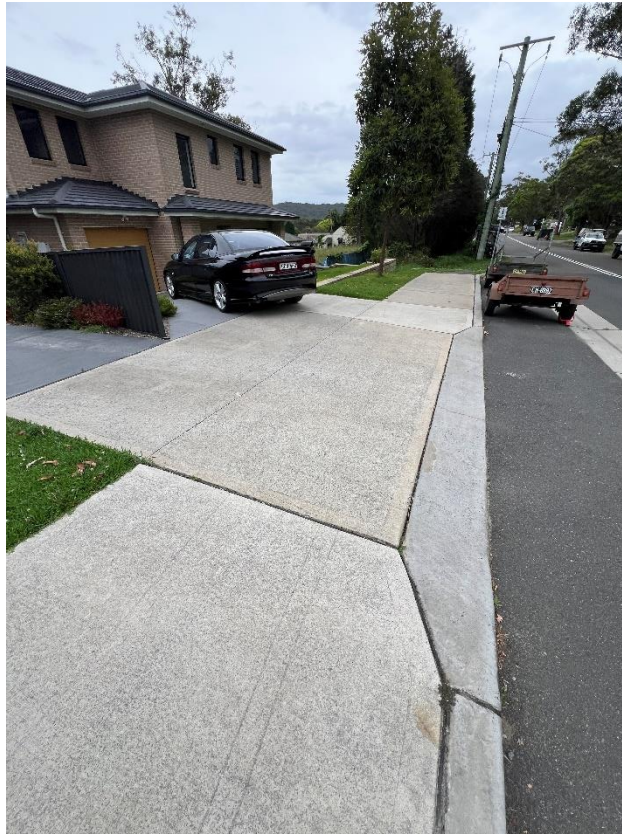
*Figure 9 – General condition of the driveway.*

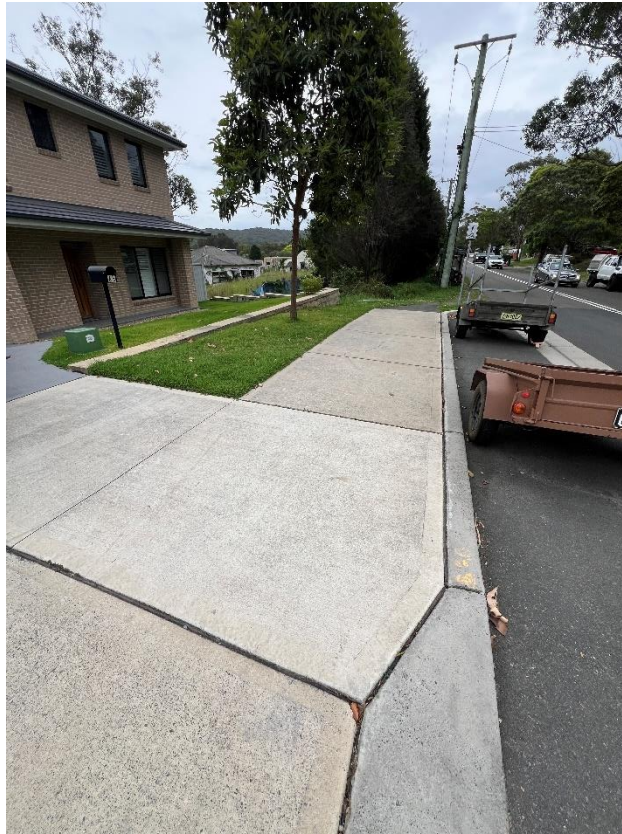
*Figure 11 – General condition of the footpath.*

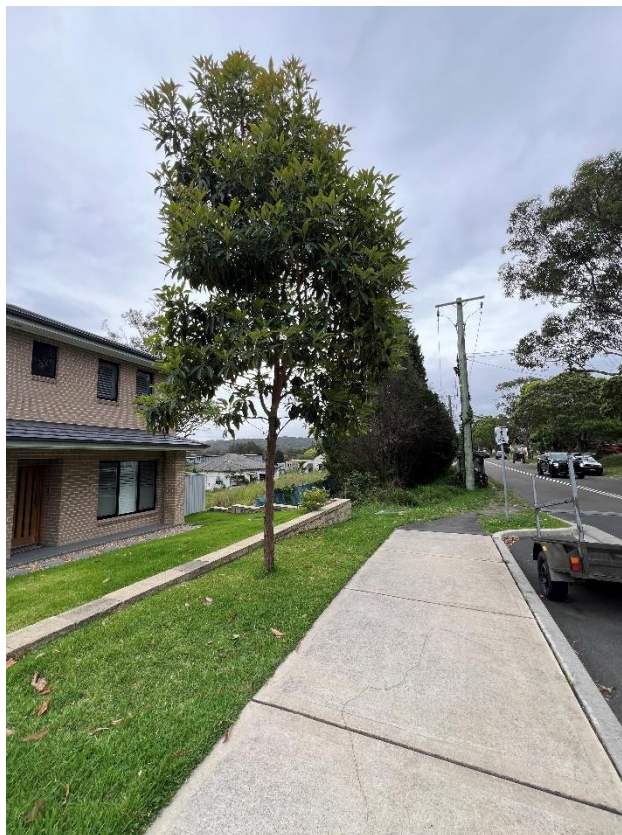
*Figure 12 – General condition of the tree.*

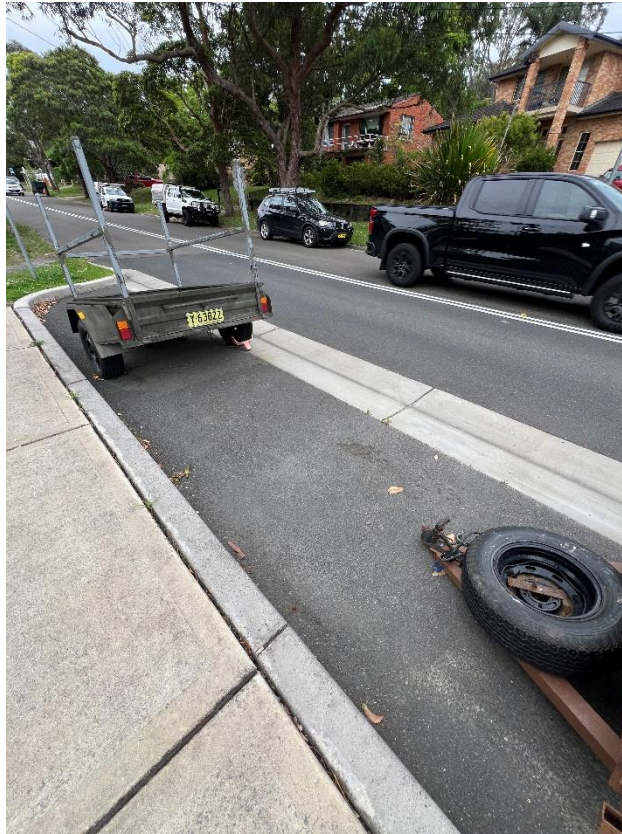
*Figure 13 – General condition of the kerb/road.*

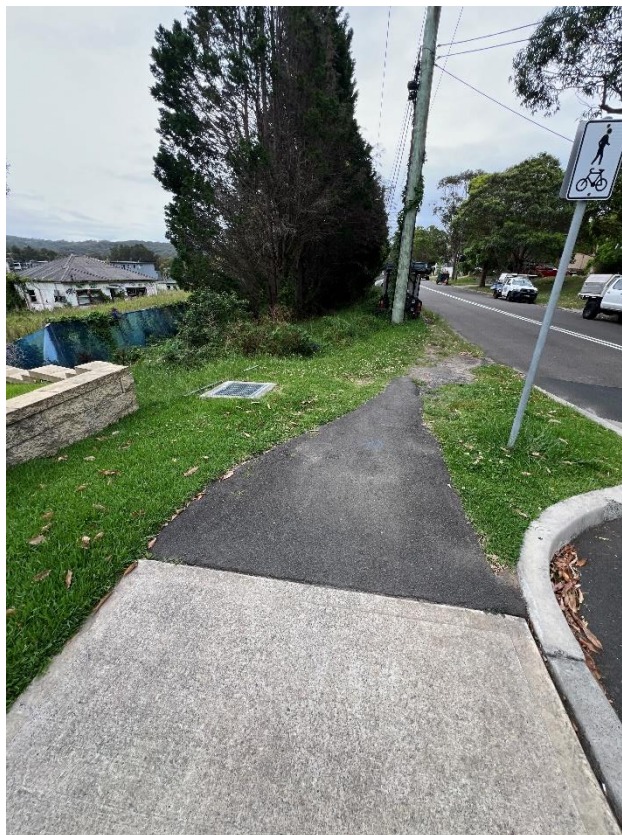
*Figure 14 – General condition of the footpath.*

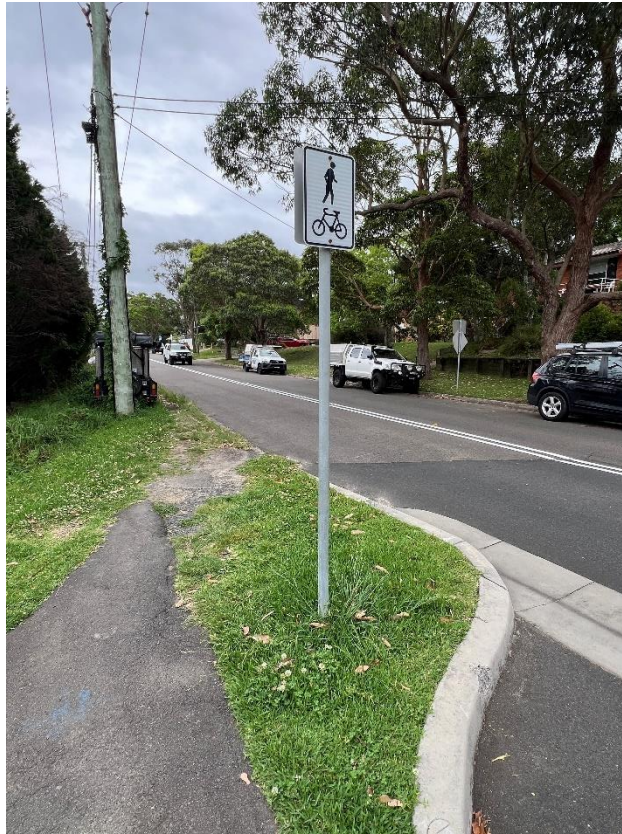
*Figure 15 – General condition of the traffic signpost.*

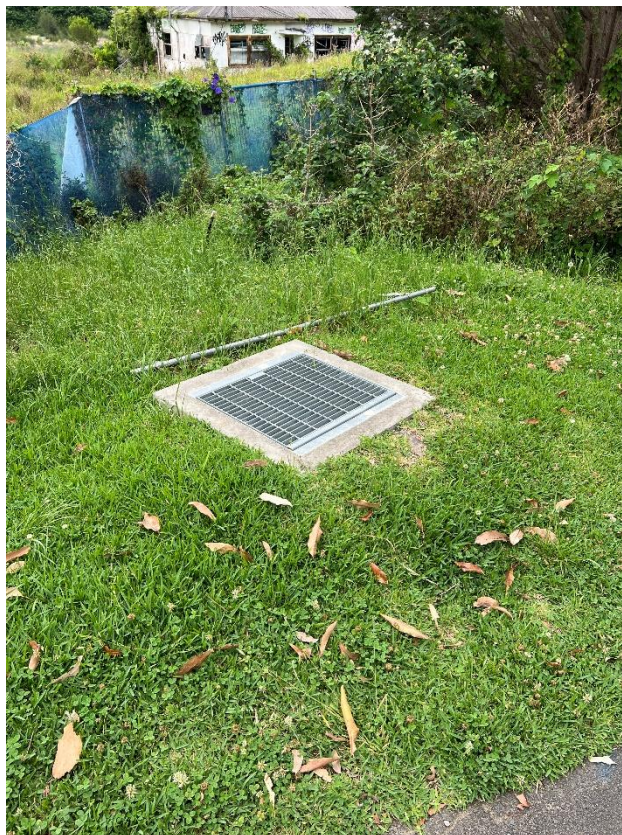
*Figure 16 – General condition of the pit.*

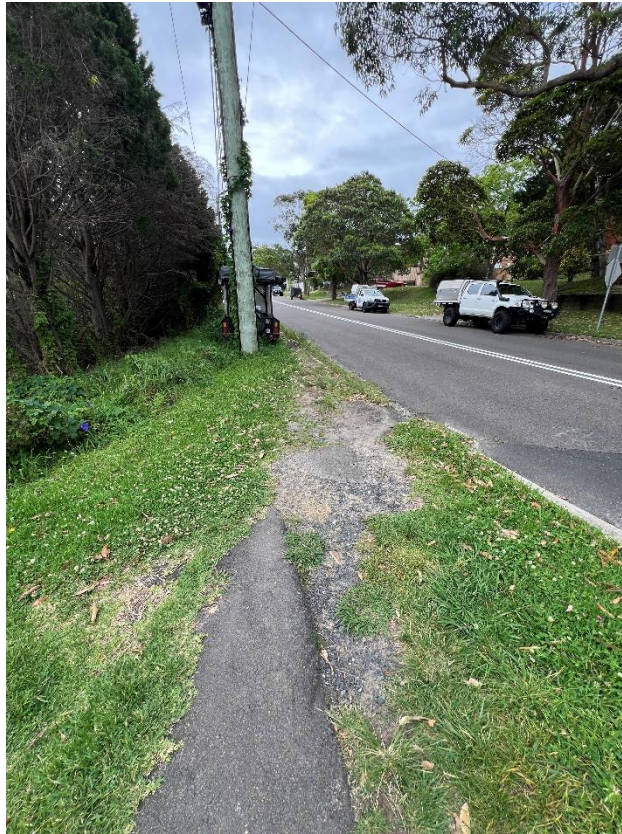
*Figure 17 – General condition of the footpath/nature strip.*

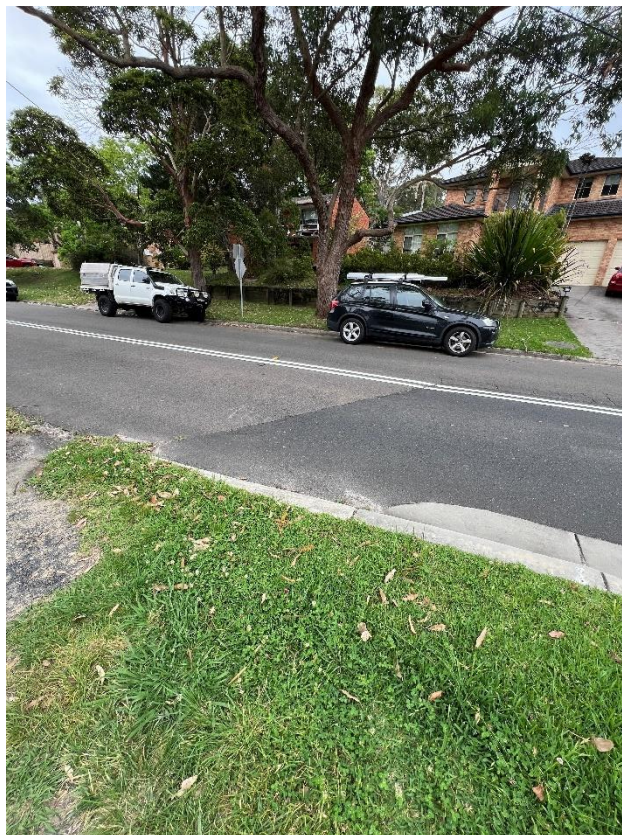
*Figure 18 – General condition of the kerb/road.*

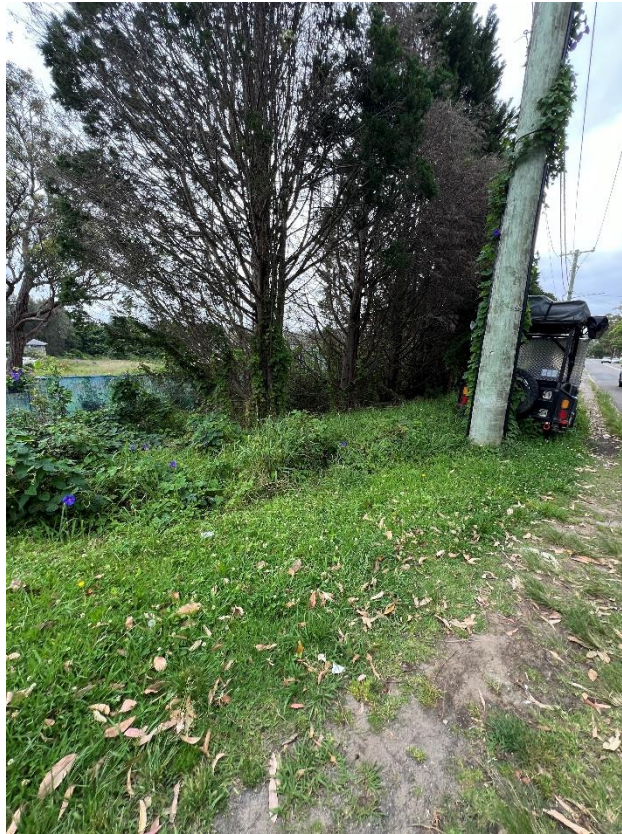
*Figure 19 – General condition of the nature strip.*

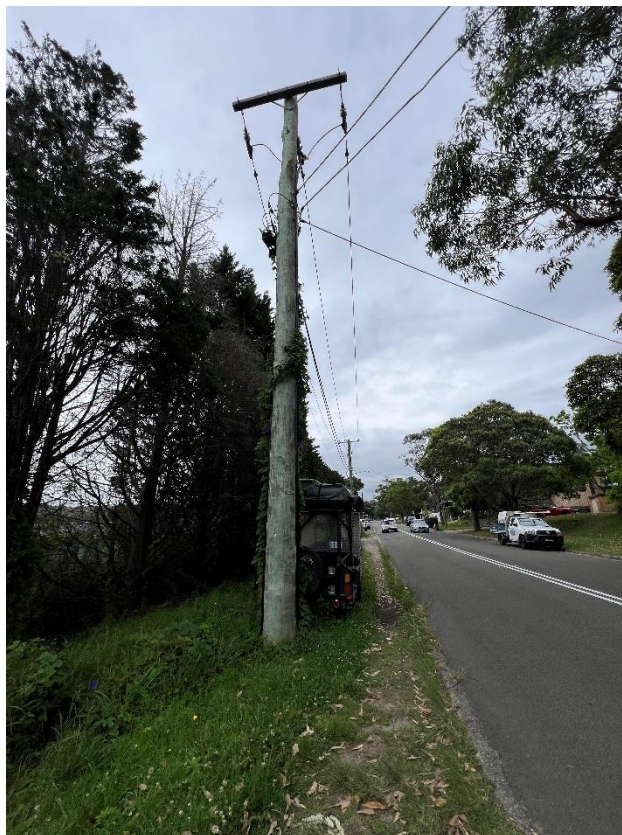
*Figure 20 – General condition of the electrical post.*

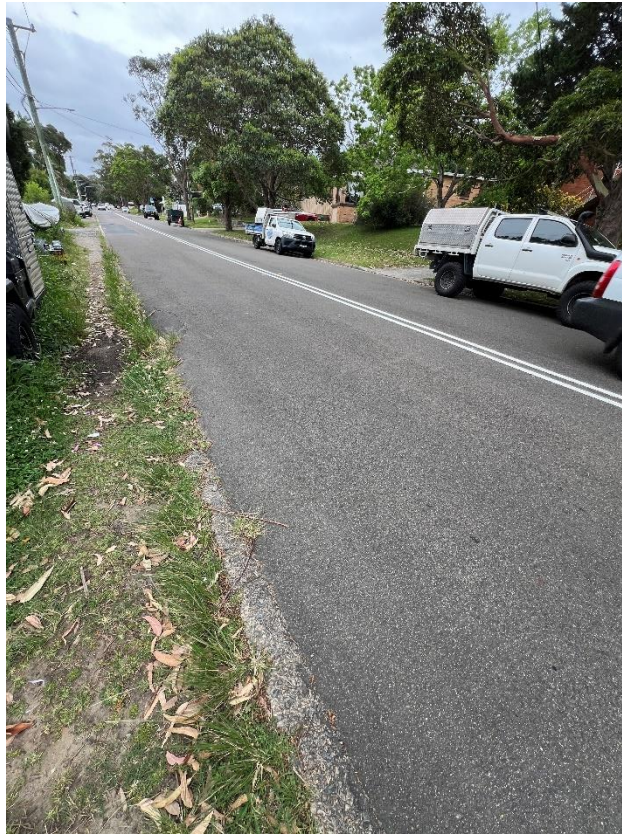
*Figure 21 – General condition of the kerb/road.*

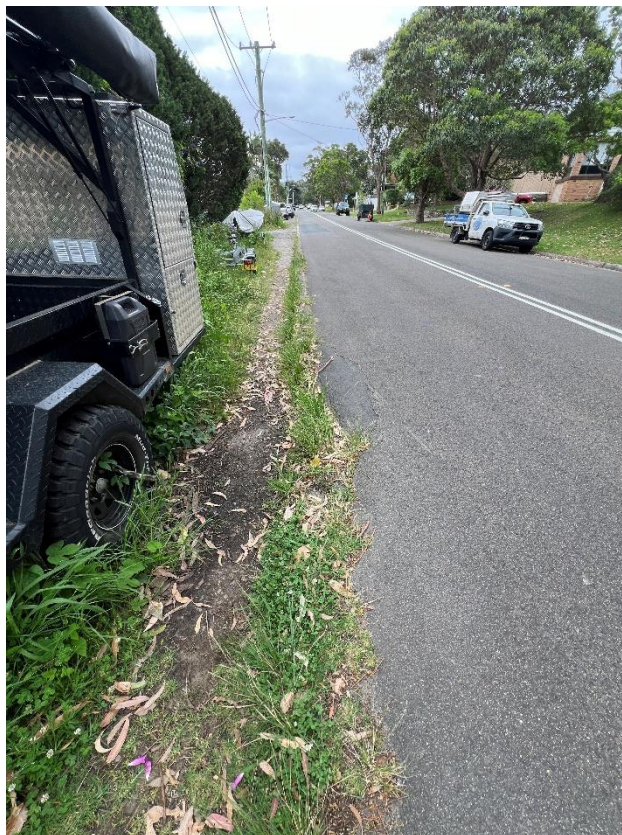
*Figure 22 – General condition of the nature strip.*

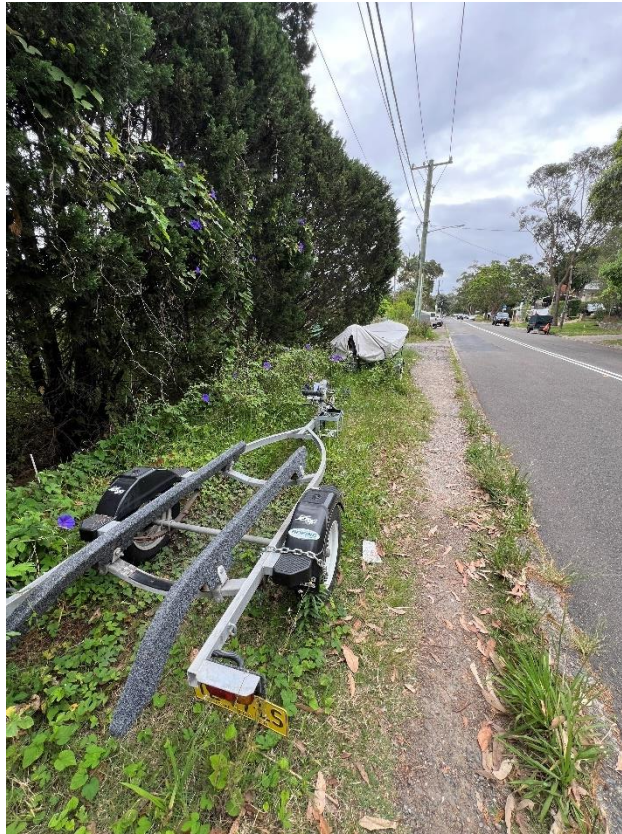
*Figure 23 – General condition of the nature strip.*

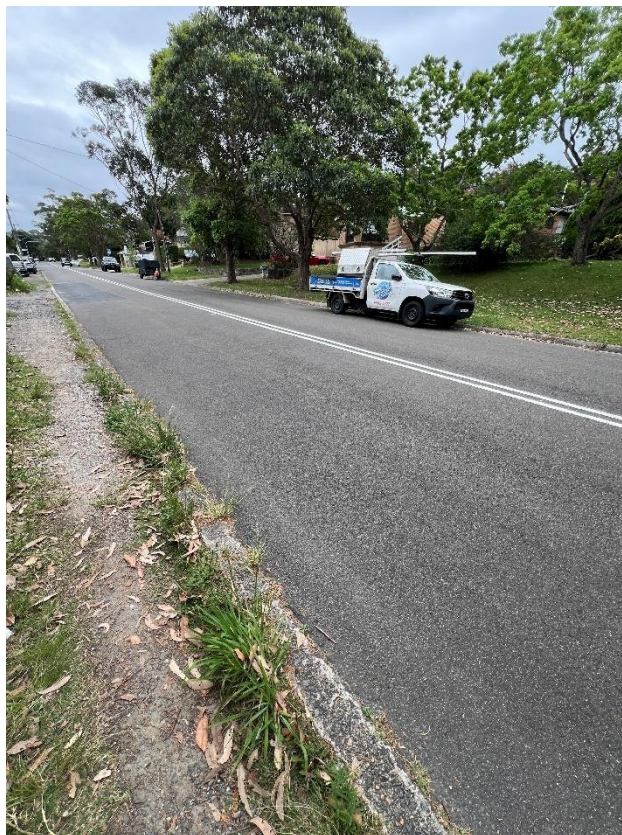
*Figure 24 – General condition of the kerb/road.*

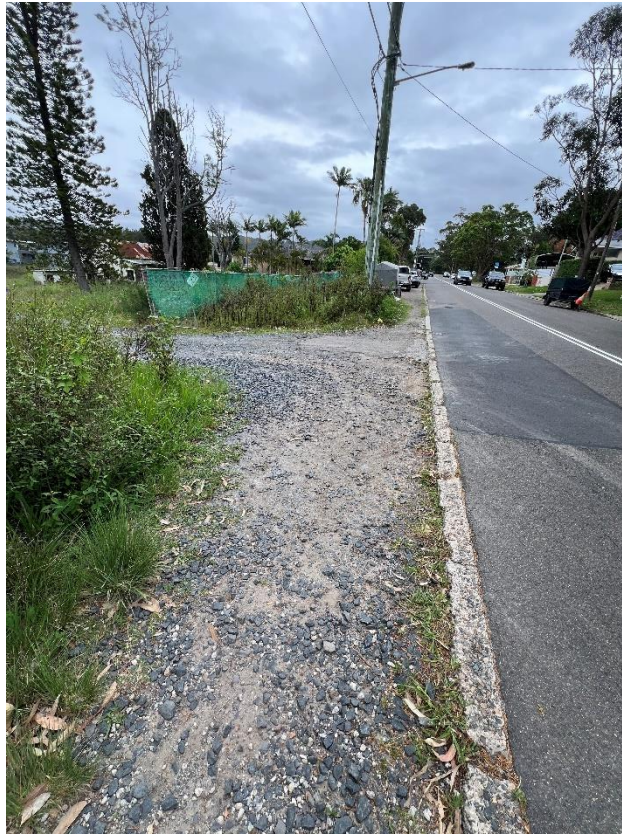
*Figure 25 – General condition of the driveway.*

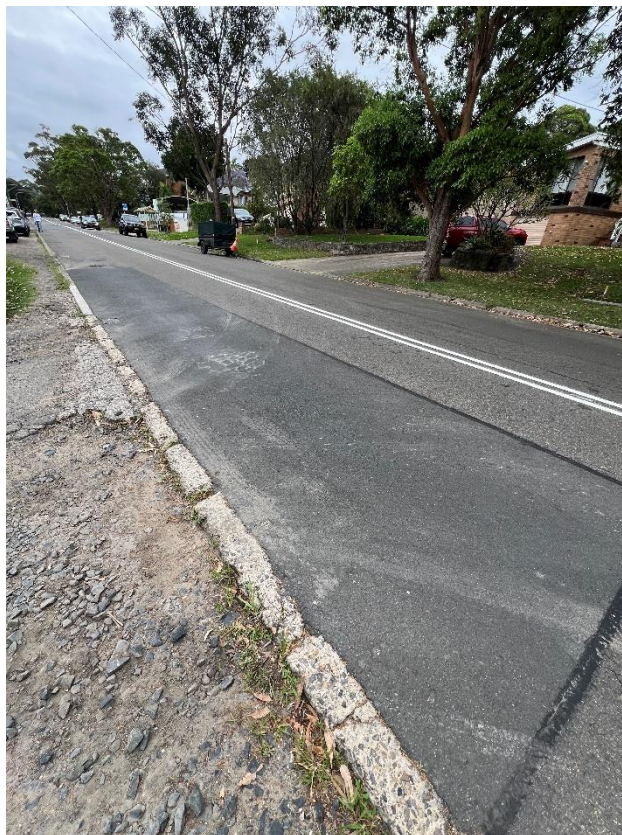
*Figure 26 – General condition of the road.*

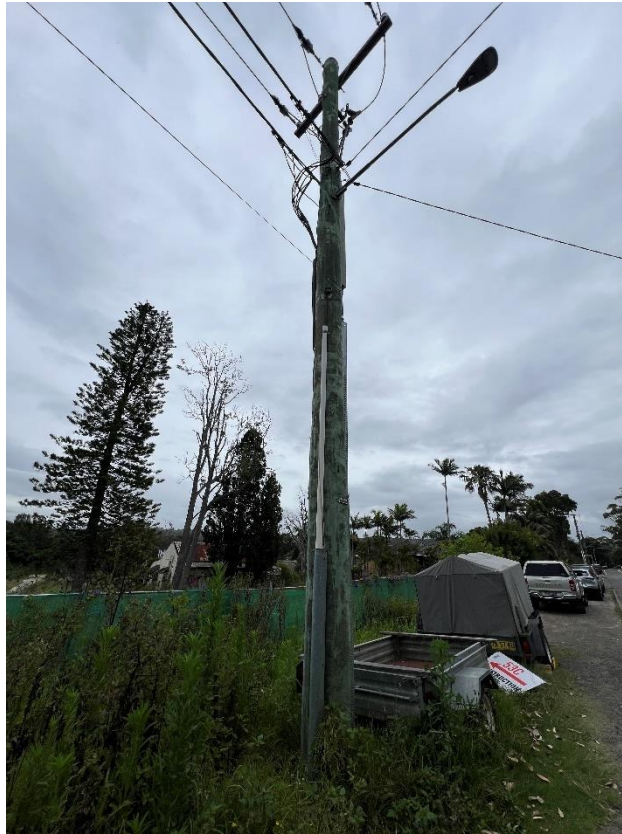
*Figure 27 – General condition of the electrical/light post.*

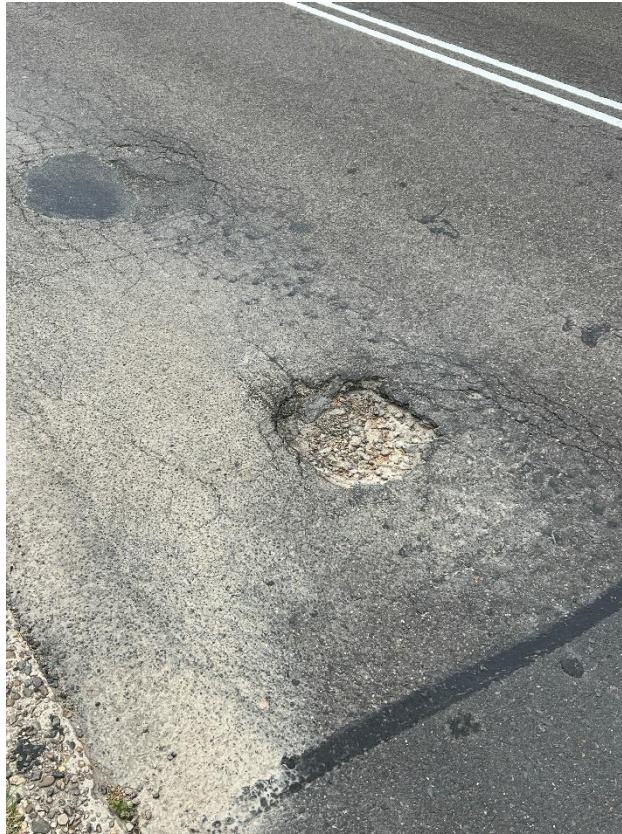
*Figure 29 – Pothole is evident to the road.*

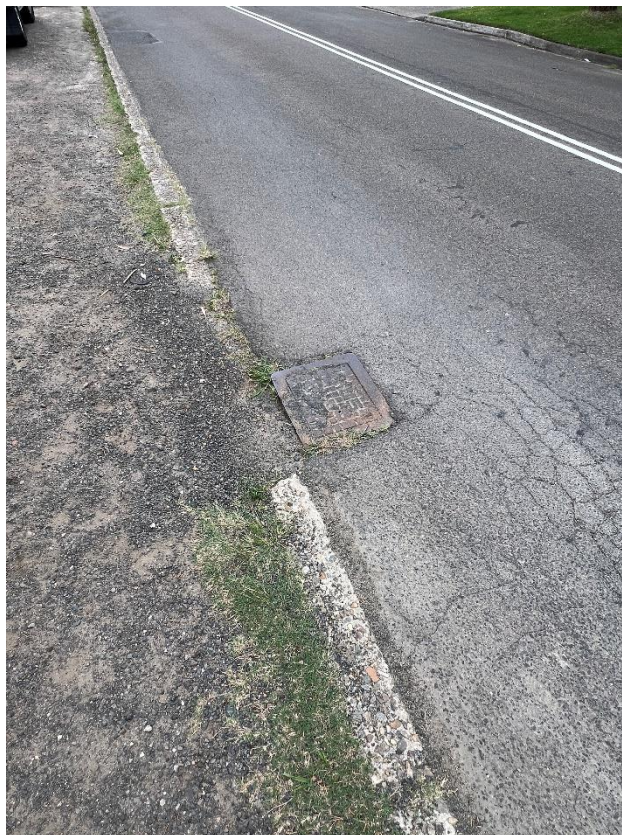
*Figure 30 – General condition of the utility lid.*

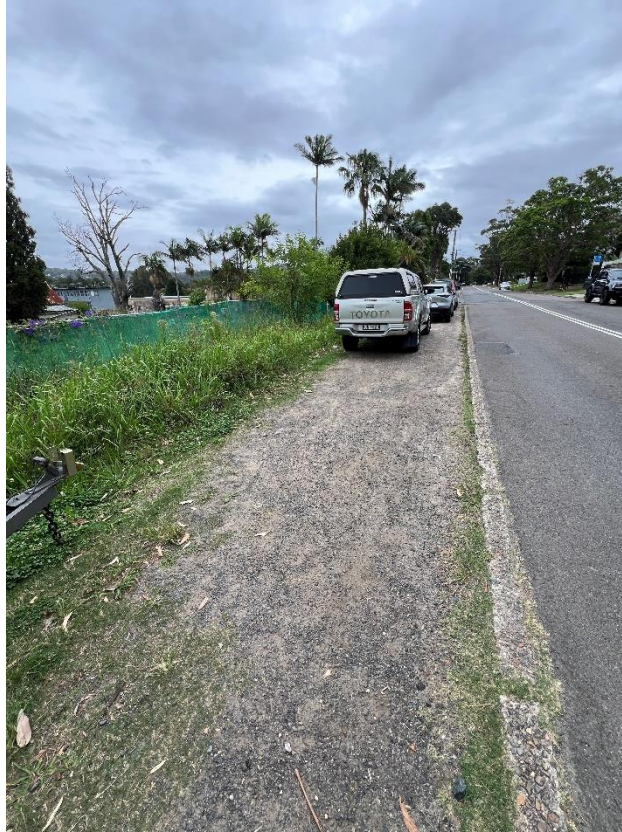
*Figure 31 – General condition of the ground.*

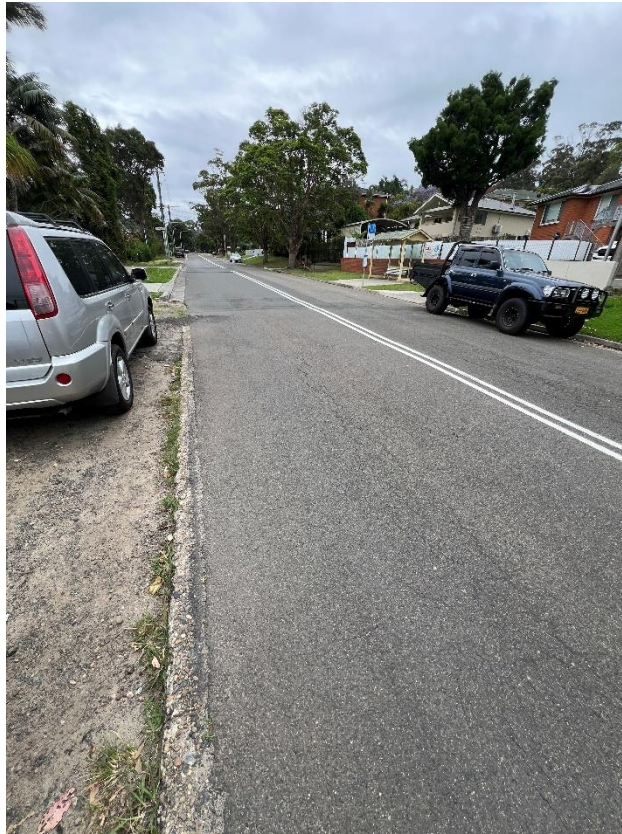
*Figure 33 – General condition of the road.*

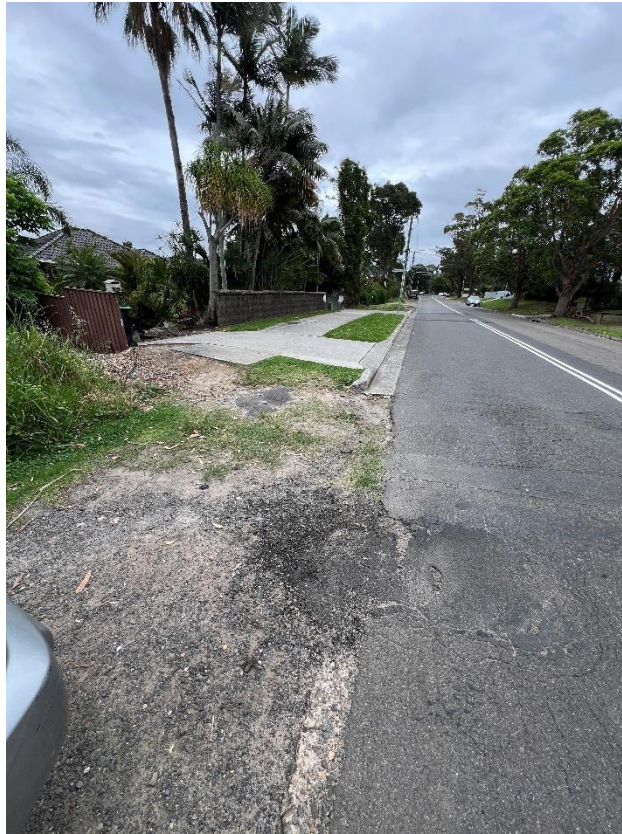
*Figure 35 – Crack is evident to the road.*

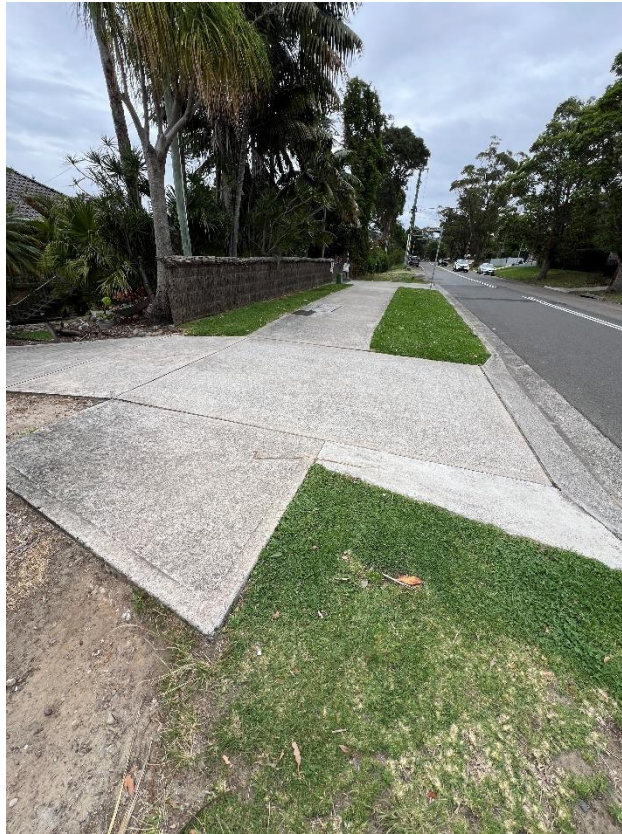
*Figure 37 – General condition of the driveway.*

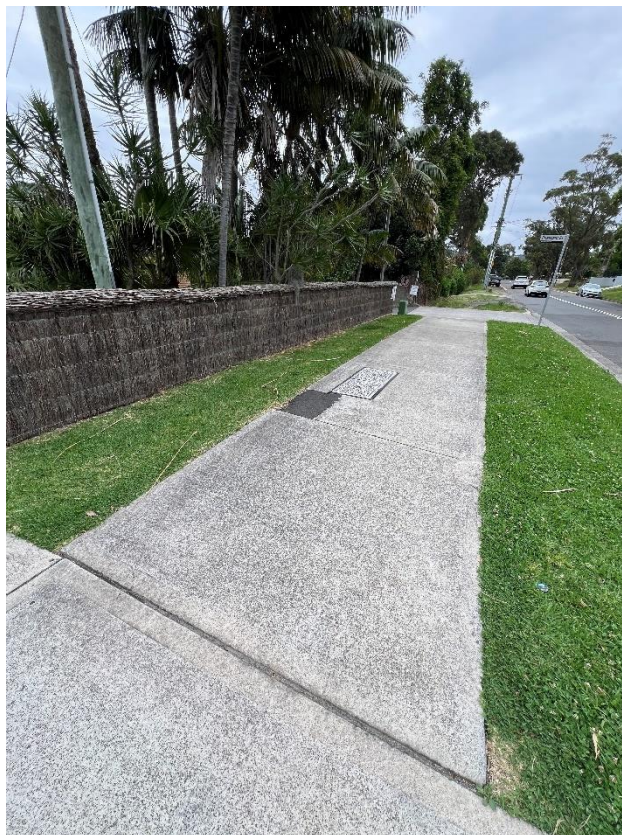
*Figure 38 – General condition of the footpath.*

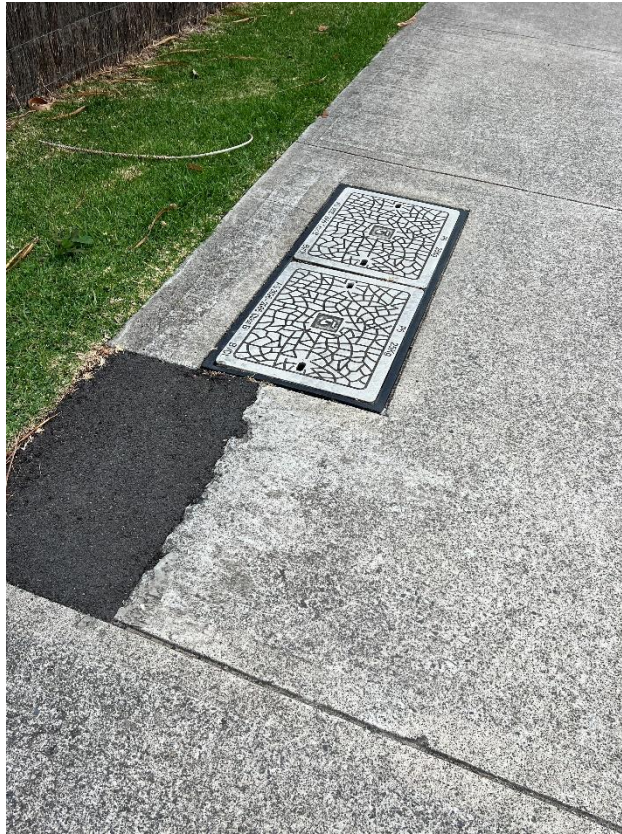
*Figure 39 – General condition of the pit.*

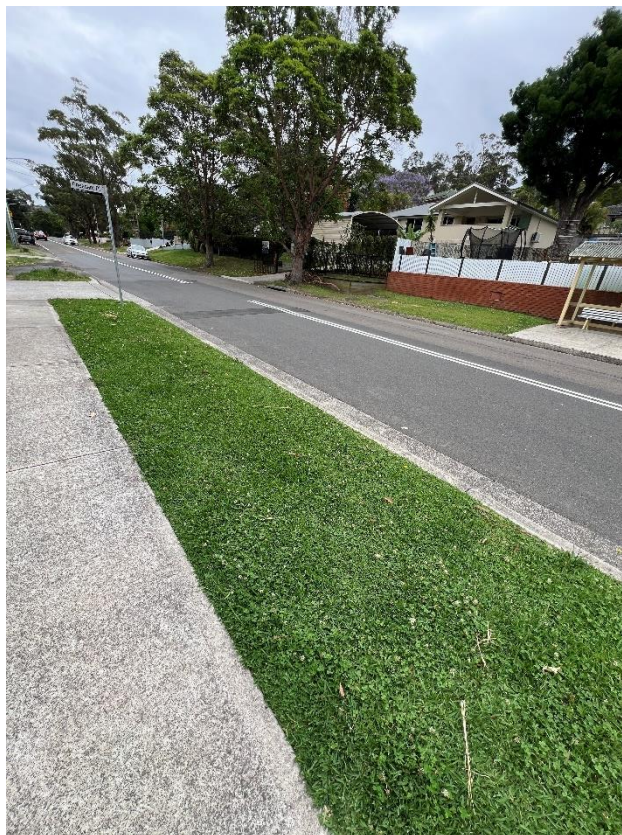
*Figure 40 – General condition of the nature strip.*

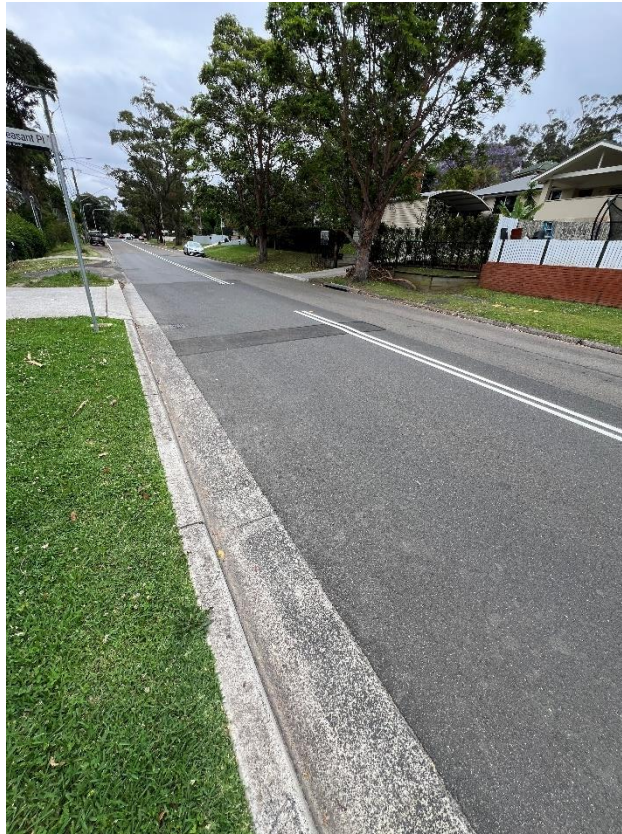
*Figure 41 – General condition of the kerb/road.*

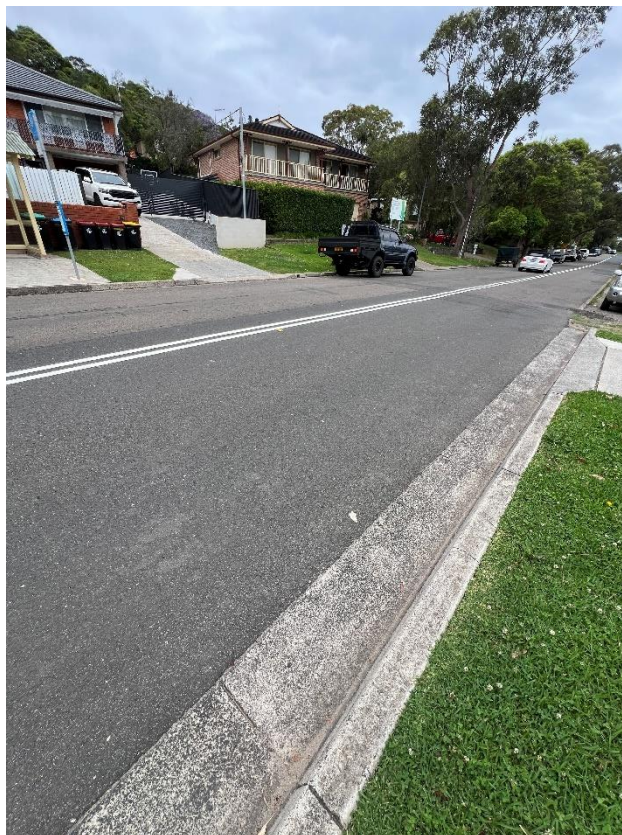
*Figure 42 – General condition of the kerb/road.*

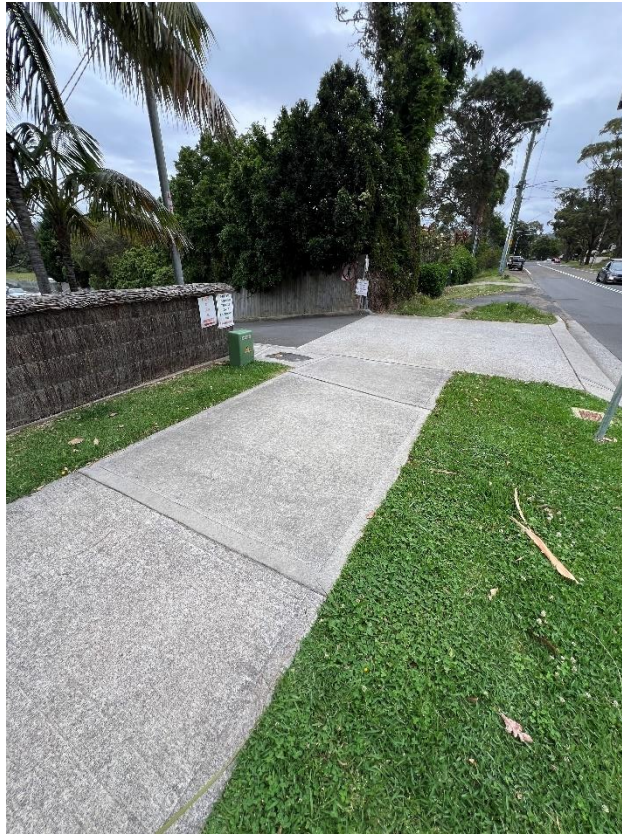
*Figure 43 – General condition of the footpath/nature strip.*

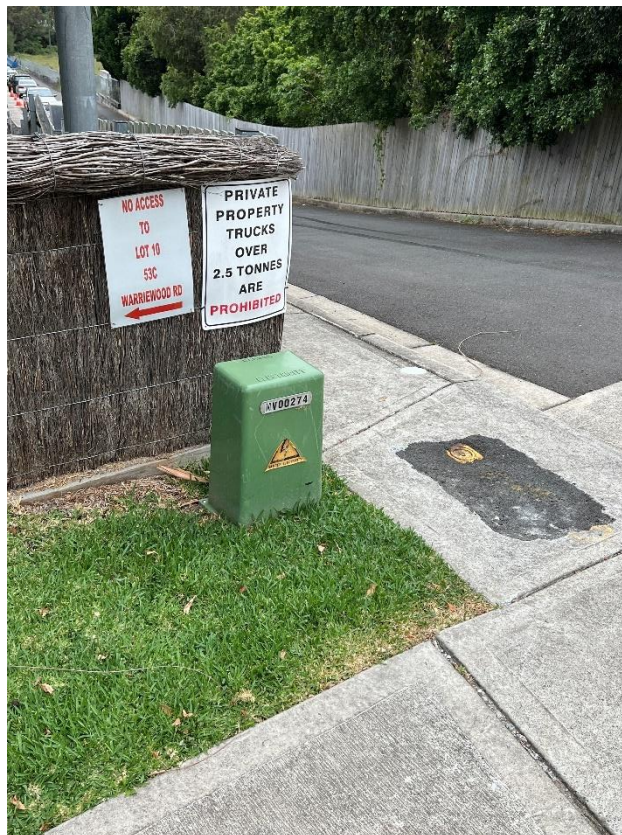
*Figure 44 – General condition of the transformer box.*

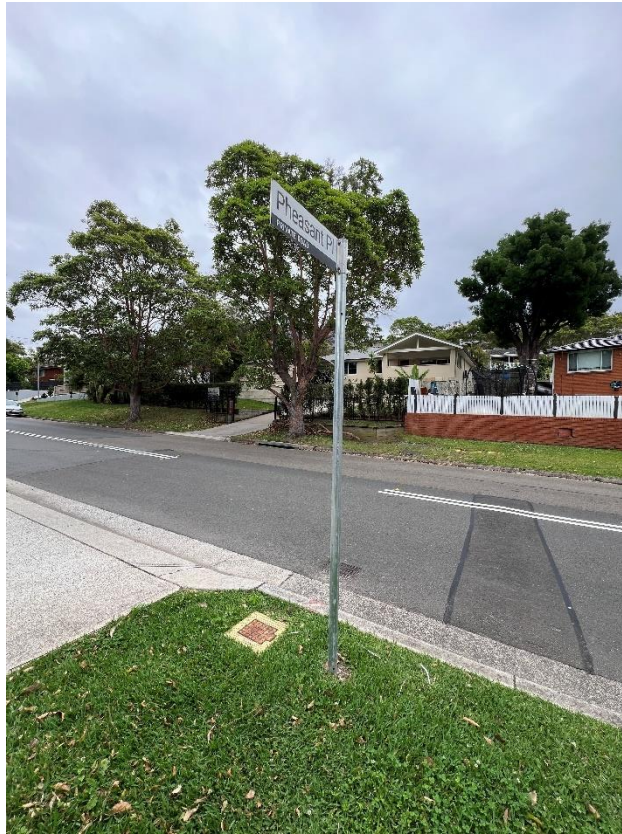
*Figure 45 – General condition of the street signpost.*

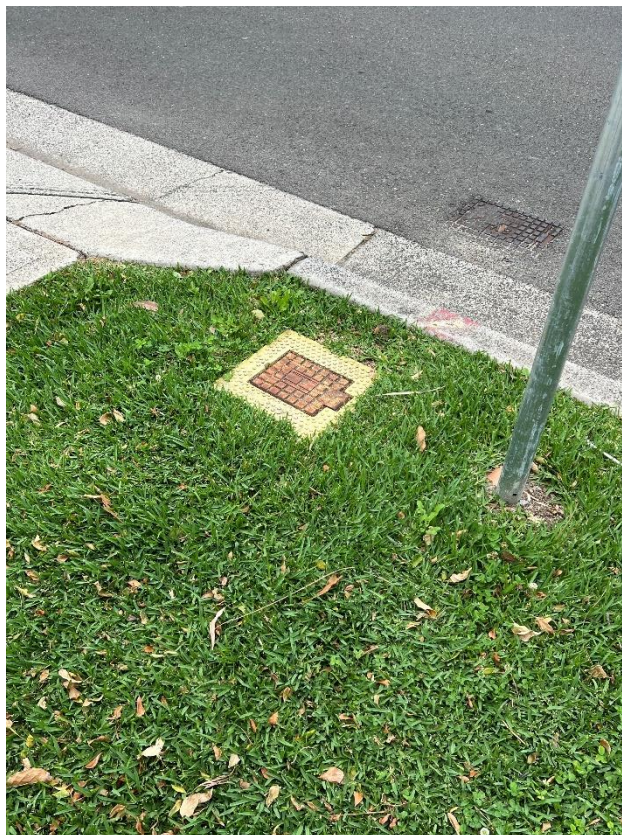
*Figure 46 – General condition of the utility lid.*

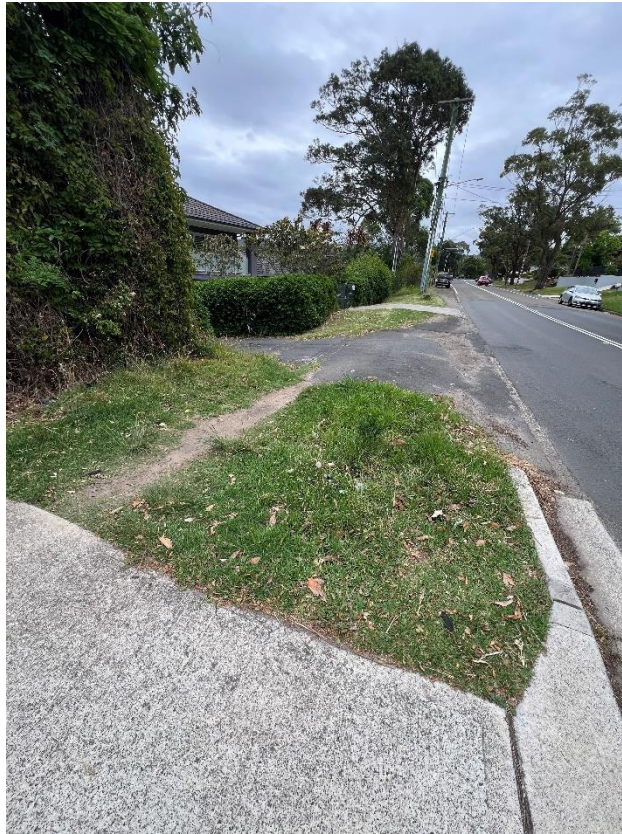
*Figure 47 – General condition of the nature strip.*

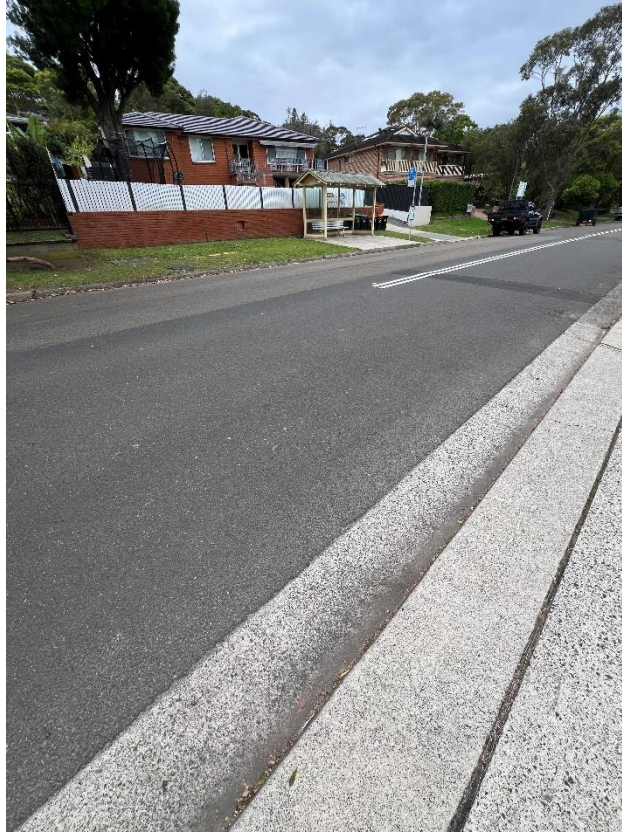
*Figure 49 – General condition of the layback/road.*

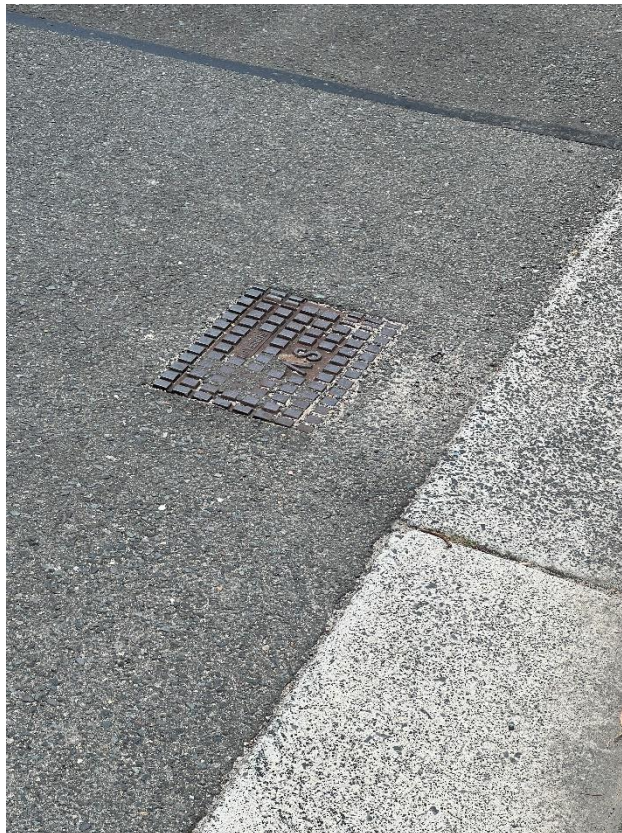
*Figure 50 – General condition of the utility lid.*

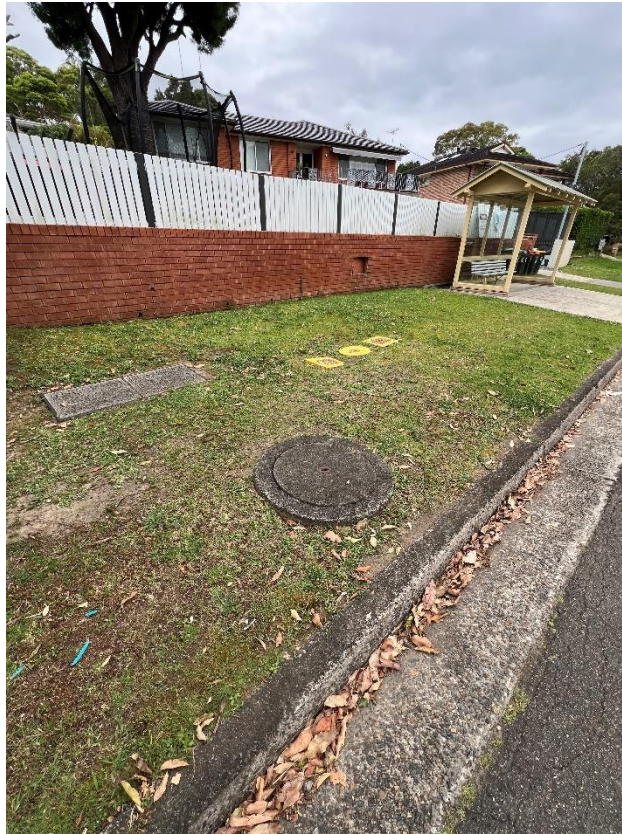
*Figure 51 – General condition of the pit.*
