# DILAPIDATION REPORT

**Warriewood Road, Warriewood**

**Prepared by: Rezoning Pty Ltd t/as Effective Building & Consultancy**

The inspection was carried out on 11 November 2024.

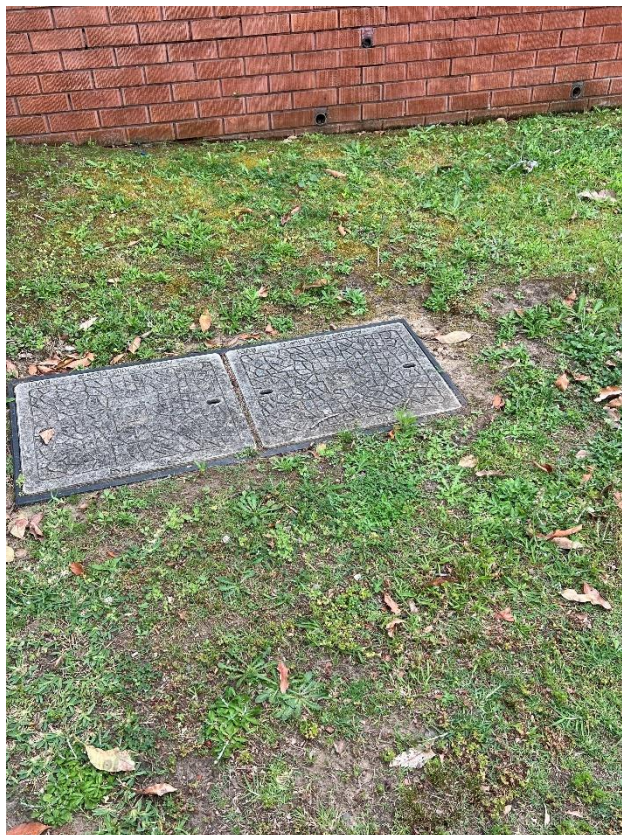
*Figure 52 – General condition of the pit.*

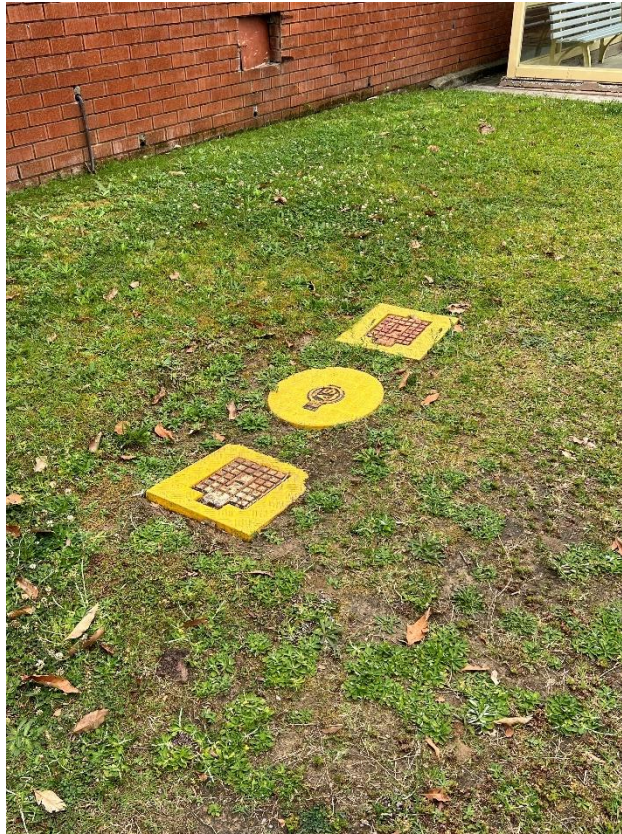
*Figure 53 – General condition of the utility lid.*

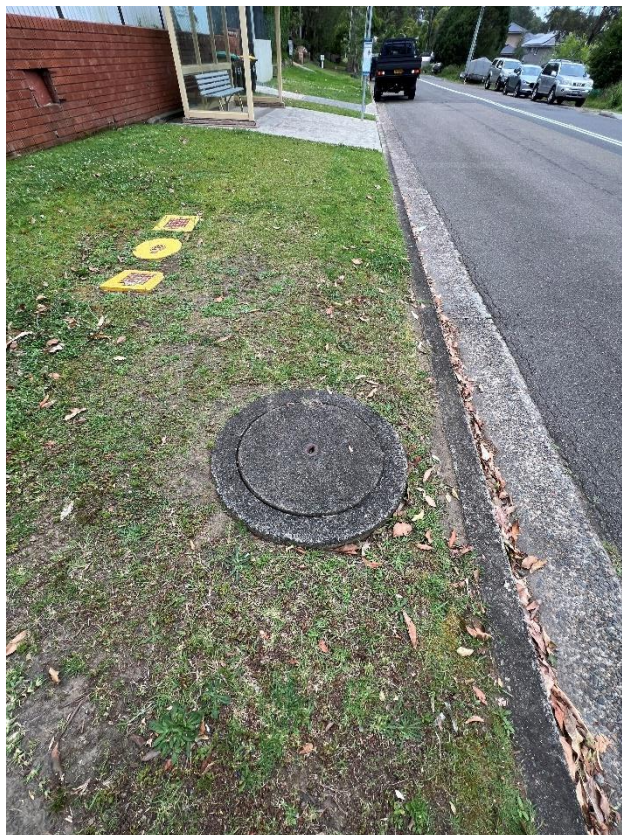
*Figure 54 – General condition of the pit.*

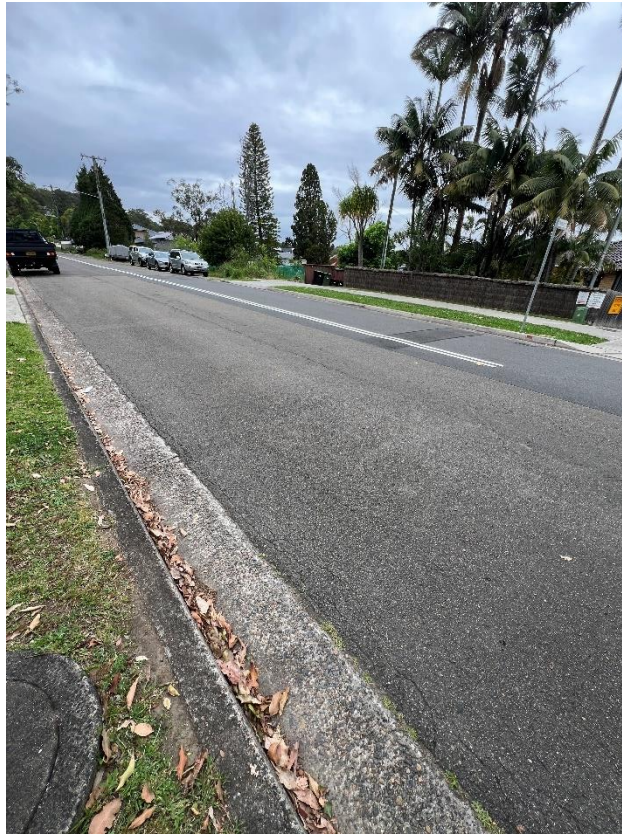
*Figure 55 – General condition of the kerb/road.*

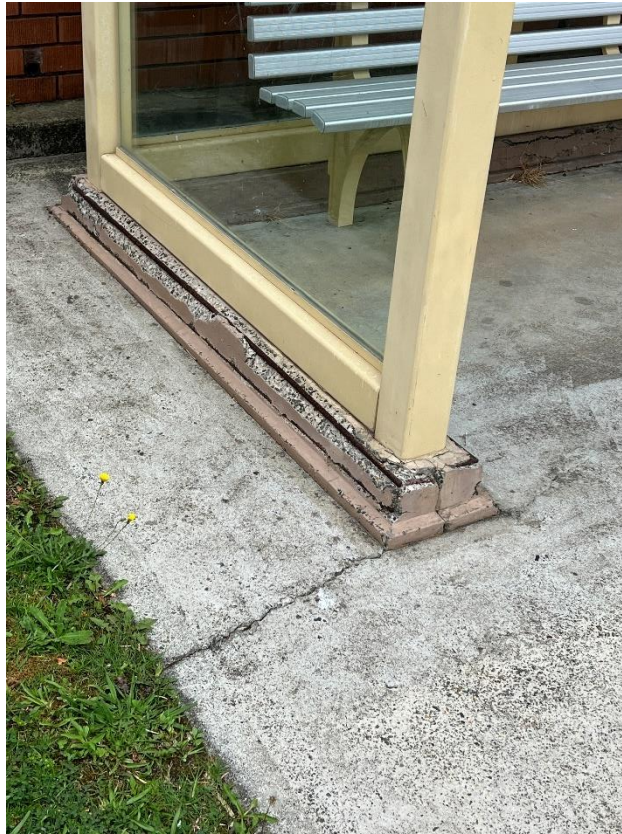
*Figure 59 – Crack is evident to the concrete at shed area.*

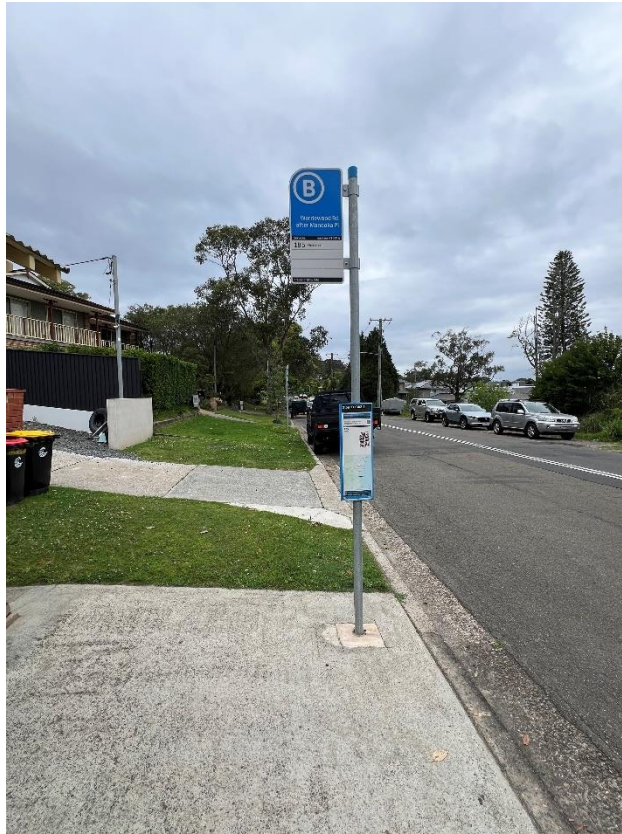
*Figure 61 – General condition of the traffic signpost.*

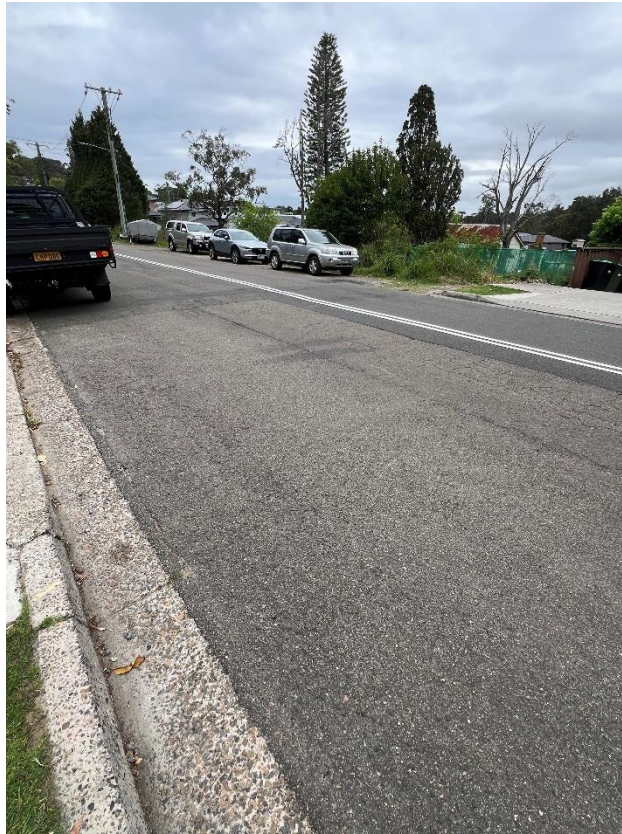
*Figure 63 – General condition of the kerb/road.*

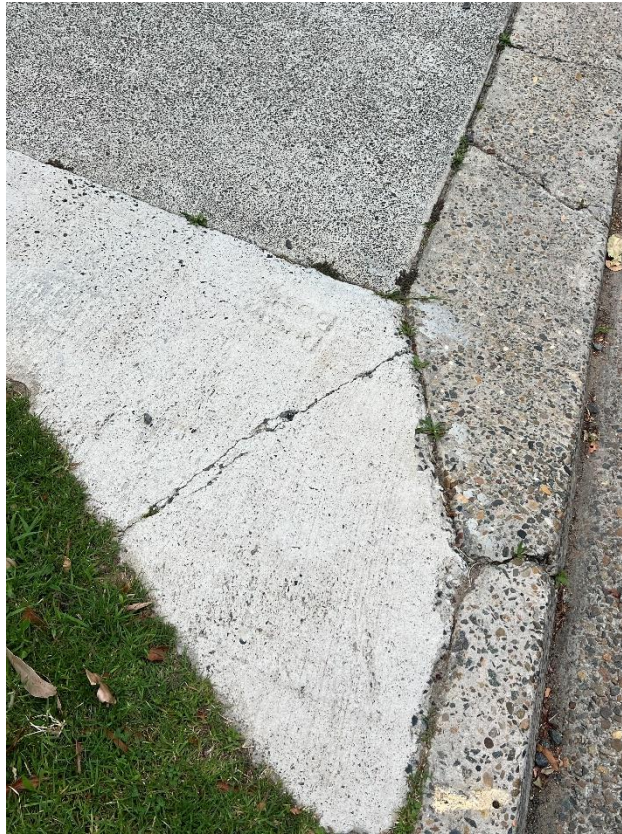
*Figure 65 – Crack is evident to the layback.*

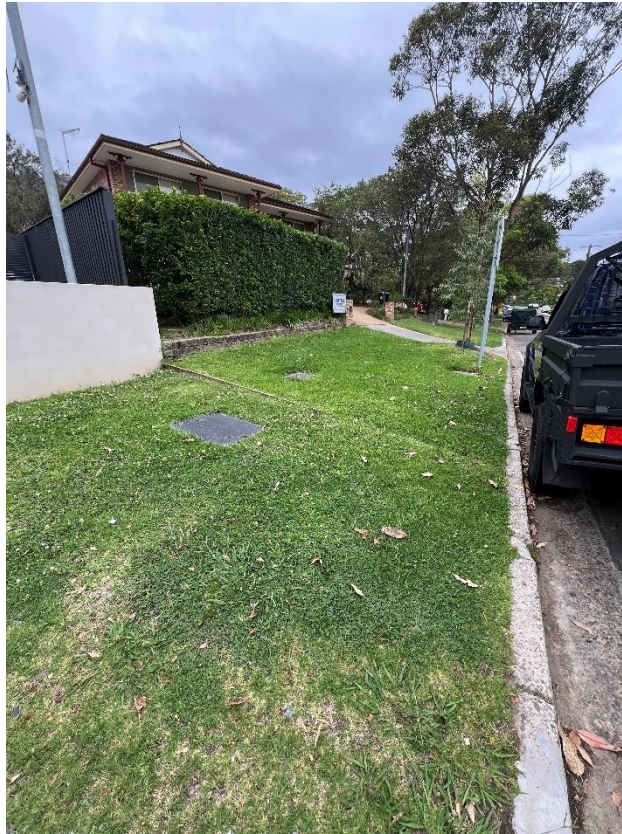
*Figure 67 – General condition of the nature strip.*

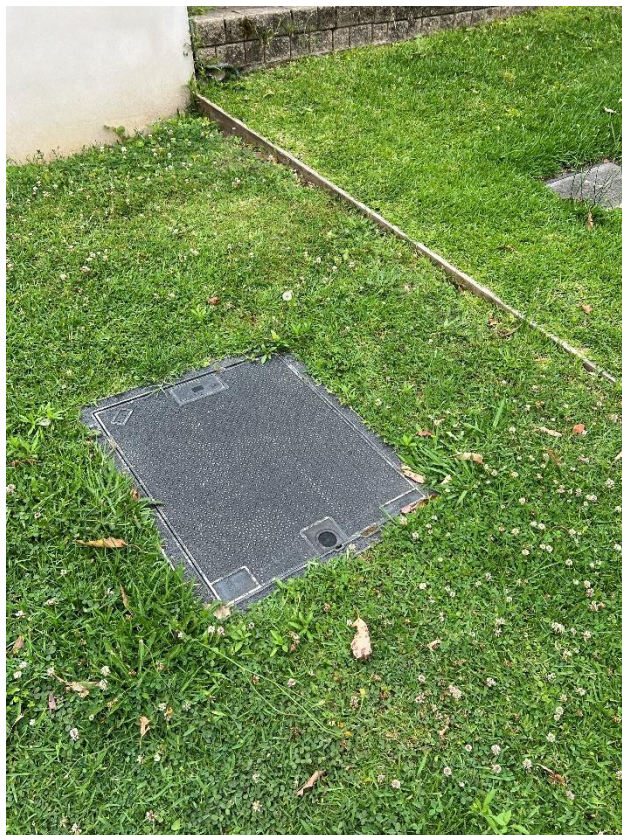
*Figure 68 – General condition of the pit.*

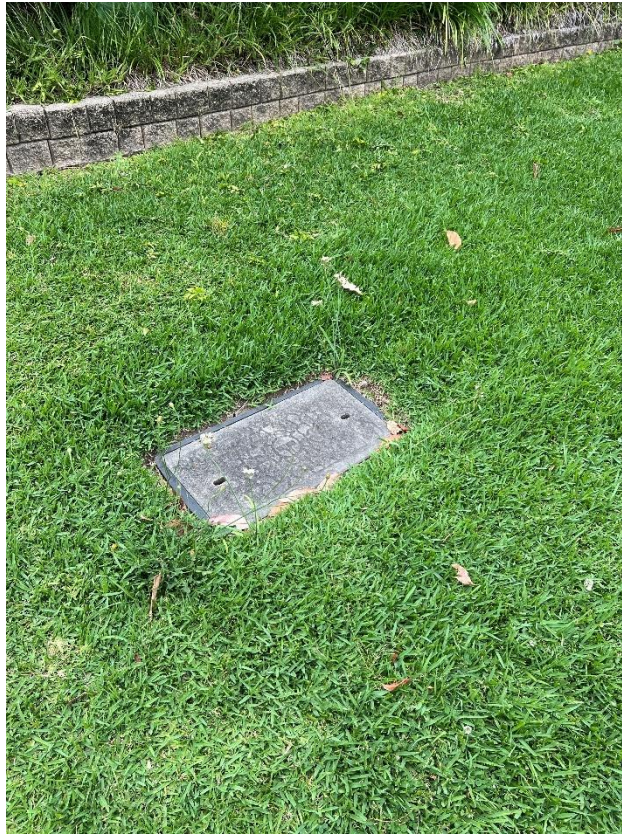
*Figure 69 – General condition of the pit.*

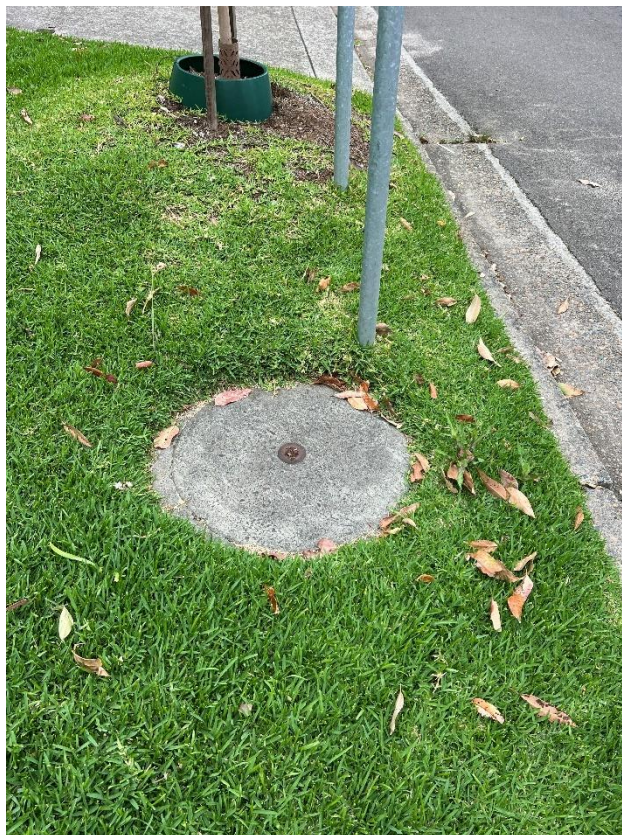
*Figure 70 – General condition of the pit.*

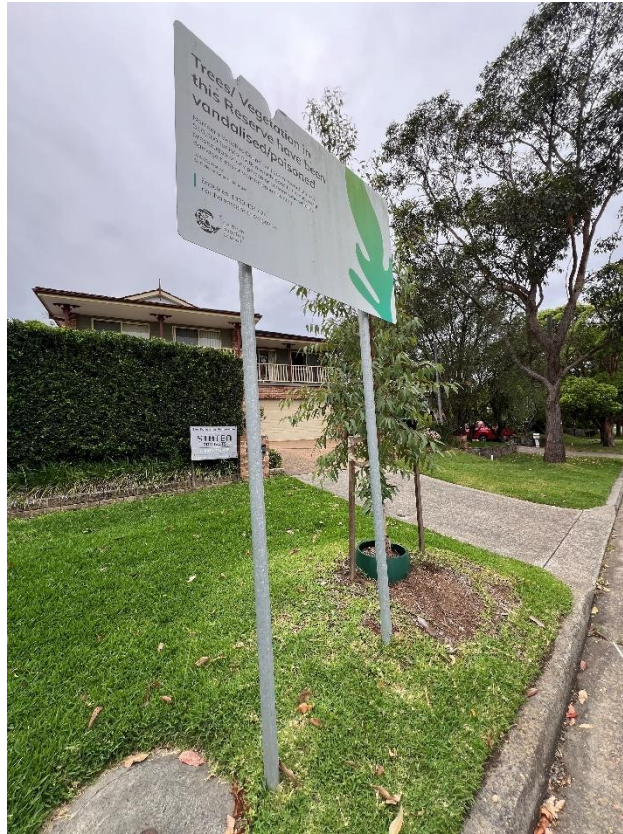
*Figure 71 – General condition of the street signpost.*

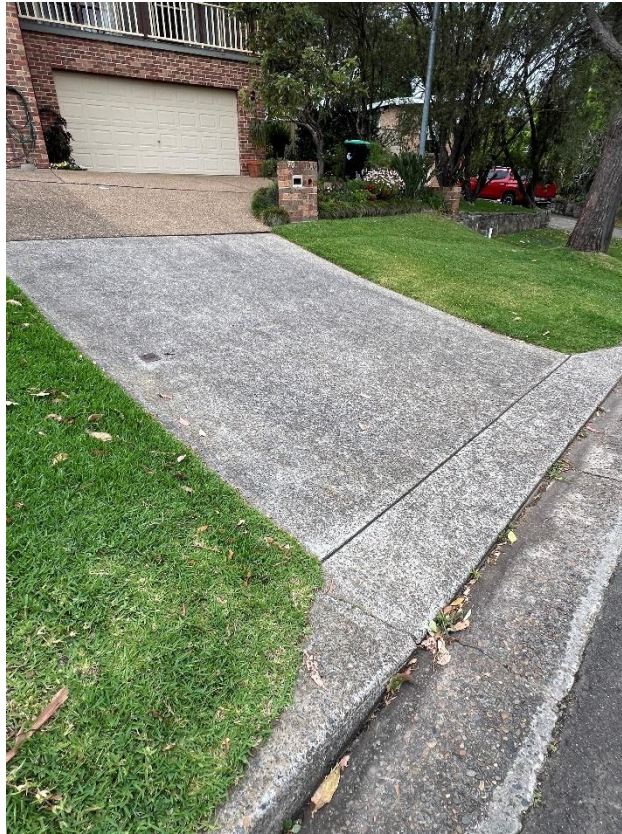
*Figure 73 – Crack is evident to the layback.*

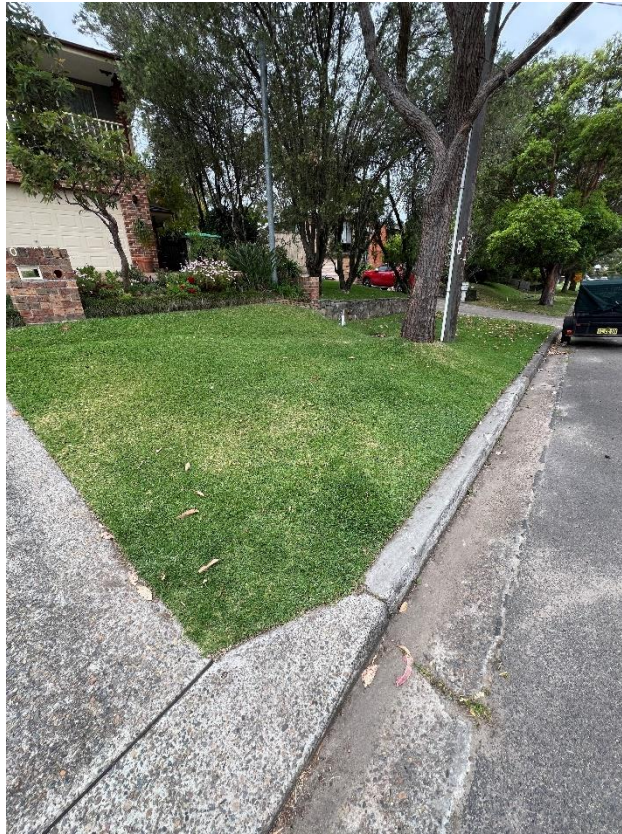
*Figure 75 – General condition of the nature strip.*

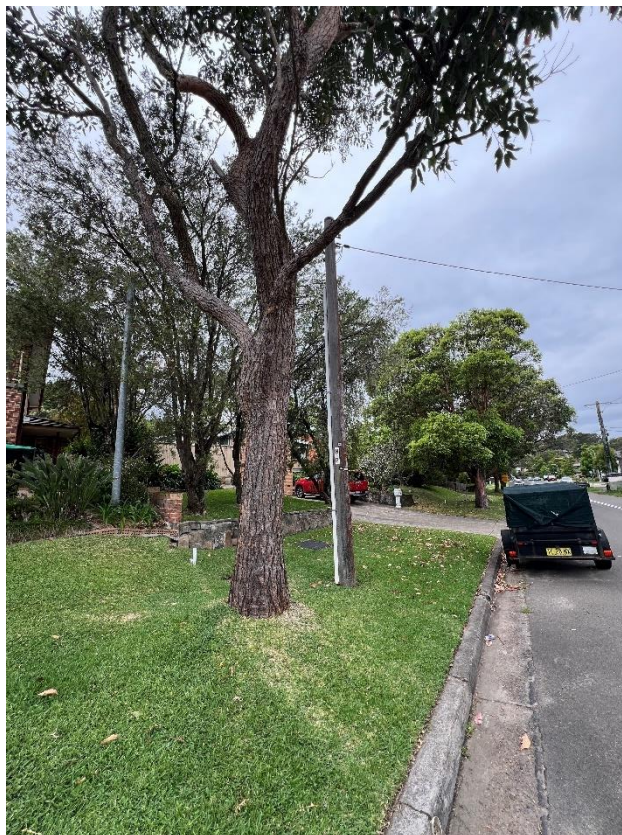
*Figure 76 – General condition of the tree.*

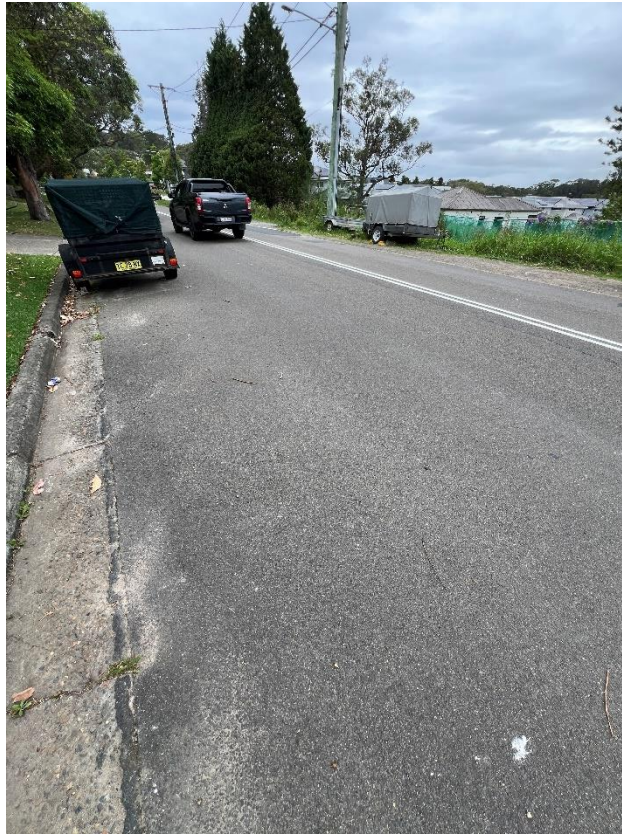
*Figure 77 – General condition of the road.*

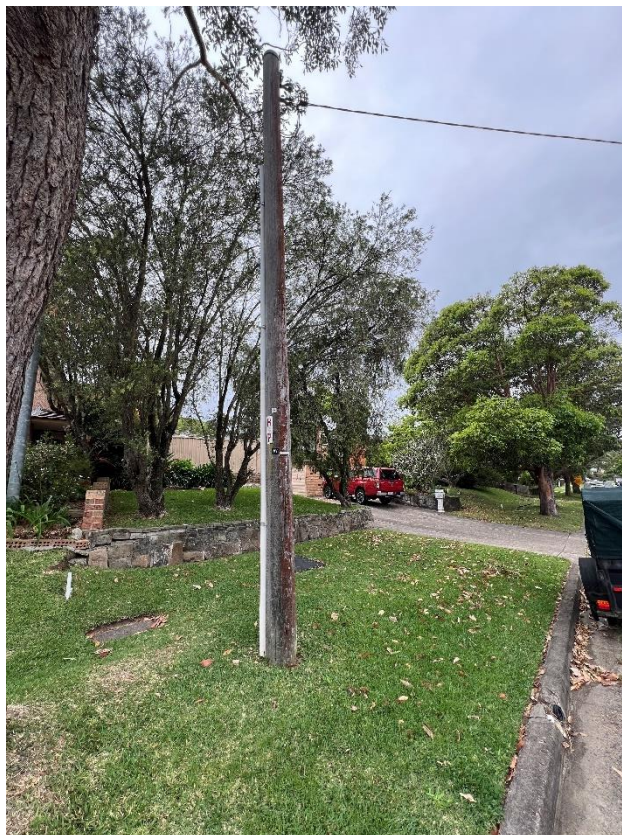
*Figure 78 – General condition of the electrical post.*

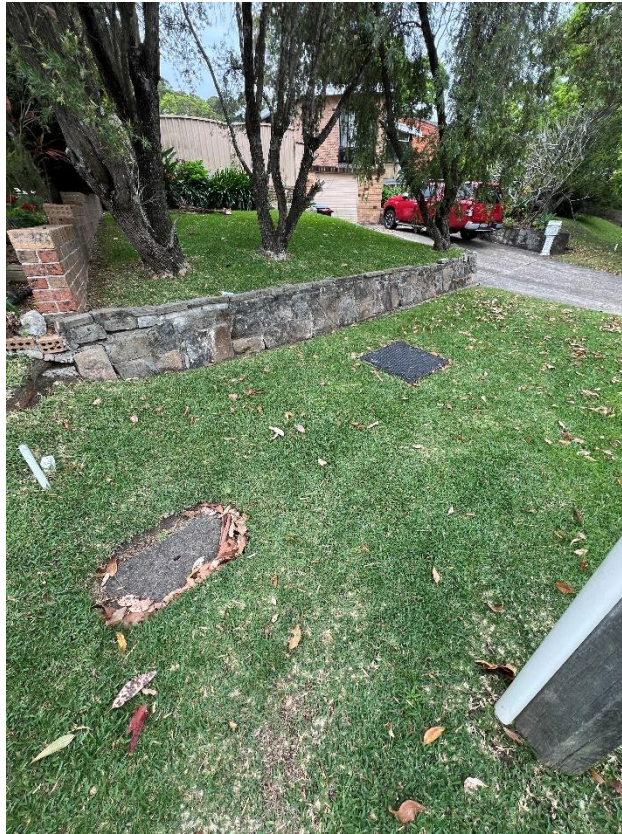
*Figure 79 – General condition of the pit.*

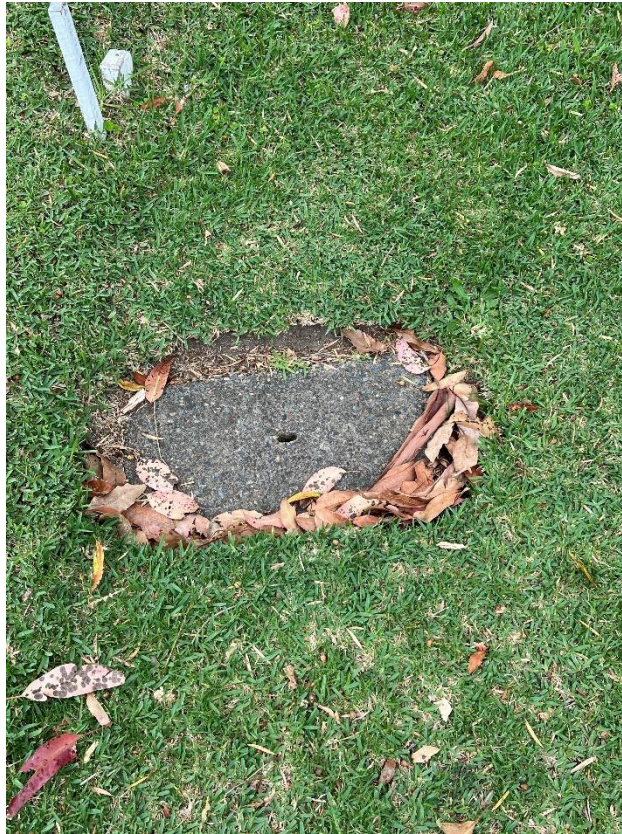
*Figure 81 – General condition of the pit.*

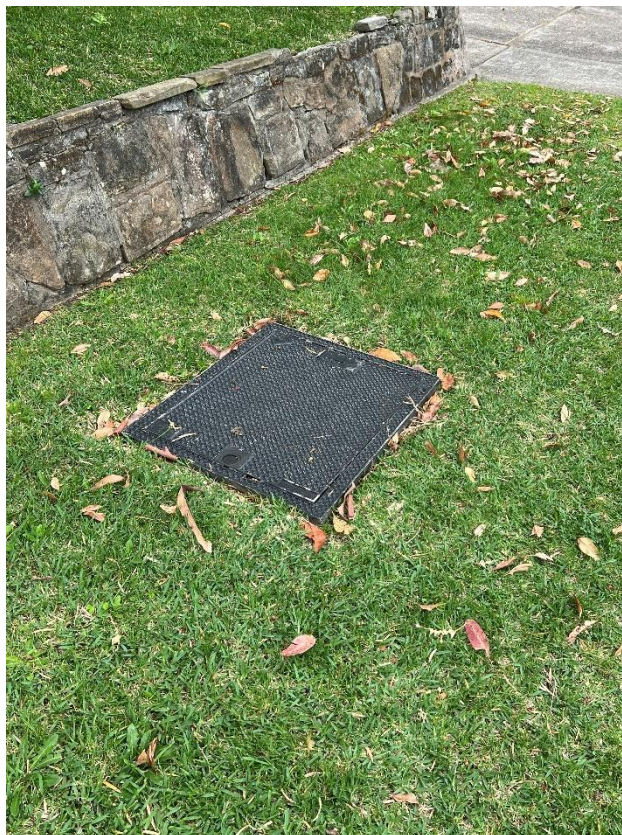
*Figure 82 – General condition of the pit.*

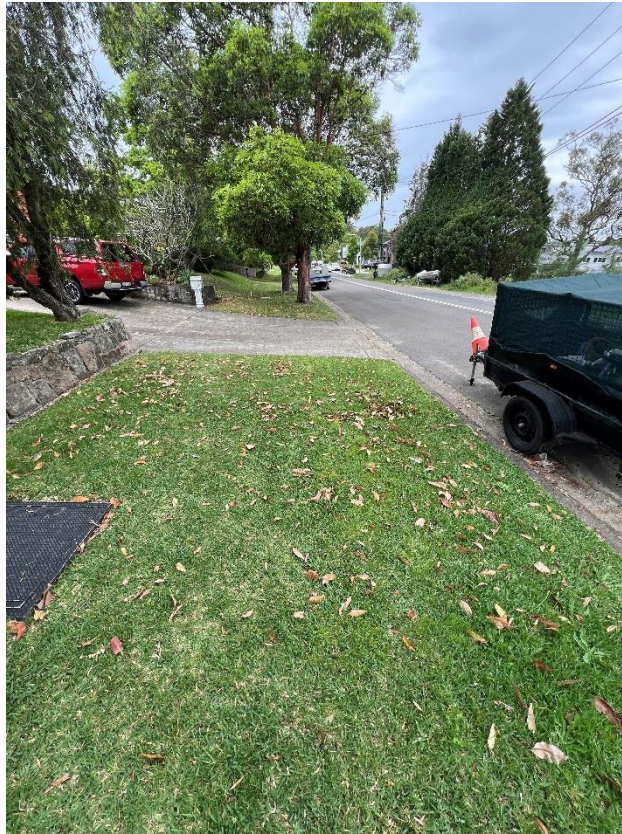
*Figure 83 – General condition of the nature strip.*

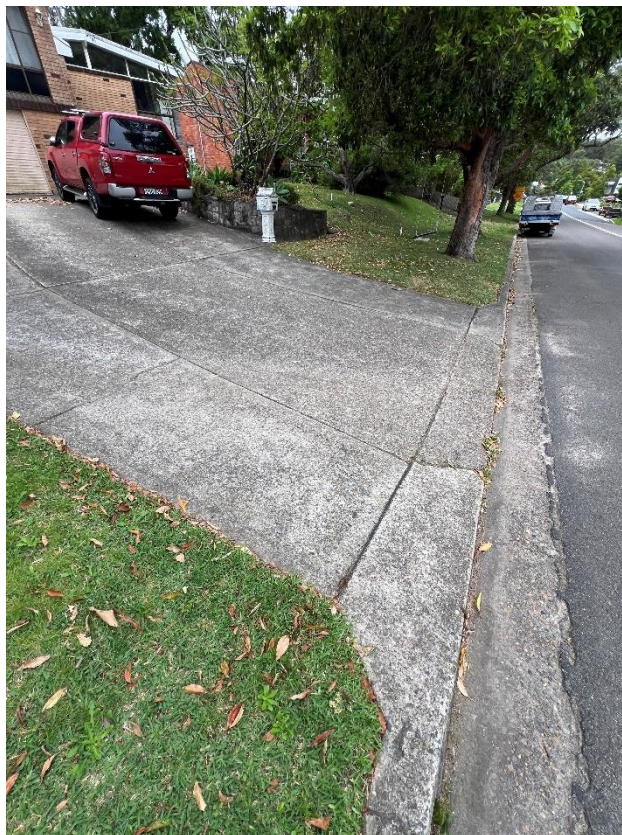
*Figure 84 – General condition of the driveway.*

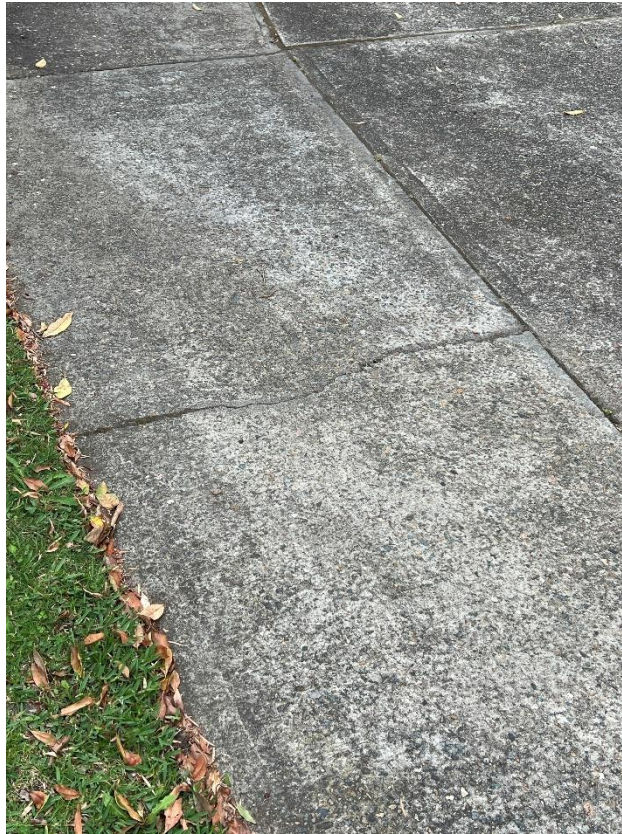
*Figure 85 – Crack is evident to the driveway.*

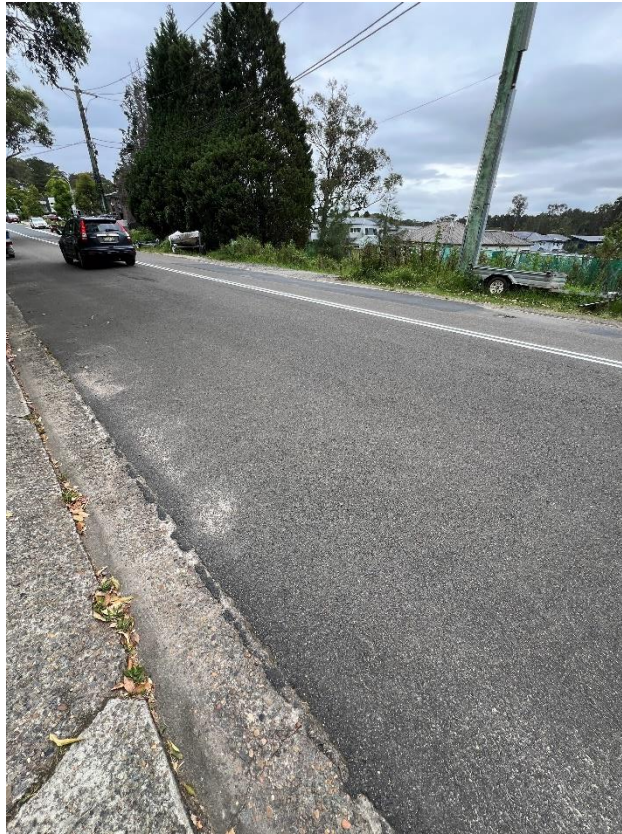
*Figure 87 – General condition of the road.*

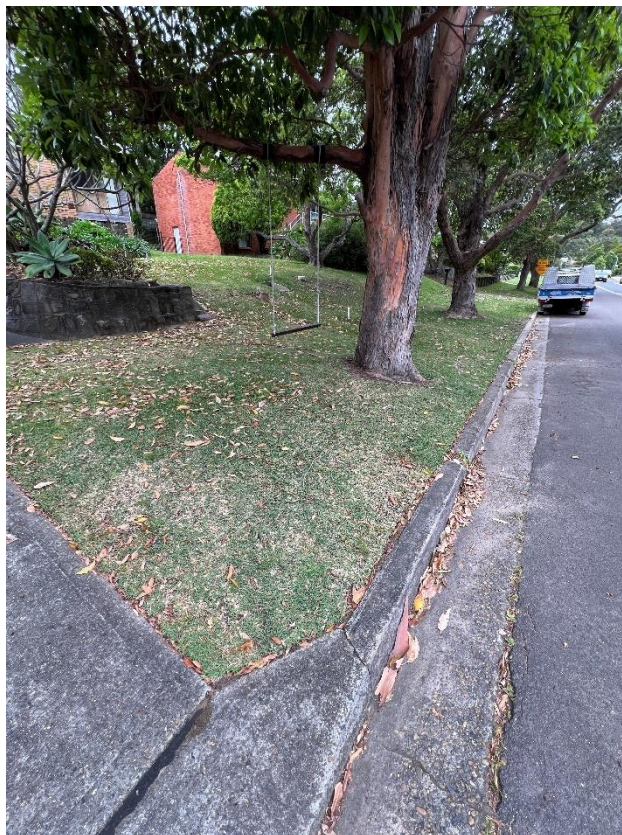
*Figure 88 – General condition of the nature strip.*

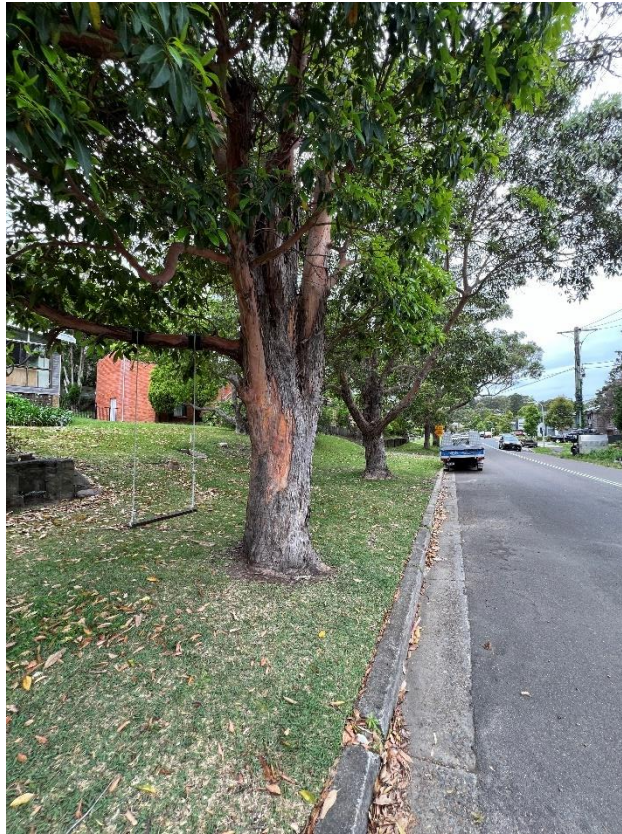
*Figure 89 – General condition of the tree.*

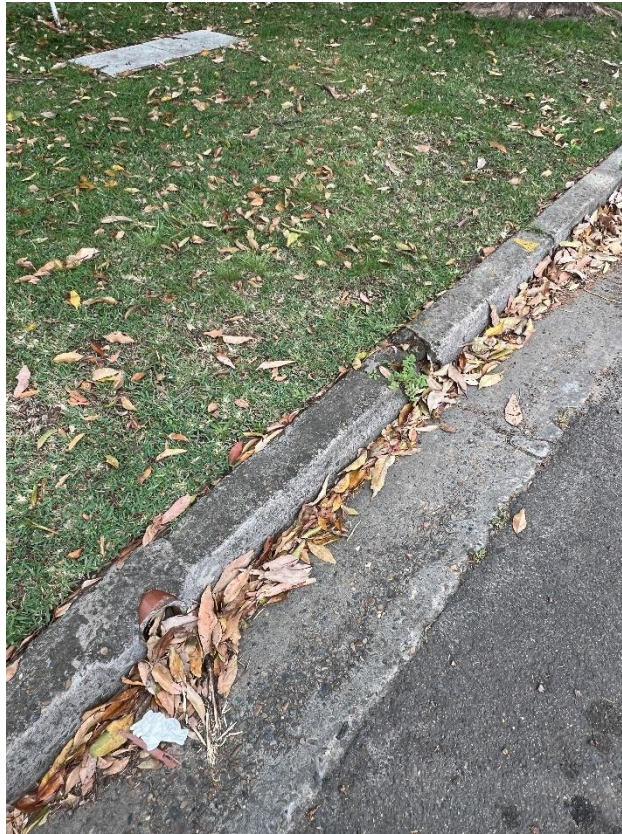
*Figure 91 – Crack is evident to the kerb.*

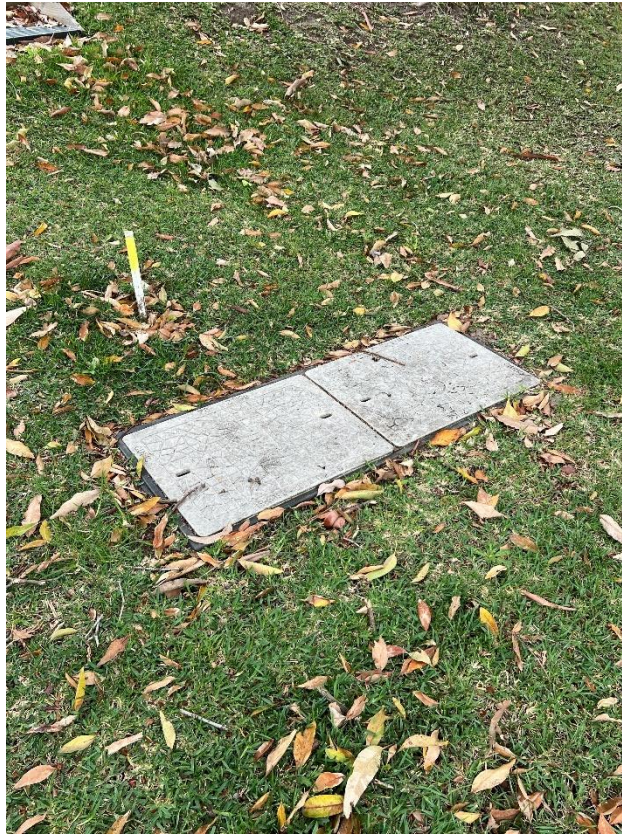
*Figure 93 – General condition of the pit.*

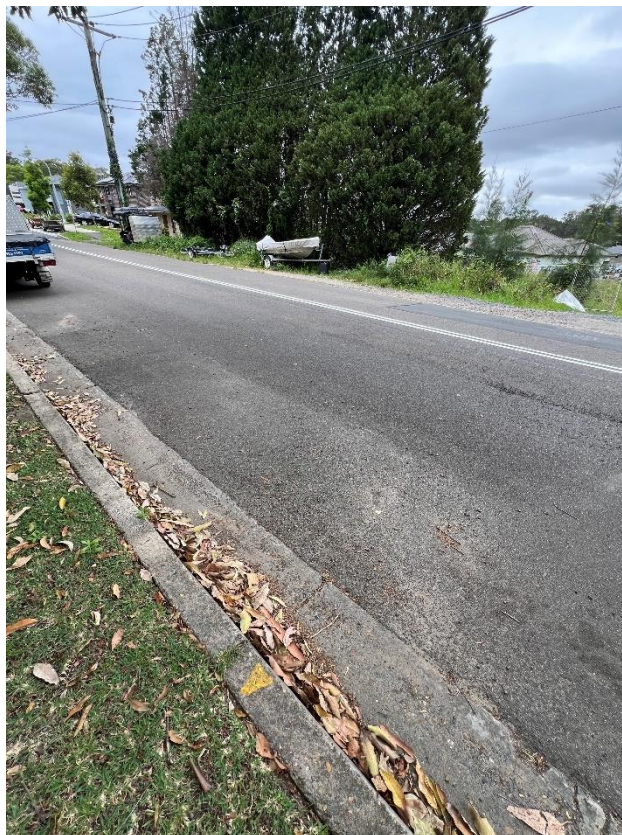
*Figure 94 – General condition of the kerb/road.*

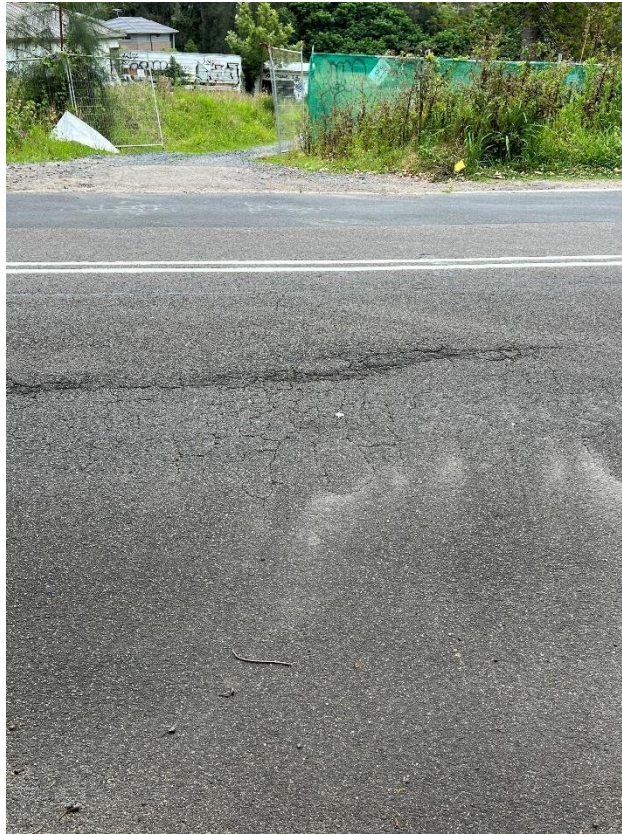
*Figure 95 – Crack is evident to the road.*

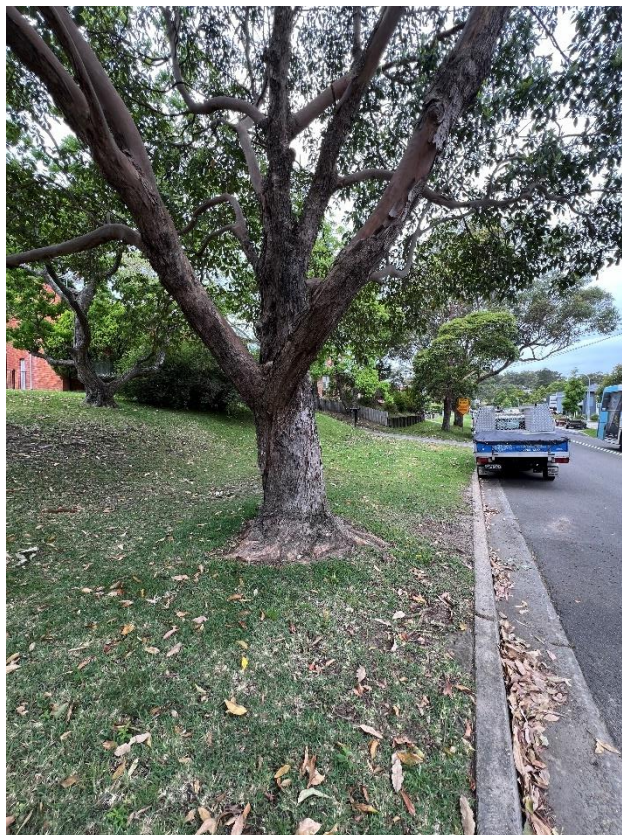
*Figure 96 – General condition of the tree.*

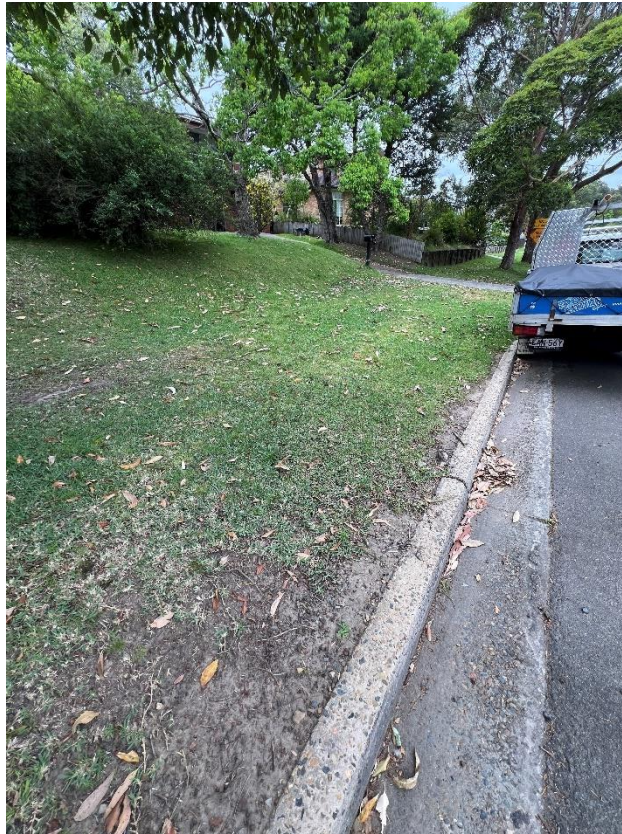
*Figure 97 – General condition of the kerb/nature strip.*

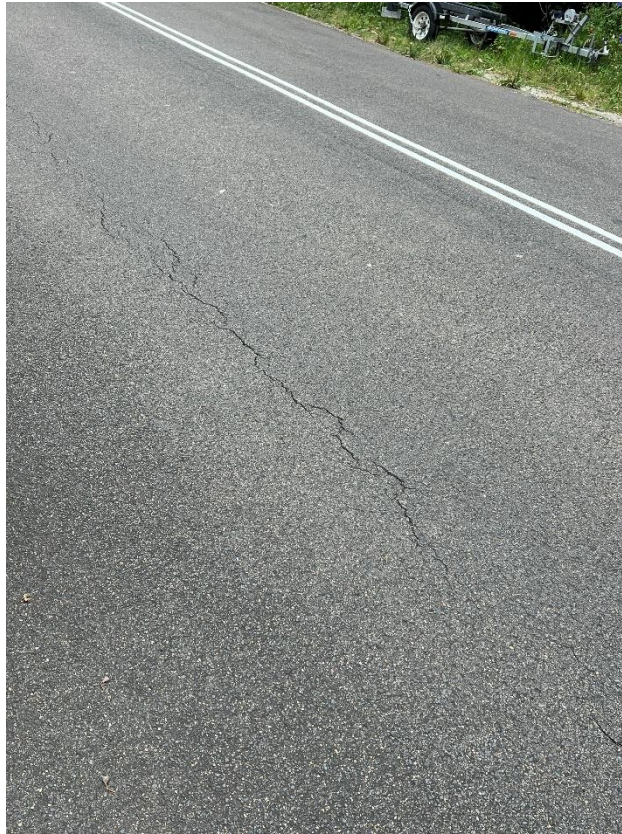
*Figure 99 – Crack is evident to the road.*

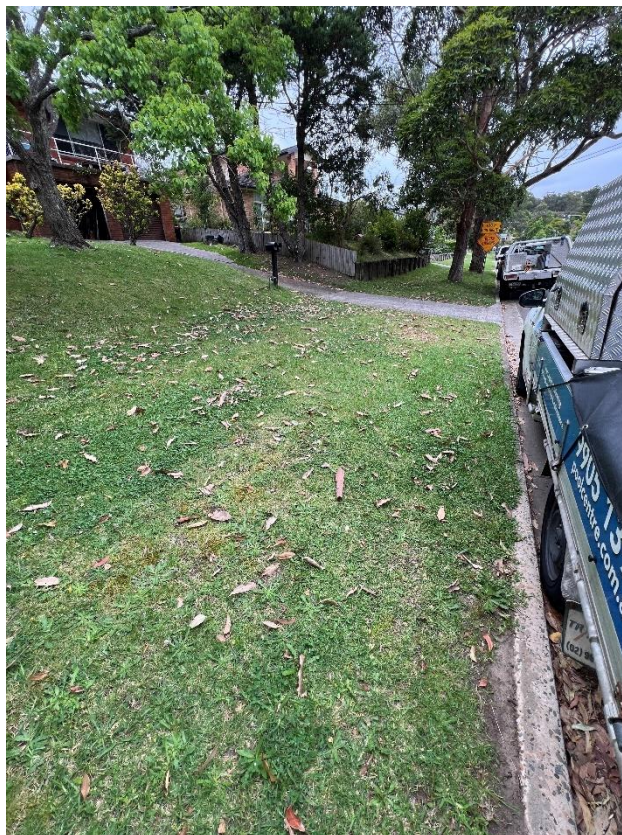
*Figure 100 – General condition of the nature strip.*

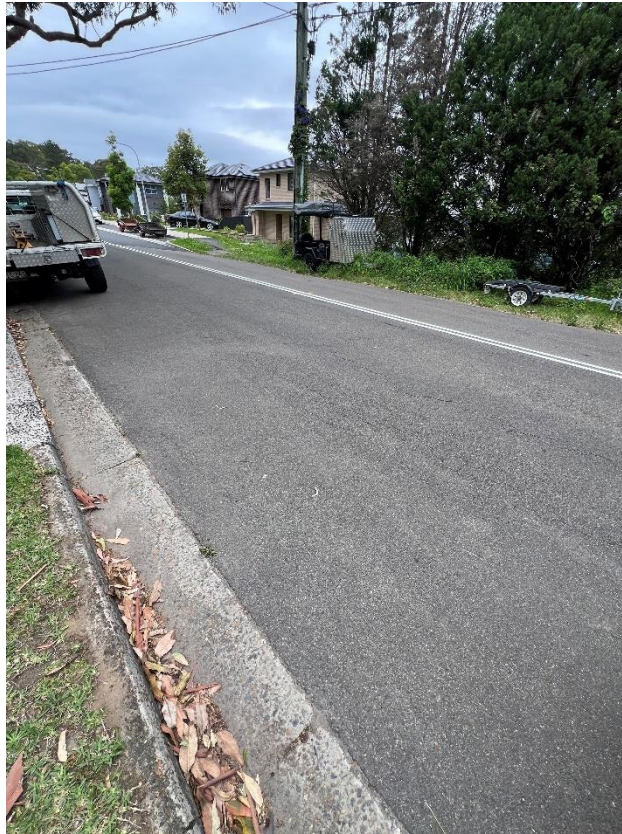
*Figure 101 – General condition of the kerb/road.*

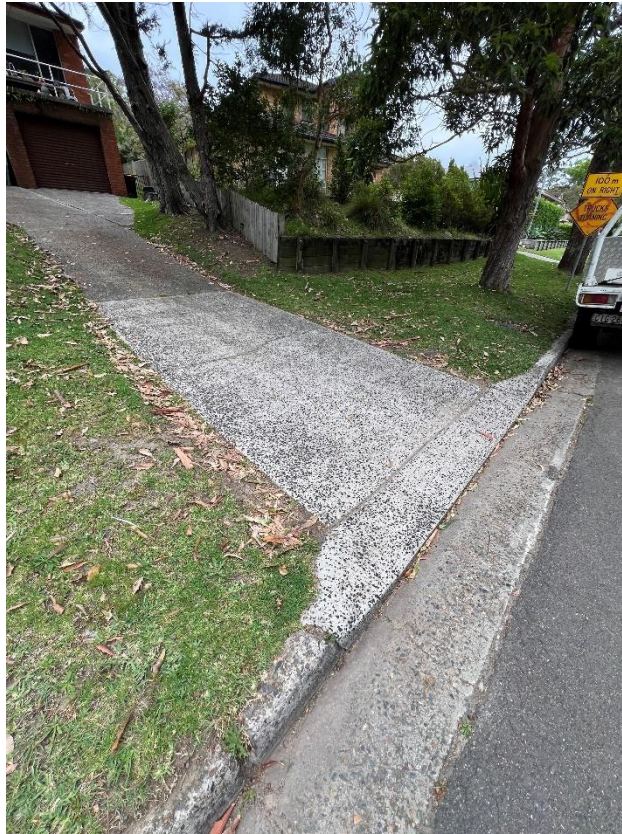
*Figure 103 – General condition of the driveway.*

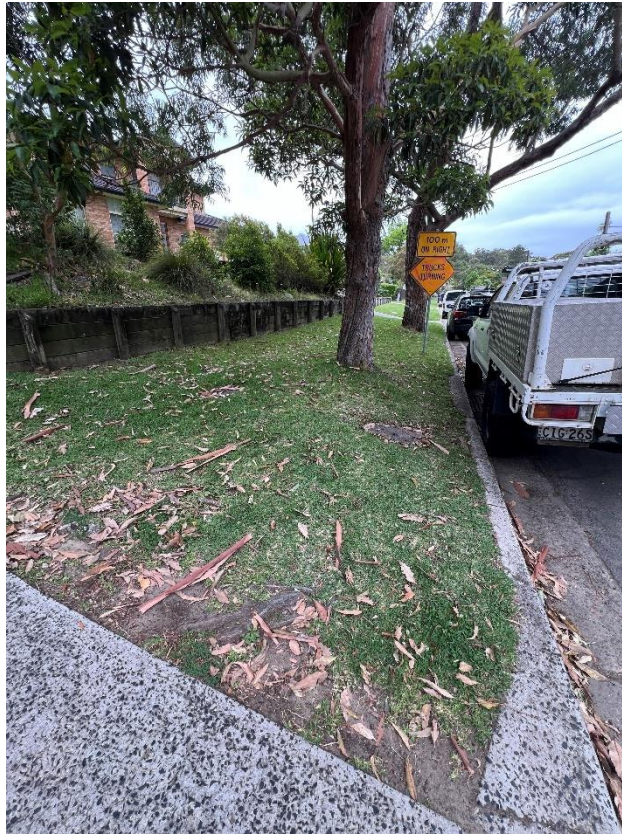
*Figure 105 – General condition of the nature strip.*

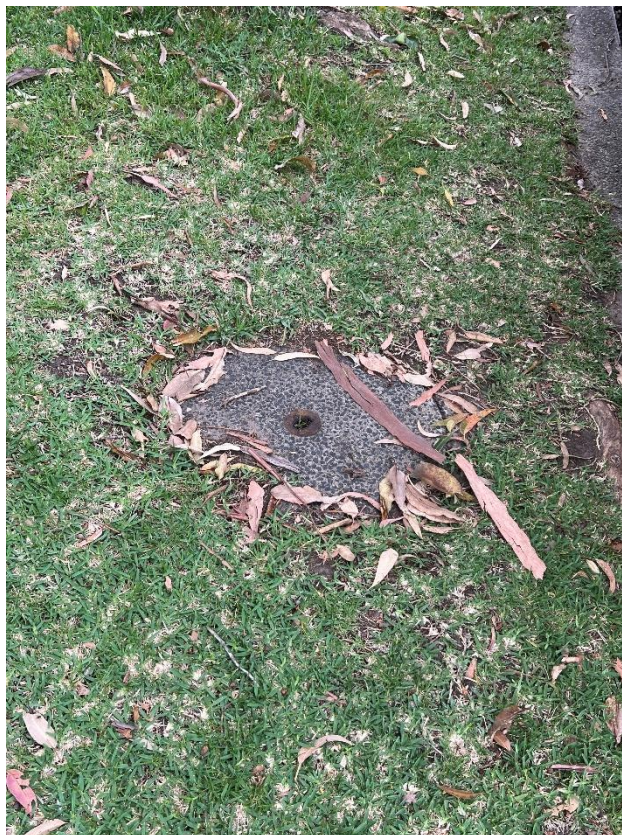
*Figure 106 – General condition of the pit.*

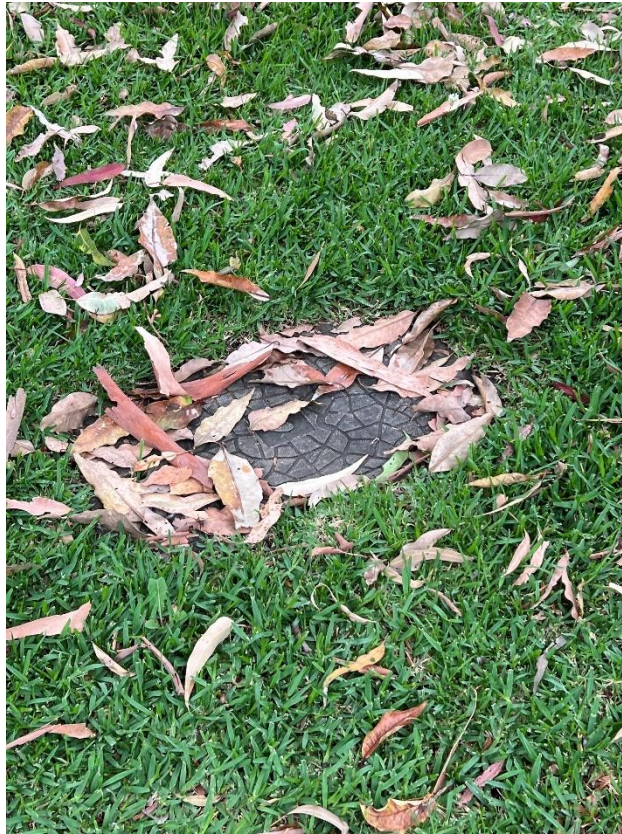
*Figure 107 – General condition of the pit.*

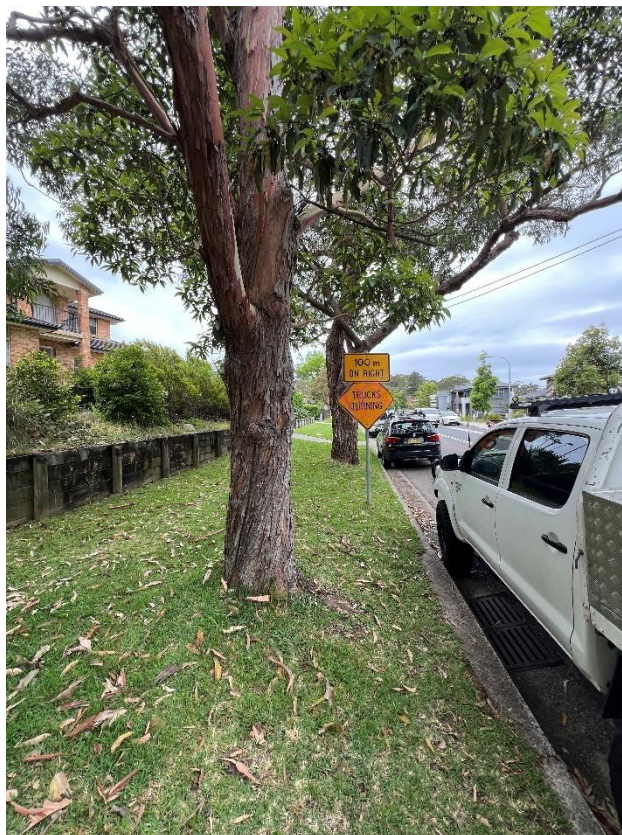
*Figure 108 – General condition of the tree.*

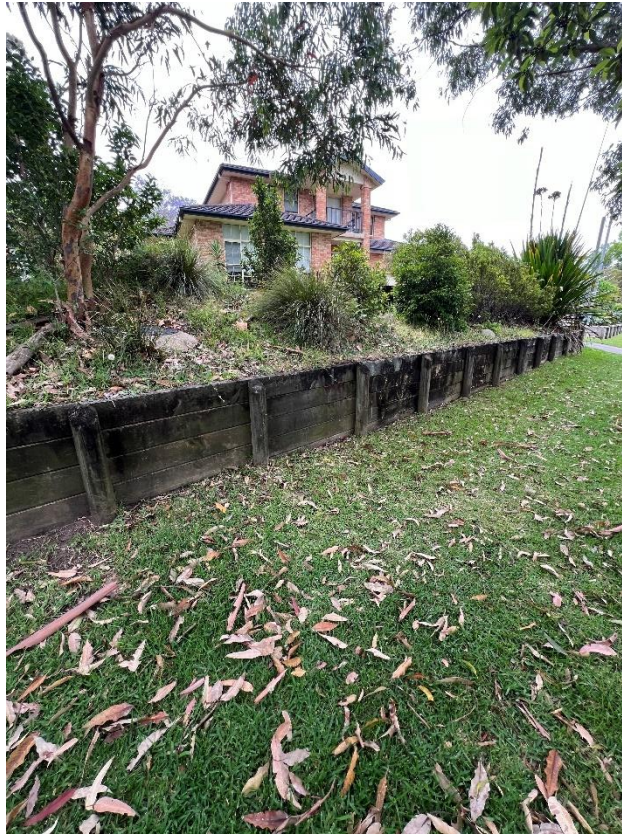
*Figure 109 – General condition of the retaining wall.*

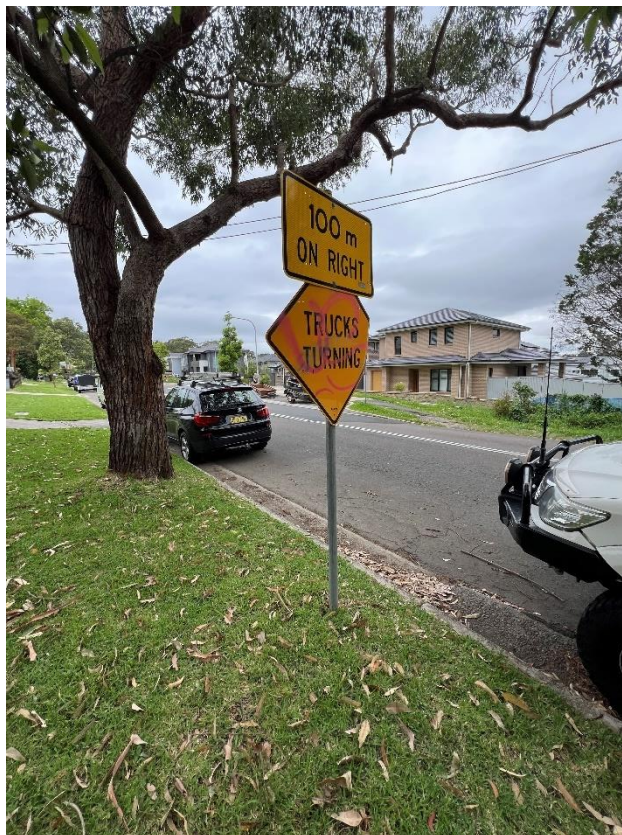
*Figure 110 – General condition of the traffic signpost.*
