# DILAPIDATION REPORT

**Warriewood Road, Warriewood**

**Prepared by: Rezoning Pty Ltd t/as Effective Building & Consultancy**

The inspection was carried out on 11 November 2024.

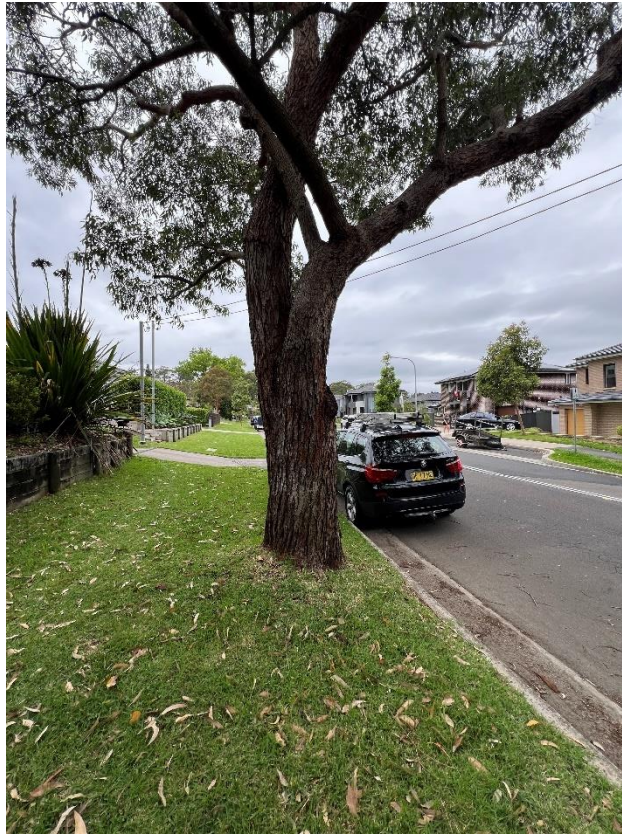
*Figure 111 – General condition of the tree.*

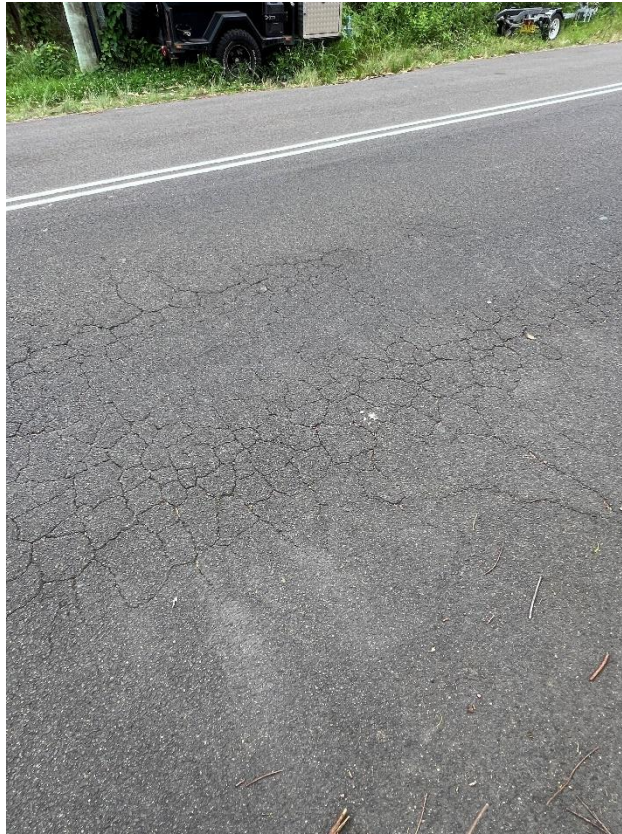
*Figure 113 – Crack is evident to the road.*

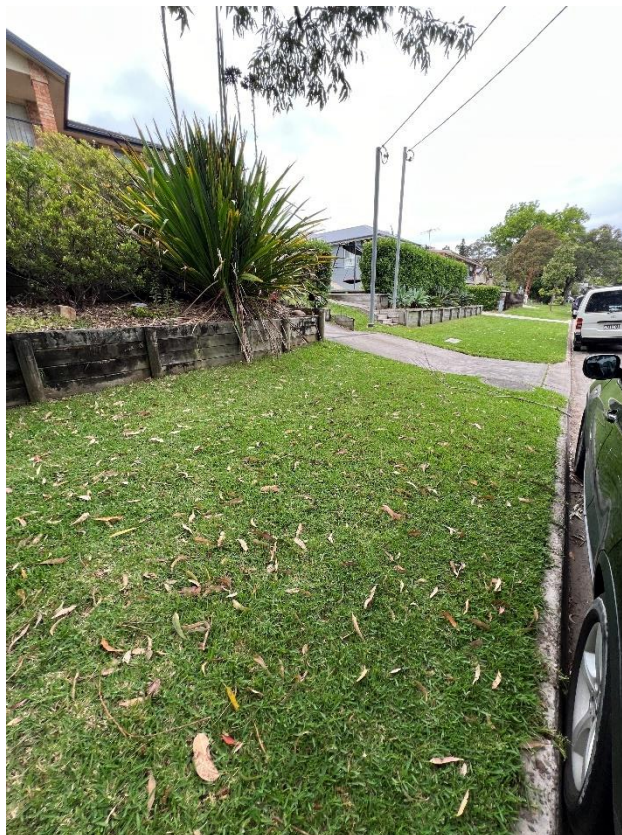
*Figure 114 – General condition of the nature strip.*

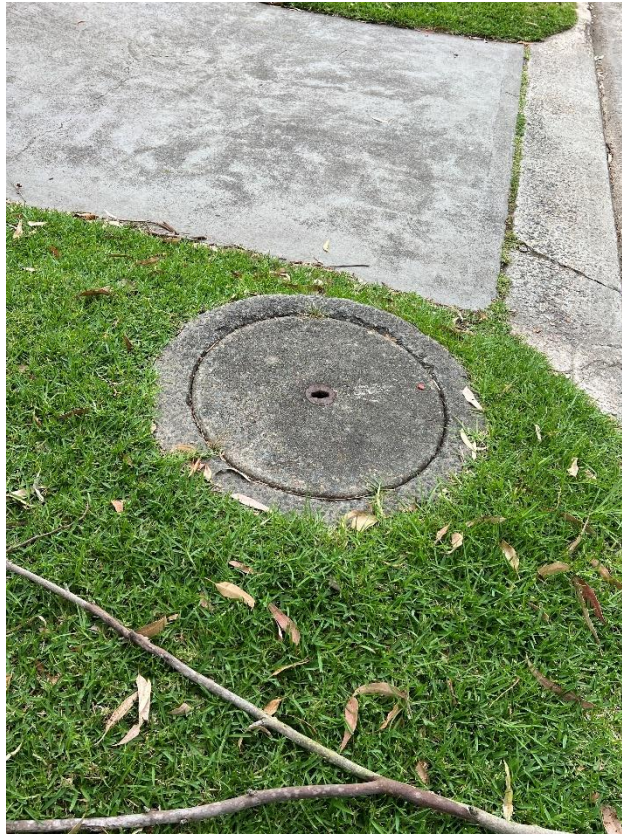
*Figure 115 – General condition of the pit.*

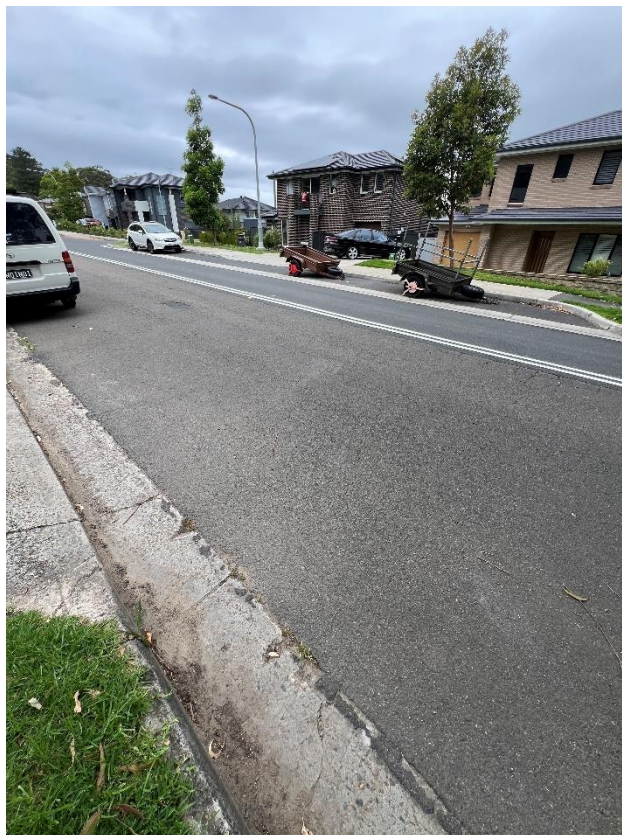
*Figure 116 – General condition of the kerb/road.*

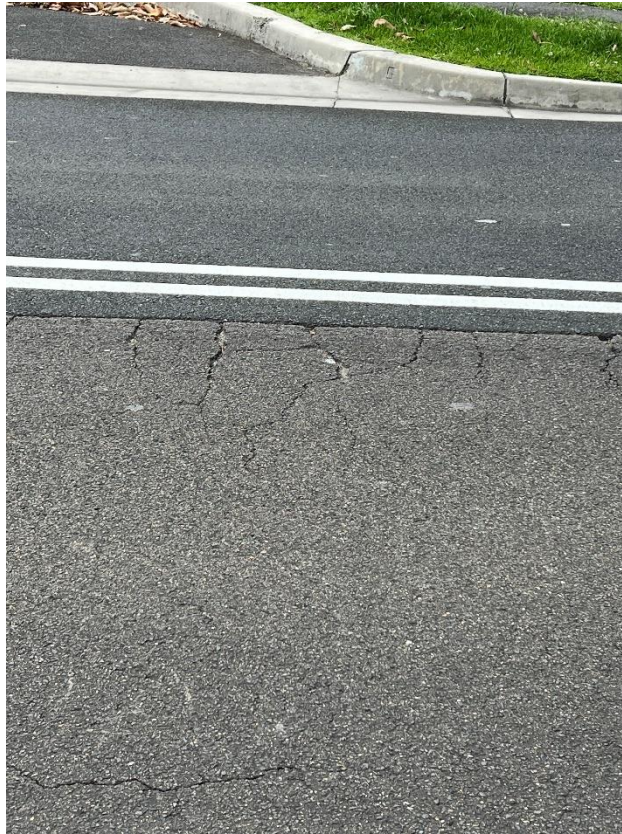
*Figure 117 – Crack is evident to the road.*

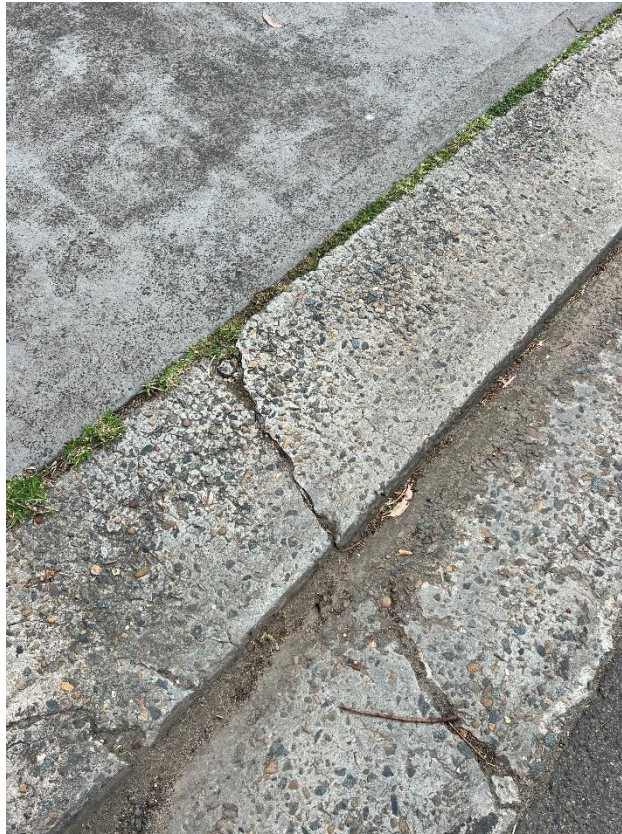
*Figure 119 – Crack is evident to the layback.*

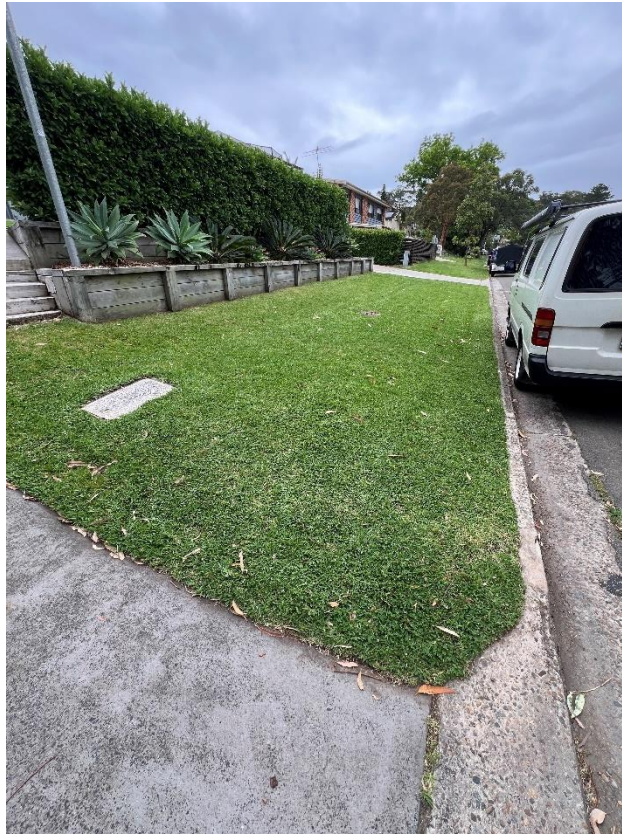
*Figure 121 – General condition of the nature strip.*

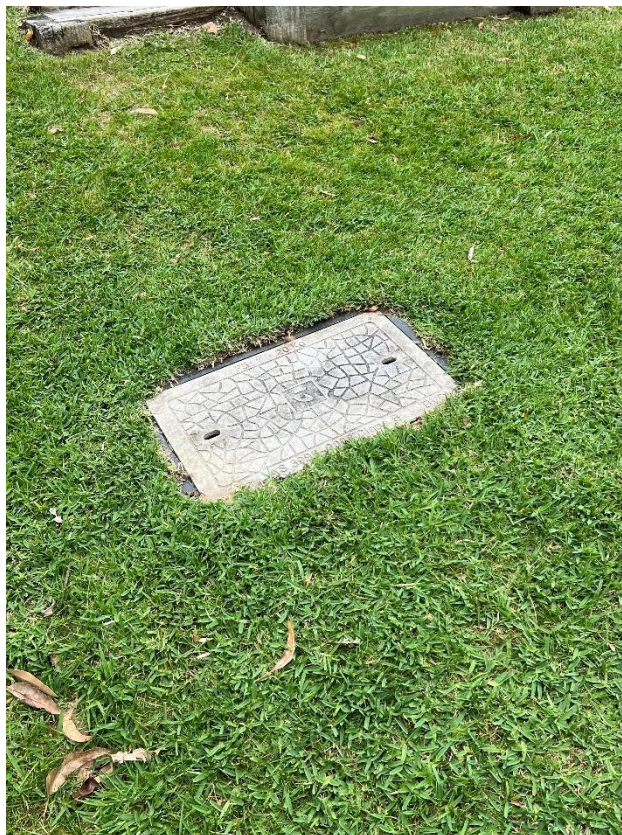
*Figure 122 – General condition of the pit.*

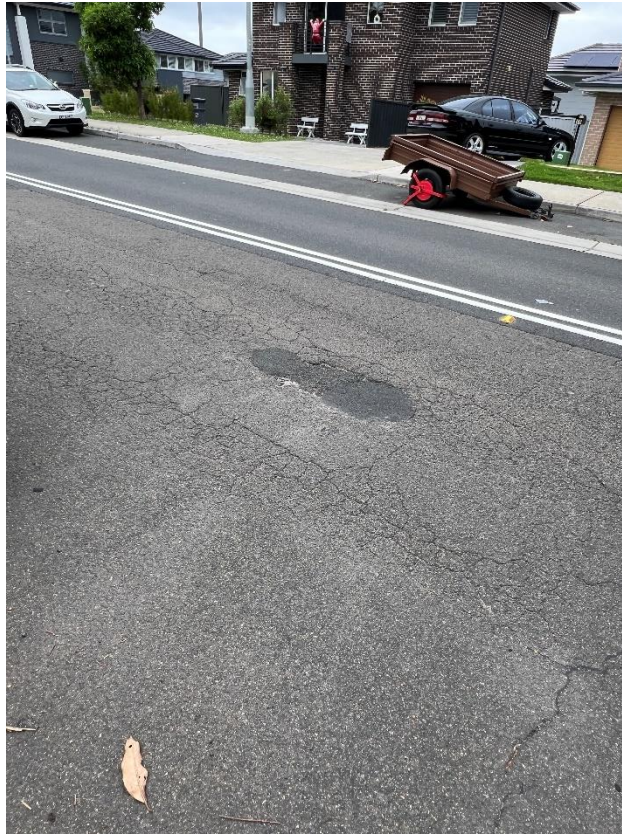
*Figure 123 – Crack is evident to the road.*

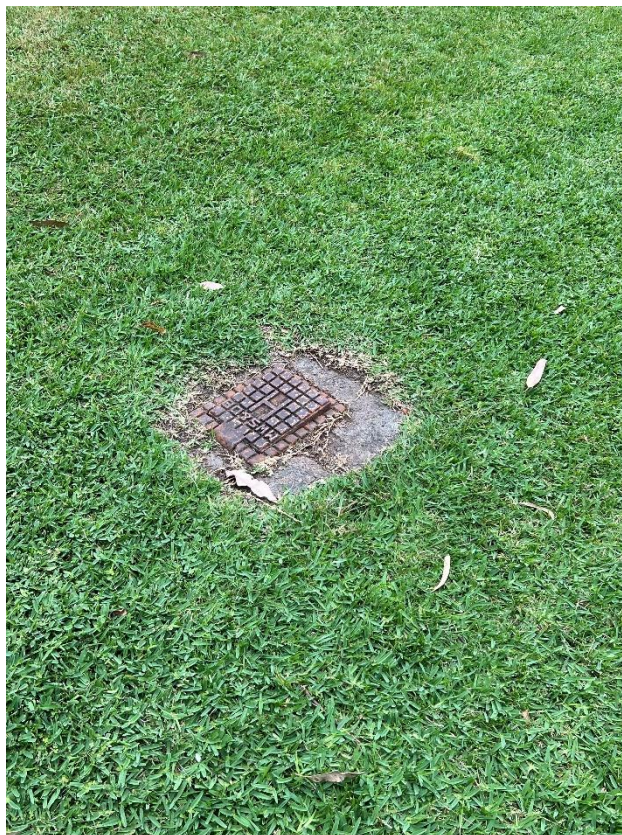
*Figure 124 – General condition of the utility lid.*

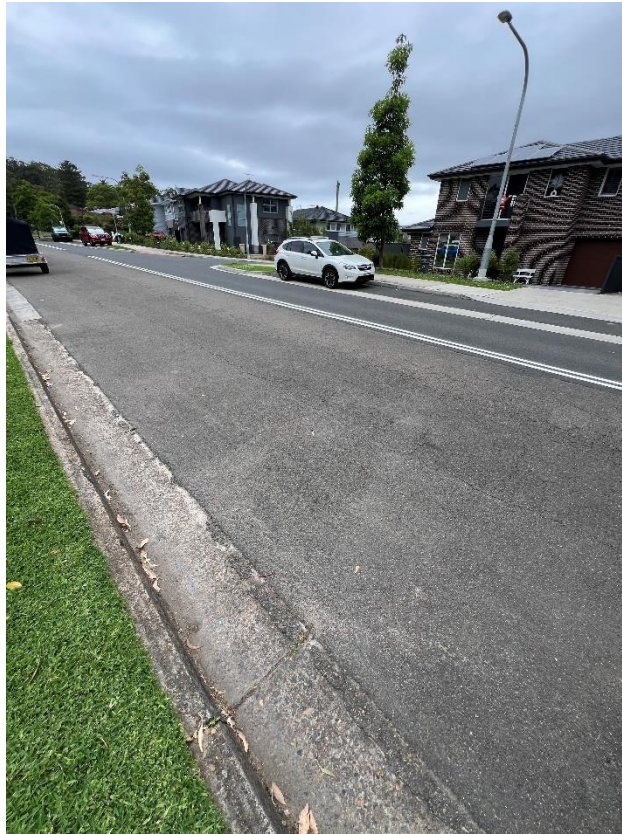
*Figure 125 – Crack is evident to the road.*

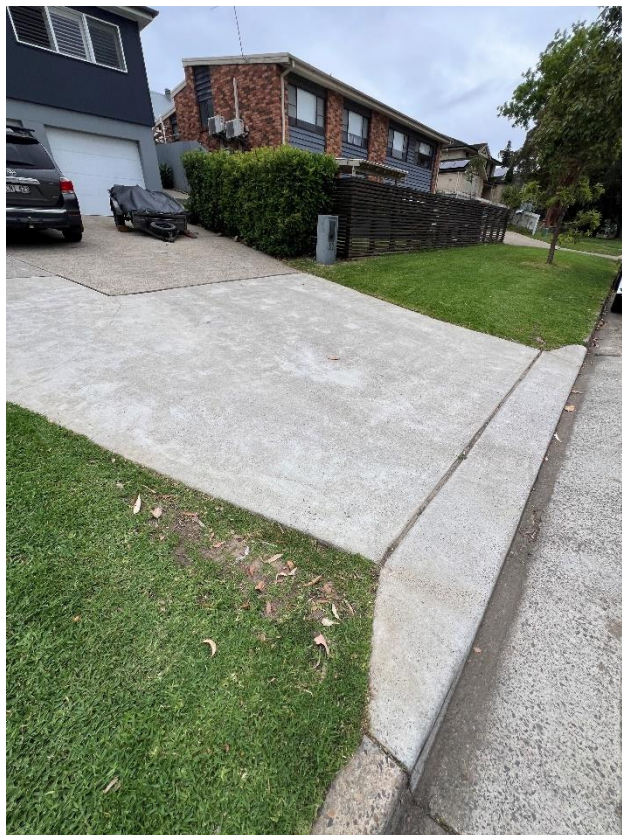
*Figure 126 – General condition of the driveway.*

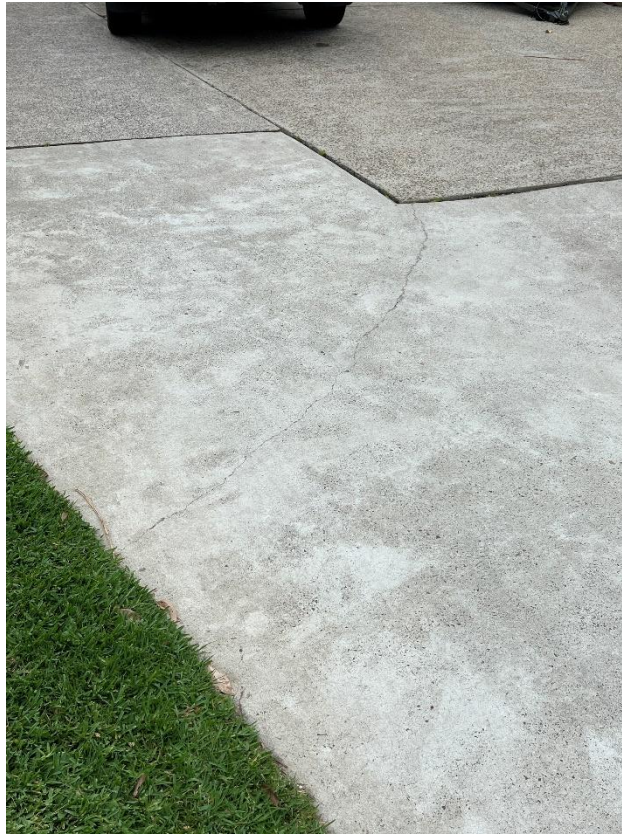
*Figure 127 – Crack is evident to the driveway.*

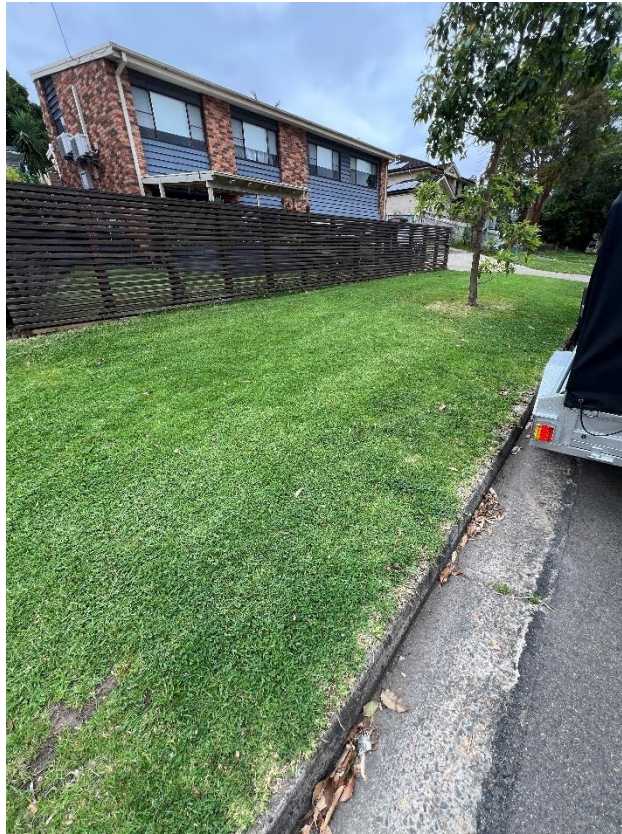
*Figure 131 – General condition of the kerb/nature strip.*

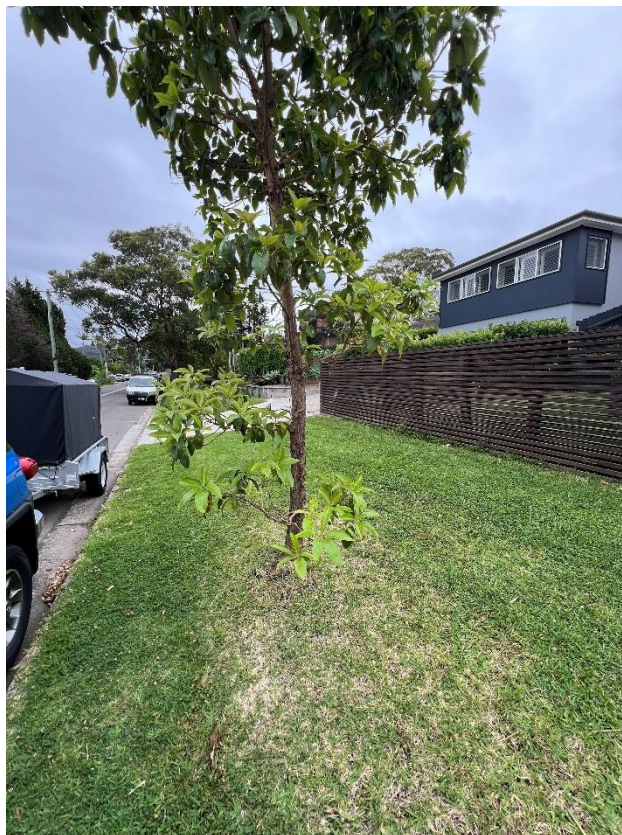
*Figure 132 – General condition of the tree.*

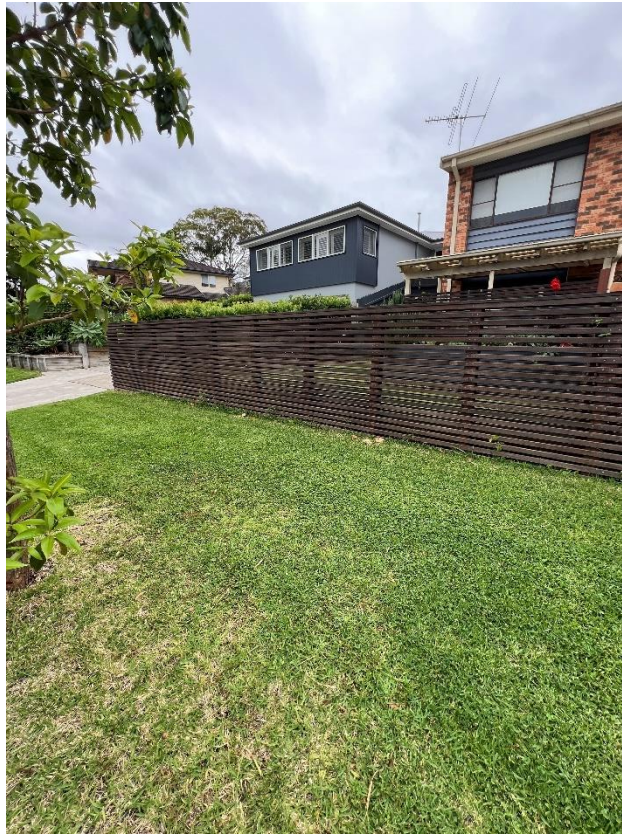
*Figure 133 – General condition of the nature strip.*

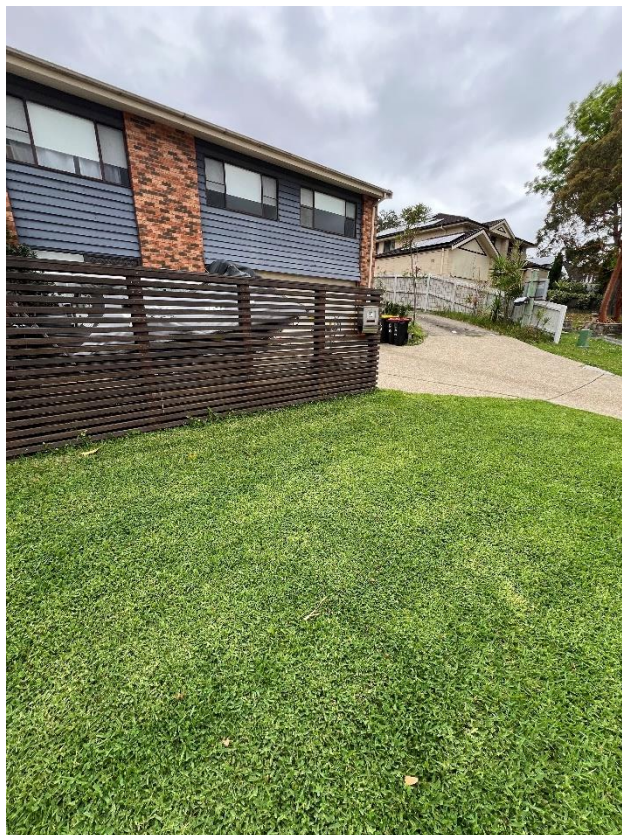
*Figure 134 – General condition of the nature strip.*

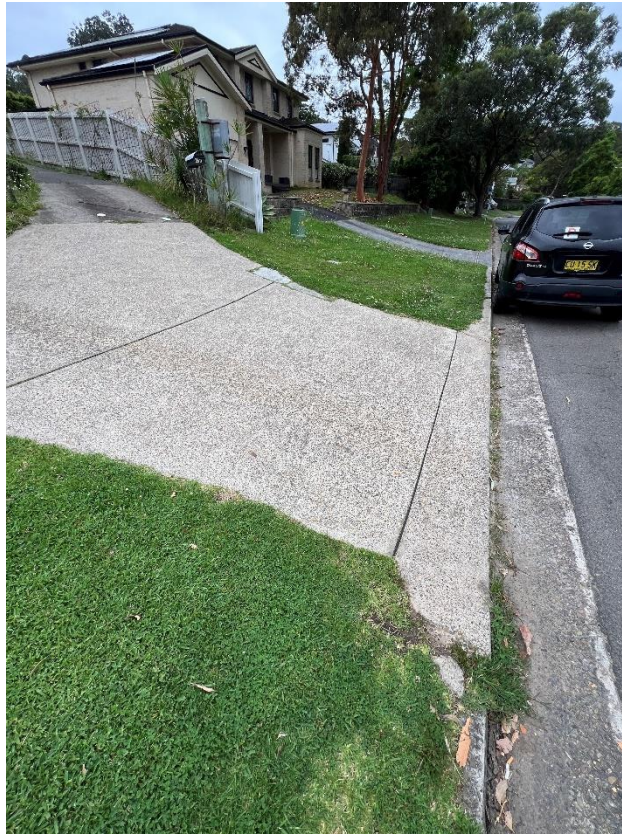
*Figure 135 – General condition of the driveway.*

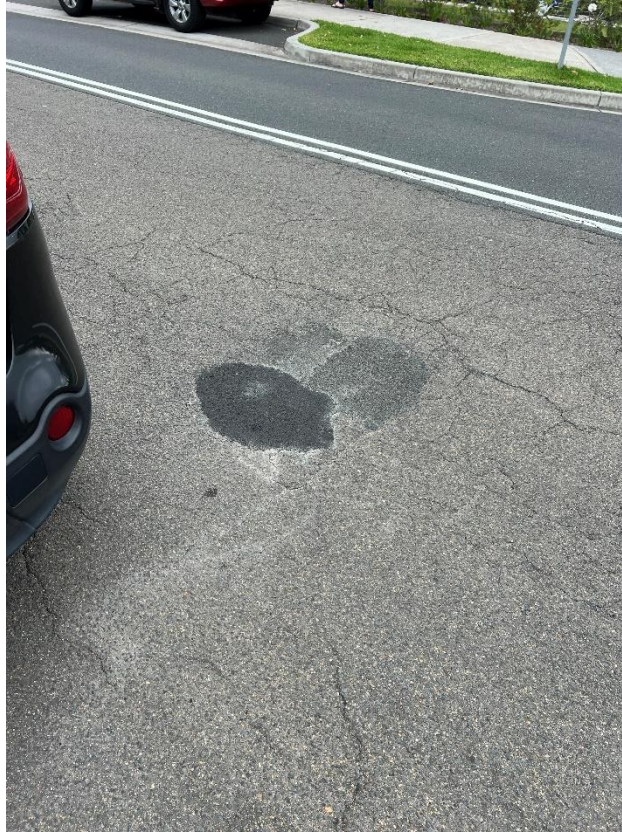
*Figure 137 – Crack is evident to the road.*

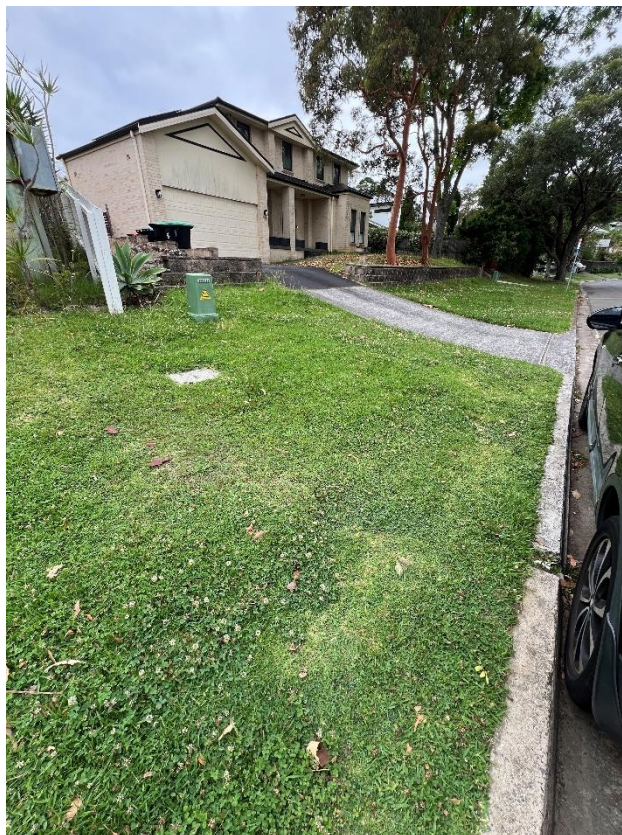
*Figure 138 – General condition of the nature strip.*
