# DILAPIDATION REPORT

**Warriewood Road, Warriewood**

**Prepared by: Rezoning Pty Ltd t/as Effective Building & Consultancy**

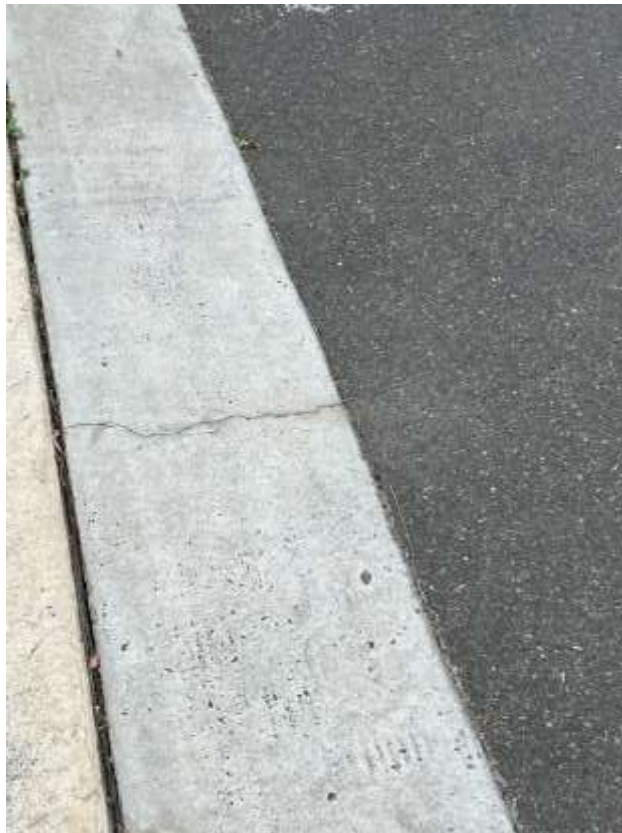
*Figure 10 – Crack is evident to the layback outside 63 Warriewood Road Warriewood.*

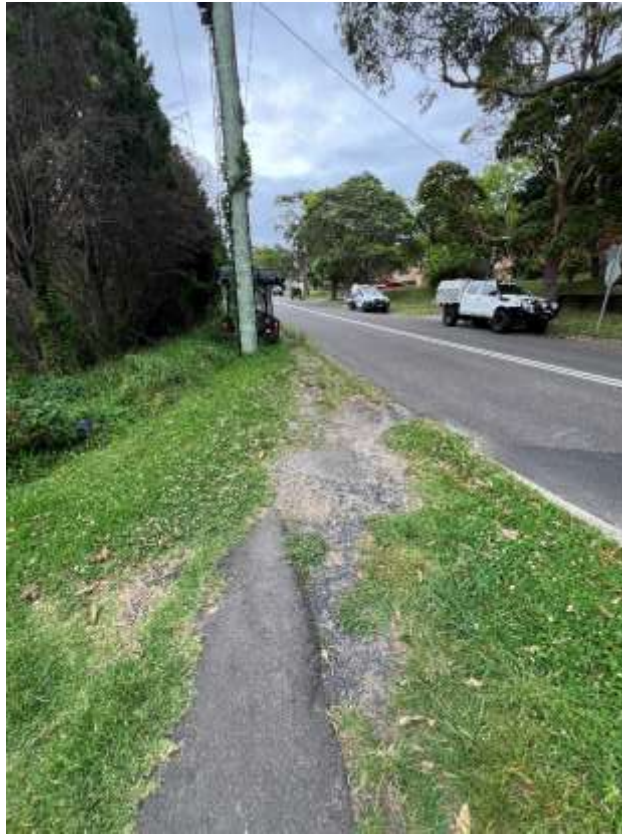
*Figure 17 – General condition of the footpath/nature strip.*

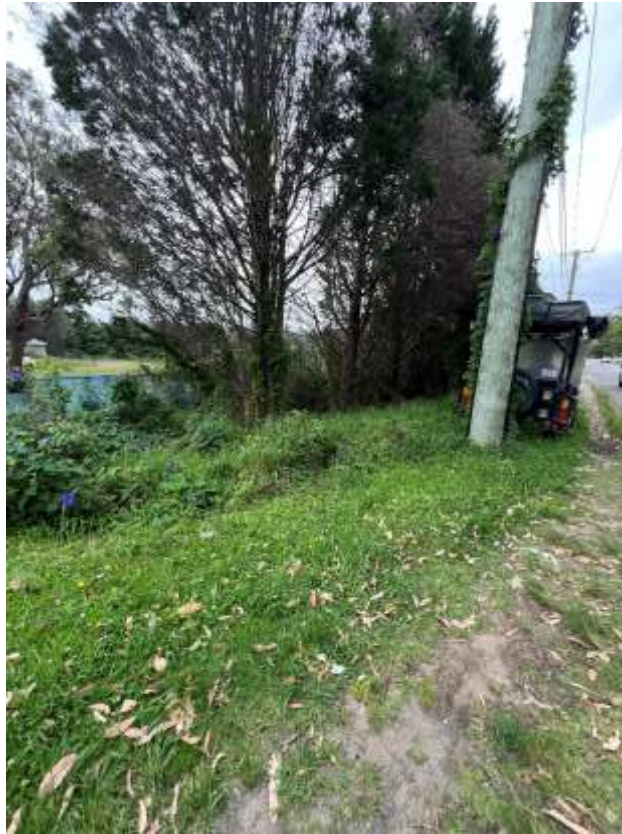
*Figure 19 – General condition of the nature strip.*

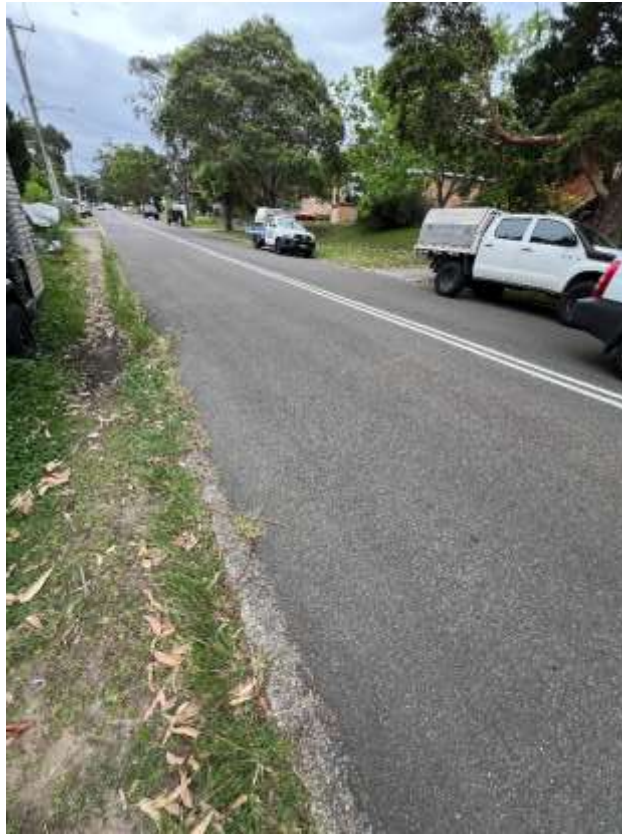
*Figure 21 – General condition of the kerb/road.*

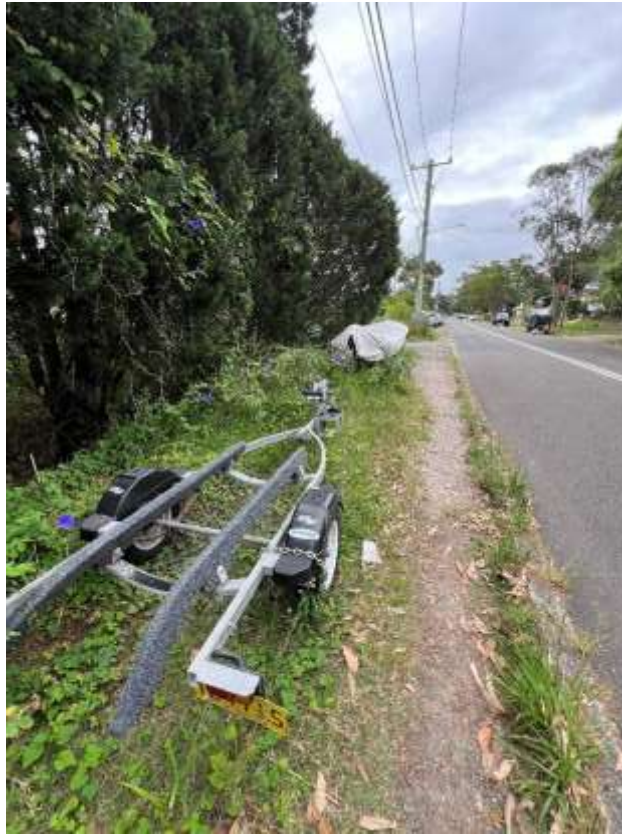
*Figure 23 – General condition of the nature strip.*

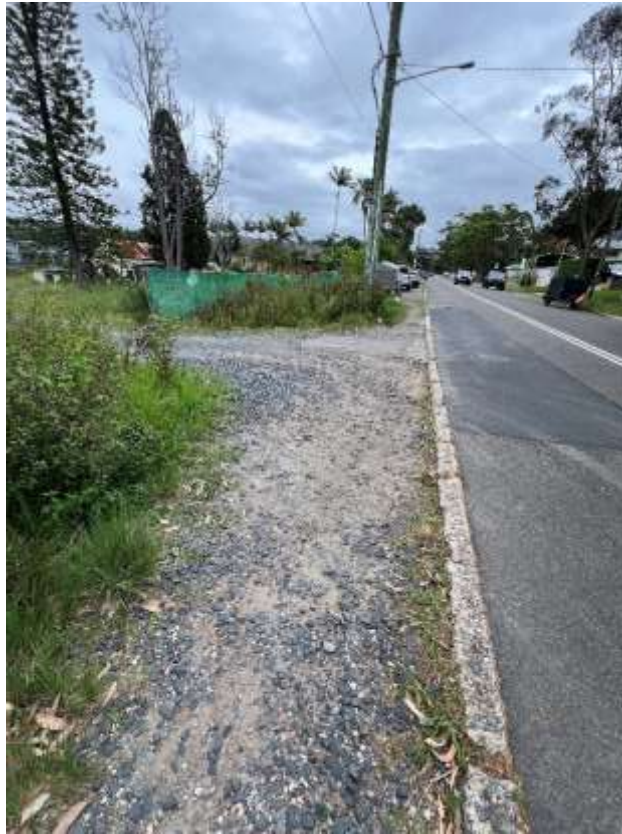
*Figure 25 – General condition of the driveway.*

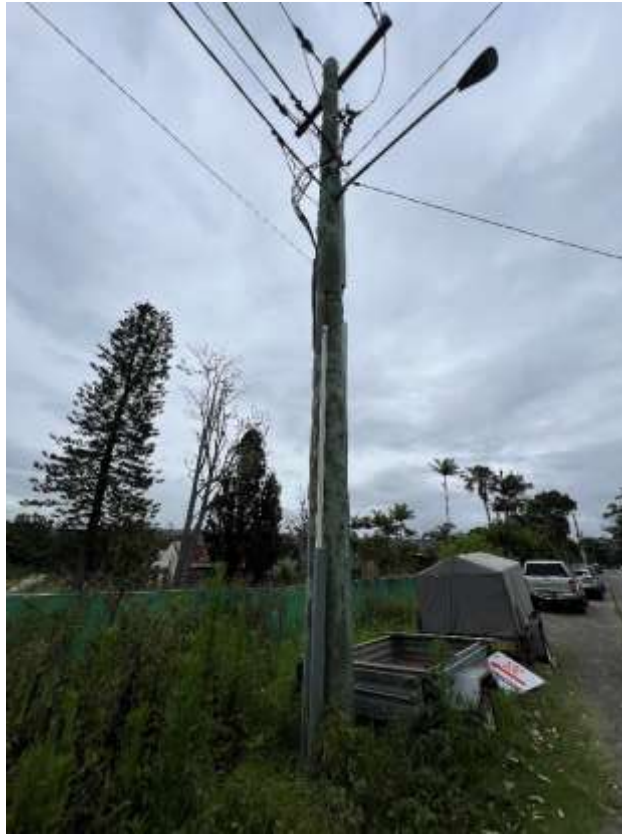
*Figure 27 – General condition of the electrical/light post.*

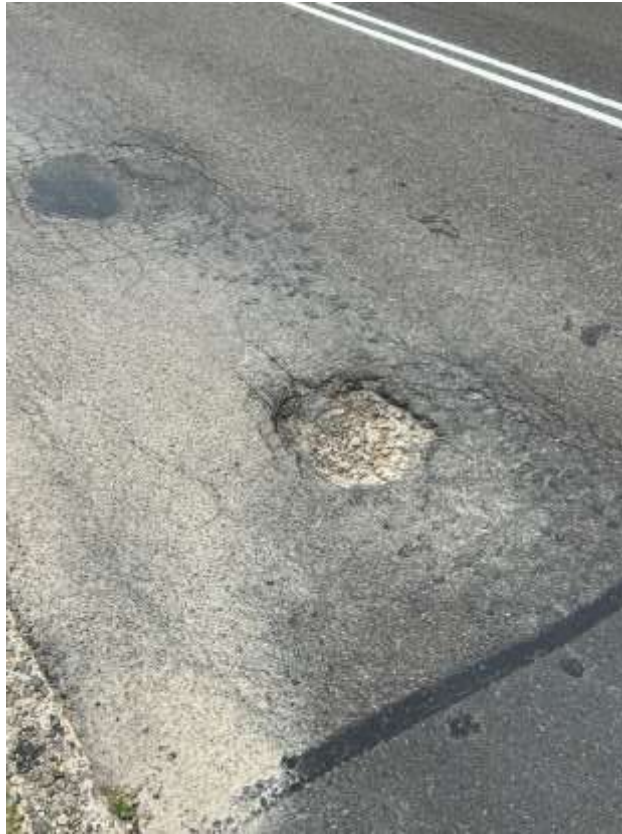
*Figure 29 – Pothole is evident to the road outside 45A Warriewood Road Warriewood.*

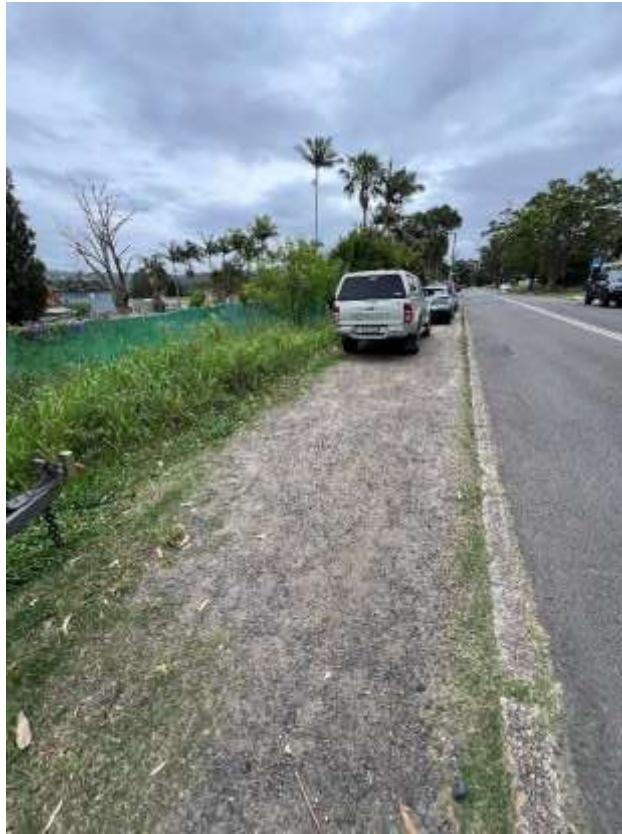
*Figure 31 – General condition of the ground.*

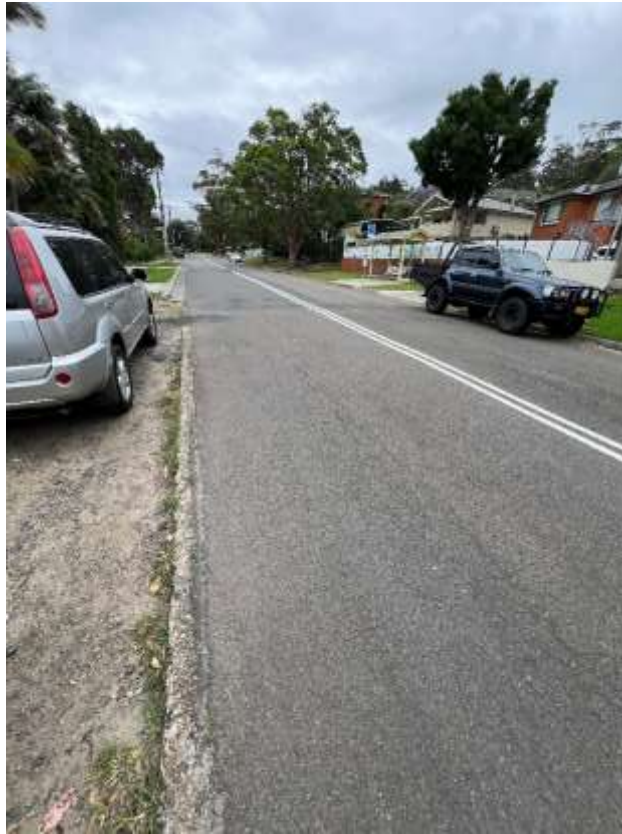
*Figure 33 – General condition of the road.*

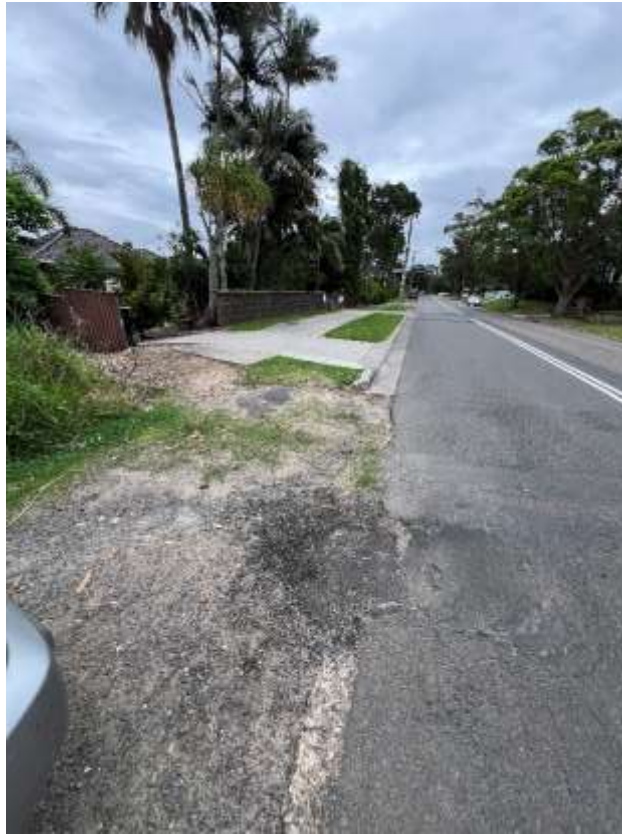
*Figure 35 – Crack is evident to the road outside 49 Warriewood Road Warriewood.*

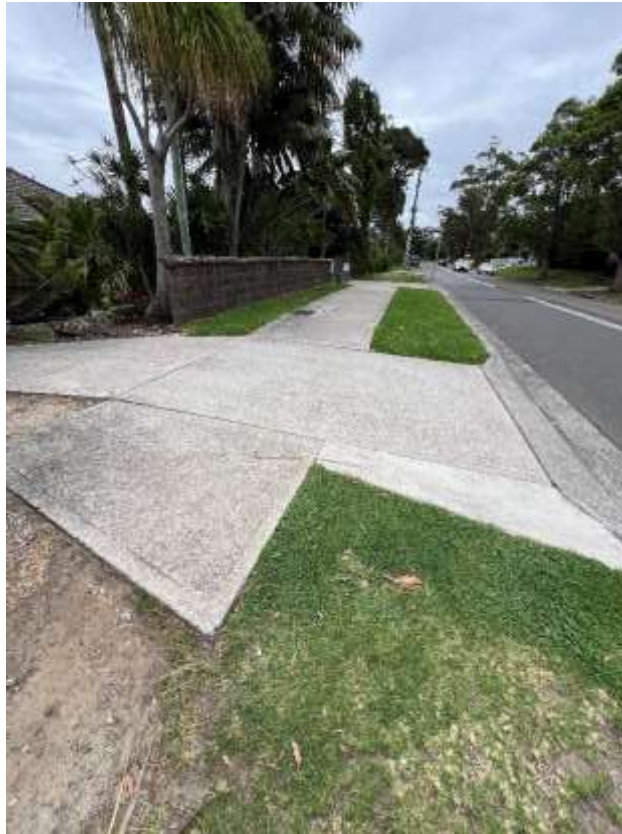
*Figure 37 – General condition of the driveway.*

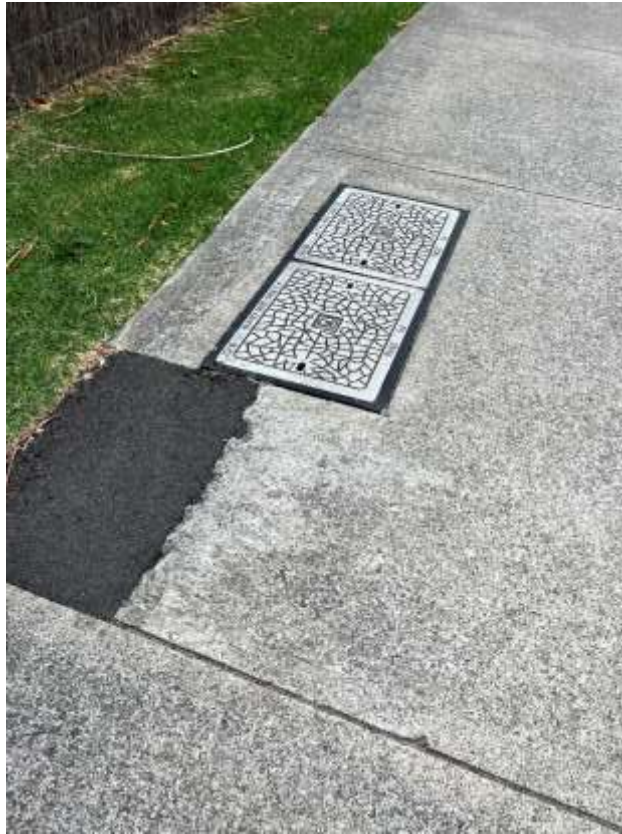
*Figure 39 – General condition of the pit.*

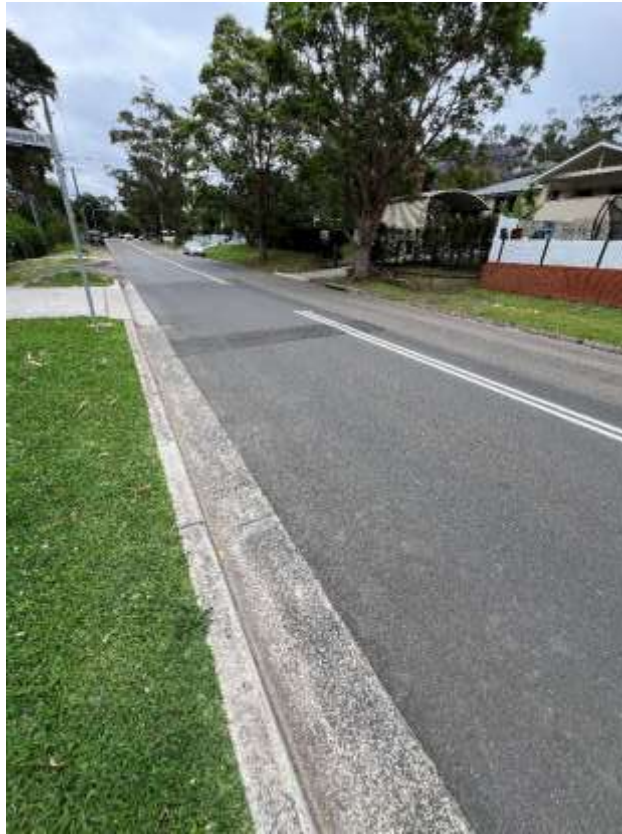
*Figure 41 – General condition of the kerb/road.*

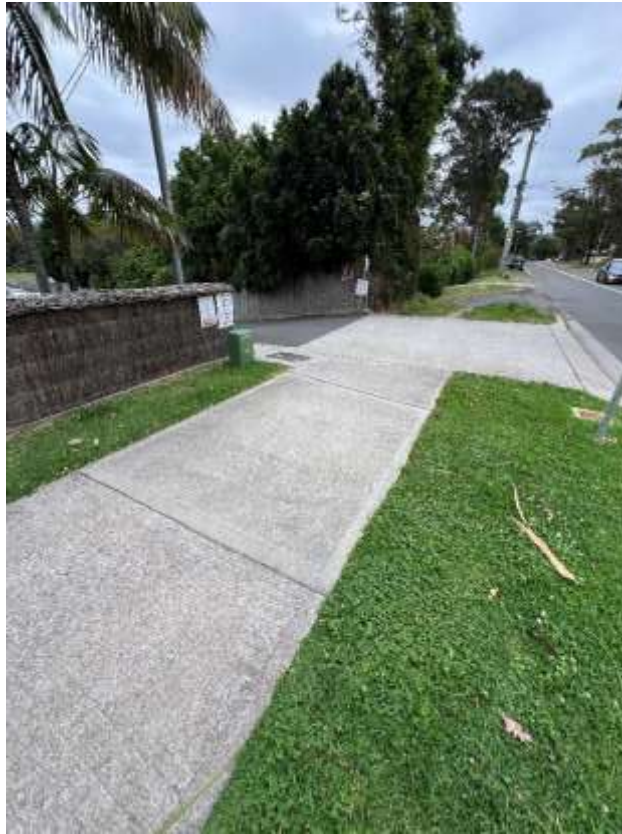
*Figure 43 – General condition of the footpath/nature strip.*

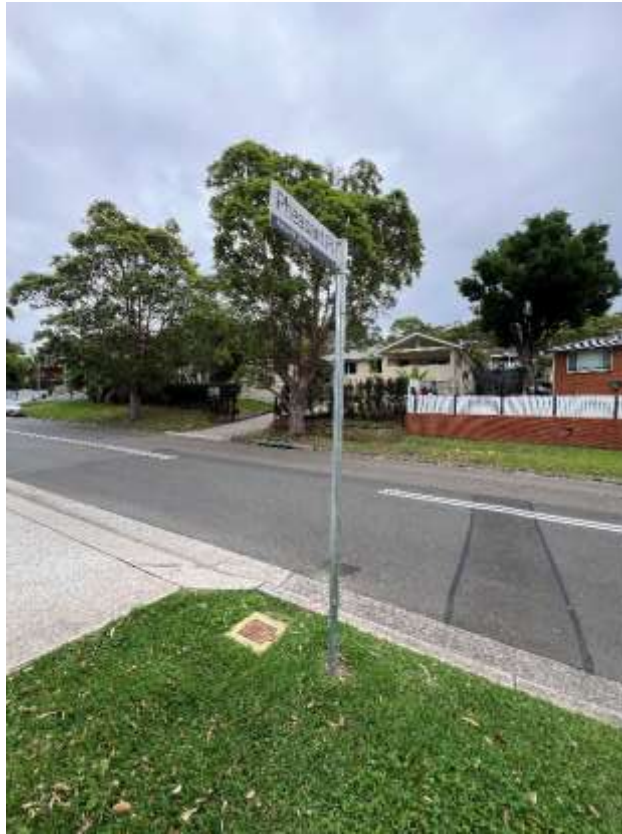
*Figure 45 – General condition of the street signpost.*

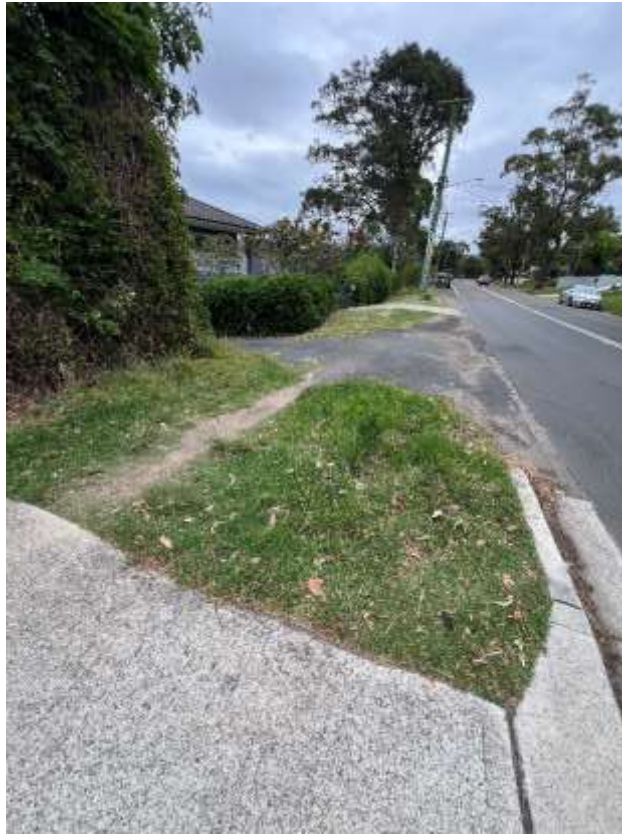
*Figure 47 – General condition of the nature strip.*

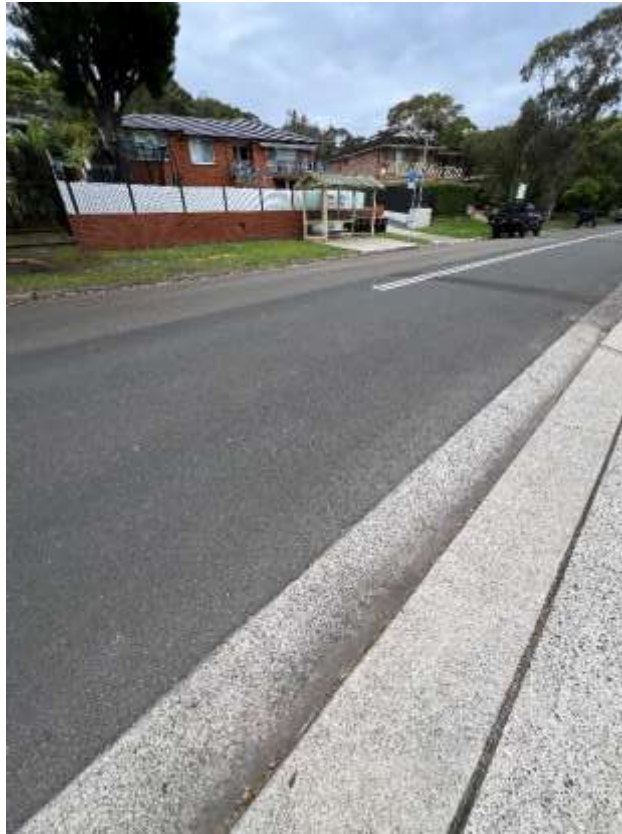
*Figure 49 – General condition of the layback/road.*

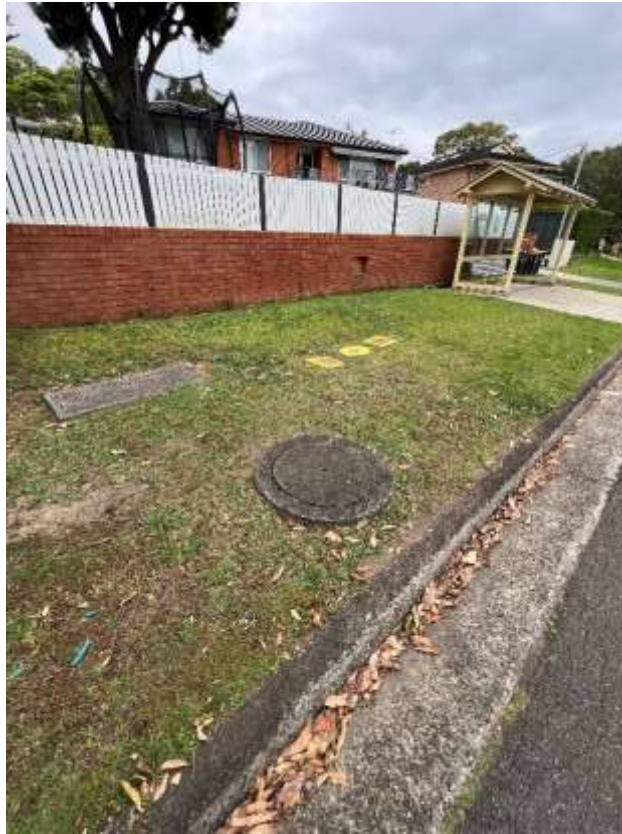
*Figure 51 – General condition of the pit.*

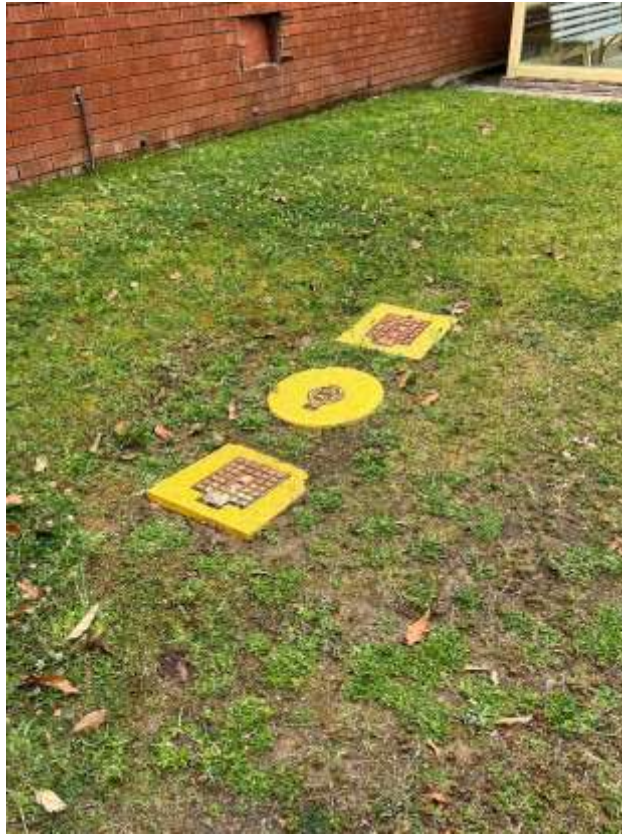
*Figure 53 – General condition of the utility lid.*

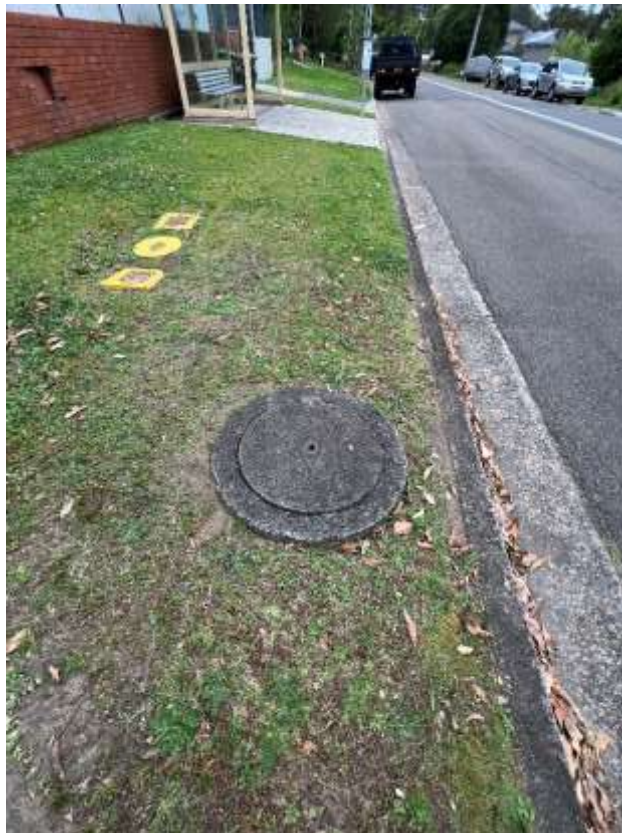
*Figure 54 – General condition of the pit.*

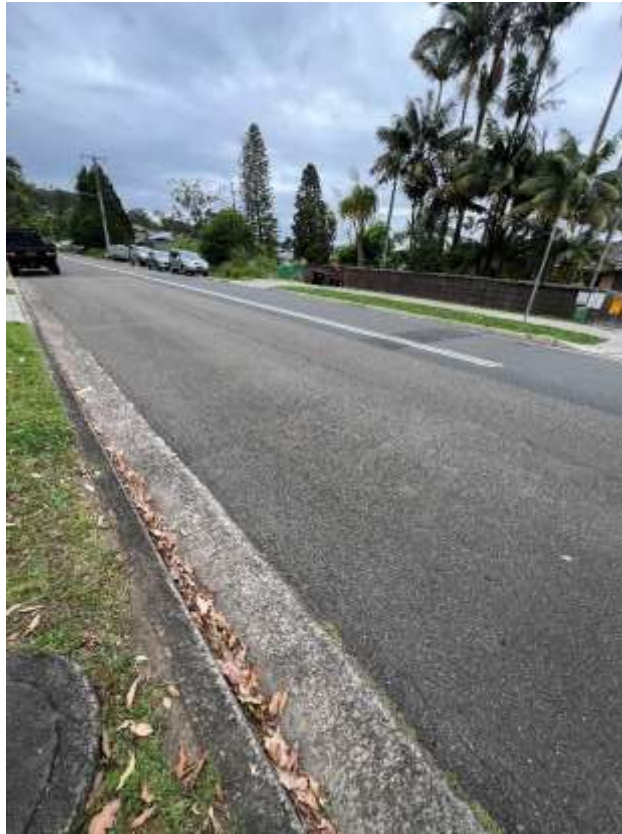
*Figure 55 – General condition of the kerb/road.*

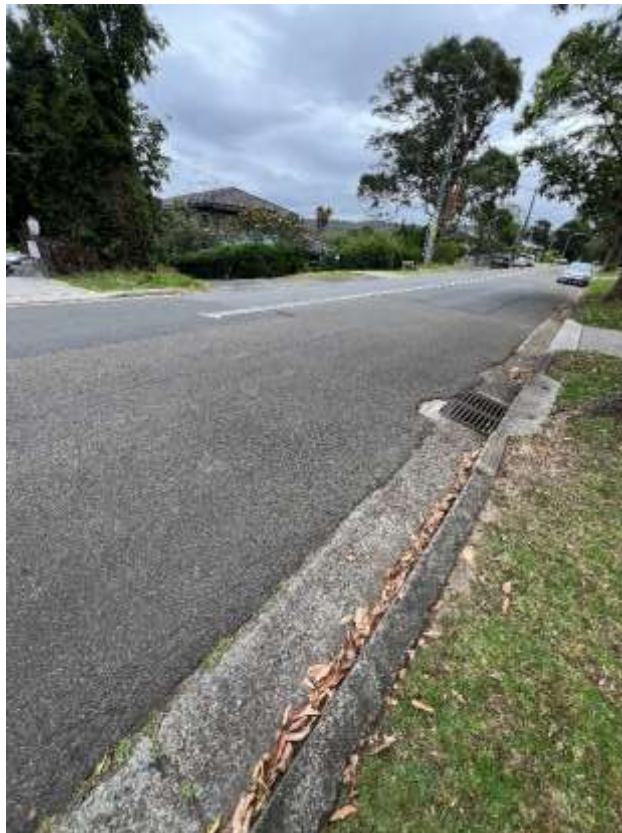
*Figure 56 – General condition of the kerb/road.*

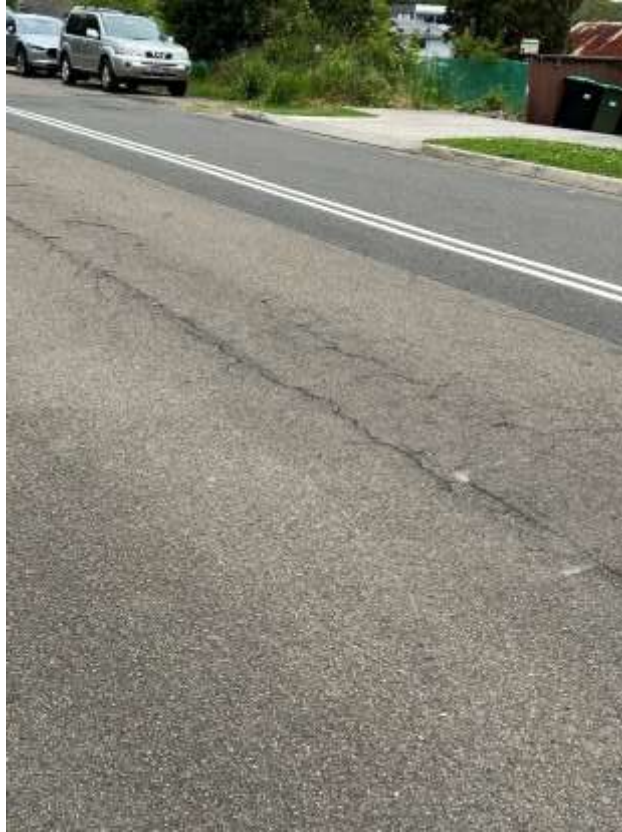
*Figure 57 – Crack is evident to the road outside 92 Warriewood Road Warriewood.*

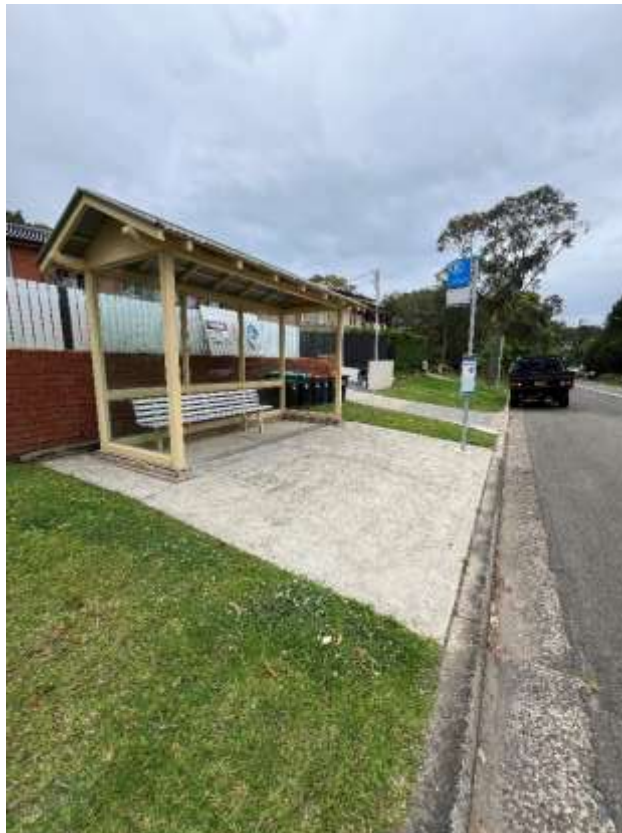
*Figure 58 – General condition of the bus stop.*

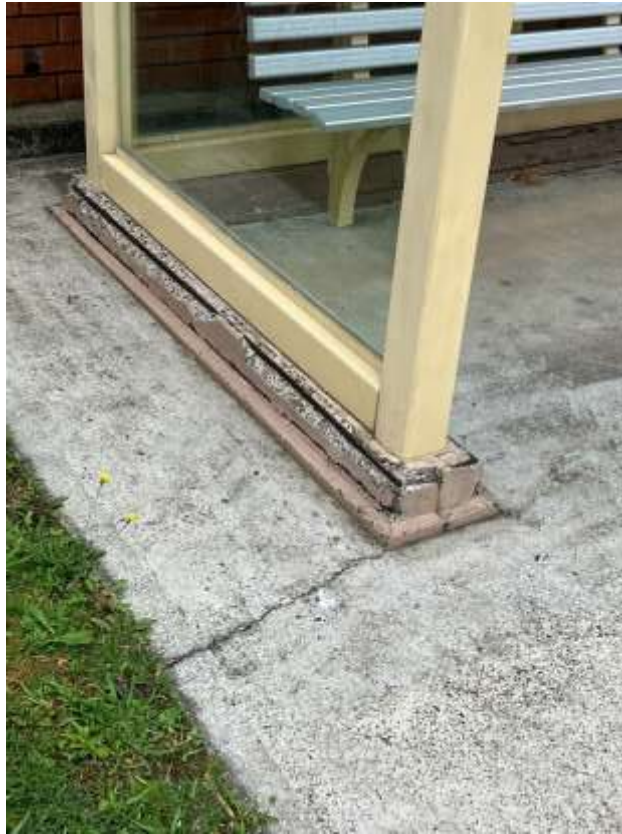
*Figure 59 – Crack is evident to the concrete at bus stop.*

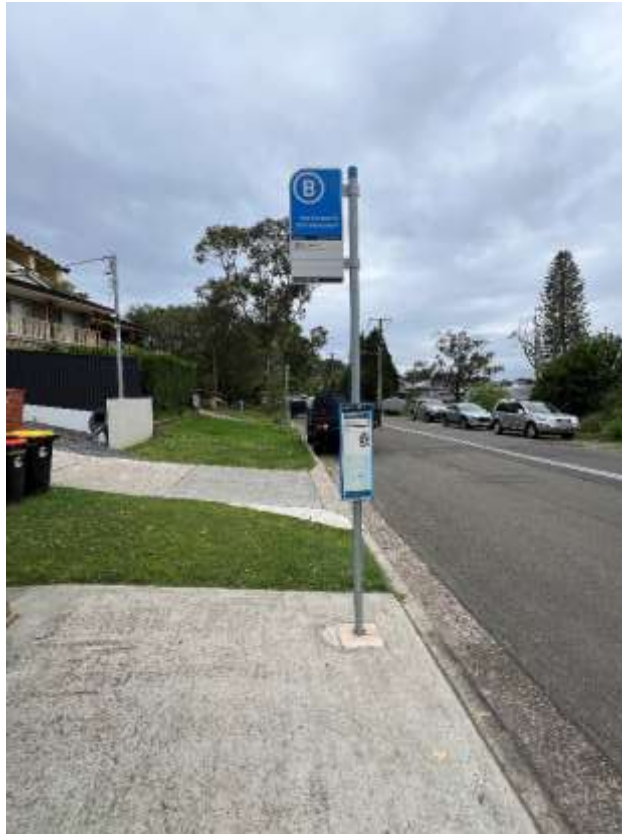
*Figure 61 – General condition of the traffic signpost.*

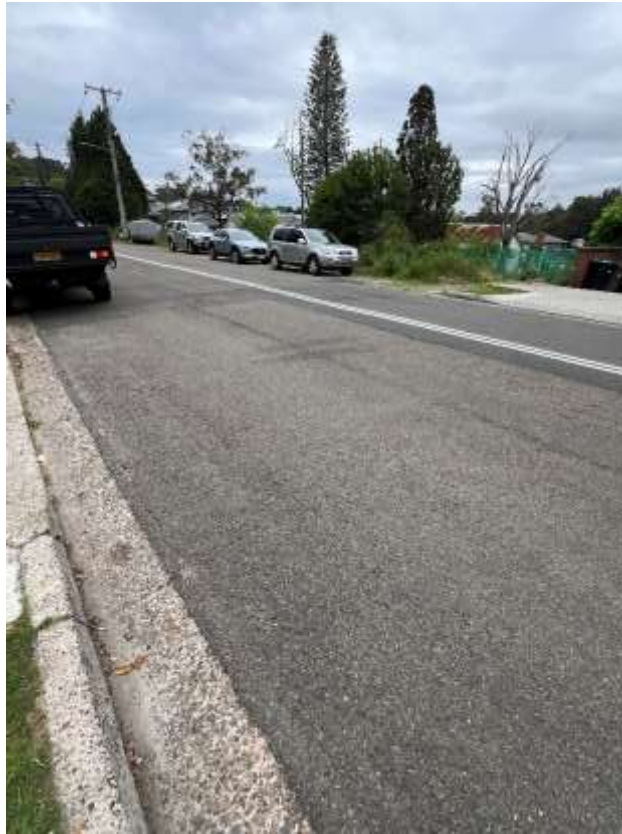
*Figure 63 – General condition of the kerb/road.*

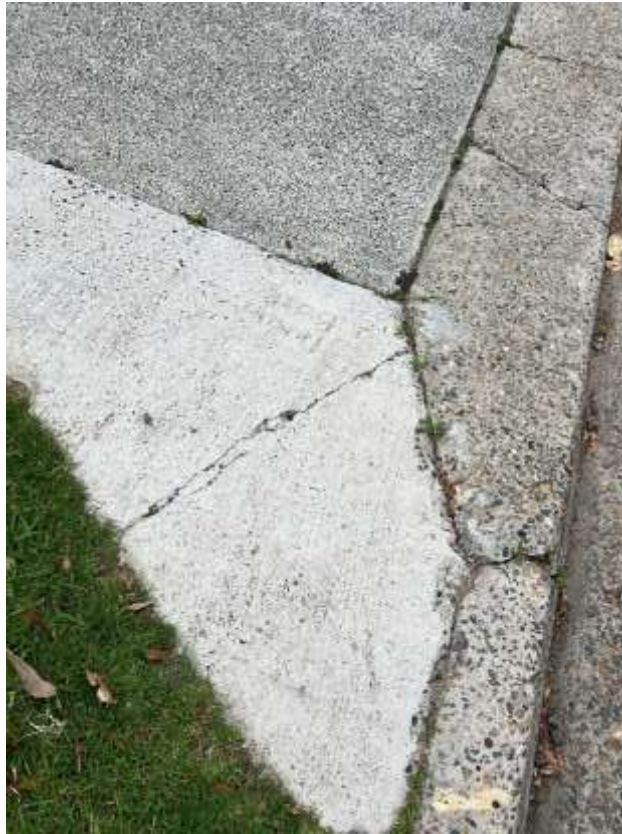
*Figure 65 – Crack is evident to the layback outside 92 Warriewood Road Warriewood.*

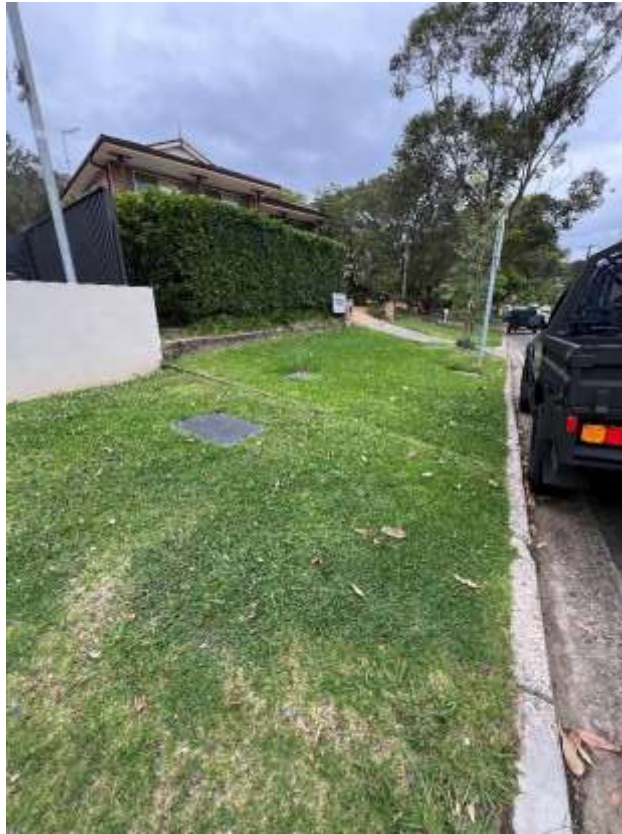
*Figure 67 – General condition of the nature strip.*

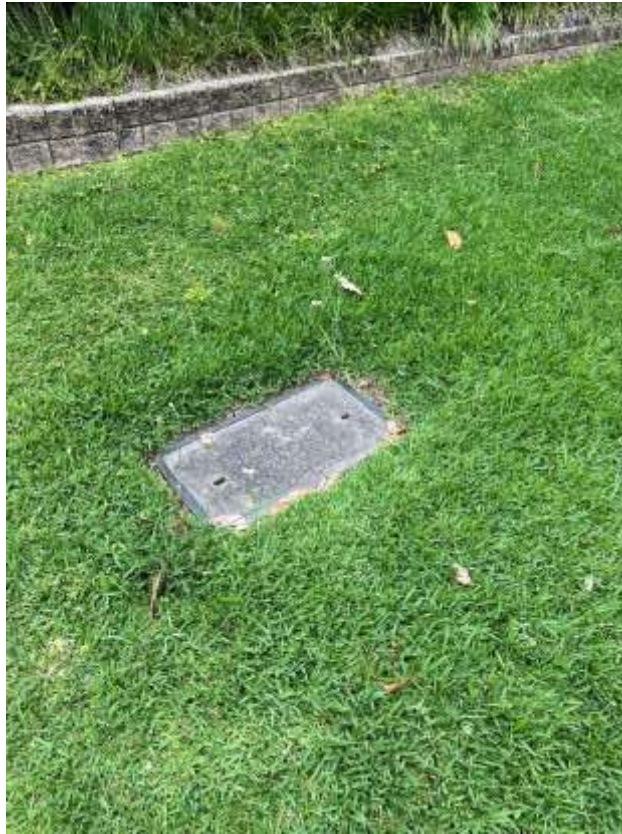
*Figure 69 – General condition of the pit.*

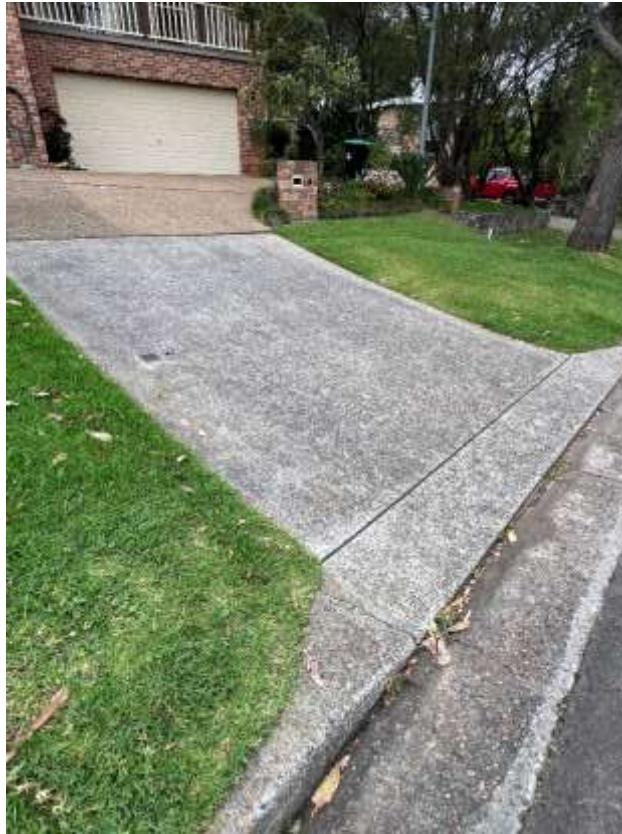
*Figure 73 – Crack is evident to the layback outside 90 Warriewood Road Warriewood.*

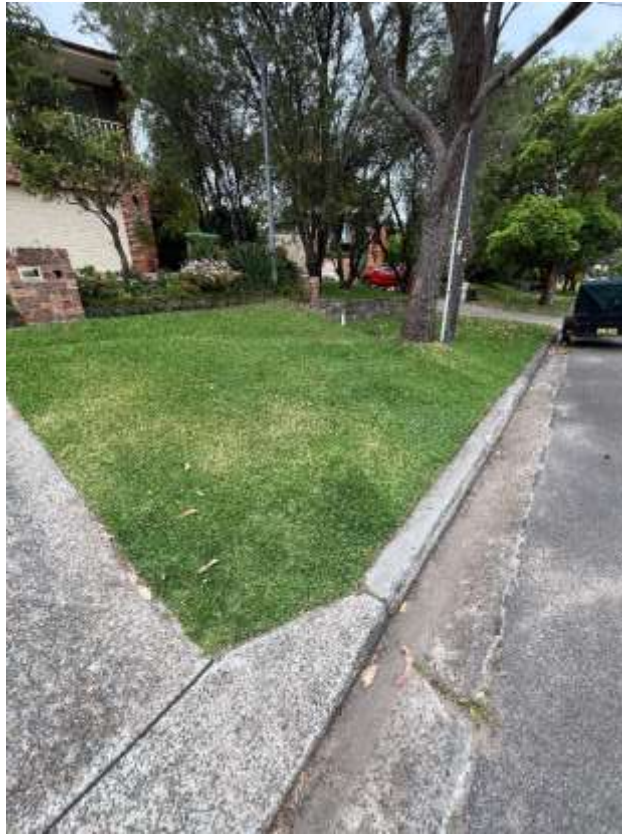
*Figure 75 – General condition of the nature strip.*

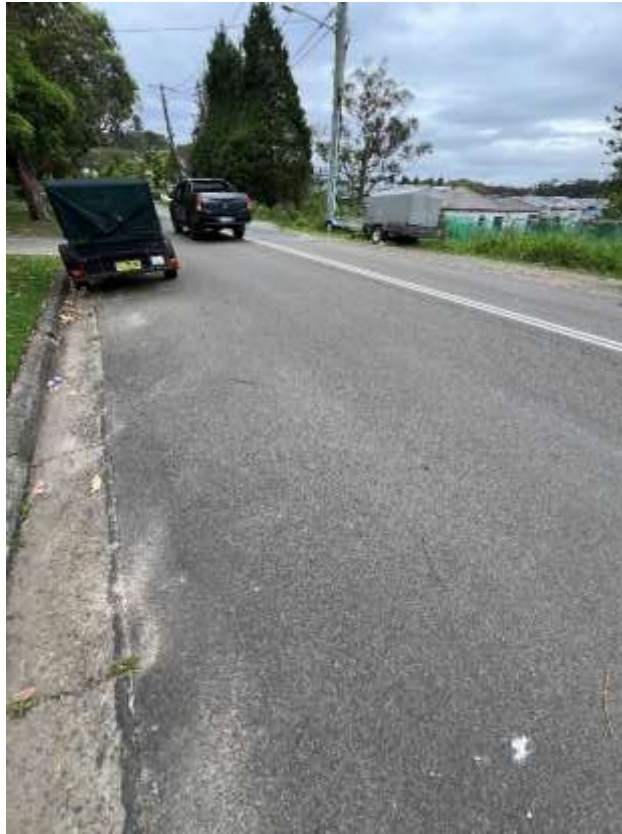
*Figure 77 – General condition of the road.*

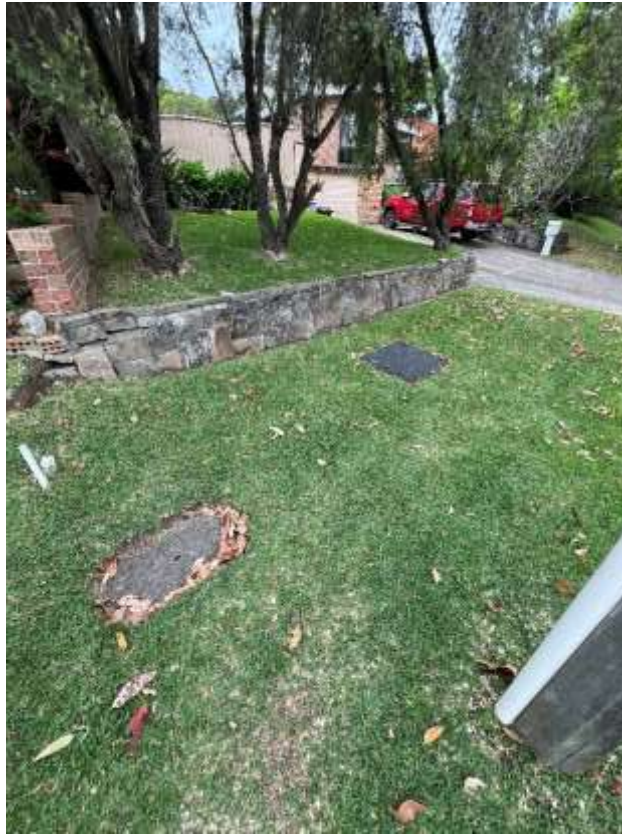
*Figure 79 – General condition of the pit.*

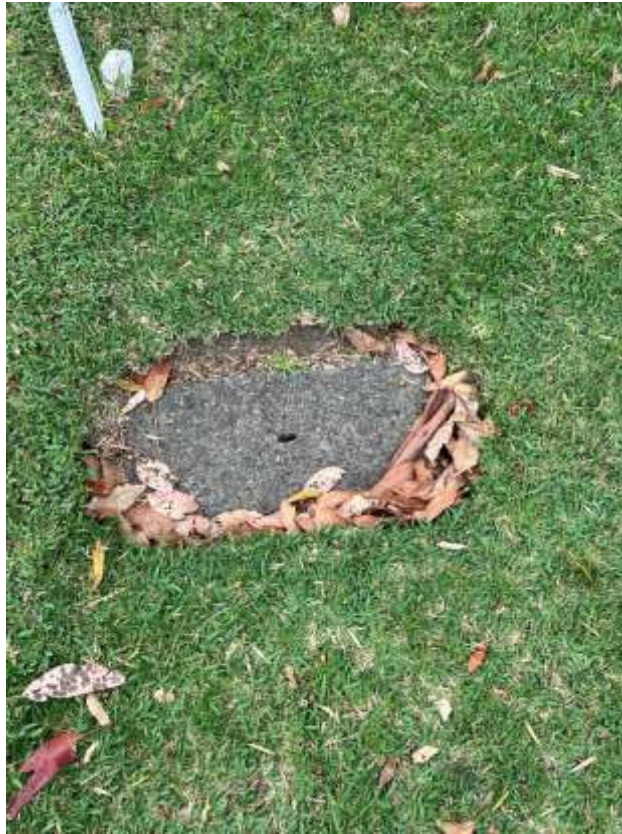
*Figure 81 – General condition of the pit.*

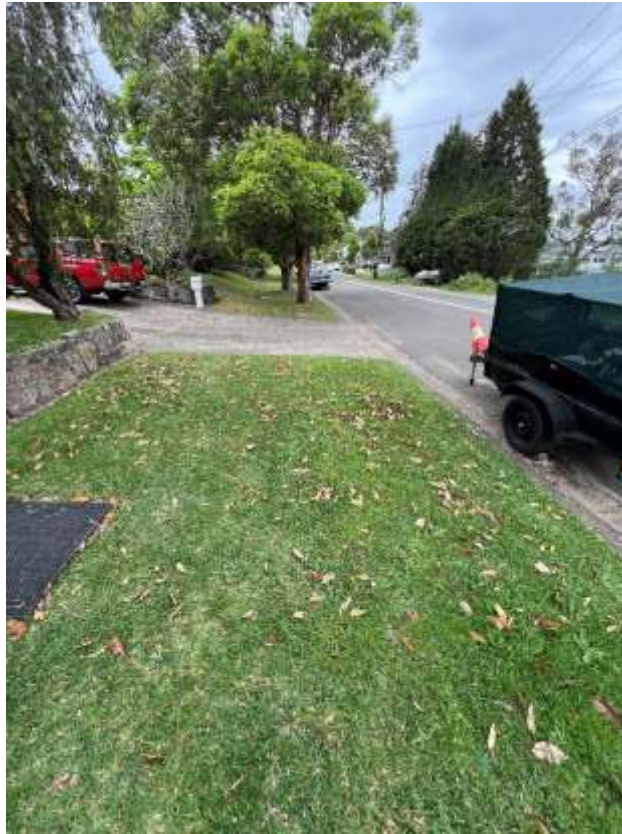
*Figure 83 – General condition of the nature strip.*

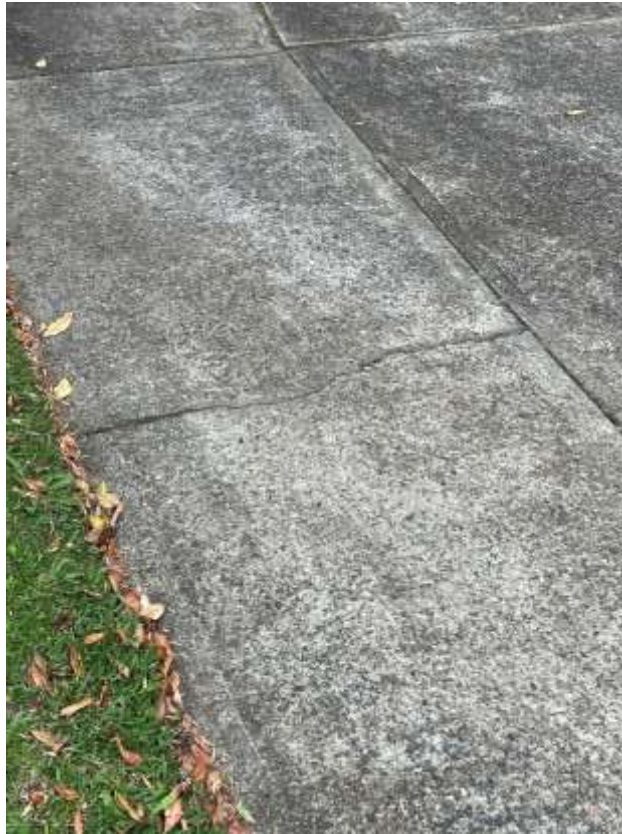
*Figure 85 – Crack is evident to the driveway outside 88 Warriewood Road Warriewood.*

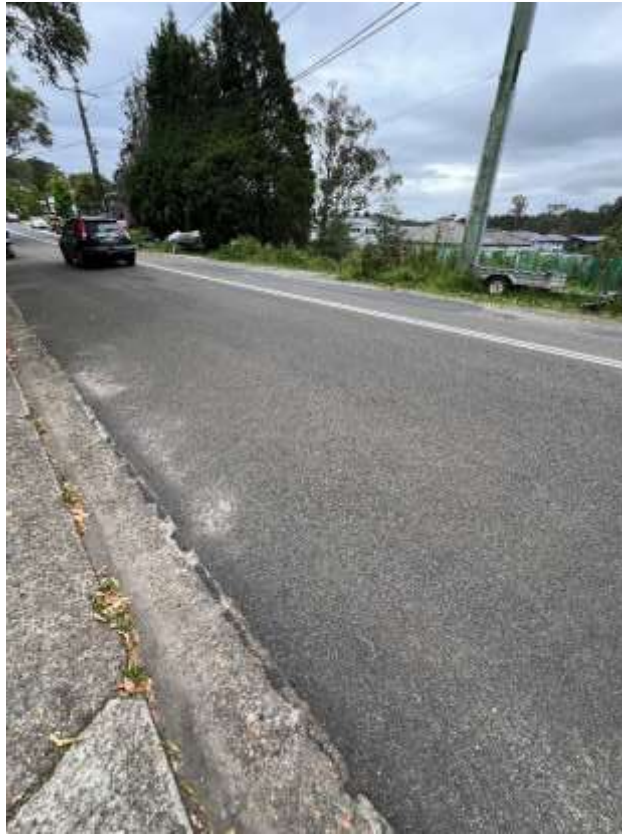
*Figure 87 – General condition of the road.*

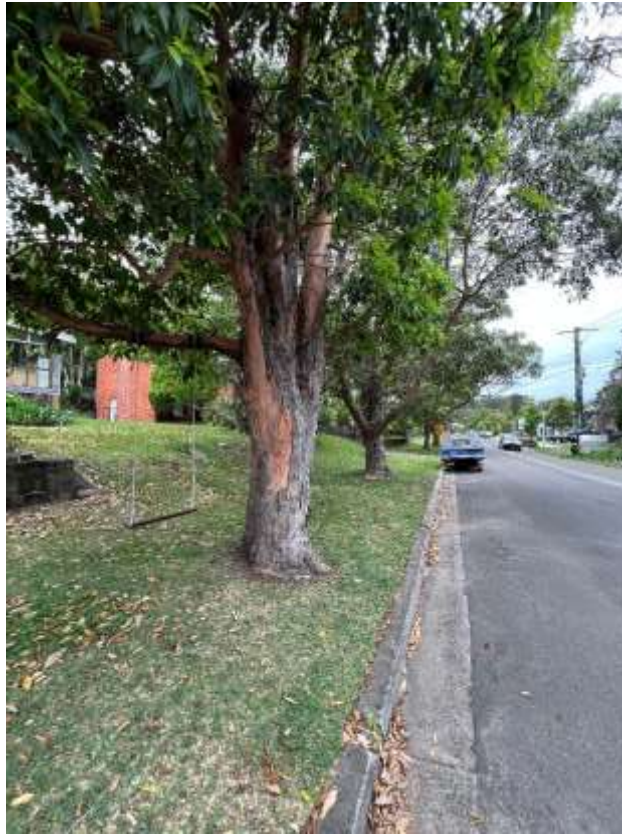
*Figure 89 – General condition of the tree.*

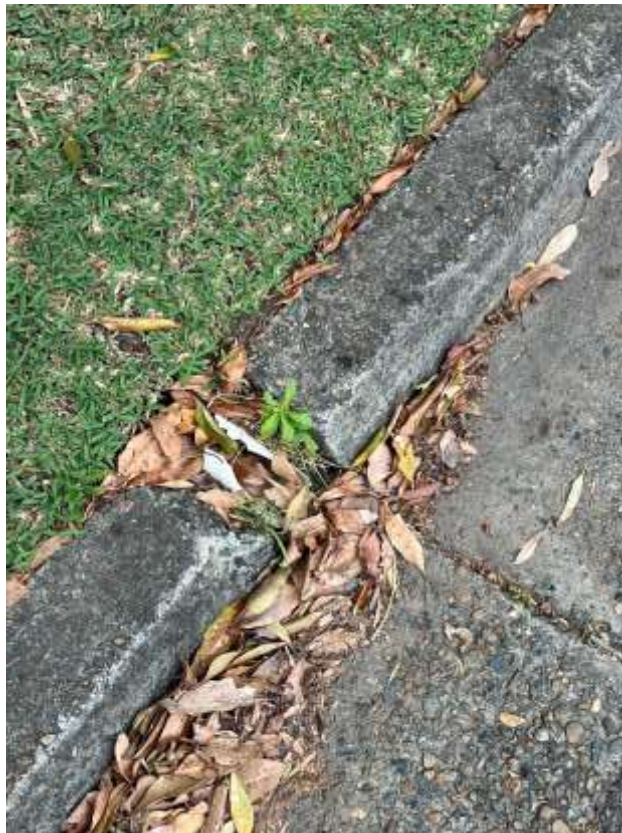
*Figure 90 – Crack is evident to the kerb outside 86 Warriewood Road Warriewood.*

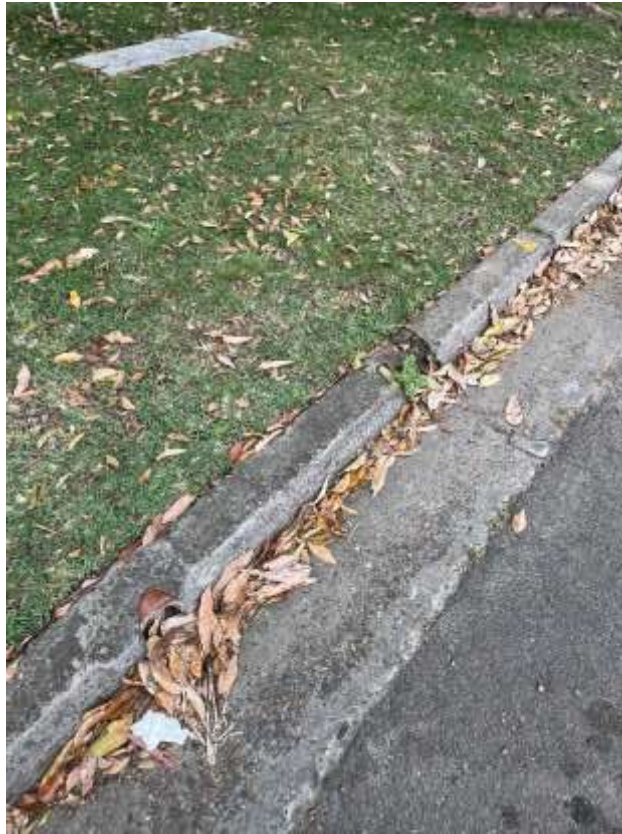
*Figure 91 – Crack is evident to the kerb outside 86 Warriewood Road Warriewood.*

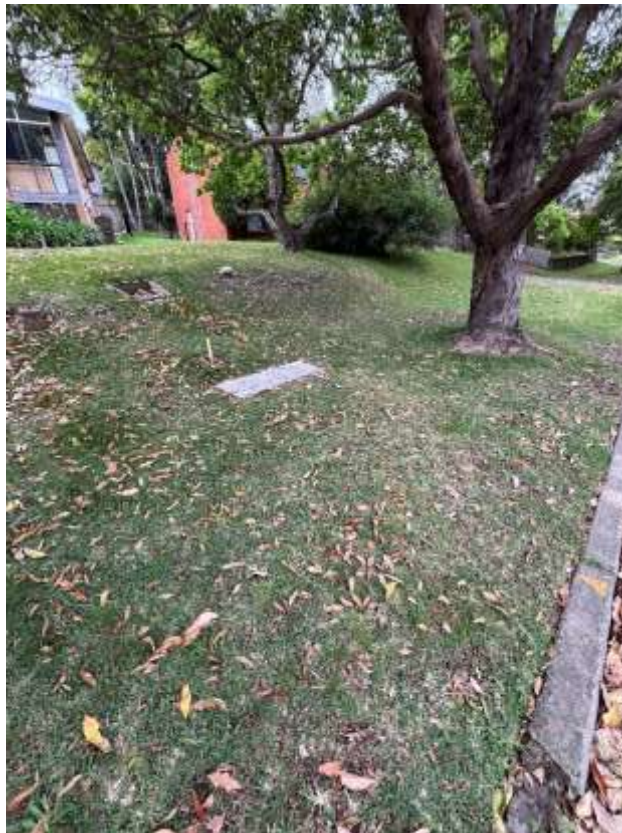
*Figure 92 – General condition of the nature strip.*
