# DILAPIDATION REPORT

**Warriewood Road, Warriewood**

**Prepared by: Rezoning Pty Ltd t/as Effective Building & Consultancy**

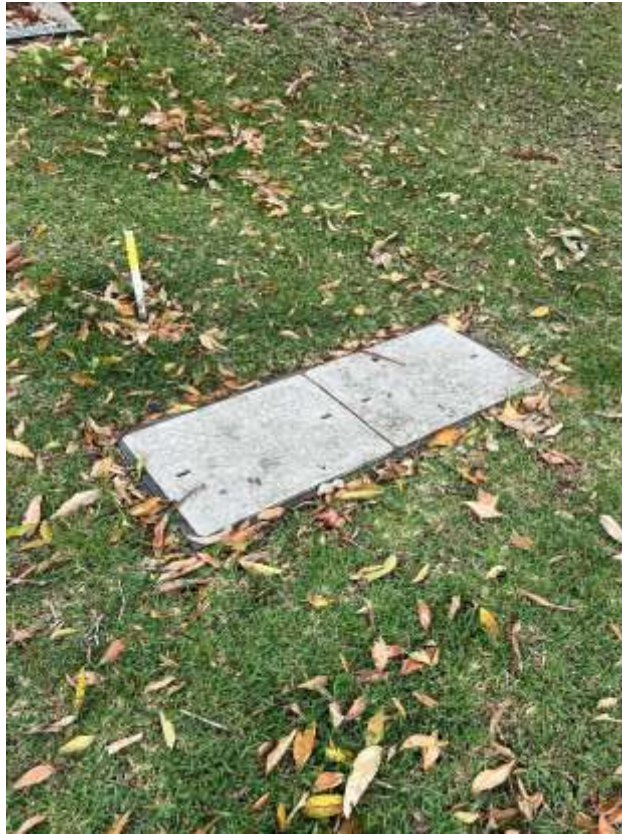
*Figure 93 – General condition of the pit.*

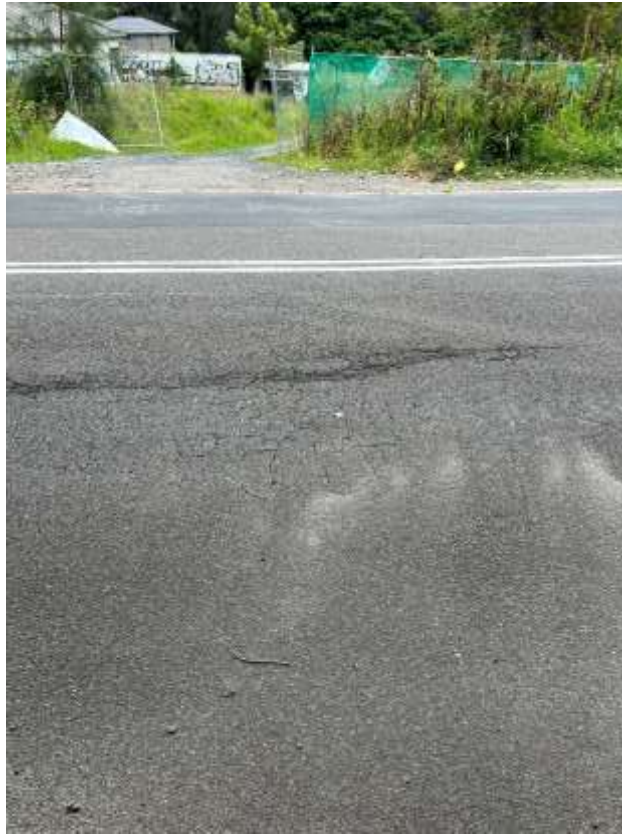
*Figure 95 – Crack is evident to the road outside 86 Warriewood Road Warriewood.*

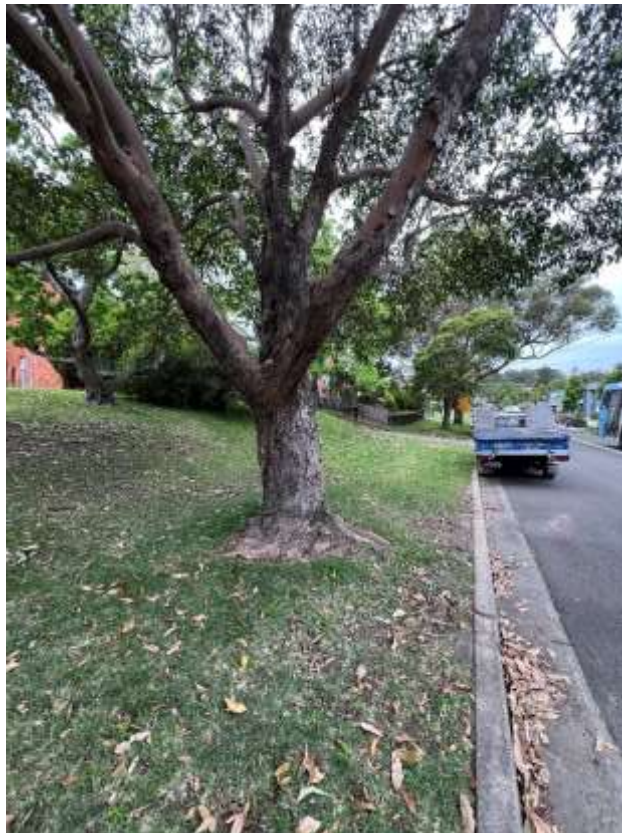
*Figure 96 – General condition of the tree.*

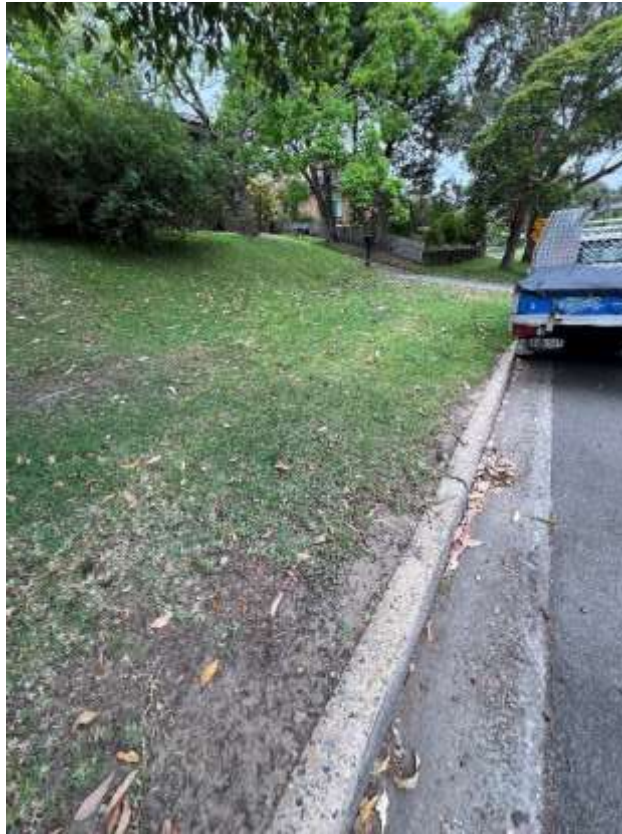
*Figure 97 – General condition of the kerb/nature strip.*

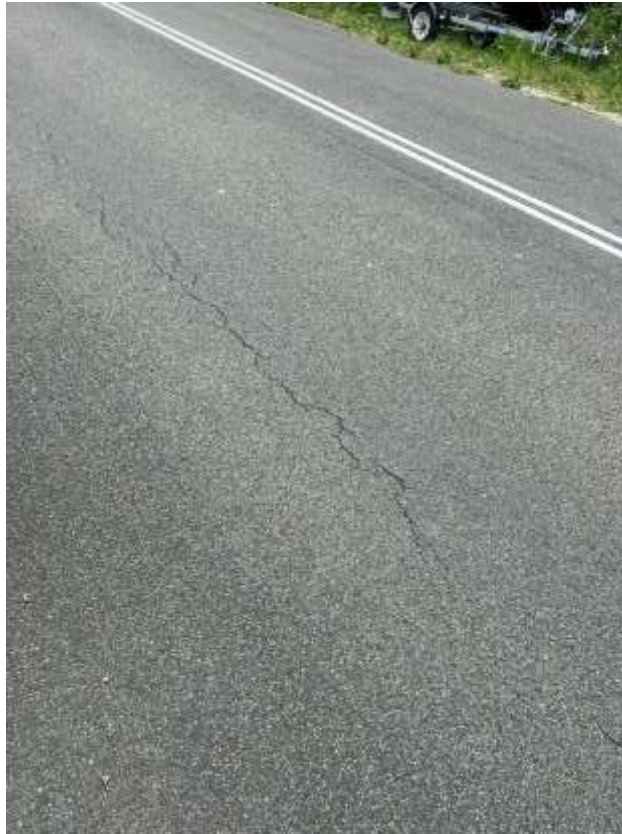
*Figure 99 – Crack is evident to the road outside 86 Warriewood Road Warriewood.*

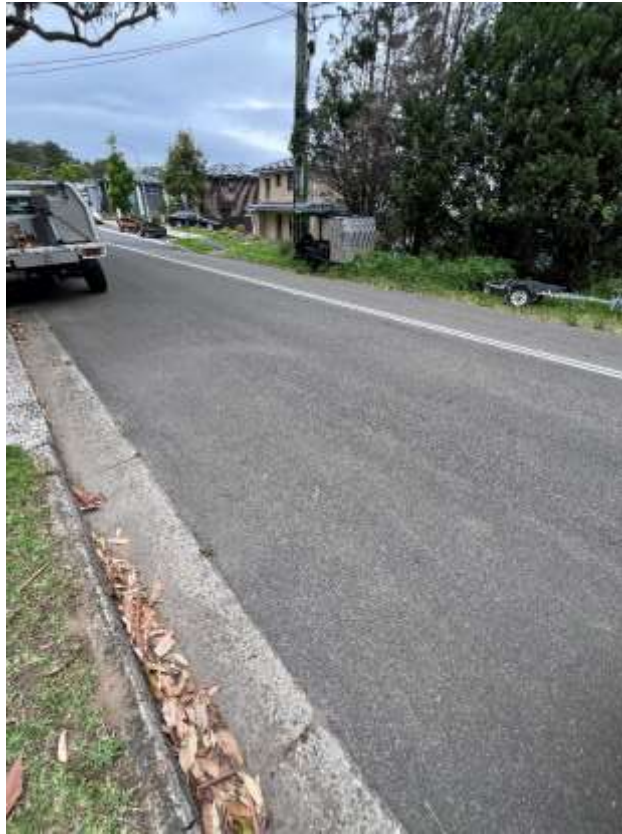
*Figure 101 – General condition of the kerb/road.*

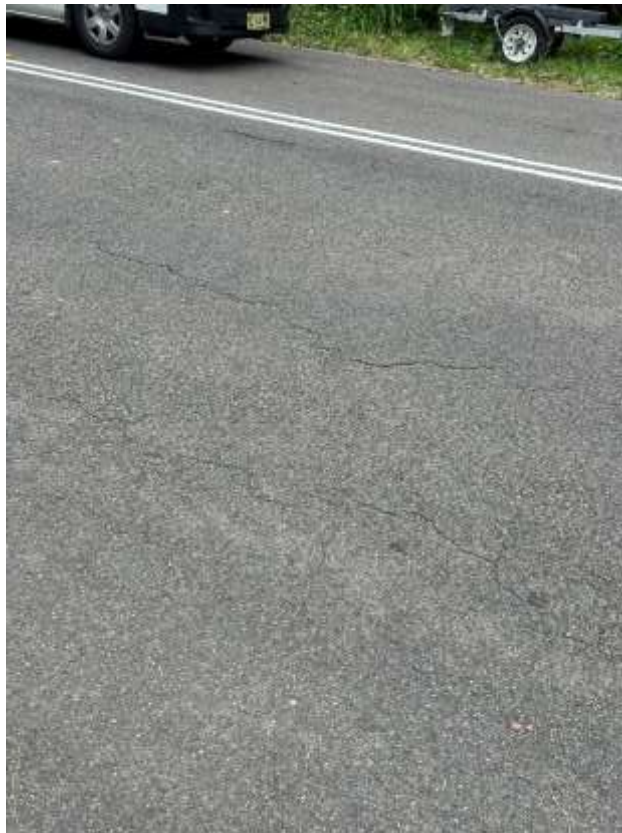
*Figure 102 – Crack is evident to the road outside 86 Warriewood Road Warriewood.*

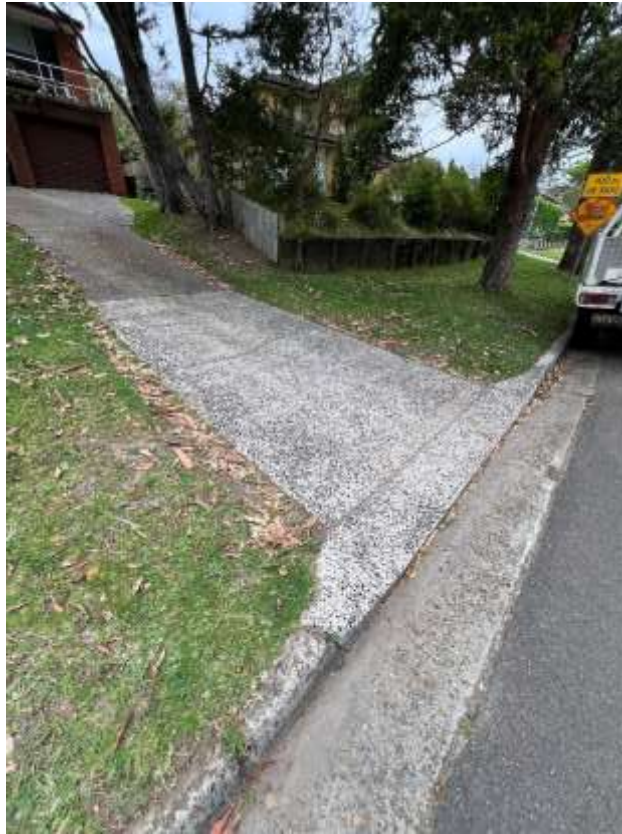
*Figure 103 – General condition of the driveway.*

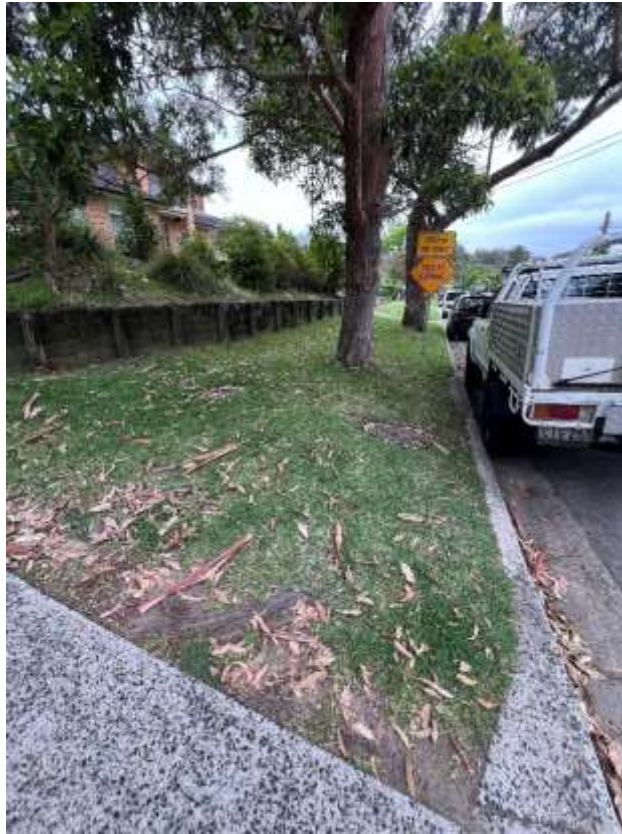
*Figure 105 – General condition of the nature strip.*

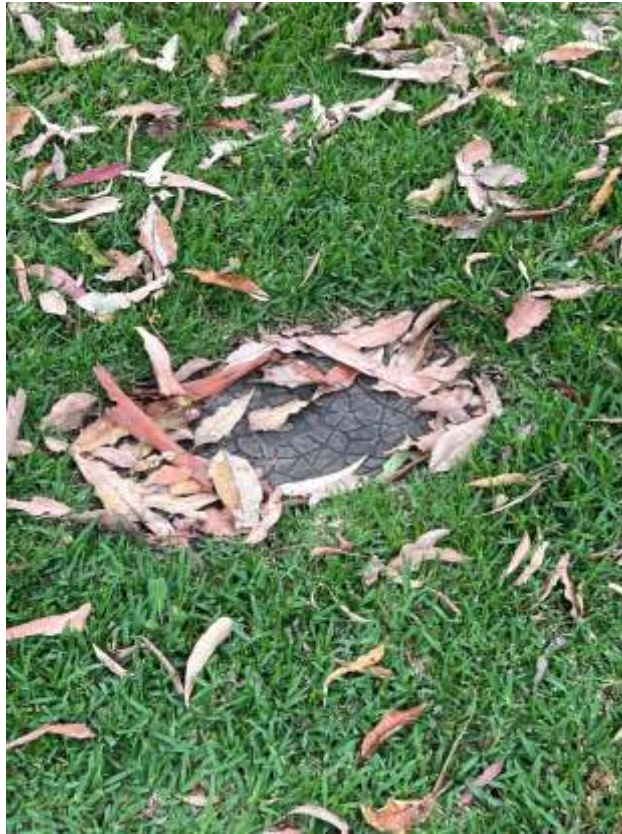
*Figure 107 – General condition of the pit.*

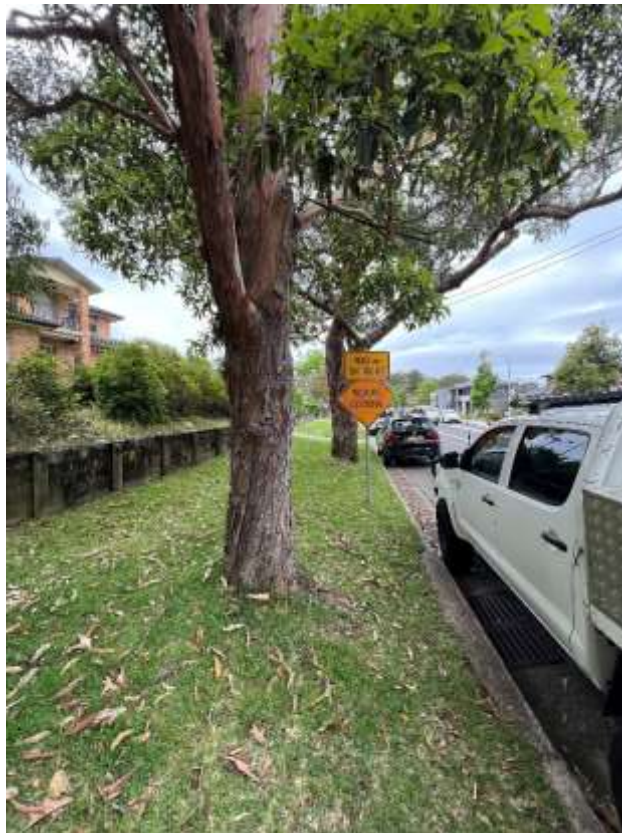
*Figure 108 – General condition of the tree.*

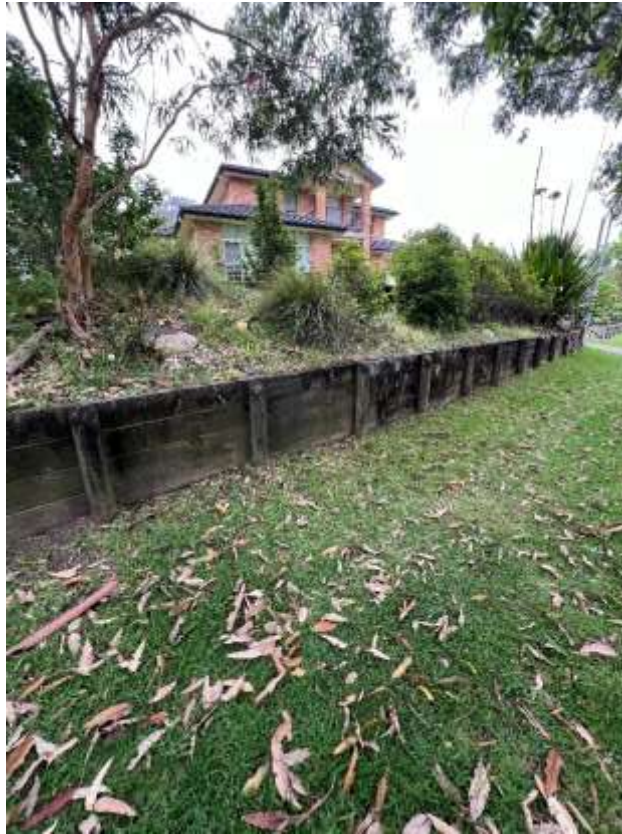
*Figure 109 – General condition of the retaining wall.*

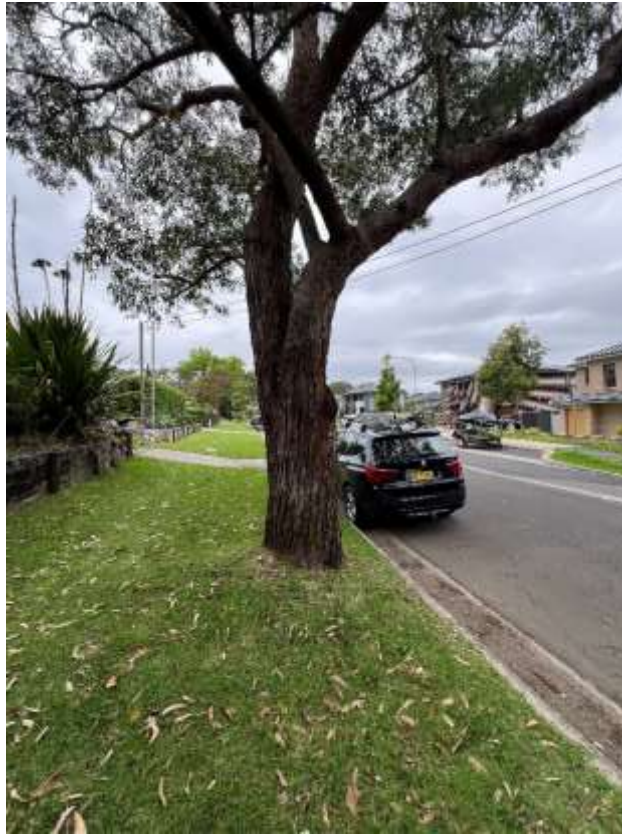
*Figure 111 – General condition of the tree.*

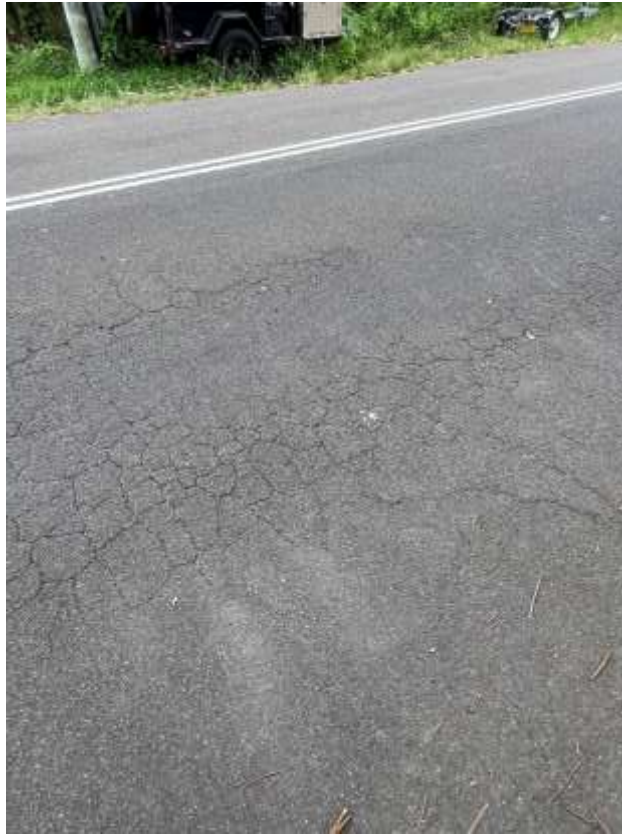
*Figure 113 – Crack is evident to the road outside 84 Warriewood Road Warriewood.*

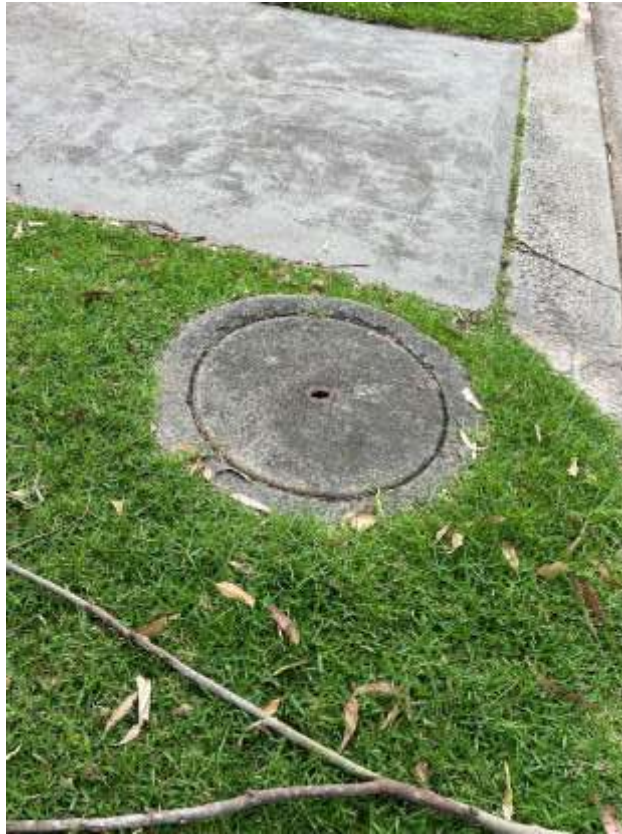
*Figure 115 – General condition of the pit.*

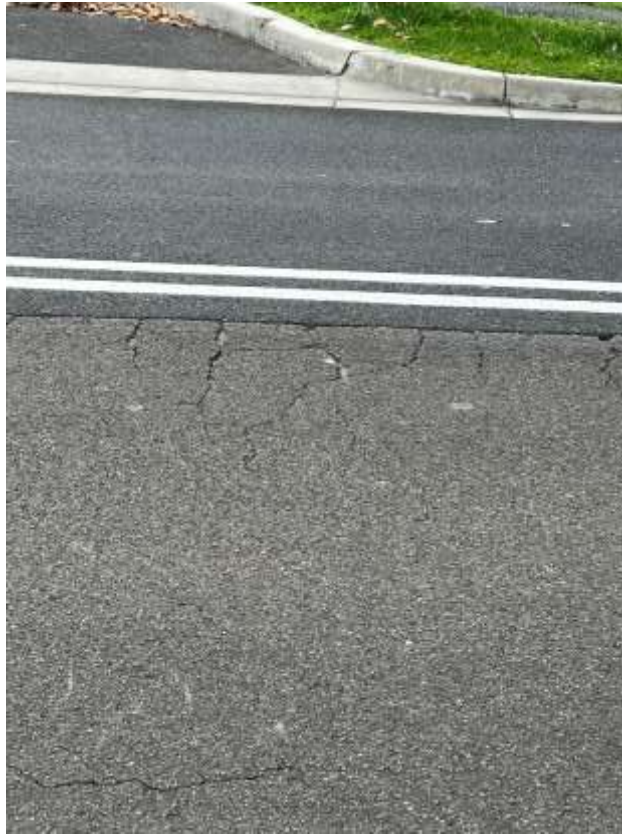
*Figure 117 – Crack is evident to the road outside 84 Warriewood Road Warriewood.*

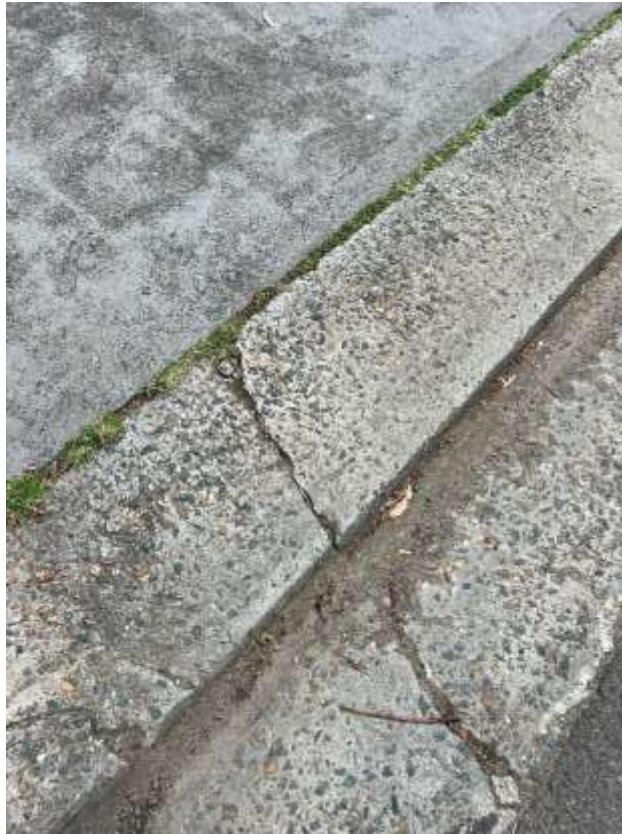
*Figure 119 – Crack is evident to the layback outside 84 Warriewood Road Warriewood.*

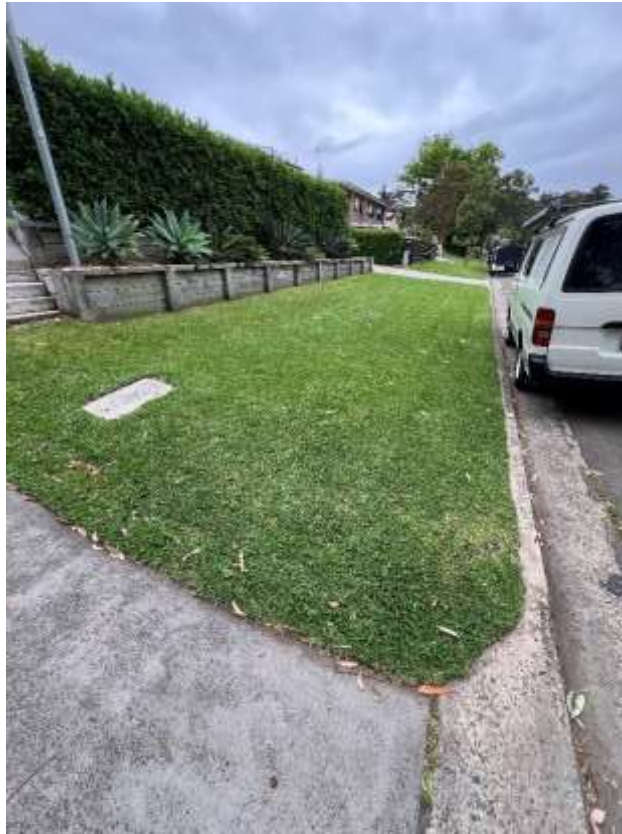
*Figure 121 – General condition of the nature strip.*

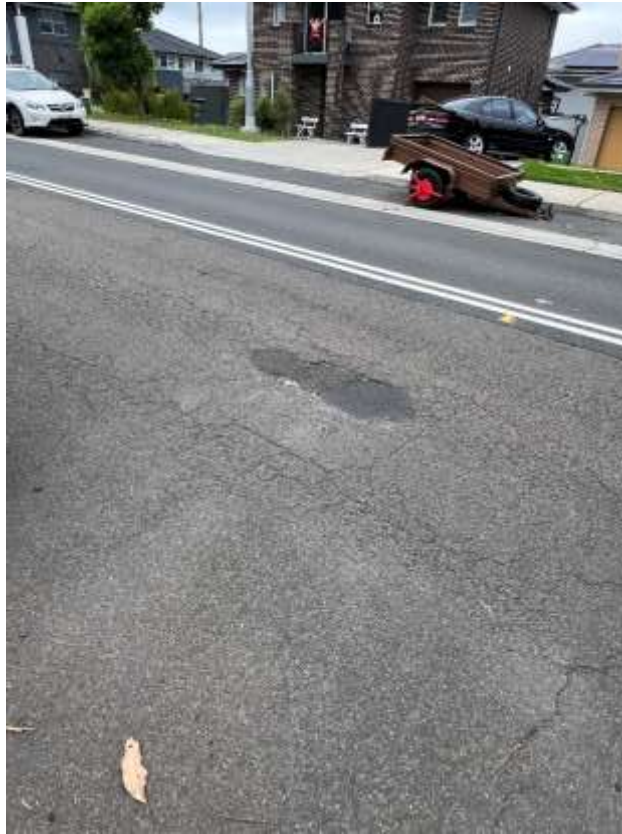
*Figure 123 – Crack is evident to the road outside 82 Warriewood Road Warriewood.*

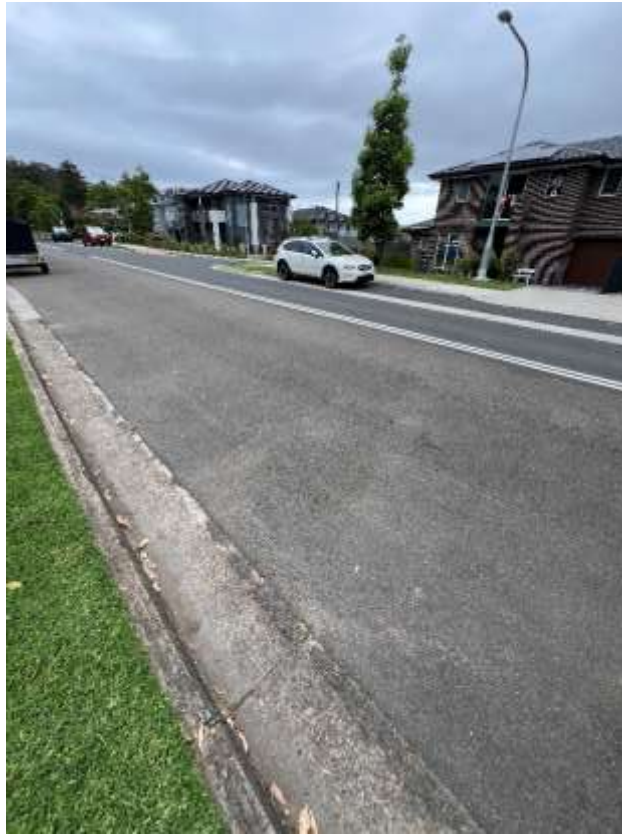
*Figure 125 – Crack is evident to the road outside 82 Warriewood Road Warriewood.*

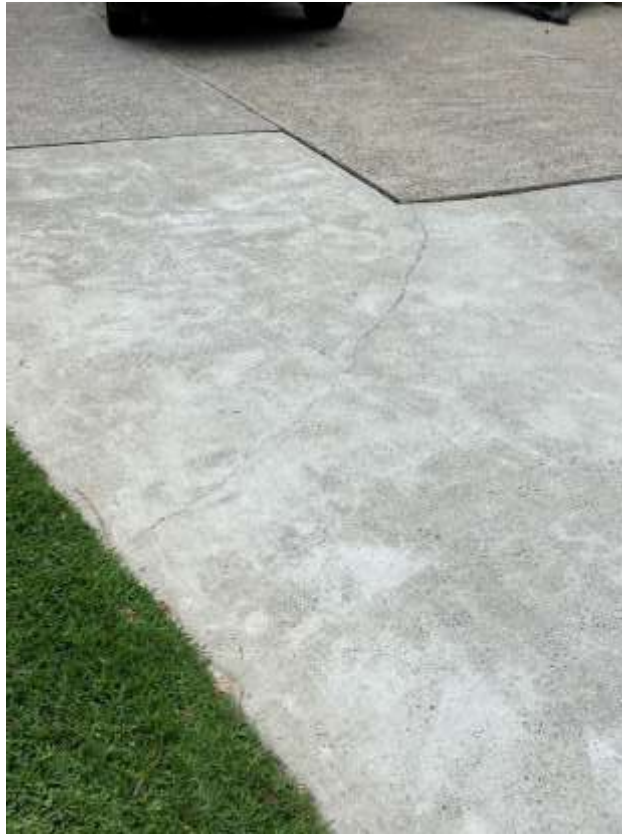
*Figure 127 – Crack is evident to the driveway outside 82 Warriewood Road Warriewood.*

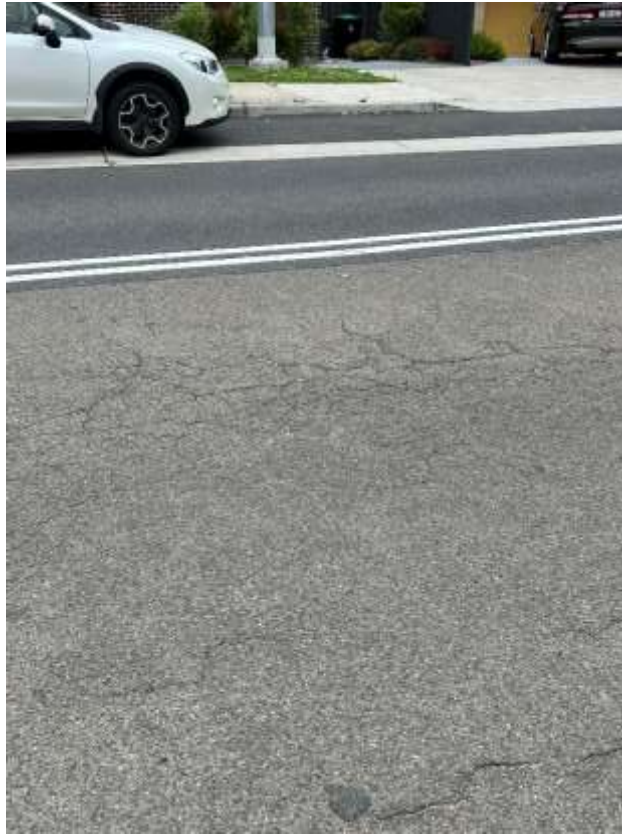
*Figure 129 – Crack is evident to the road outside 82 Warriewood Road Warriewood.*

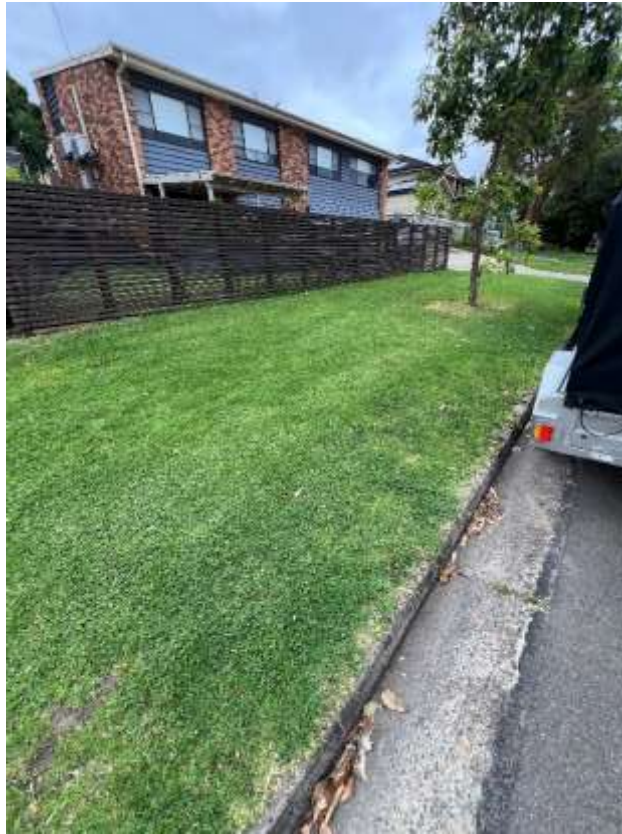
*Figure 131 – General condition of the kerb/nature strip.*

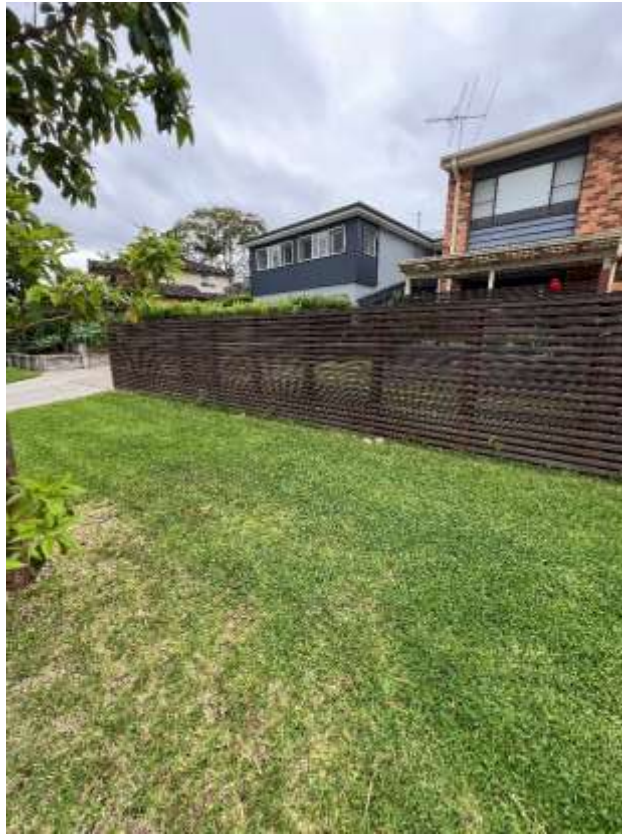
*Figure 133 – General condition of the nature strip.*

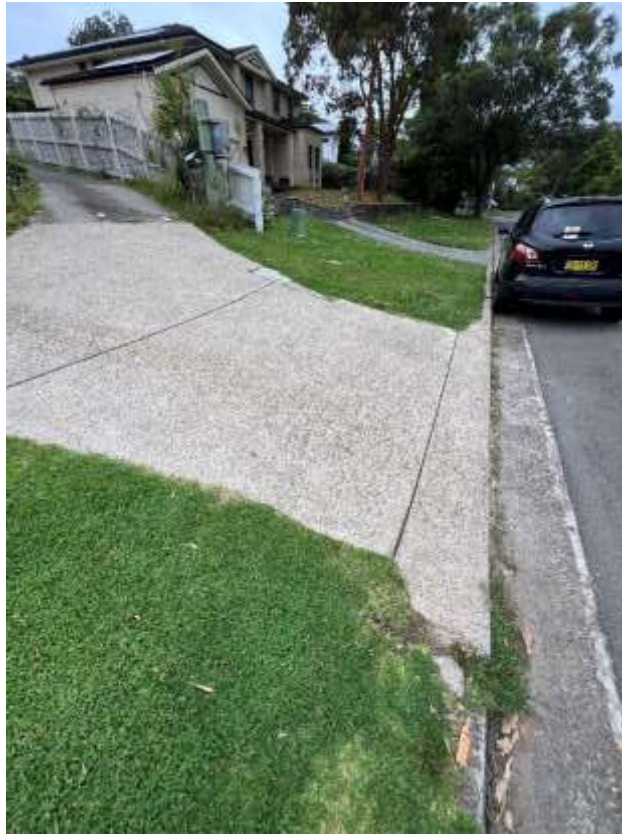
*Figure 135 – General condition of the driveway.*

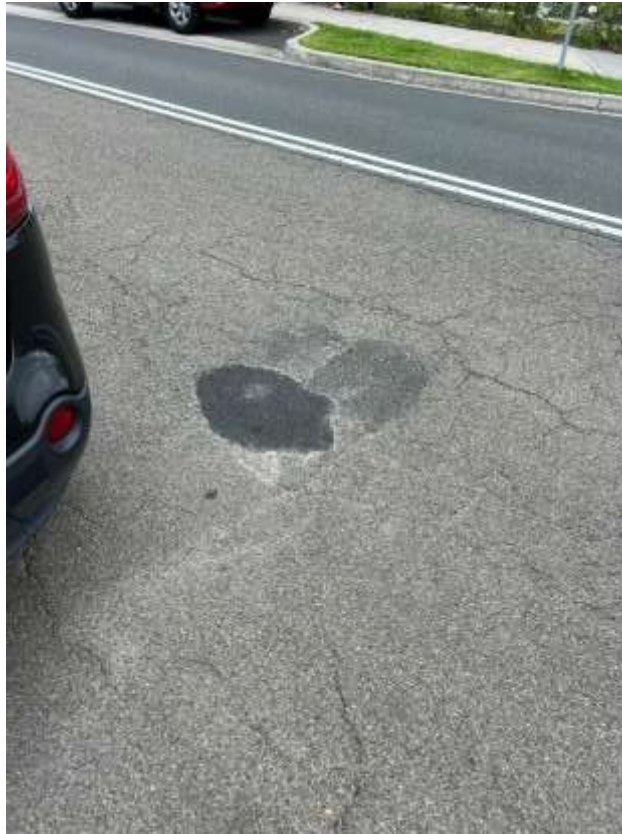
*Figure 137 – Crack is evident to the road outside 80 Warriewood Road Warriewood.*

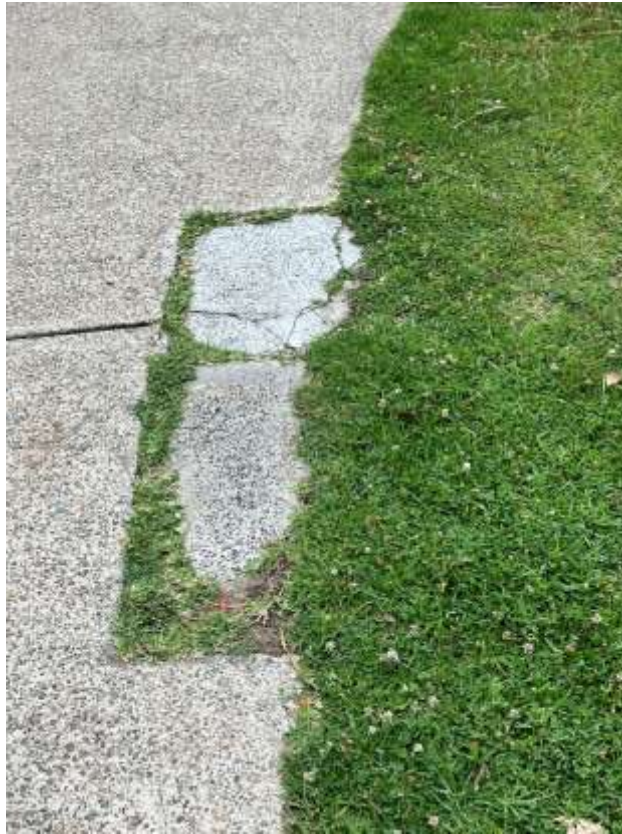
*Figure 139 – Crack is evident to the pit outside 80 Warriewood Road Warriewood.*
