Review of Future Maintenance and Upkeep Cost for Brookvale Oval

May 2010

Prepared for the Warringah Council

Prepared By –
Waypoint Pty Ltd
Suite 2, Level 1
197 Bay Street
Brighton Victoria 3186
Phone – 03 9595 6007

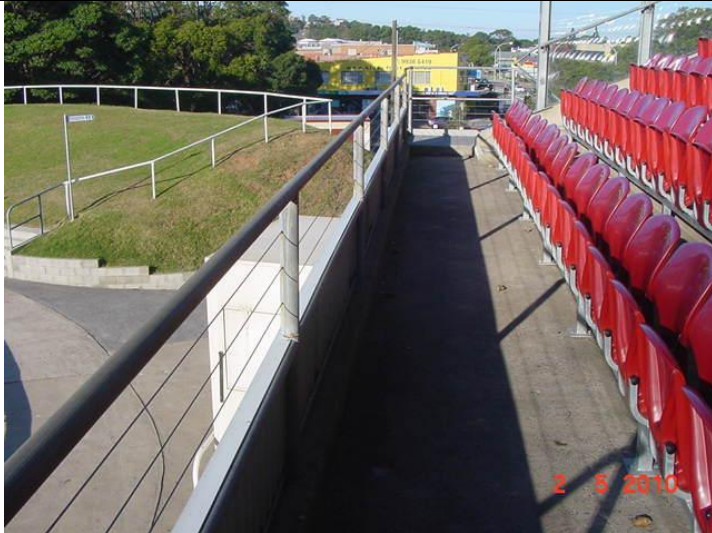
Photo 7

View of the lower aisle with sufficient width. The balustrade does not meet D2.16h(ii)A requirements of the BCA as openings to the tensioned wires exceed 125mm

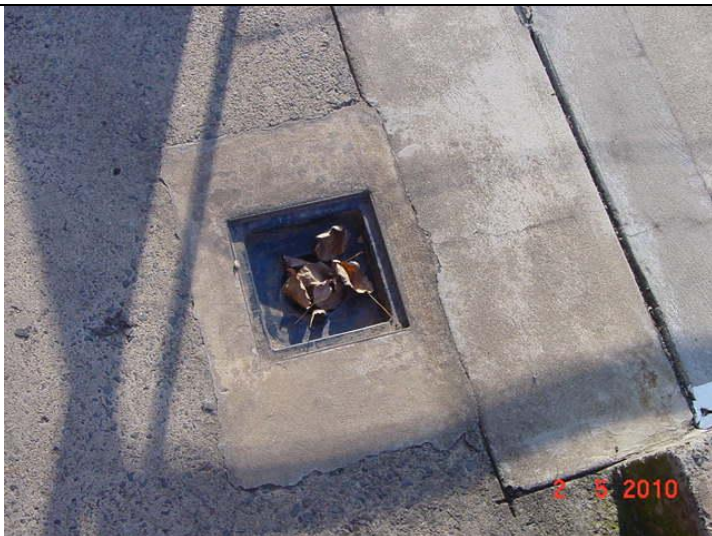
Photo 8

View of missing grate to the lower aisle

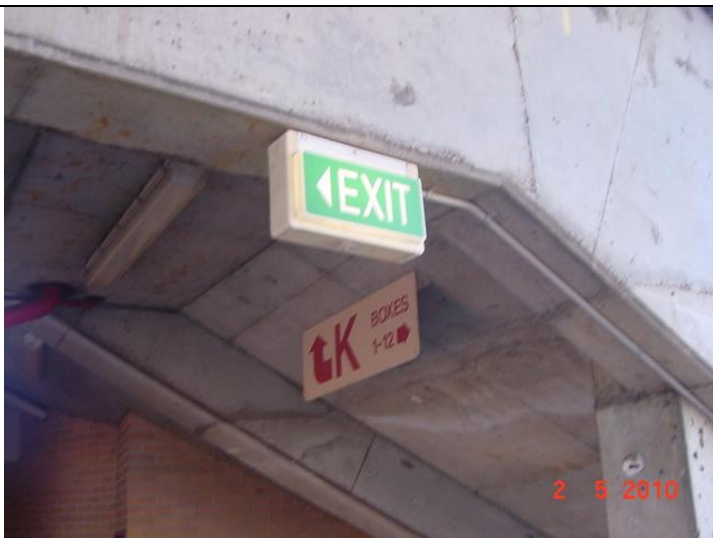
Photo 21

View of illuminated exit sign west
end above the Athurson stand exit.
No other exit signs are provided to
the stand

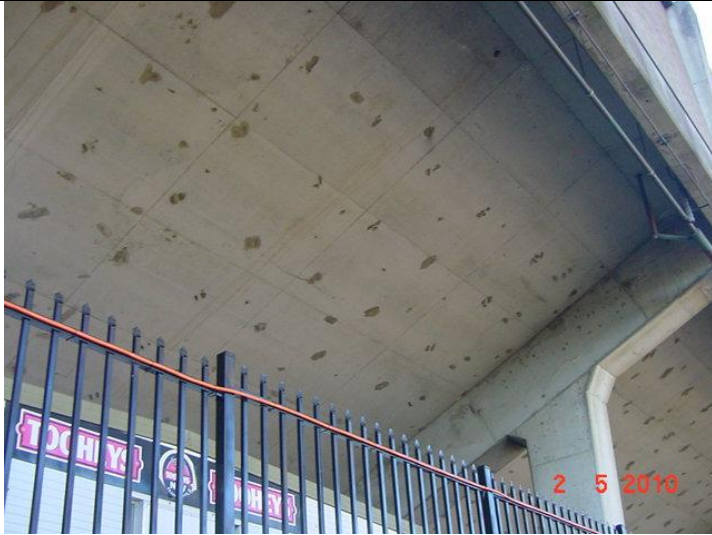
Photo 22

View of patched concrete to the underside of the stand which is recommended to be painted

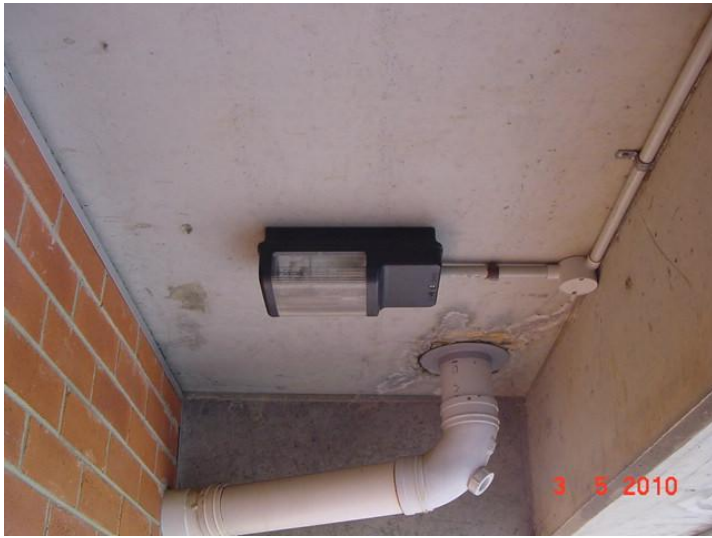
Photo 25

View of lighting to the exterior of the ground level toilets

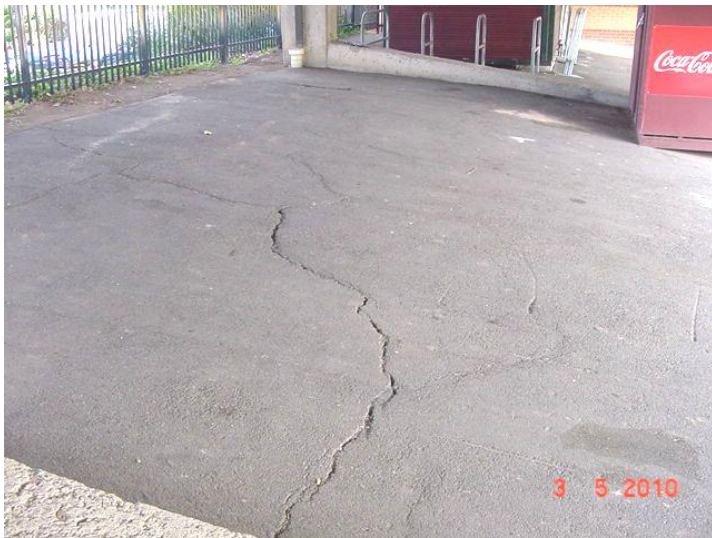
Photo 26

View of cracked asphalt pavement under the stand

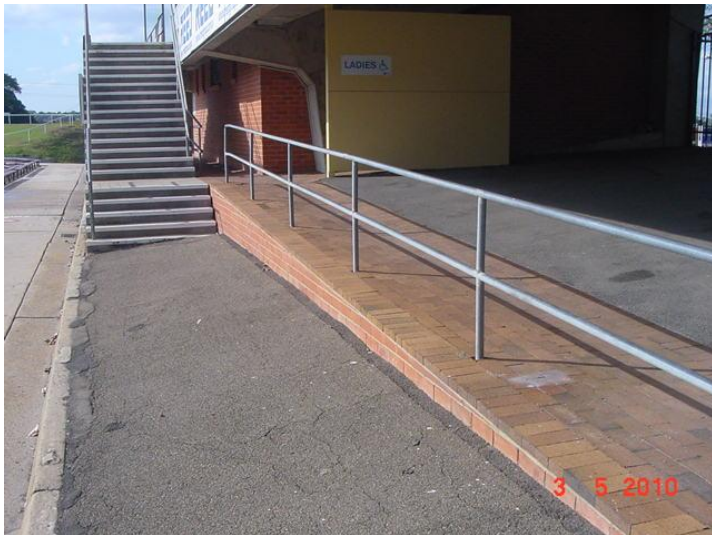
Photo 29

View of northern exit stairs and adjoining ramp to the ground level toilets. The ramp does not comply with AS1428.1-4 and the stairs do not comply with the BCA

- There are no gates restricting access to the entrances to the stand.
- The ground level ramps leading to the public toilets does not meet code requirements and are recommended to be replaced with new ramps with the gradient requirements of 1:14, tactile indicators and handrails to both sides.

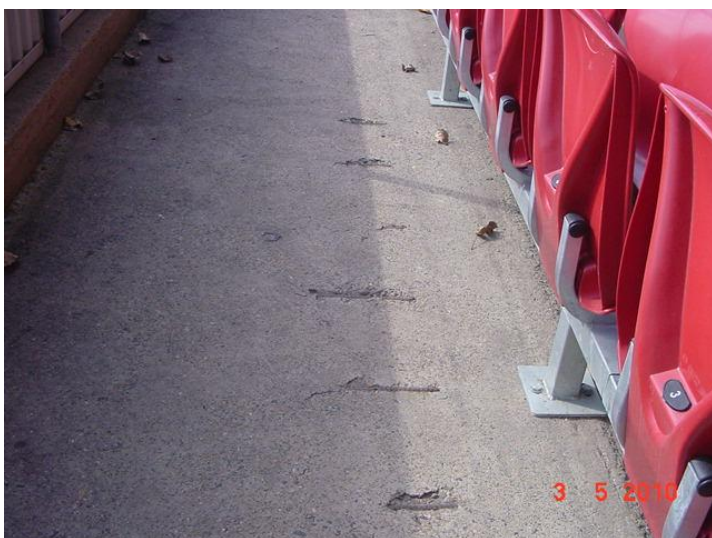
Photo 30

View of exposed concrete reinforcement to the front aisle. Refer structural report

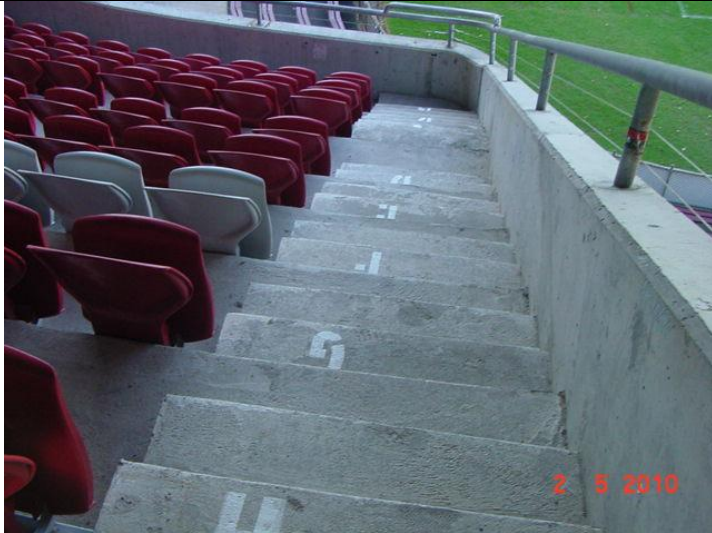
Photo 37

View of Level 2 aisle stairs without delineation of the stair nosings or tactile indicators to AS1428.1-4 requirements. The front and side stair balustrade does not comply with D2.16h(ii)A of the BCA with openings exceeding 125mm between the horizontal wires. Where the concrete section of the balustrade is less than 760mm in height and has a drop of 4 meters or more, the balustrade must meet D2.16h(ii)B requirements and not facilitate climbing.

- Whilst vision strips are provided to all entry and aisle stair nosings, there are no tactile indicators for the vision impaired.
- Whilst handrails heights are generally to code the rail diameter and extensions do not meet code requirements. Whilst new stainless steel grab rails have been installed to select seating areas to the southern end of the stand, additional grab rails along the remaining aisle stairs would assist patron's especially ambulant disabled persons.

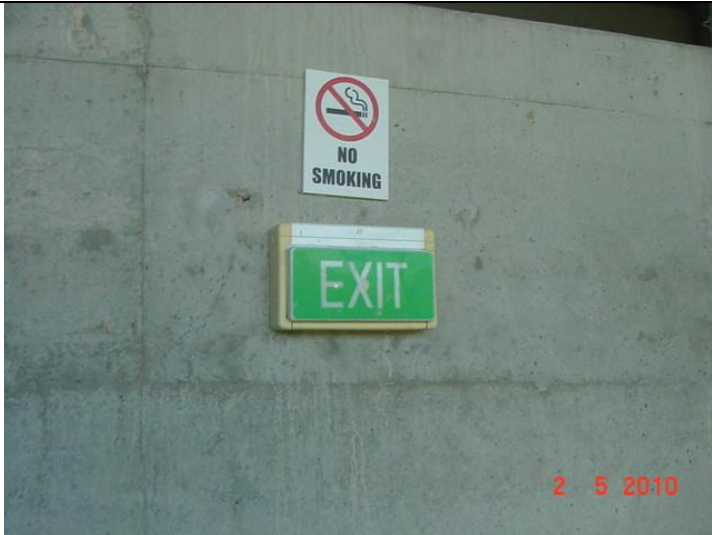
Photo 40

View of corroding exit sign to the stand. All original fittings are corroding due to sea air exposure

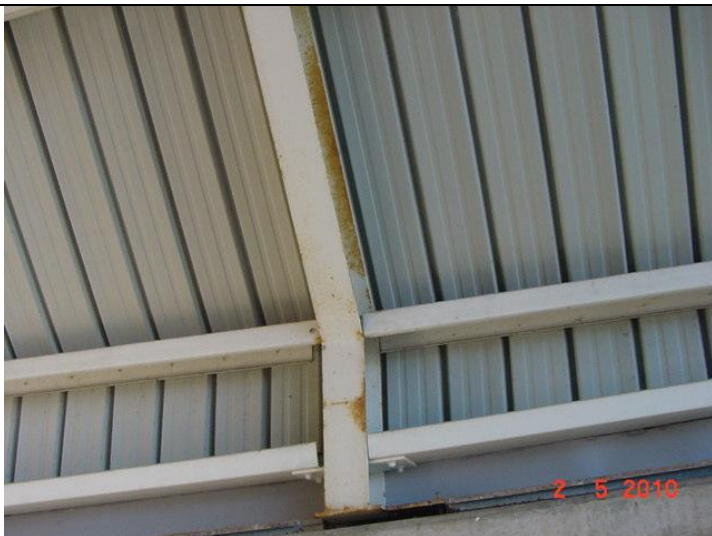
Photo 47

View of surface corrosion to the north end splayed roof. The splayed roofing is also recommended in the structural report to be replaced

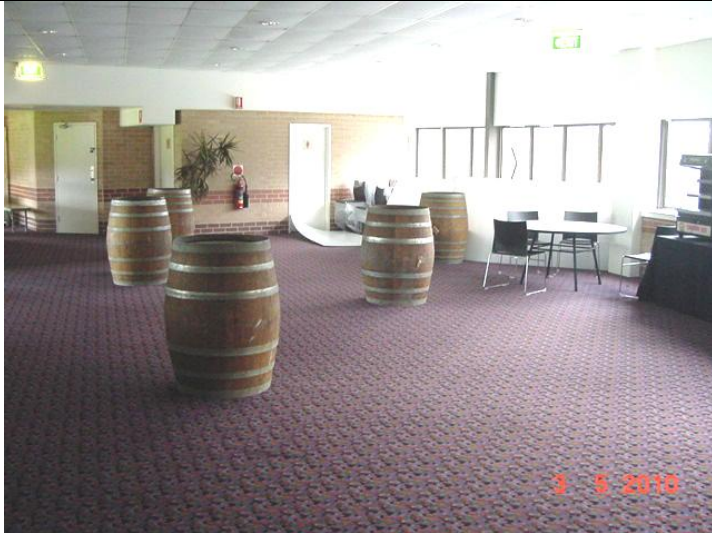
Photo 52

View of un-renovated President's Lounge (south end) in average condition with older carpet, original ceiling (with warped panels) and lighting

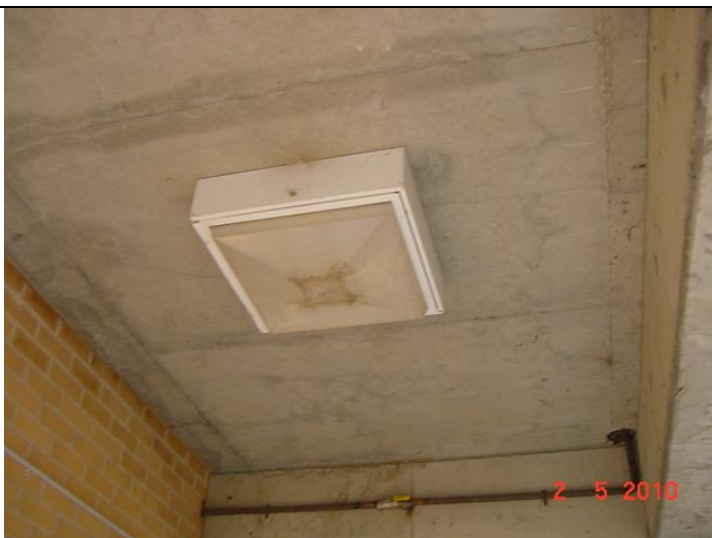
Photo 59

View of original light fittings at ground level which is recommended for replacement in the short term

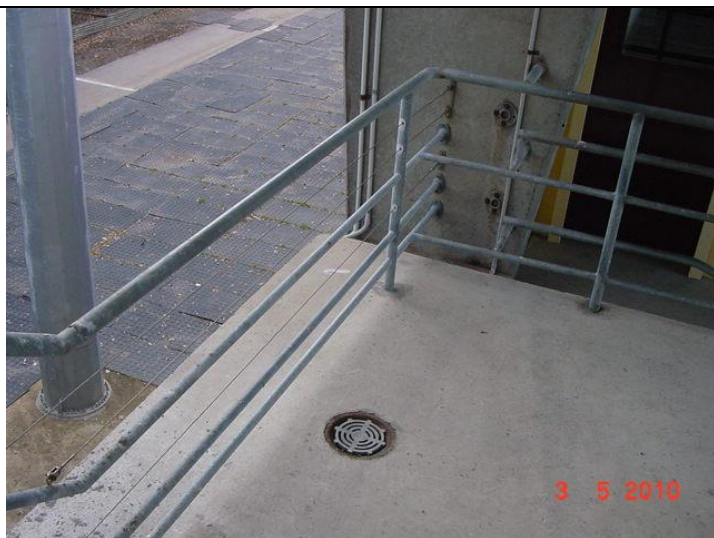
Photo 65

View of low height balustrade (under 1000mm) to a low level exit stair landing. The rails are recommended to be raised a minimum 1000mm above the landing.

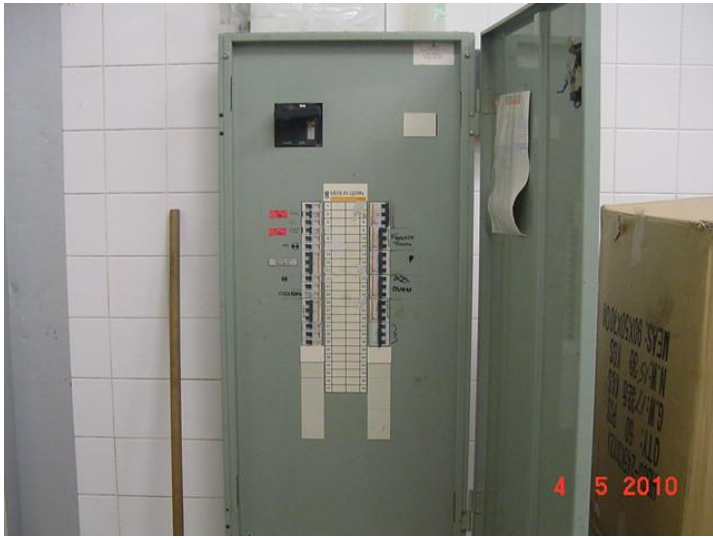
Photo 67

View of ground level kitchen original electrical distribution board

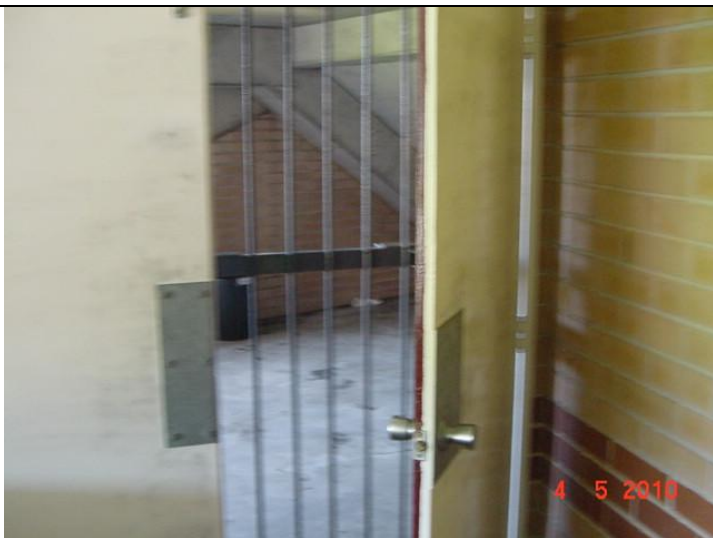
Photo 69

View of padlocked grille blocking safe egress from the south exit of the President's Lounge. The grille gates are recommended to be removed

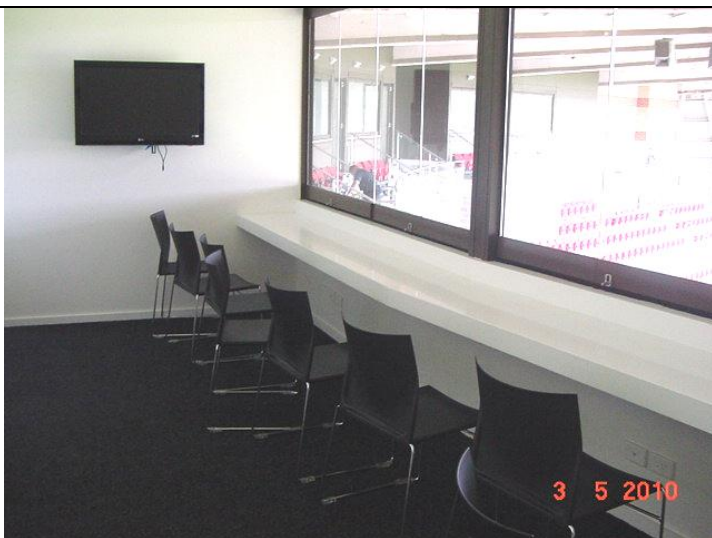
Photo 71

View of recently constructed box to Level 3

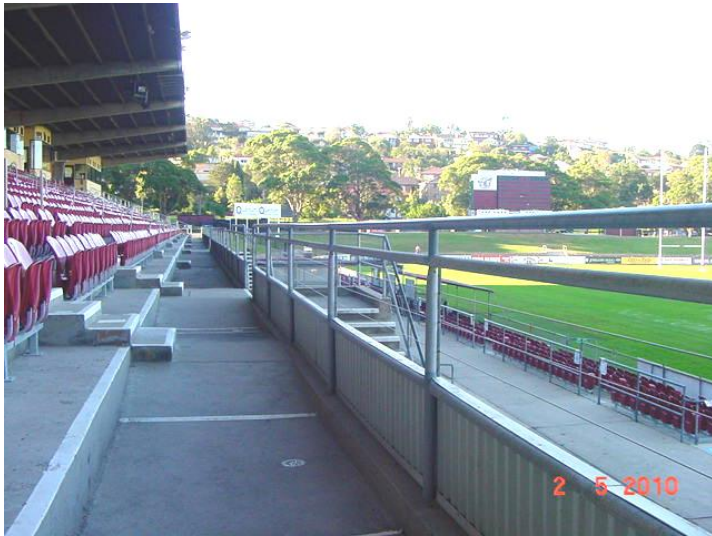
Photo 74

View of the front balustrade to the stand which does not comply with D2.16h(ii)A with openings exceeding 125mm. Whilst the balustrade is climbable the drop is less than 4.0m as stipulated in D2.16h(ii)B. Additional wires with higher tensioning is required to Table D2.16a. Note delineation of the stair nosing, but no tactile indicators to the base of the stairs (only to the ramps).

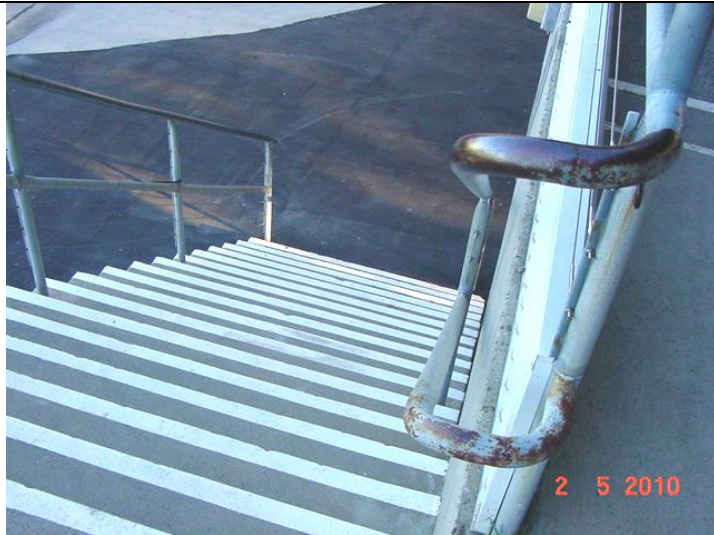
Photo 76

View of front exit stairs with delineation of stair nosings but no tactile indicators. The stair balustrades have tension wires whilst the landings have wires and weldmesh

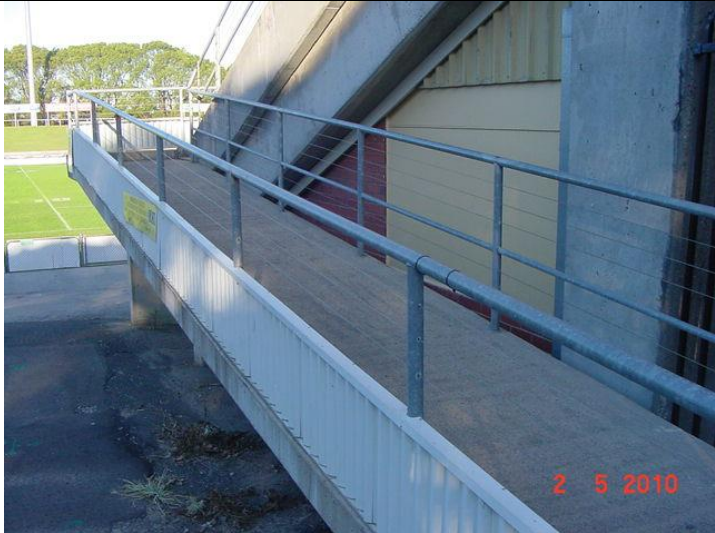
Photo 79

View of the north elevation ramp. The length of the ramp and the design of the hand rails do not comply with AS1428/1-4. Tactile indicators are also required. Access from the car park or other parts of the ground to the base of the ramp does not comply with the Code. Note stand balustrade along the tiered seating does not comply with the BCA although drop is less than 4 meters.

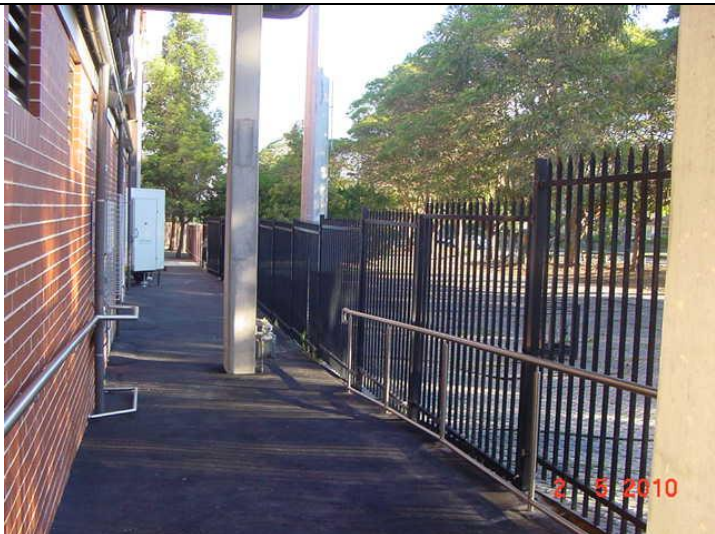
Photo 81

View of south elevation ramp. Configuration of the ramps is to Code but handrails do not meet Code requirements and tactile indicators are required at the top, base and landing. The handrail to the RHS of the mid landing has insufficient offset from the wall

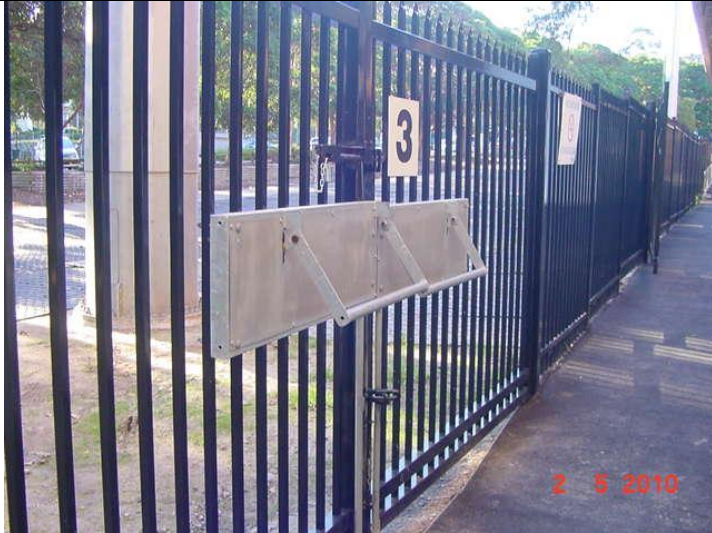
Photo 82

View of rear path showing support rails along the sloped section but not to Code

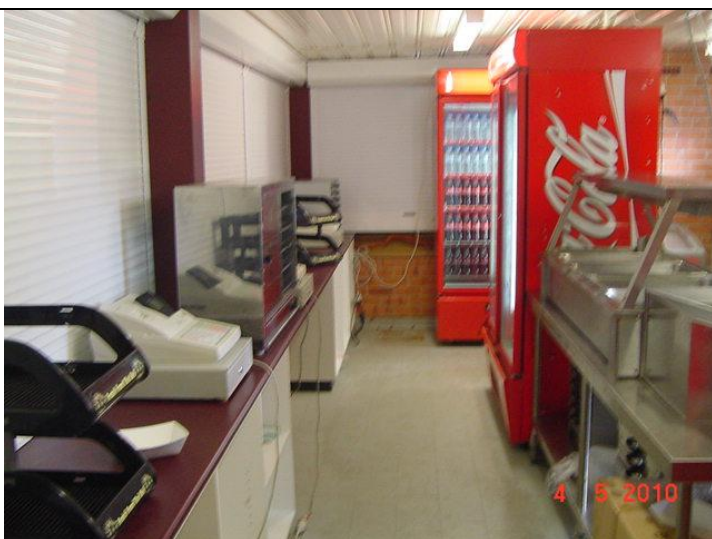
Photo 111

View of kiosk serving area to the ground level

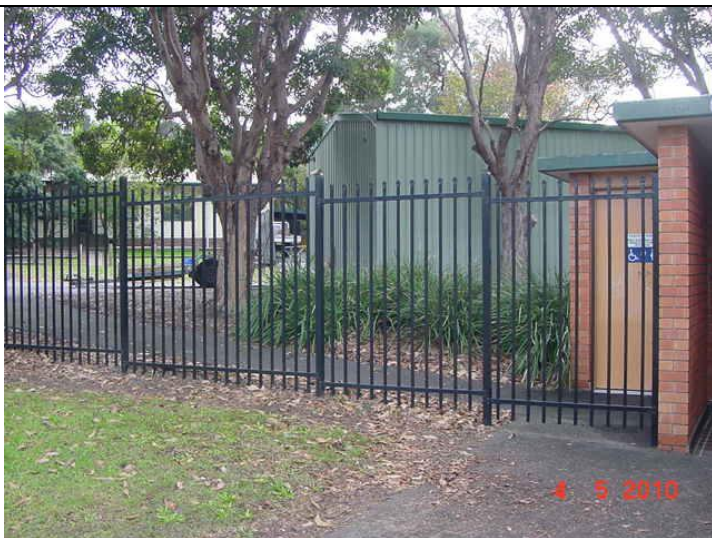
Photo 117

View of solid brick public male, female and disabled toilet block with concrete roof. The building is in good condition for its age

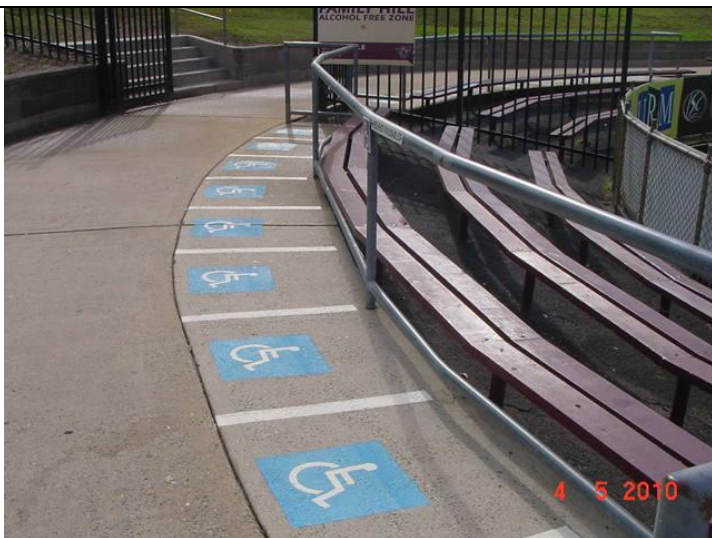
Photo 137

View of western end seating and allocated disabled wheelchair spaces to AS1428 requirements. Similar disabled seating spaces are required to the elevated grand stands

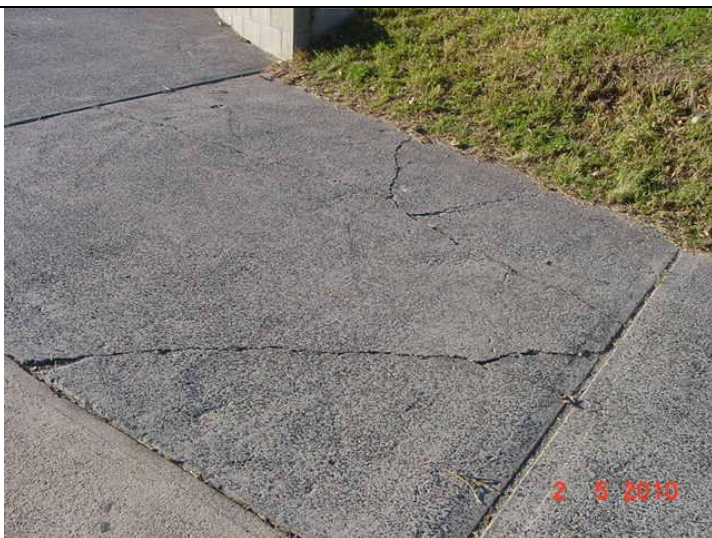
Photo 140

View of subsided pavement to the SE side of the Southern stand
