**FINAL OCCUPATION CERTIFICATE**

**CC2008-00439**

Address 213-215 Riverview Road, AVALON 2107  
Lot No Y  
DP - 110460

| Description | Demolition of existing structures & Construction of new dwelling & swimming pool |

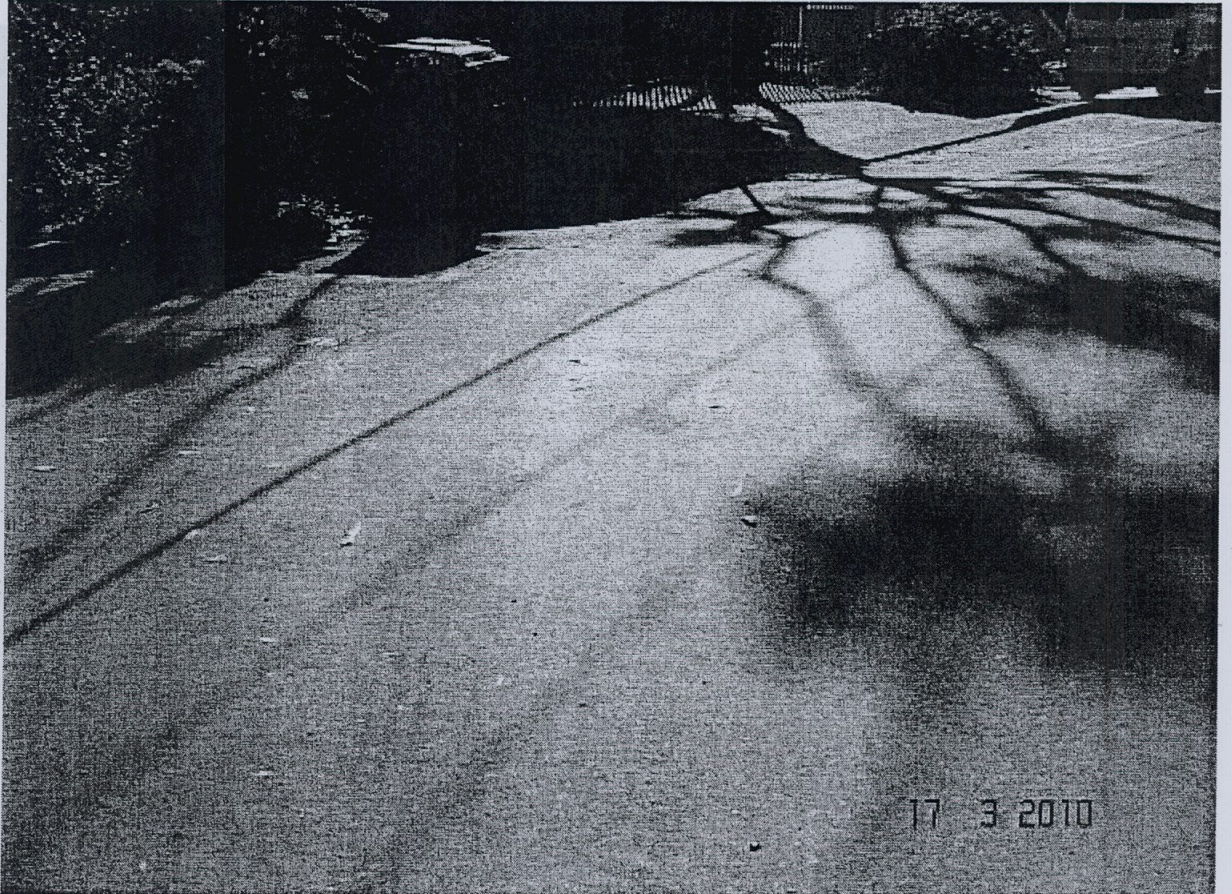
PHOTO 8: As previous.

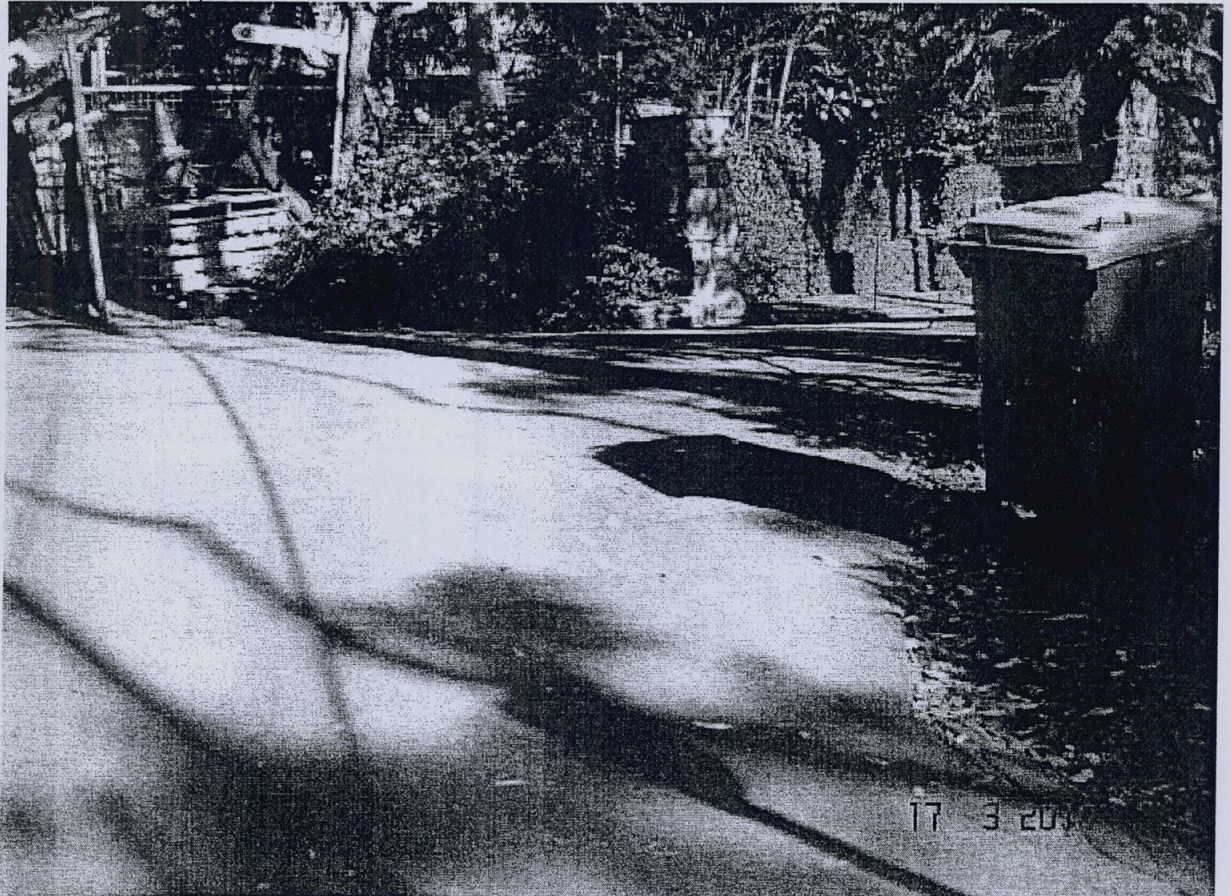
PHOTO 10: As previous.

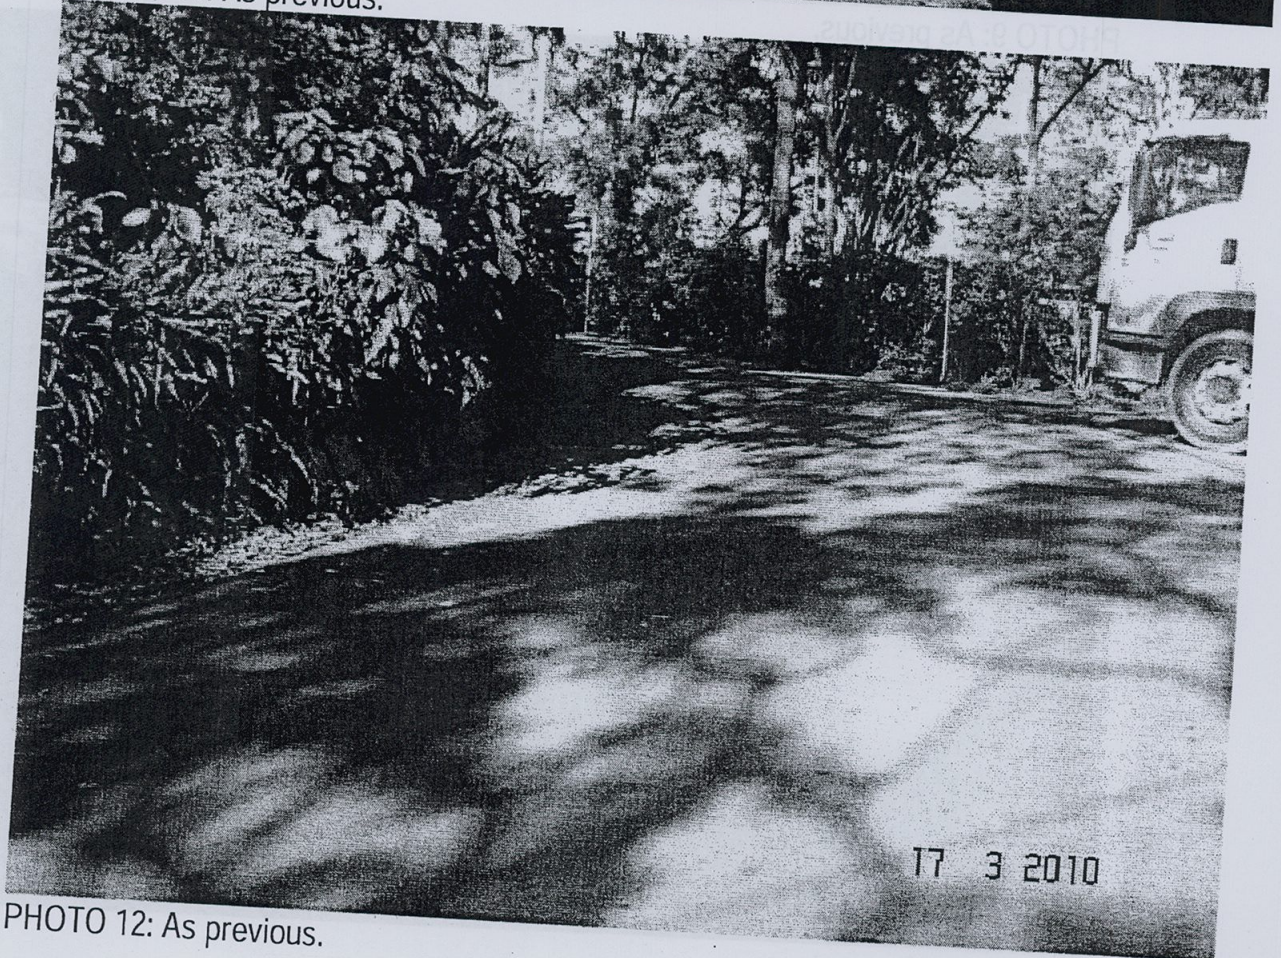
PHOTO 12: As previous.

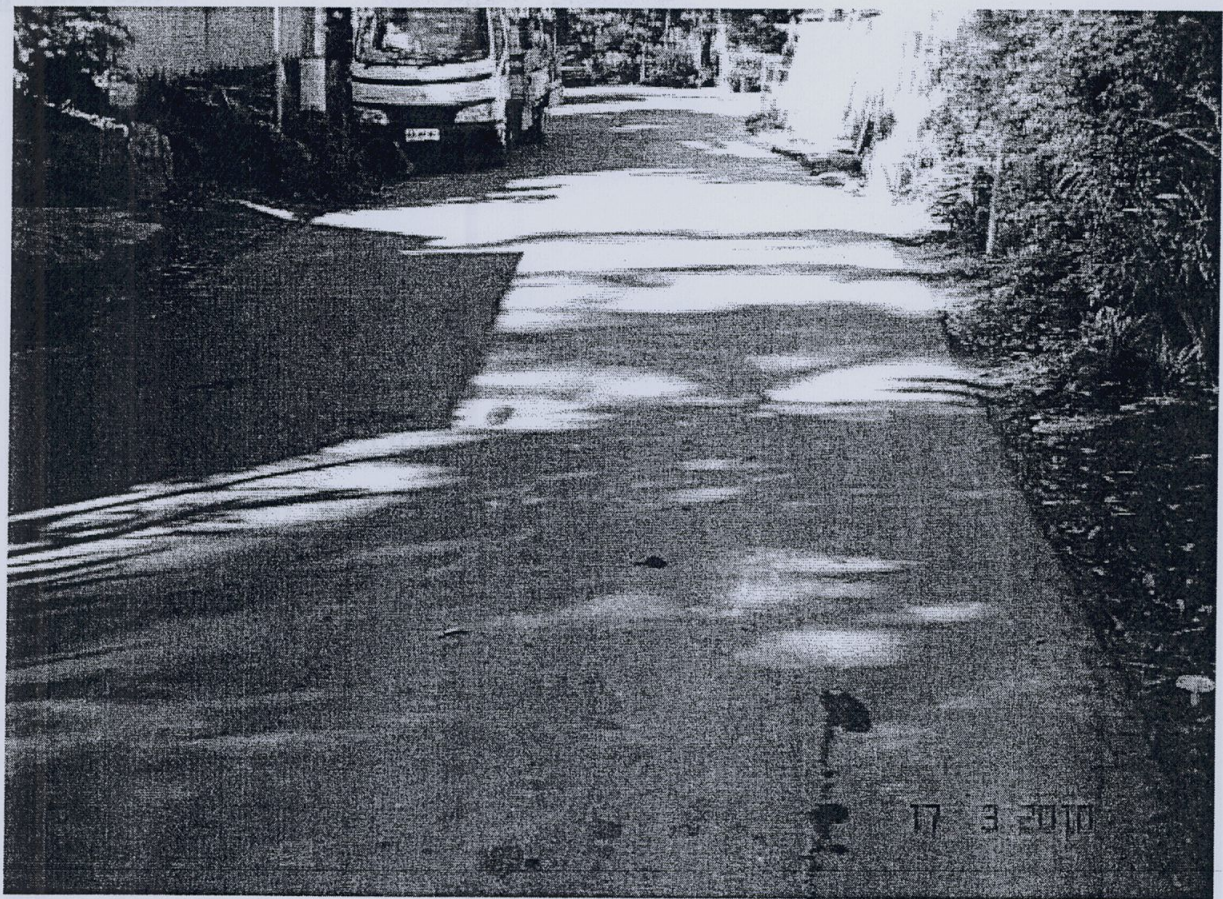
PHOTO 13: As previous.

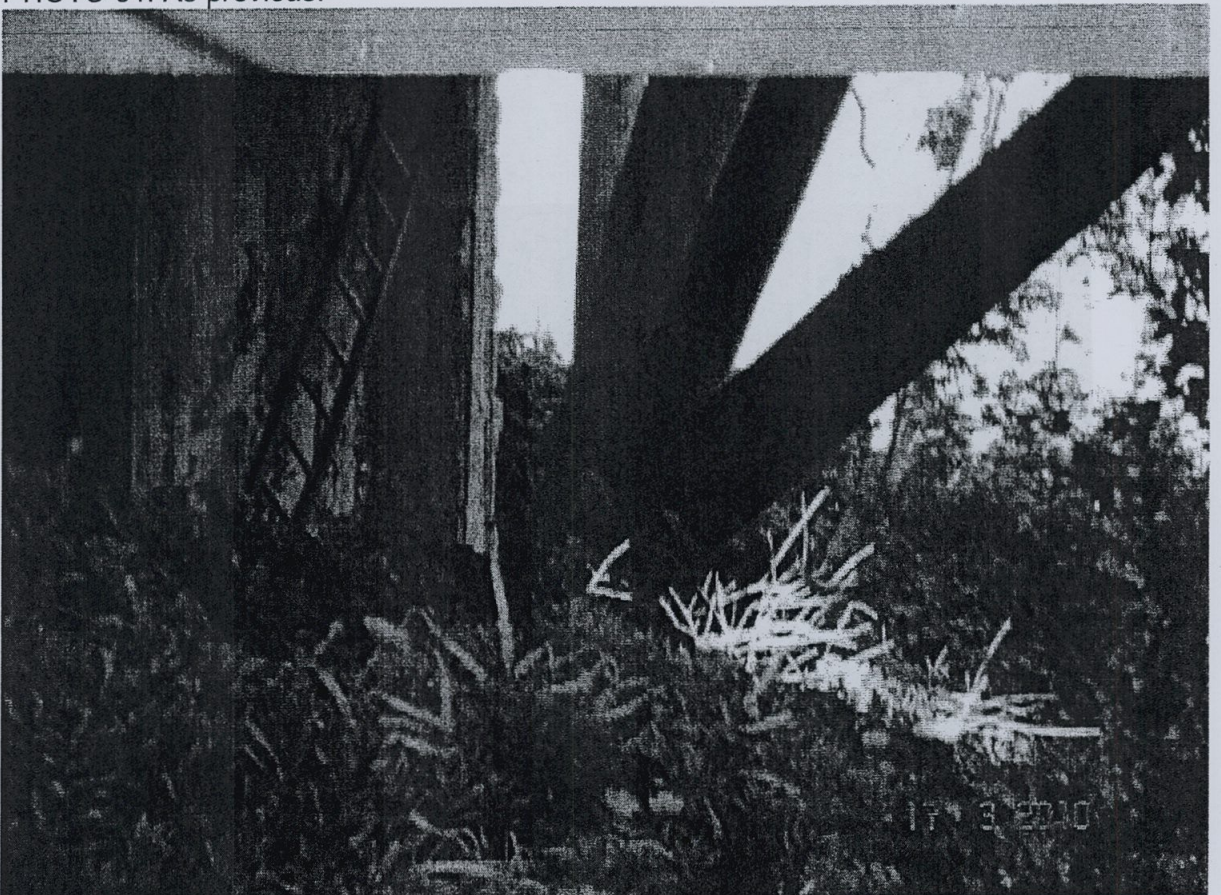
PHOTO 32: As previous.

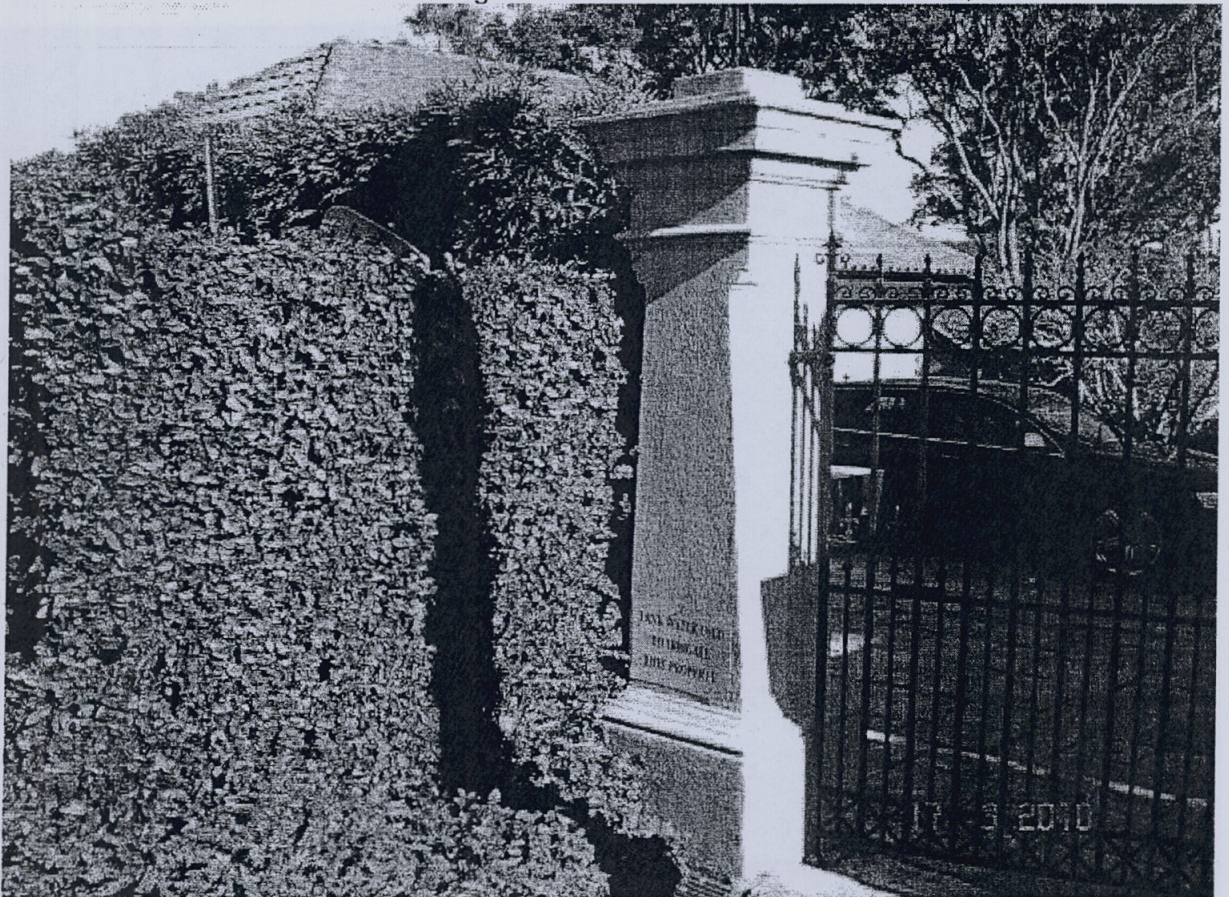
PHOTO 38: As previous.

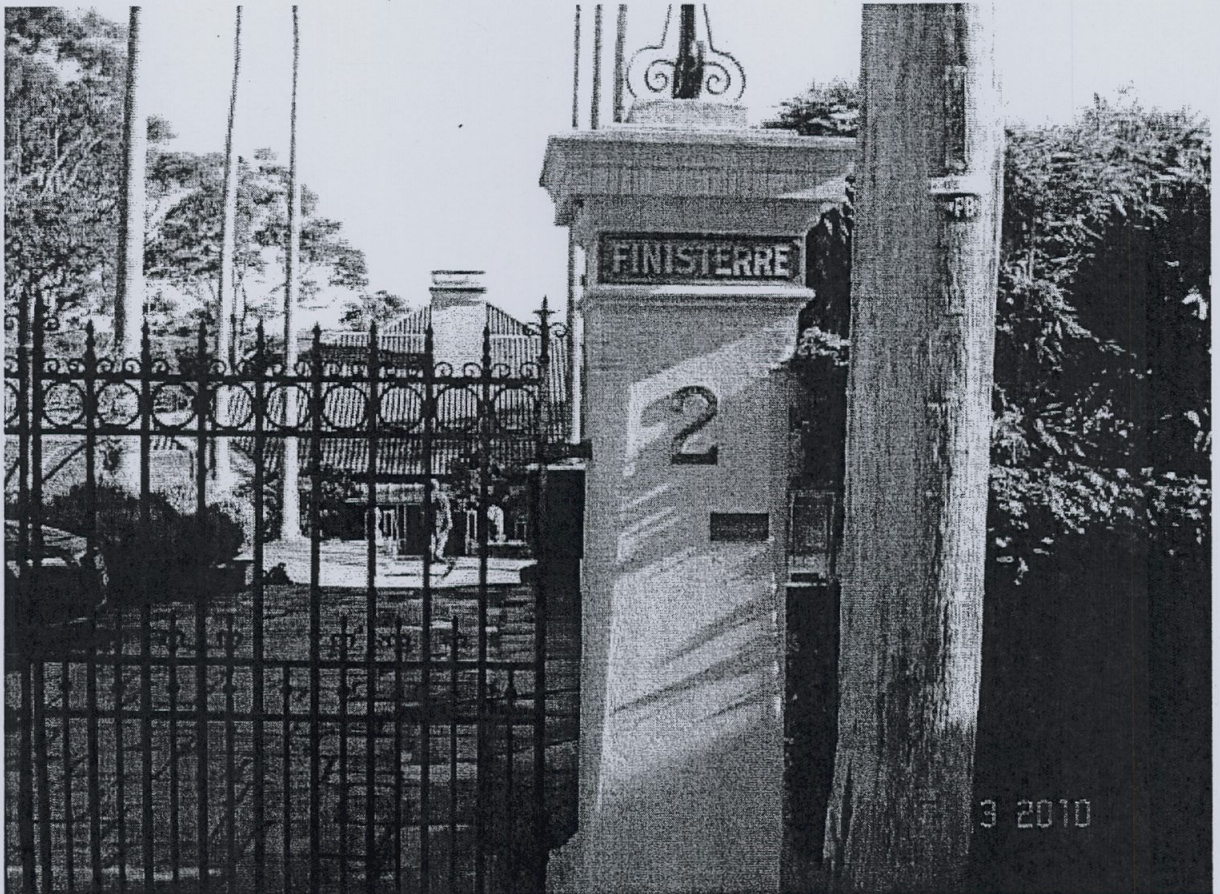
PHOTO 39: As previous.

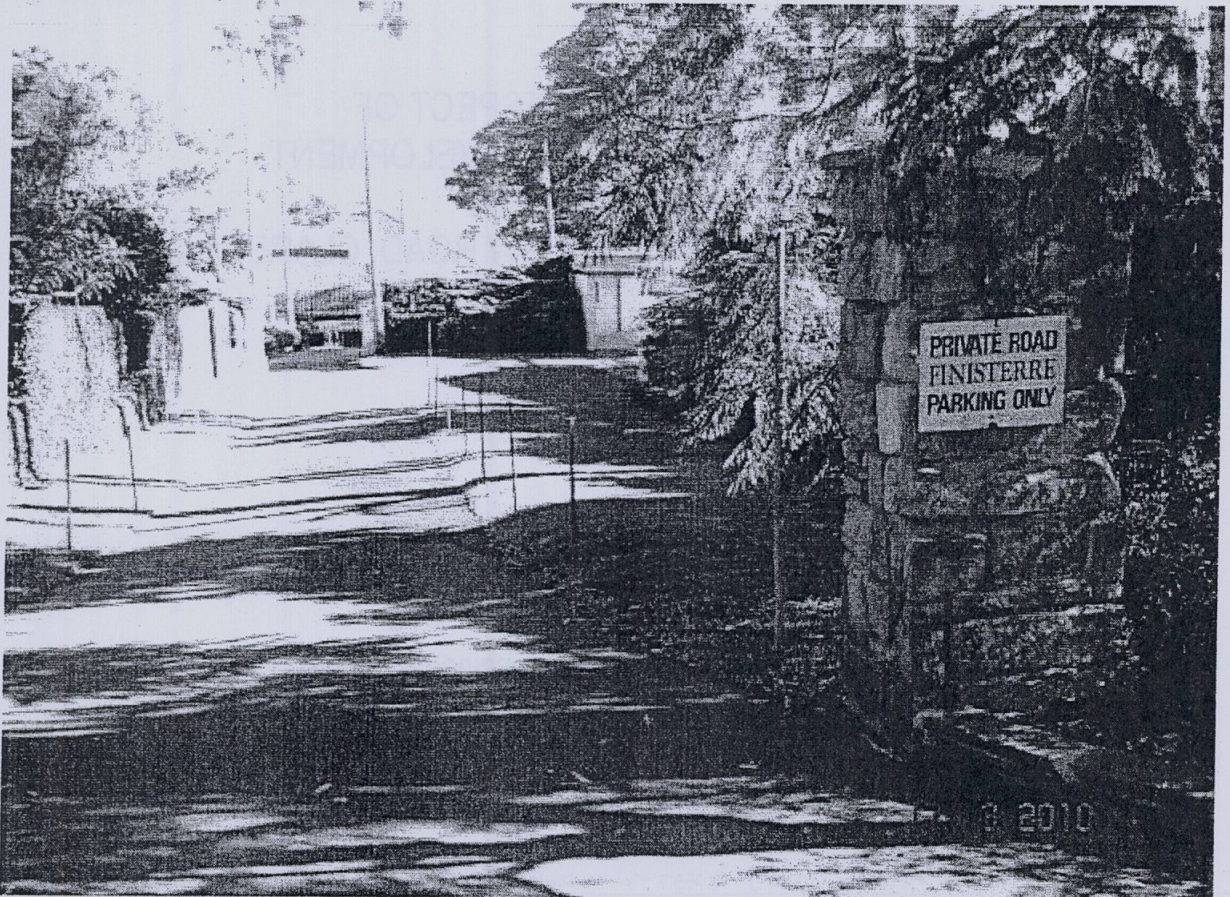
PHOTO 42: As previous.

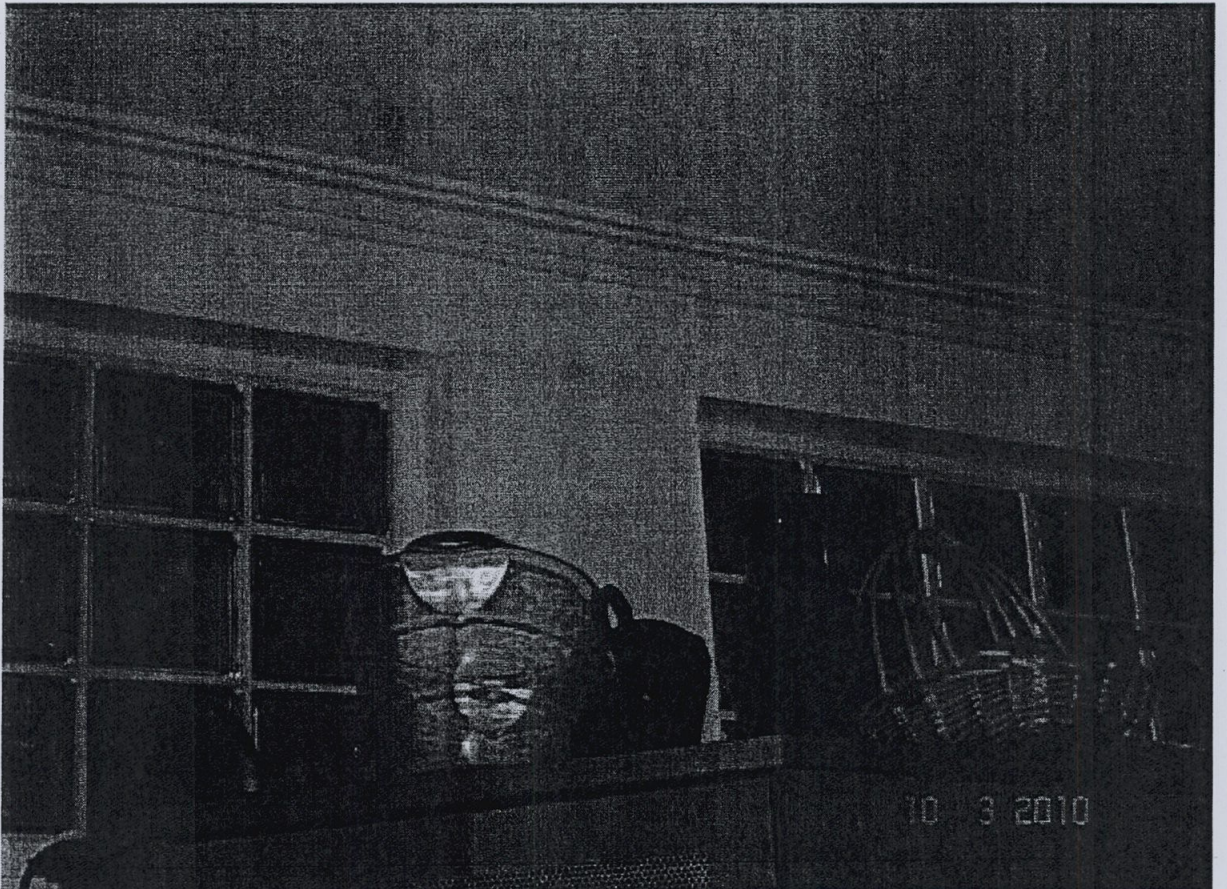
PHOTO 1: As previous.

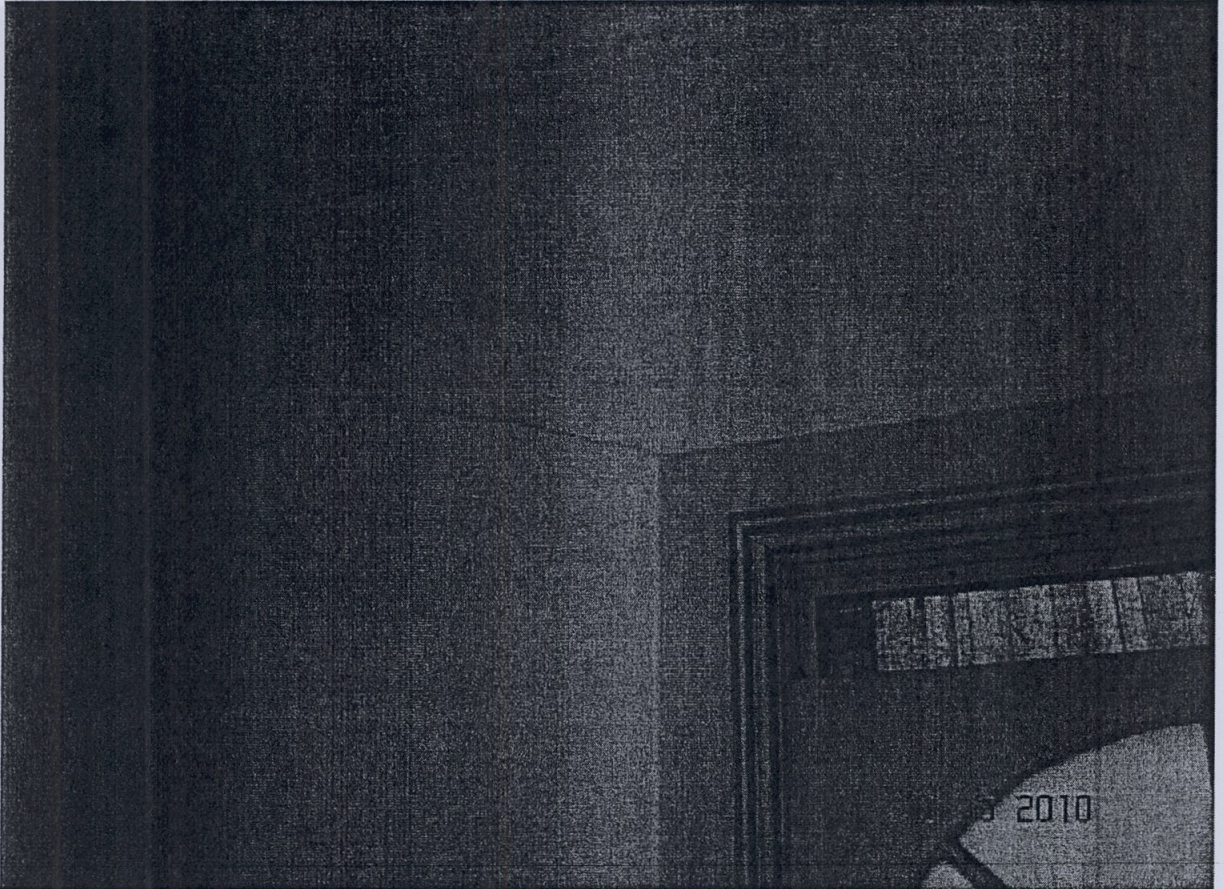
PHOTO 14: As previous.

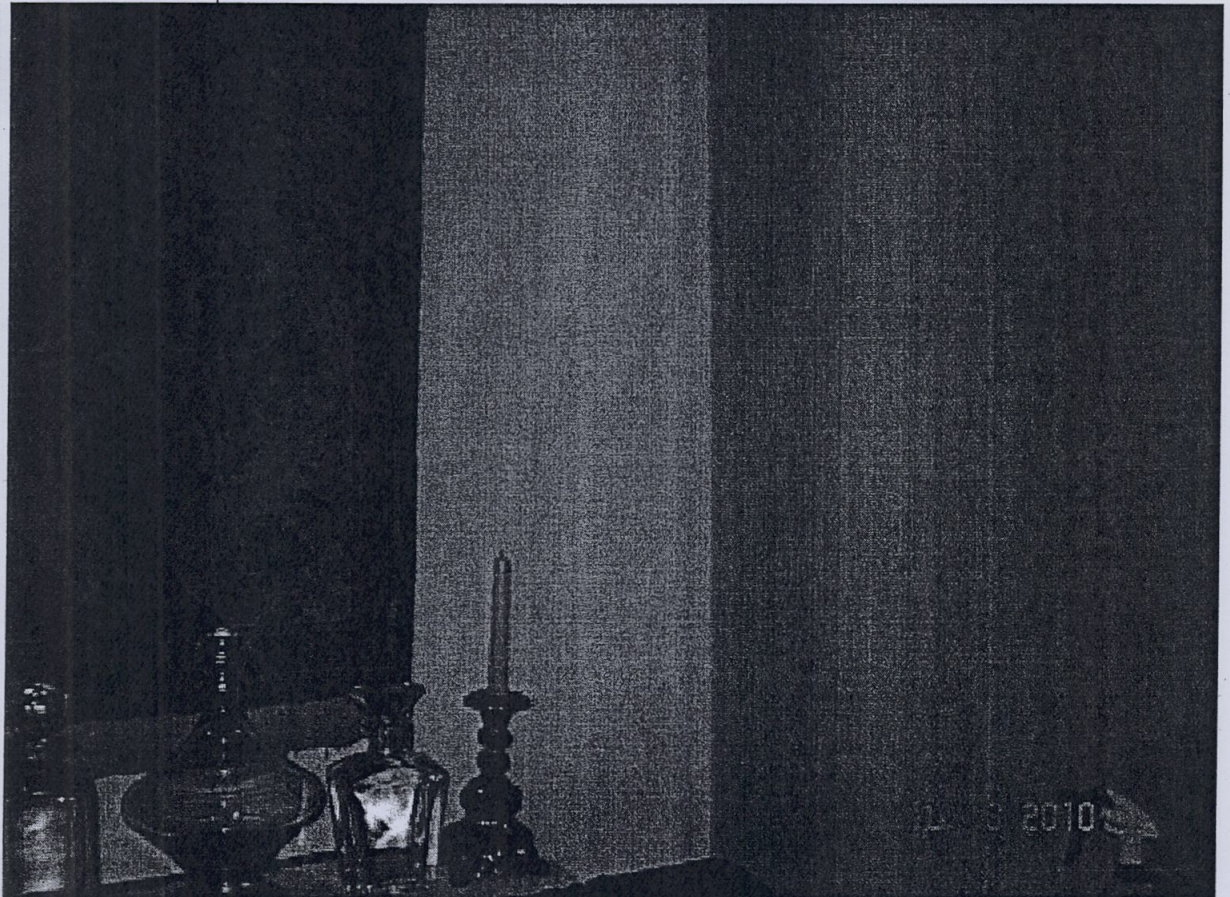
PHOTO 19: As previous.

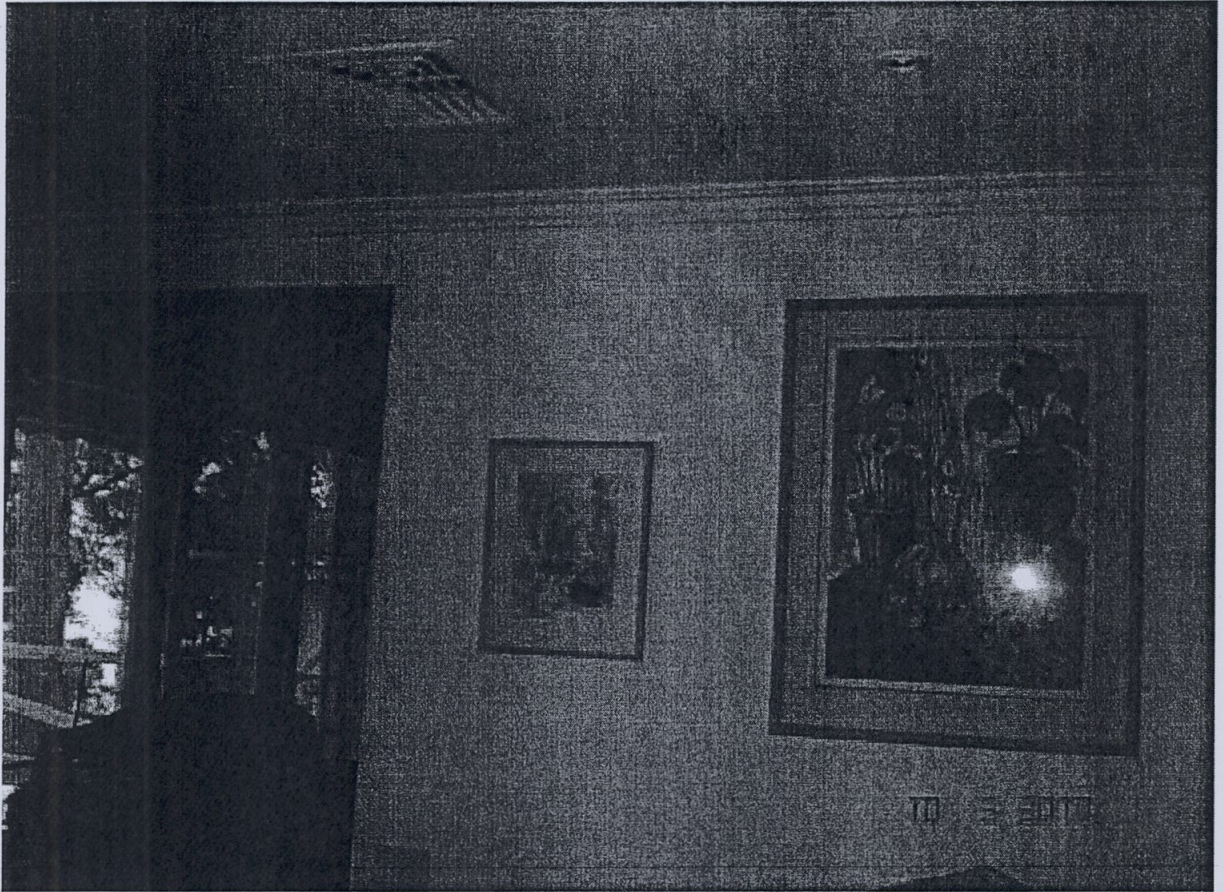
PHOTO 22: As previous.

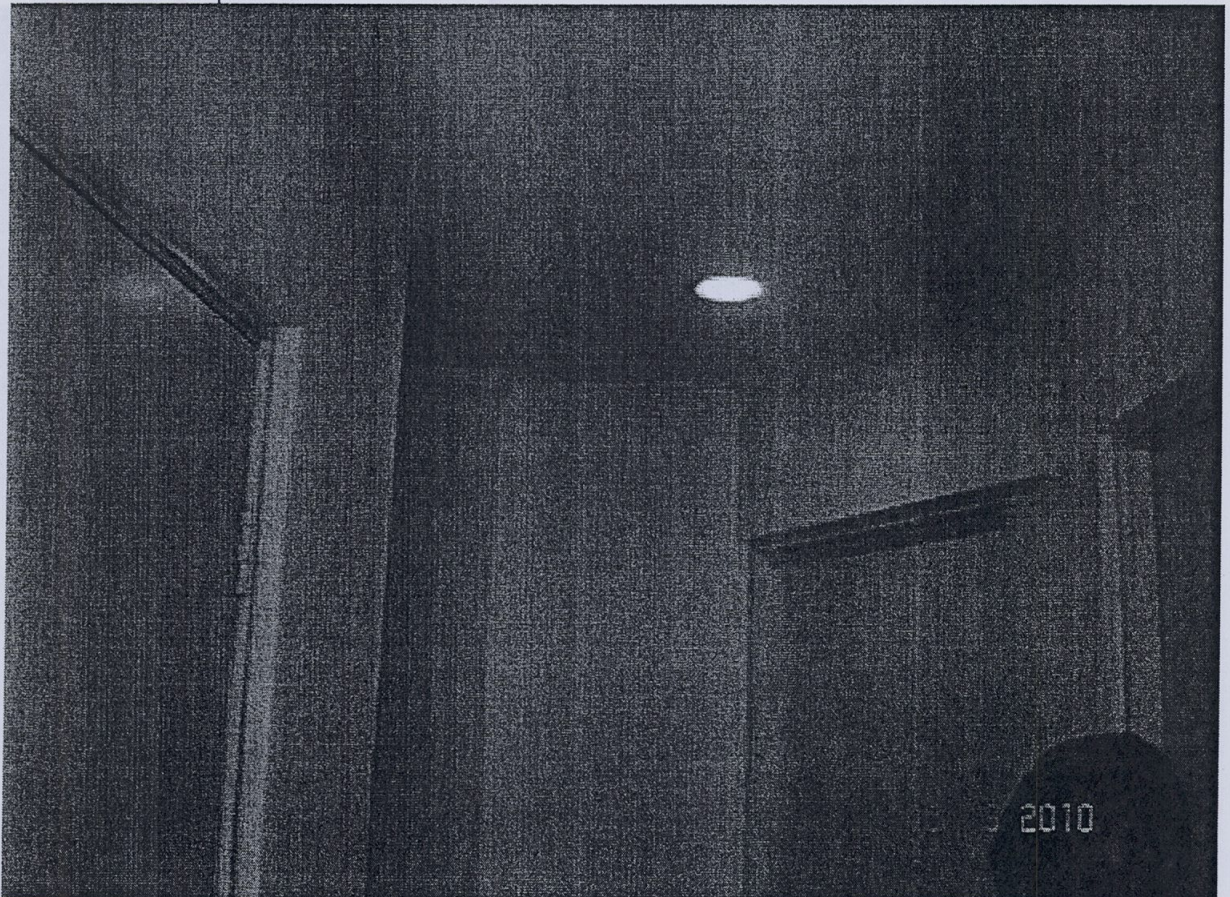
PHOTO 27: As previous.

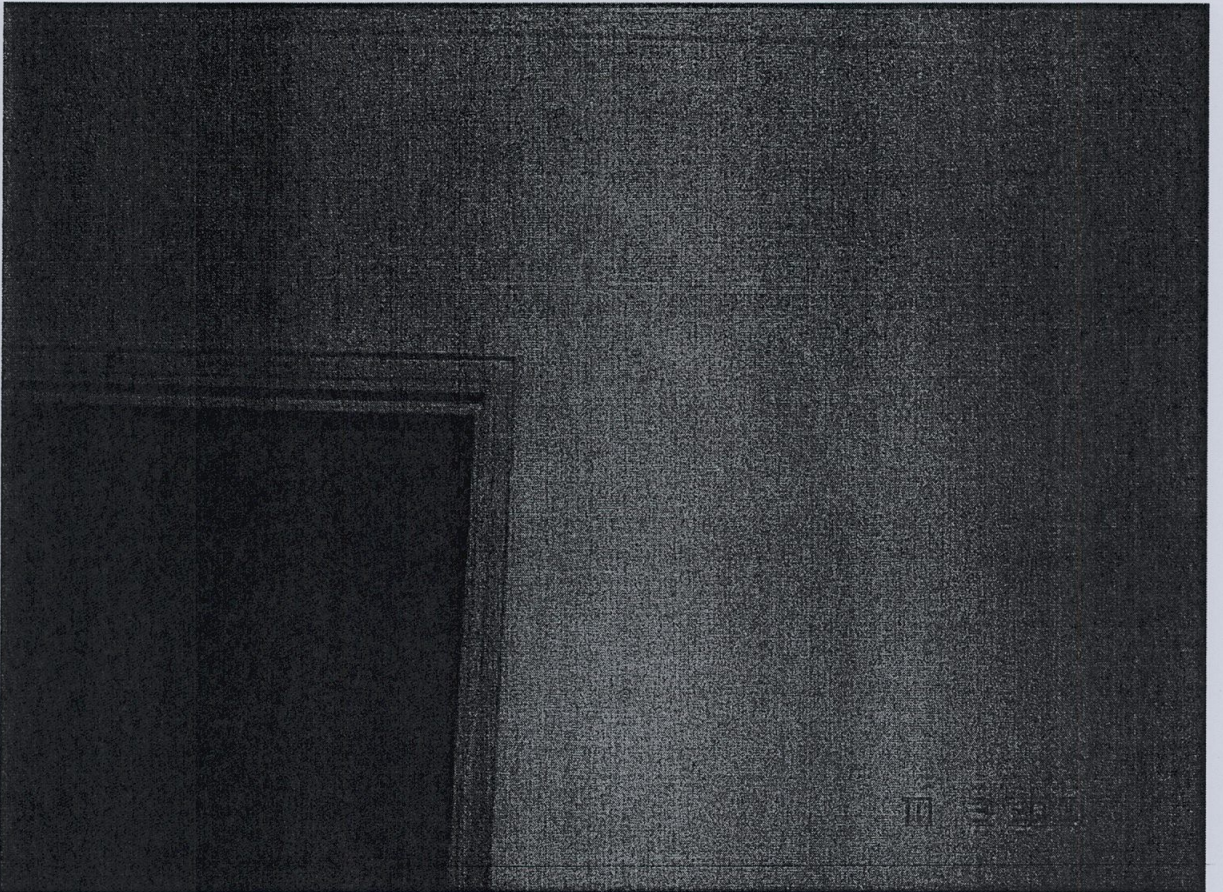
PHOTO 28: As previous.

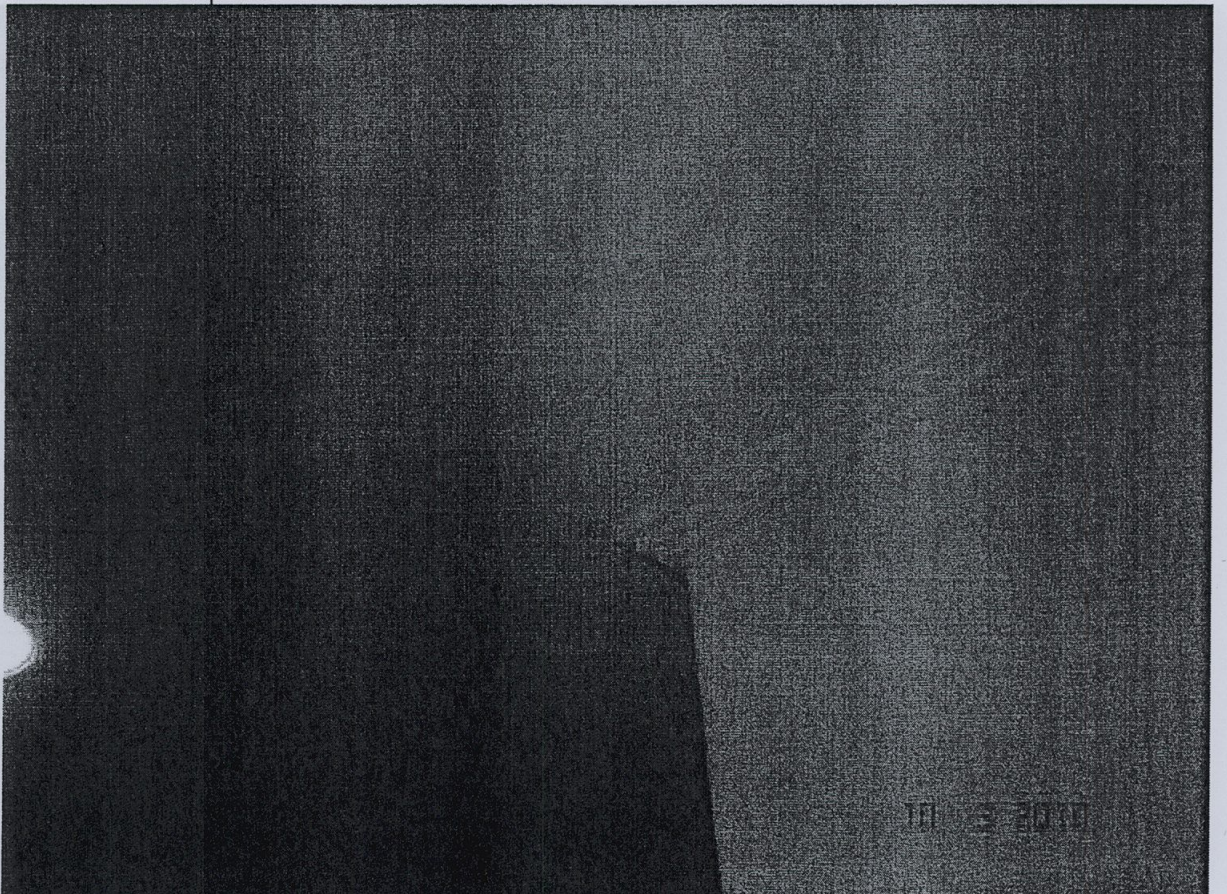
PHOTO 29: As previous.

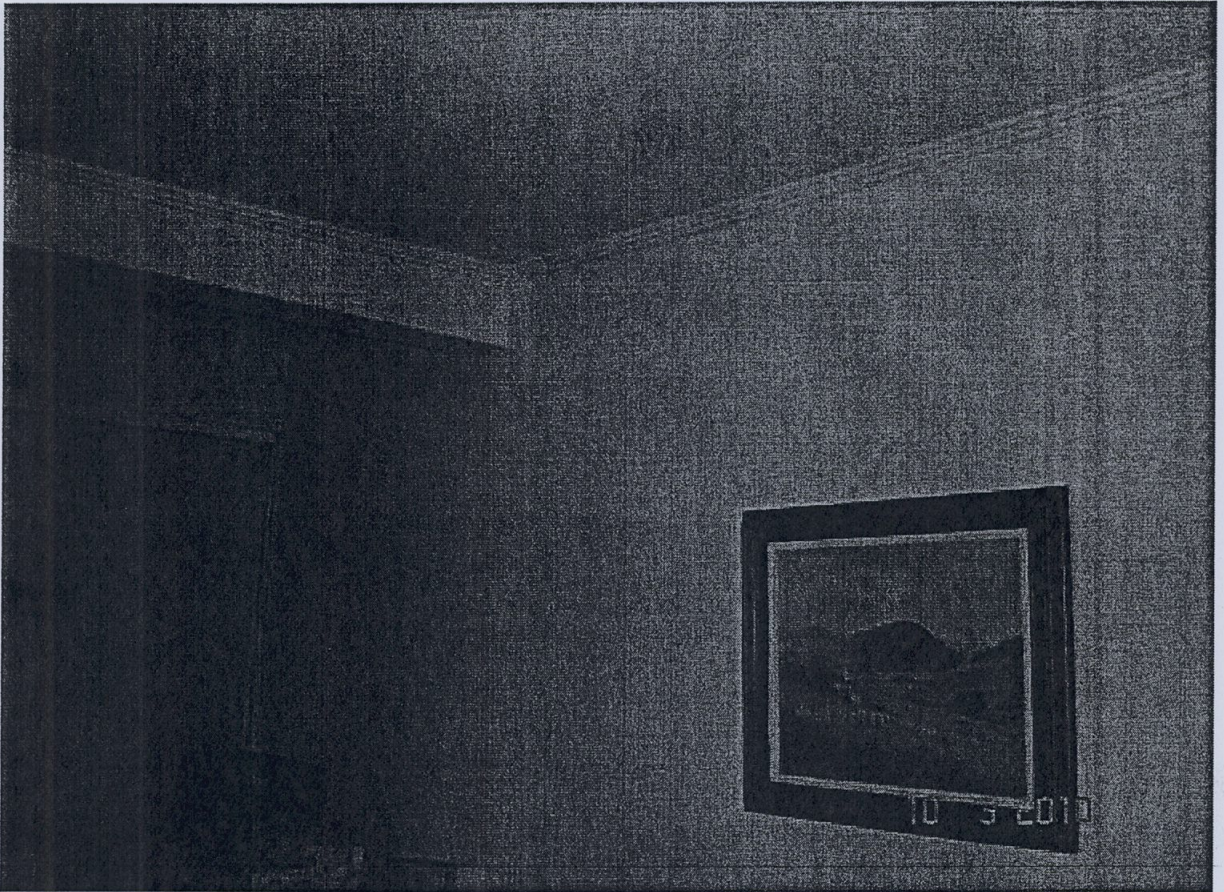
PHOTO 30: As previous.

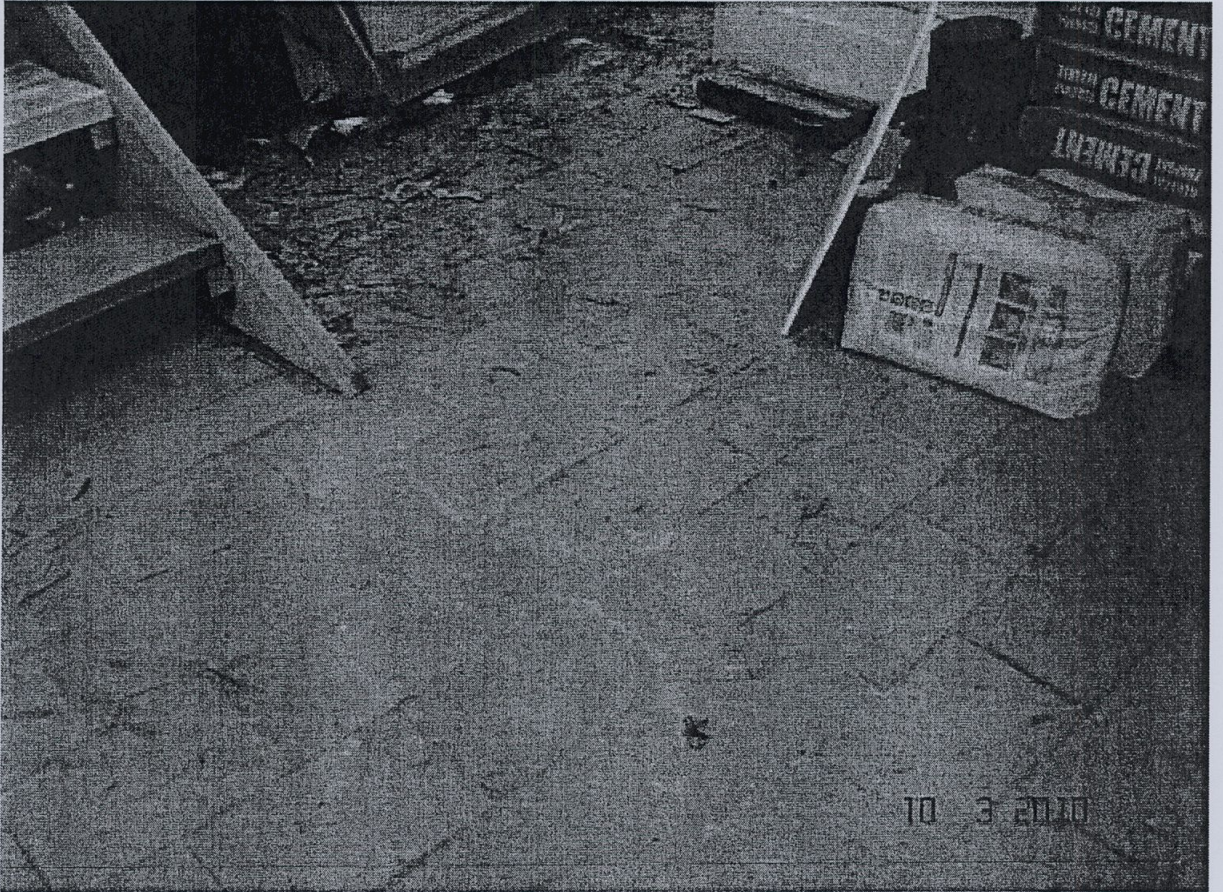
PHOTO 36: As previous.

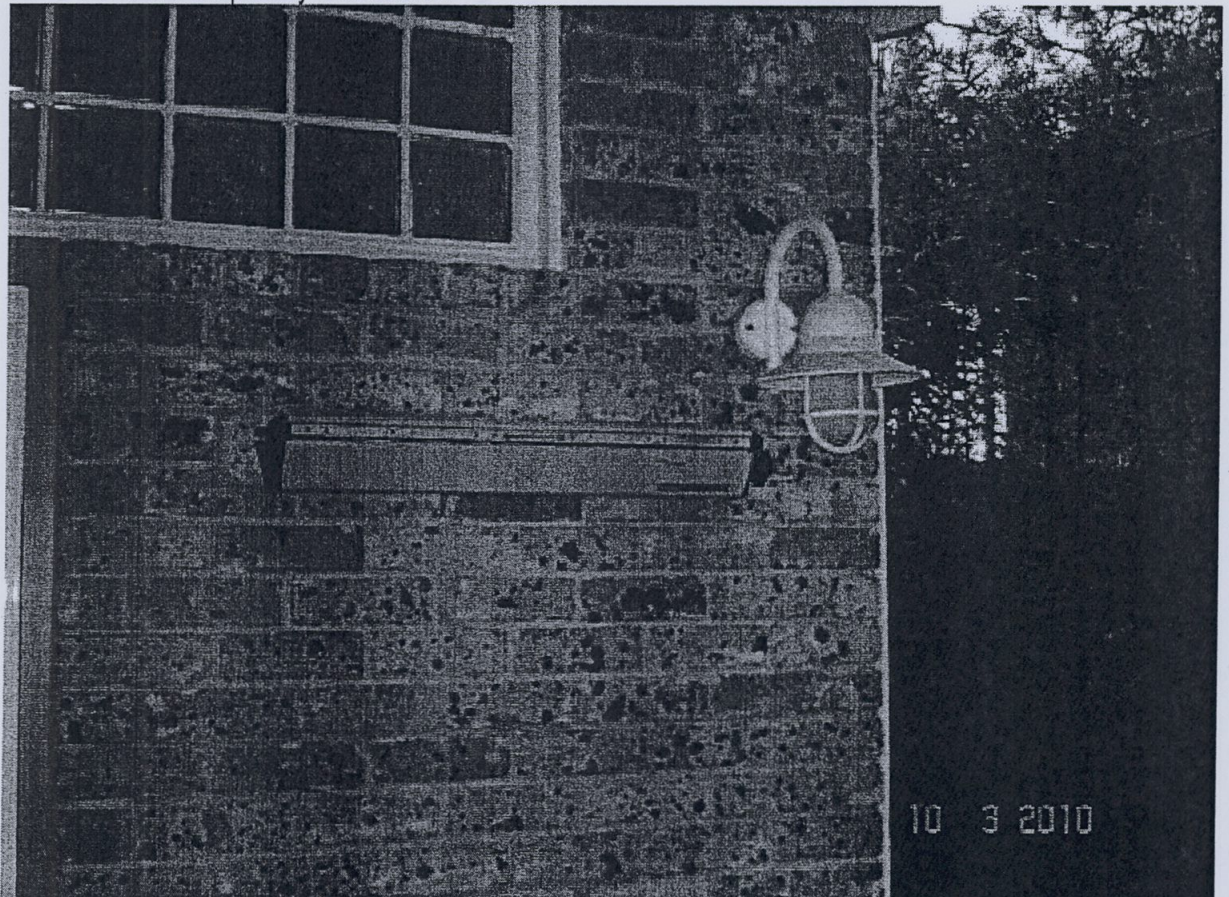
PHOTO 43: As previous.

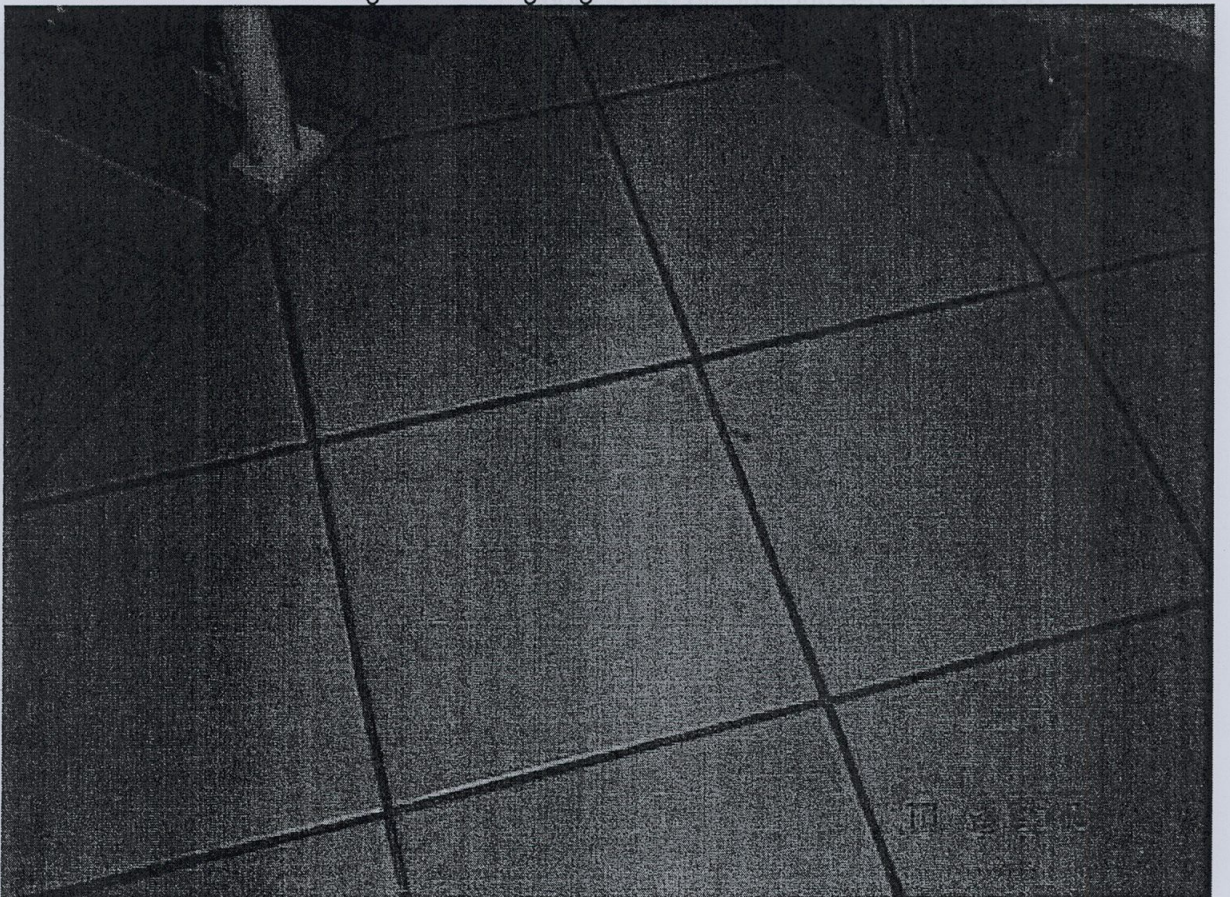
PHOTO 49: As previous.
